**FARM BUILDINGS AT MARR HALL FARM, MARR,  
SOUTH YORKSHIRE:  
AN ARCHAEOLOGICAL BUILDING RECORD OF  
ADDITIONAL BUILDINGS**

For: Mr and Mrs J Harrison

**CS Archaeology**  
December 2011

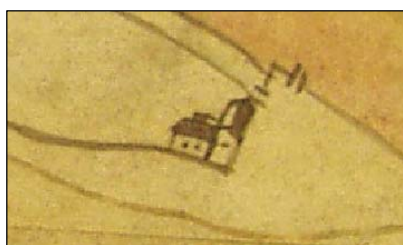
Extract from Figure 3, the plan of 1711

- 7.2 Probably the earliest depiction of Marr Hall Farm comes in the Marr estate map of 1711 where there is a depiction of two roofed buildings, the hall and a taller building closely associated, and set at right angles to the hall. Marr Hall lay within the fork of the road, with the gated northern road branching off towards the church. The two buildings, both with windows, were depicted with the church indicating the village's principal buildings. Lesser houses on the plan are depicted as a series of crosses along the north side of the road. It cannot be ascertained whether or not any of the buildings recorded in this report relate to the 1711 depiction. But it can be noted that the barn (Building 7) is still set at right angles to the hall and so these could represent the two buildings depicted.

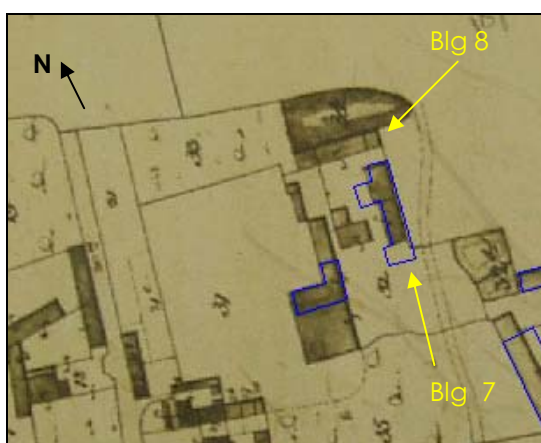
Extract from Figure 3, the 1845 tithe map with 1819 buildings in blue

- 7.3 It was not possible to reproduce the Marr estate map of 1819, the building positions have been noted and are represented in **Figure 3** (blue overlay see below). The farmstead enjoyed a very spacious layout, with good communications and had the benefit of two ponds. By 1819 the layout of the farmstead features Marr Hall with a group of four buildings east of the hall. The buildings include the barn (Building 7), a north-south building range, northeast of the house, which was still extant. Cartographically, the barn (Building 7) pre-dates the estate map of 1819 and may be represented by the taller building depicted on the 1711 map (above).
- 7.4 The first detailed view of the farmstead is noted on the Marr Tithe Map of 1845 (**Figure 3**: extract below).

- 7.5 Between 1819 and 1845 the hall was extended to the south together with a rear service range and detached dovecote. The shelter shed (Building 8) would appear to have been constructed between 1819 and 1845 and correlates very well with the present building.
- 7.6 The Ordnance Survey map of 1851 (**Figure 4**) shows there has been almost no change to the layout of buildings 8 and 9 apart from the construction of the Fruit Store (Building 11) in the northeast corner of the orchard which was laid out between 1845 and 1851 as a rectangular enclosure. Between 1851 and 1892 a further shelter shed (Building 9) had been built, in part, in front of Building 8.

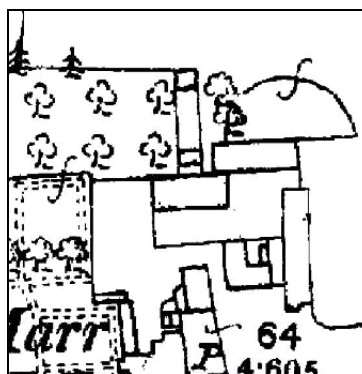
Extract from Figure 4, the 1892 map

- 7.7 A now demolished building, on the site of Building 10, a modern lean-to, was built in the southeast corner of the orchard and was first depicted on the Ordnance Survey map of 1892 (Figure 4). The former buildings walls are still in situ but assorted coping stones have now been appended to the lowered walls.
- 7.8 By 1966 the pond to the north of the first shelter shed (Building 8) had been bisected and the eastern end back-filled.

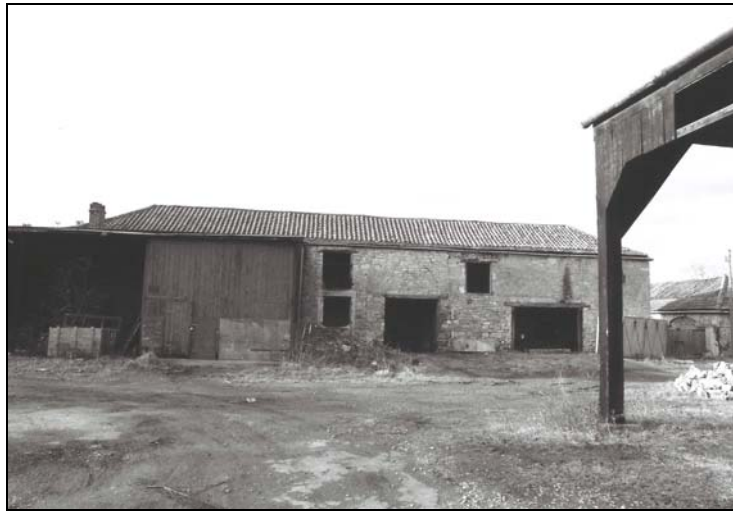
**Plate 50**, 238: the barn (Blg.7), view of the east elevation, from the east

- 8.1.2 The *East Elevation* (l 27.6mm x ht. to eaves 4.06m) can be divided into north and south sections. The southern section was built as a plain rear wall and this represents the latest historic building phase. This is denoted by a vertical building line and characteristic quoin stones (Figure 10: Plate 51, 236) that relate to the northern, 5 bayed section of the building (Plate 52, 237). The first bay features a chimney that relates to an internal fireplace. The heat from the fire has eroded the outer stone work which has been historically replaced in brick. Also at first floor level a window has been inserted, marked by irregular quoin stones. There is a vertical quoin building line between the 4<sup>th</sup> and 5<sup>th</sup> bays. The 5<sup>th</sup> bay features a window [6] at ground floor level with inserted doorway above. Window [7] features a rebated ashlar surround with in situ shutter hinges, and represents a historical insertion which probably dates to the early 19<sup>th</sup> century. Wide doorways have been inserted, at ground floor level, into the walls of the 6<sup>th</sup> and 7<sup>th</sup>/8<sup>th</sup> bays. To the 7<sup>th</sup> bay is a quoin doorway, this represents an original pitching door for the barn's first floor. Examination of the walls throughout the elevation failed to reveal any openings which would indicate original access points (apart from window [7]).

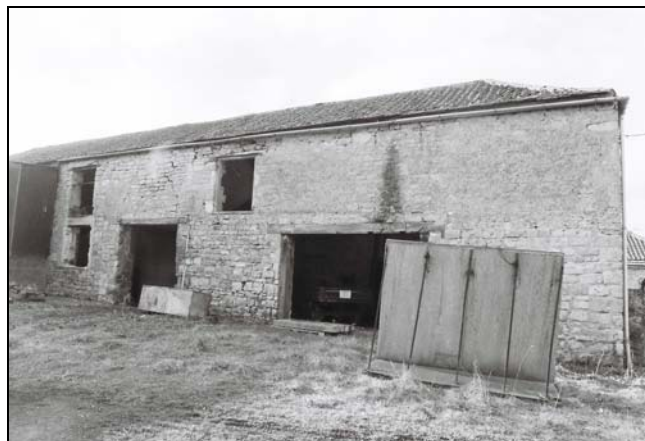
**Plate 51**, 236: the barn (Blg.7), oblique view of the east elevation, from the east

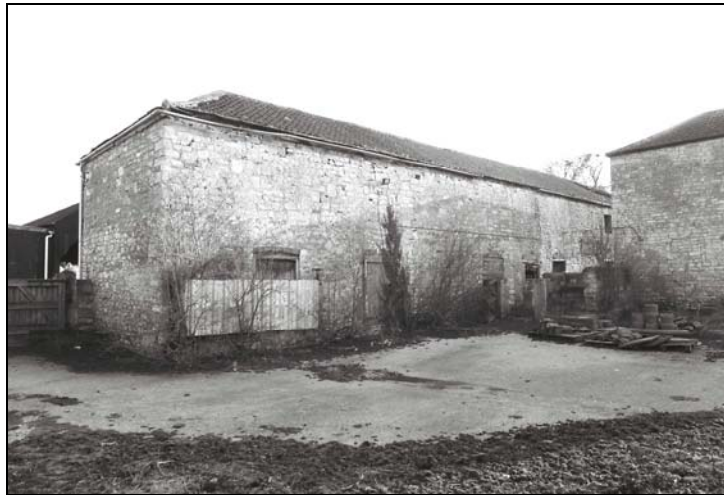
**Plate 53**, 275: the barn (Blg.7), oblique view of the west elevation (north end), from the northwest

- 8.1.4 The *West Elevation* features an array of inserted and original openings (Plate 53, 275). There are two original doorways [8&9] and these are characterised by chamfered quoined surrounds (Plate 54, 279). Interestingly the northern door [8] also features a plain moulded surround (Plate 55, 306). This surround probably denotes an original plaster line and is evidenced by diagonal tooling to facilitate lime render. The use of a rendered exterior is unusual and was employed post construction in order to emphasise this particular doorway (Figure 11 inset). Corresponding to the East Elevation is a quoined vertical building line marking two phases of construction. This would appear to indicate that the northern end of the building predates the southern half. The two windows to the ground and first floors appear to be historic insertions. Evidence for a triangular ventilator at ground floor level was discovered north of doorway [9] suggesting that originally the building had no fenestration to the west elevation.

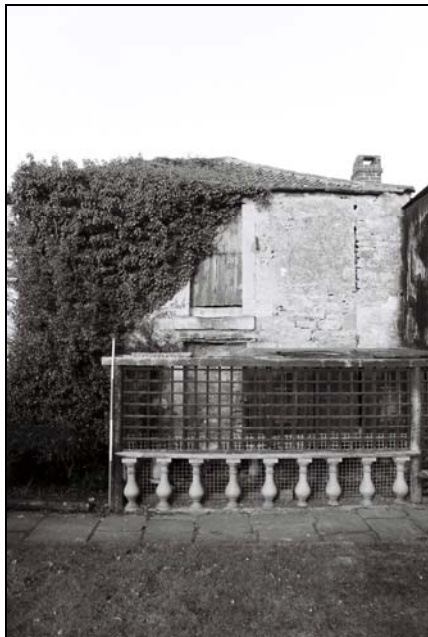
**Plate 56**, 280: the barn (Blg.7), view of the partially obscured south elevation, from the south

- 8.1.5 The South Elevation has been modified as evidenced by a quoined vertical building and blocked ground floor doorway [11] (Plate 56, 280). The historic map of 1919 confirmed that there was an addition to this elevation which had, by 1845, been removed. Doorway [11] would have accessed this addition and was probably blocked when the addition was removed. Both of the doorways [10 & 11] were historic insertions as evidenced by their ashlar surrounds, increasing internal light levels.

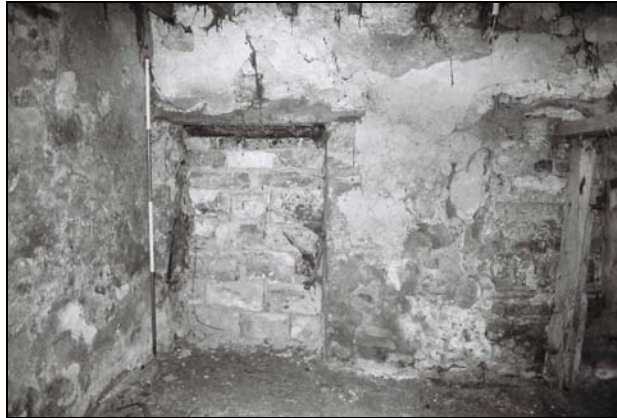
**Plate 57**, 240: the barn (Blg.7/39), view of the blocked doorways to the west wall, from the east

- 8.1.6 Room 39 (l 5.52m x w 2.55m x ht 2.4m) is situated at the southern end of the building, and is characterised by modified accesses. There is a modern concrete floor, the walls are of limestone rubble with an exposed ceiling. The ceiling features machine cut timbers indicating a late 19<sup>th</sup>/ early 20<sup>th</sup> century date. To the south wall is the blocked doorway [11] and the later inserted blocked doorway to the west wall which is adjacent to the original doorway [8] which was largely obscured (Plate 57, 240). The room's last function was as a cattle stall with a feeder trough along the east wall.

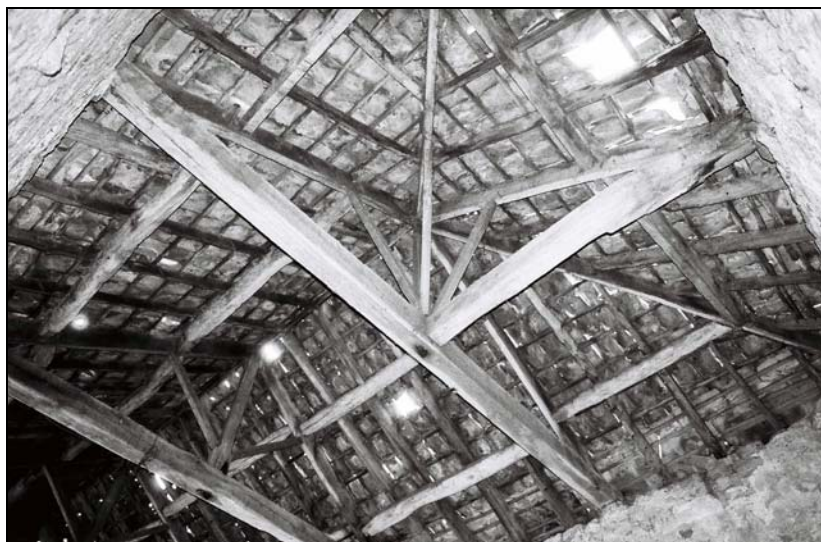
**Plate 59**, 305: the barn (Blg.7/44), view of the hipped roof from the ground floor, from the northeast

- 8.1.11 Room 44: (*l* 9.38m x *w* 5.1m x *ht* 4.7m) consists of a two storey barn with exposed roof and is positioned at the northern end of the building. The roof features four king post trusses with a half truss forming the roof's hip (Plate 59, 305). Graffiti has been historically carved into the tie-beam of a type 1 truss (Plate 60, 298) which records the name of 'T.Everitt..MH..A' . The blocked doorway to the west wall (Plate 61, 257) confirms that the transverse wall between rooms 41 and 42 is a modern insertion. Evidence in the form of brick alcoves, suggests the possible presence of either original alcoves or ventilators (Figure 9, a). Accesses have been heavily modified; there are inserted openings to the east and south walls. There is no evidence for original access points in the form of barn or winnowing doors, it therefore must be assumed that either the existing openings have removed, preventing original access flows to be extrapolated.

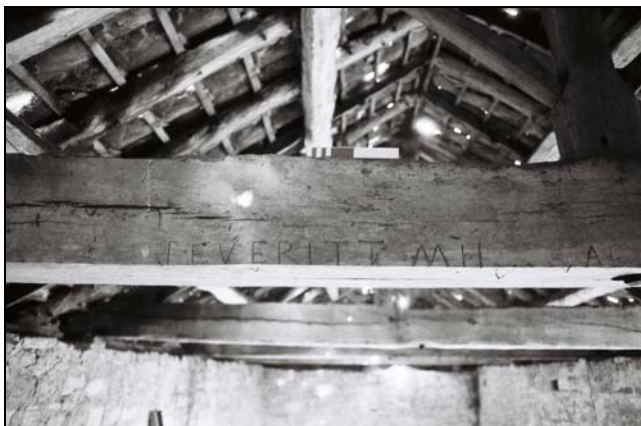
**Plate 60**, 298: the barn (Blg.7/46), detail of graffiti 'T.Everitt..MH..A' on south side of the tie-beam (type 1 truss) ,  
from the east

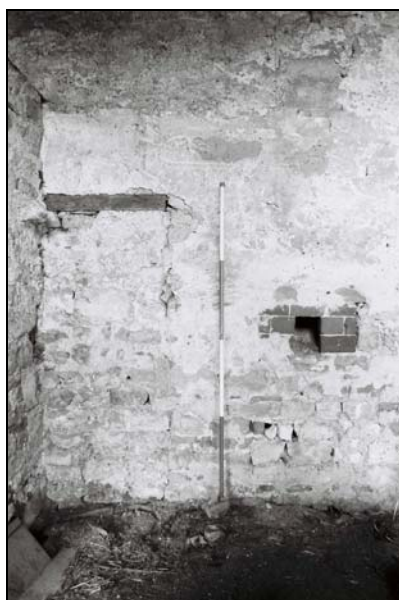
**Plate 61**, 257: the barn (Blg.7/44), detail of the blocked opening and brick opening to the west wall, from  
the east

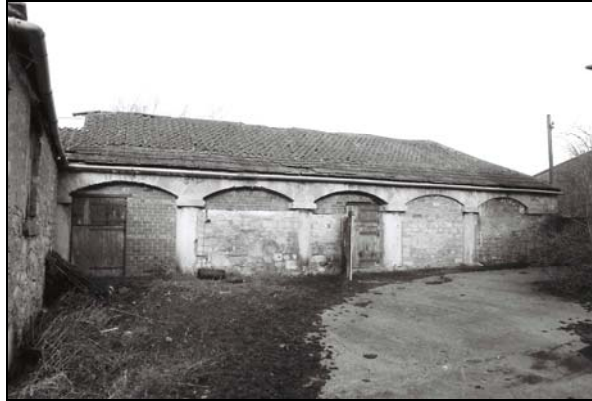
**Plate 62**, 273: the shelter shed (Blg.8), view of the front, south elevation with cylindrical piers from the south

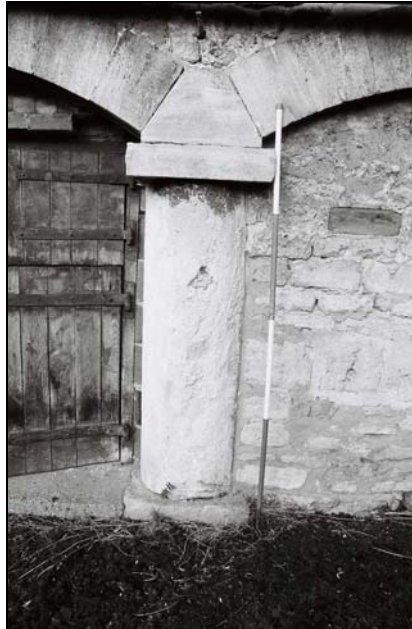
**Plate 63**, 288: the shelter shed (Blg.8), external detail of one of the cylindrical stone piers with square capitals, from the south

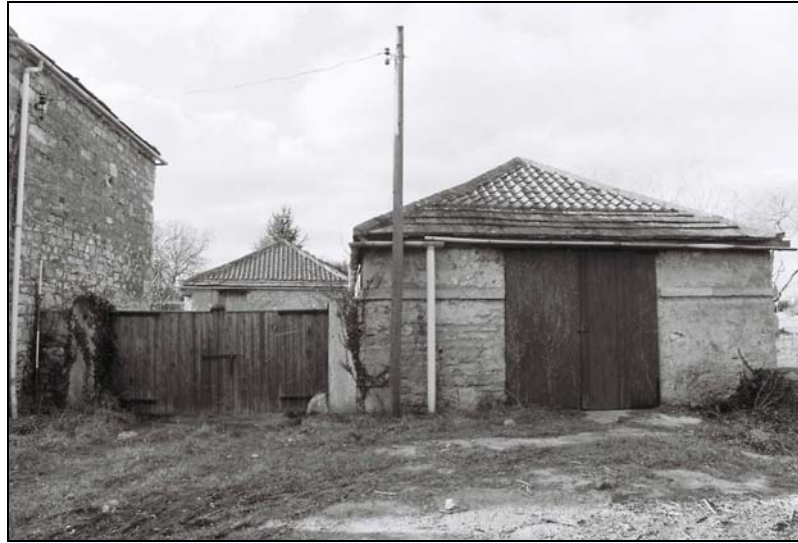
**Plate 64, 259:** the shelter sheds (Blgs. 8&9), view of the western elevations with string course to building 8, from the east

elevation. The *East Elevation* (Plate 64, 259) features an inserted doorway which has truncated the decorative string course. The gate piers are still in situ and feature wheel diverts in order to safeguard the piers from damage from passing cart hubs. The *North Elevation* abutts the historic pond (which is now dry) and features three inserted windows. Whether or not these were enlargements is unknown. The *North Elevation* could originally have been plain without a decorative string course. The *North Elevation* has no plain wall, the decorative string course seen in the south and east elevation is not carried through. The *West Elevation* was also originally plain (Plate 65, 314) but has been breached by the insertion of two doorways, one of which was historically blocked.

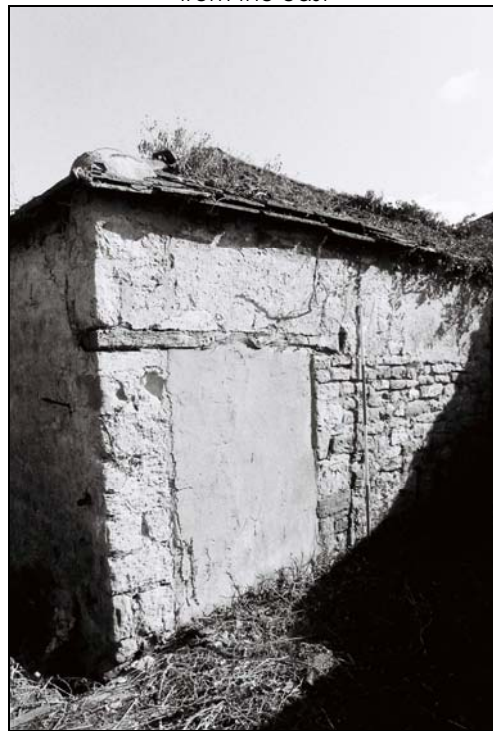
**Plate 65, 314:** the shelter shed (Blg.8), view of the west *elevation* with an inserted and blocked doorway, from the northwest

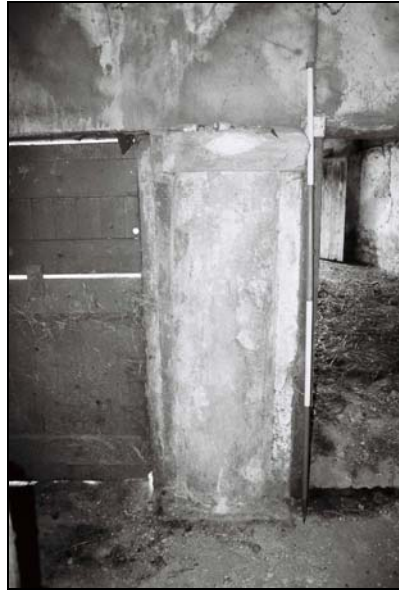
**Plate 66**, 265: the shelter shed (Blg.8), detail of one of the protruding stone piers to the south wall, from the north

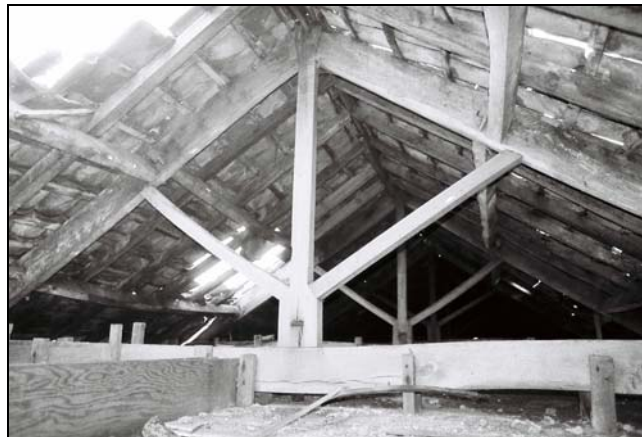
**Plate 67**, 310: the shelter shed (Blg.8), general view of the roof with type 1 trusses, from the west

- 8.2.3 Room 47 (l 19.5m x w 5.5m x ht 2.51m) forms a single space which has been subdivided into concrete and steel barred pig stalls with a concrete walled annexe for the electrical transformer. Little remains of the historic fabric apart from the half exposed piers to the south wall (Plate 66, 265) which are 1.6m in height. The walls have been cement rendered and there is a modern insulated suspended ceiling. There are three 4-light inserted windows, with a top internal opener, to the north wall. Above the ceiling views the original hipped roof were recorded and this featured type 1, king post roof trusses (Plate 67, 314).

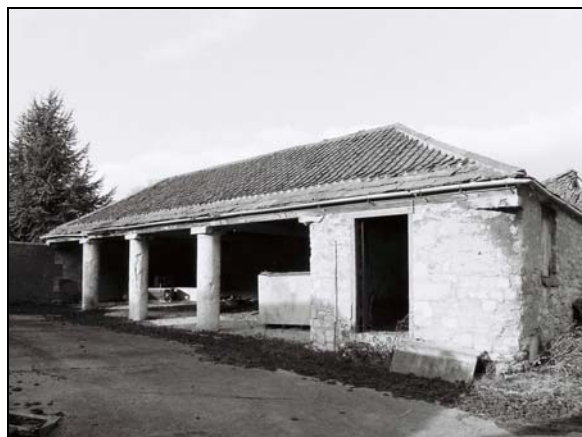
**Plate 68**, 272: the shelter shed (Blg.9), general view of the front, south elevation, from the southeast

- 8.3.2 The front *South Elevation* features four square headed openings supported by three imposing limestone cylindrical piers (Plate 68, 270). The East Elevation features a window but the north and east walls are featureless apart from the hipped roof (Plate 69, 283).

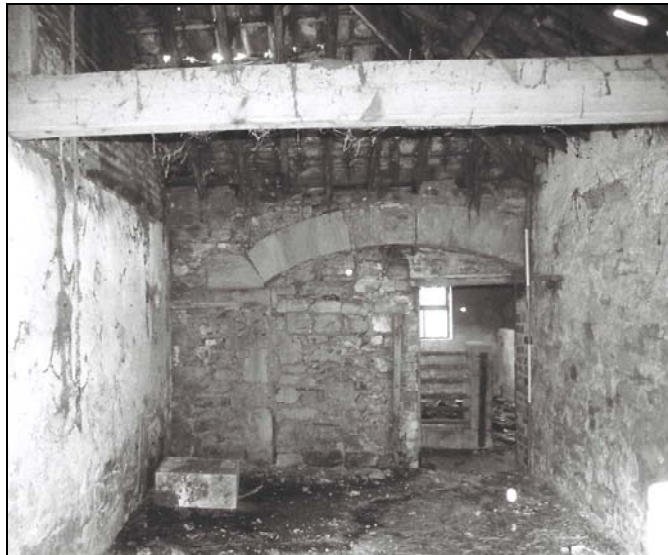
**Plate 70**, 264: the shelter shed (Blg.9/48), general view with the blocked arch to the north wall from the south

- 8.3.3 Room 48 (l 6.54m x w 3.18m x ht 2.27m) consists of a concrete floor with rubble walls which in places still has lime plaster adhering. There is no ceiling and the hipped roof is exposed to the rafters. The exposed half truss features stopped chamfers to the tie-beam. An interesting feature of the stable is the round corners to the south wall. The doorway is positioned to the centre of the south wall and has splayed reveals. To the east wall is a boarded up 3-light window. The north wall still retains the western, part blocked archway of the first shelter shed (Building 8: Plate 70, 264).

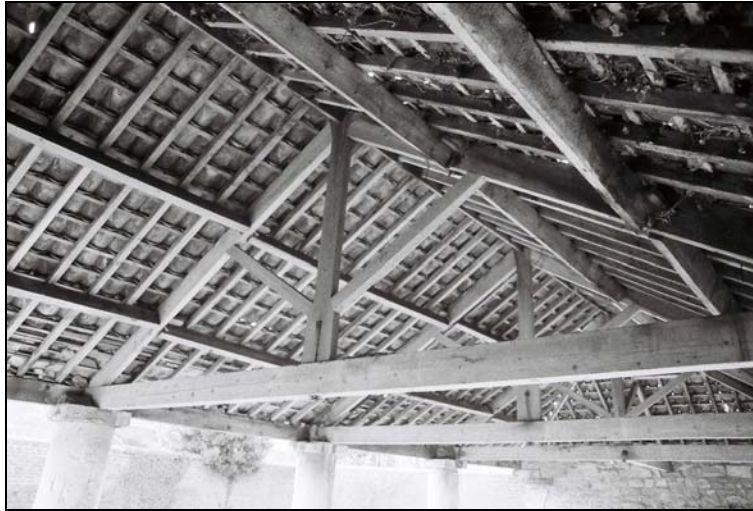
**Plate 71, 268:** the shelter shed (Blg.9), general view with the exposed roof, from the north east

- 8.3.4 Room 49 represents a 4 bayed open fronted shed with an exposed roof (Plate 71, 268). There are three extant piers along the south 'wall' that still retain their original tooling marks (e.g. Plate 72, 271). The north wall has a wide doorway and this exists to the north via the west wall of the earlier shed (Building 8). There is an earth floor and exposed rubble walls

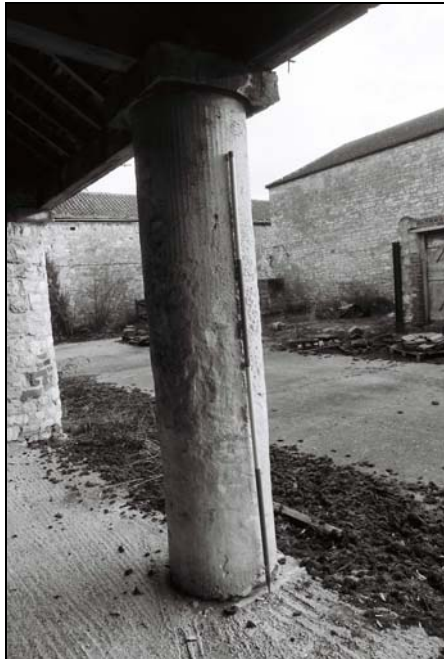
**Plate 72, 271:** the shelter shed (Blg.7), from the east

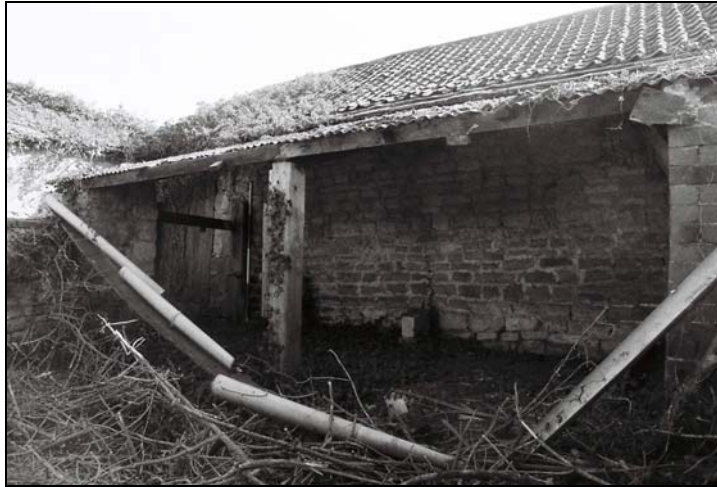
**Plate 73, 313:** the shed (Blg.10), general view, from the northwest

8.4.1 This represents a modern lean-to stable (Plate 73, 313) which was built on the site of a Victorian building which together with building 10 (below) was annexed from an regular enclosure northwest of the farm house, to form an orchard between 1845 and 1851 (Figures 3 and 4).

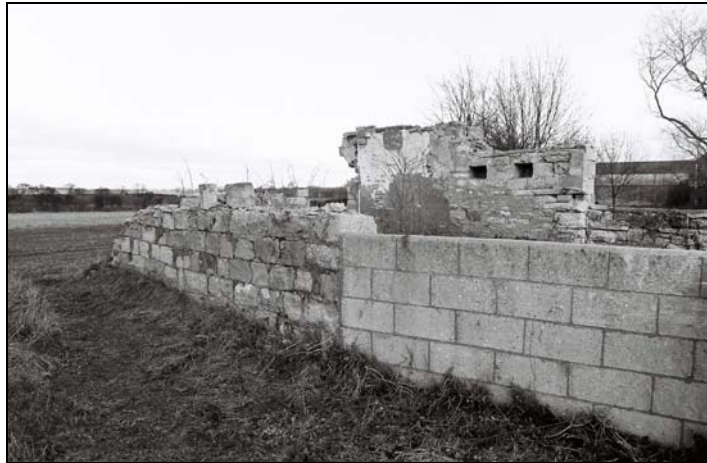
**Plate 74, 285:** the fruit store (Blg.11), general view, from the east

8.5.1 This former store featured a pyramidal roof above well coursed ashlar limestone walls with quoins (Plate 74, 284), similar in nature to the rebuilt east elevation of the barn (Blg. 2). It is in a rapidly deteriorating condition, the roof and upper walls are no longer in situ. The building appears to have been two storied, as evidenced by possible joist holes to the east wall and was internally plastered (Plate 75, 285).
