STUD FARM, CARLTON, BARNESLEY, SOUTH YORKSHIRE: AN ARCHAEOLOGICAL EVALUATION AND PHOTOGRAPHIC SURVEY

CS Archaeology
November 2012

Project Number: 108

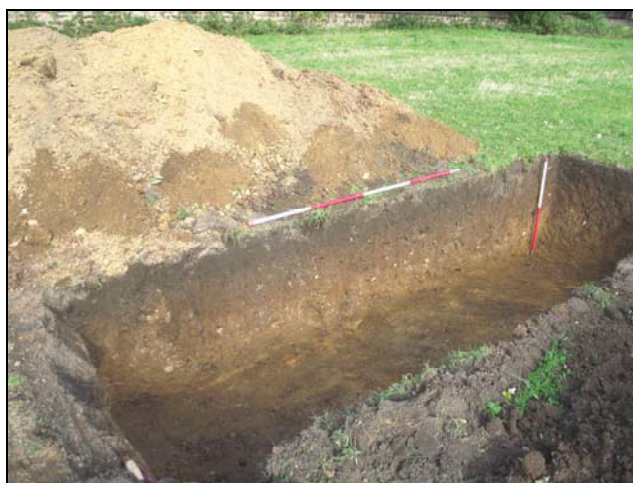
6.3 Trench 1 (**Figure 12**) was excavated from the east, its stratigraphy was characterised by fairly level deposits of top soil and plough soils. Natural sands and gravels [103] lay between 0.7 and 0.8m below the surface (**Figure 12**). Because of geological variations, the bottom of the trench was extended to ensure the natural substrate had been reached. The top soil [100] extended up to 0.22m below the surface, and the subsoil extended throughout the trench at a constant depth of c0.5m. The consistency and gradual interface between the sub soil and natural suggests the development of a plough soil which had truncated the natural [103].

Plate 50, 169: Oblique view of the southeast facing section, from the southwest

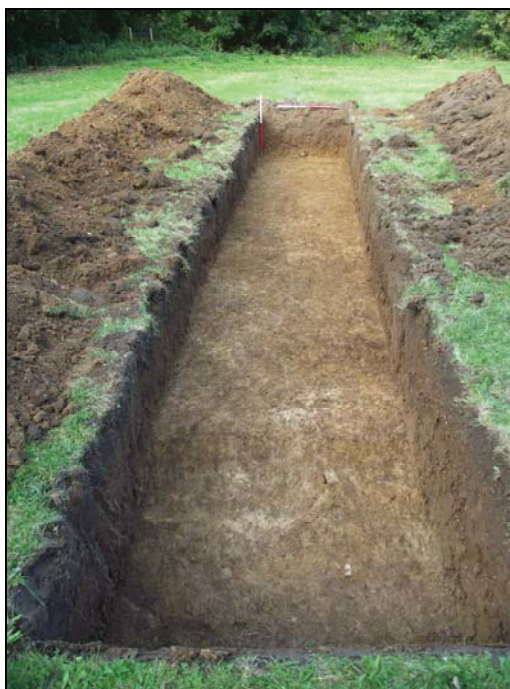
6.5 Trench 2 (**Figure 12**) was opened from the south; a sondage was employed to check the natural substrate had been reached. As with Trench 1, no significant archaeology was revealed, and the trench revealed an unremarkable section through leveled arable, notable only by an absence of settlement evidence. Because of the alignment between trenches 1 and 2 any potential evidence for fields systems, furrows in particular, would be expected to be revealed.

Plate 51, 170: Post-excitation view, from the south

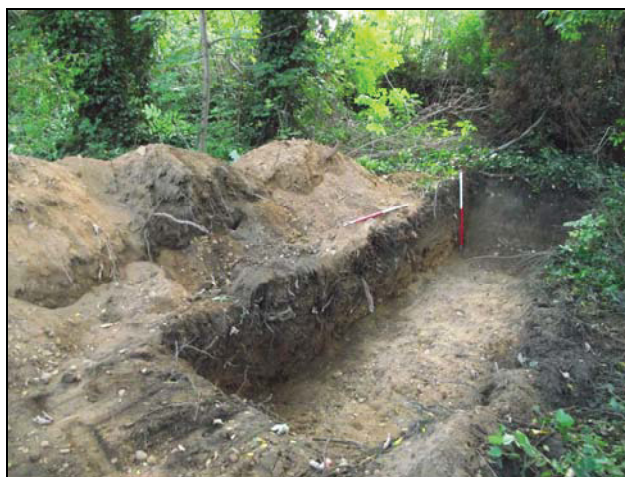
- 6.7 Trench 3 (Figure 13) was excavated within an area of mature woodland. As a result the soils were very dry and had been heavily disturbed by root activity. At the western end of the trench the natural lay just 0.35m below the surface. This increased to 0.5m at the eastern end and appears to represent a natural rise in the topography which was probably modified by anthropogenic activity (ploughing /garden landscaping).

Plate 52, 171: Post-excitation view, from the north east

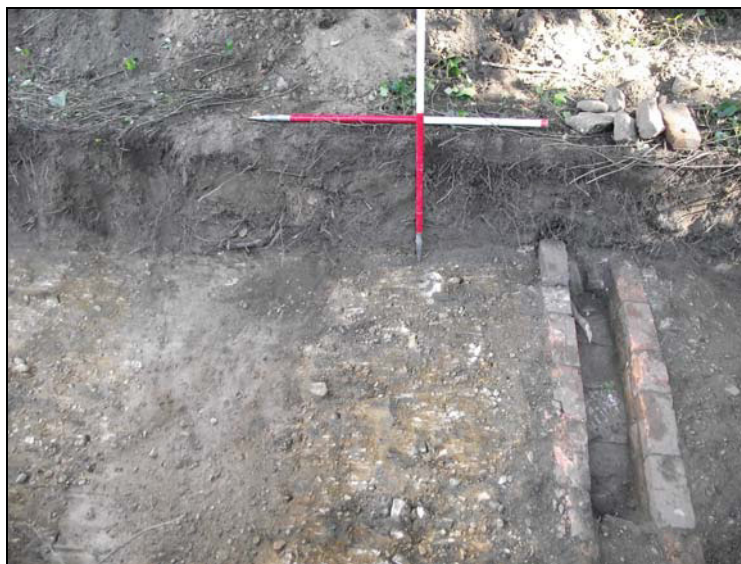
- 6.8 Trench 4 (Figure 13) was also excavated close to mature trees, so had also been affected by frequent root action. The natural substrate was revealed 0.6m below the surface. Two linear features, a ditch [404] and a drain [405], with similar alignments, were revealed. The drain [405] was very well built and featured a 1m wide flagstone 'floor' with two walls of coursed brickwork which extended up to three bricks high (0.35m) creating a channel 0.3m wide. The central channel was

cleared of fallen in bricks and further flagstone fragments, possibly from flagstone capstones. No in situ evidence for the flagstone capstones was found. North of the drain [405] was a further feature defined by a well defined cut [404] to the northern side and a sandy fill. Clearly affected by root action this ditch like feature either predated the drain [405] or was constructed later as a relief drain following a possible blockage.

Plate 53, detail of the brick lined drain [405]

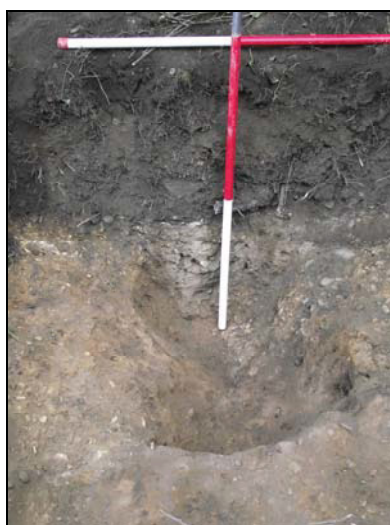
Plate 54: Post Excavation view of the adjacent drain [404]

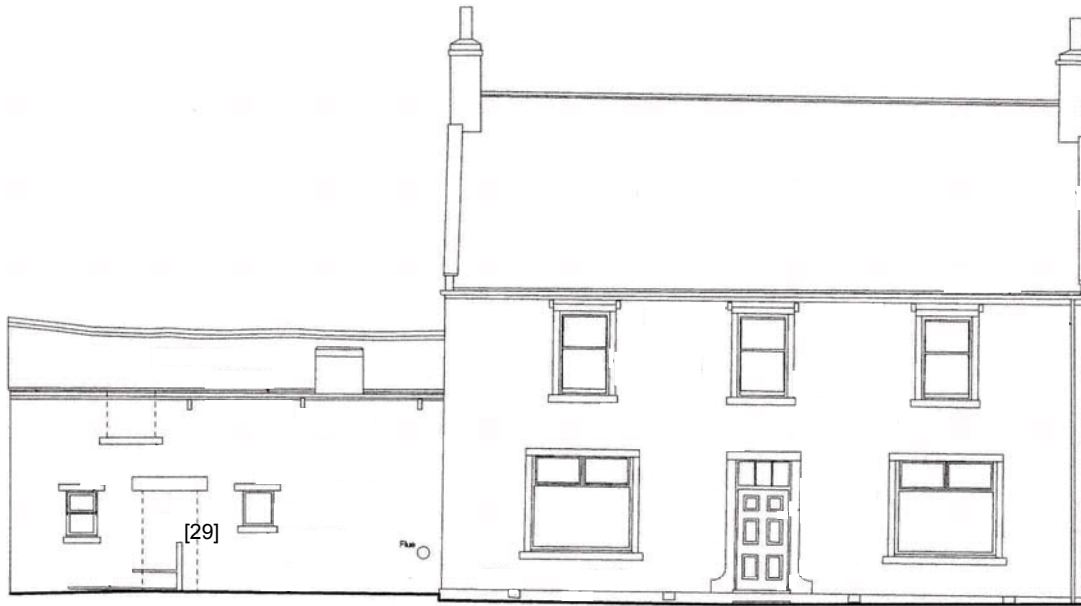
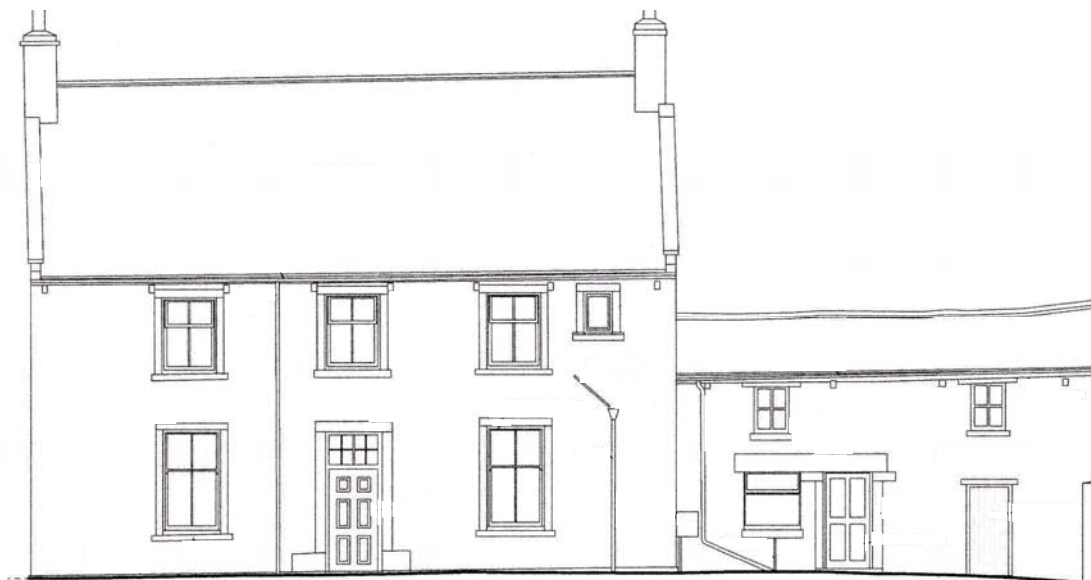
Figure 5: The Farmhouse
(Blg A) Front and Rear
Elevations

The Front, Southwest Elevation

The Rear, Northeast Elevation

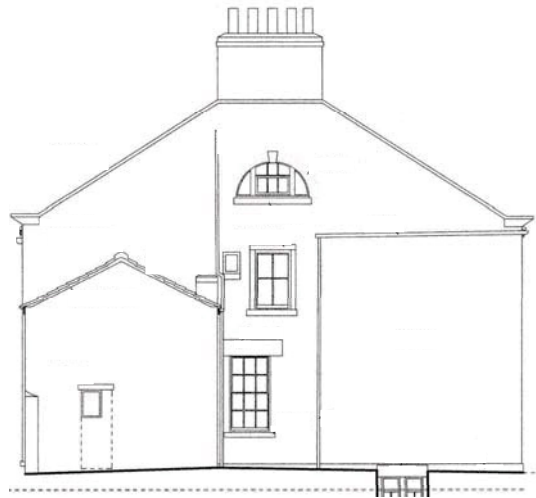
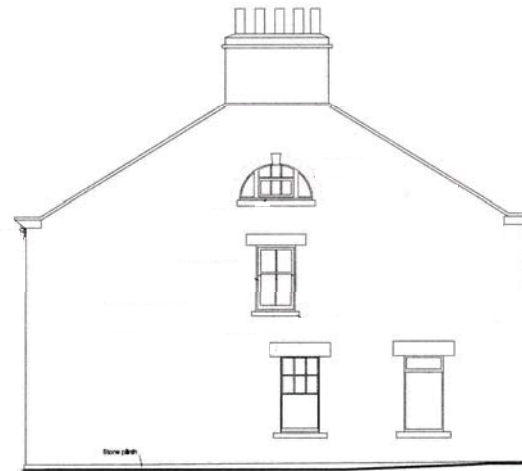
Figure 6: The Farmhouse,
Gable Elevations and Cross-
section

The Northwest Elevation

The Southeast Gable Elevation

Cross Section A-B

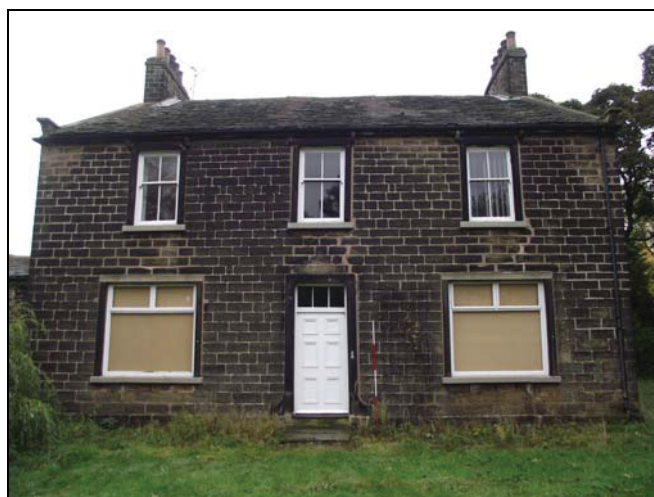
- 5.1.4 The front *Southeast Elevation* is very well proportioned with a central doorway, two ground floor windows and three first floor sash windows (**Figure 5: Plate 1, 159**). The elevation's appearance has been greatly affected by the widening of the two ground floor windows and insertion of two casement windows. The walls are of well coursed stone below a flag stone, gabled roof featuring moulded kneeler stones and a stone cap to the gables. The two chimney stacks were built flush with the gable, ensuring clean crisp lines to the design, and feature string courses to the top of the stacks. The front six panelled door has a top light and ashlar stone surround which features a graceful lower splay (**Plate 2, 161**) resting on the continual plinth.

Plate 1, 159: View of the front Southwest Elevation, from the southwest

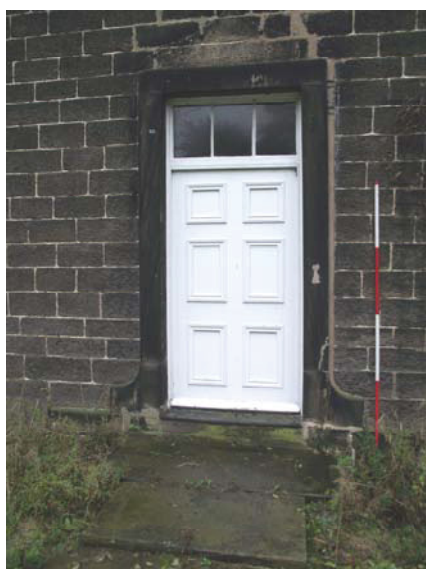
Plate 2, 161: Detail of the front door, from the south southwest

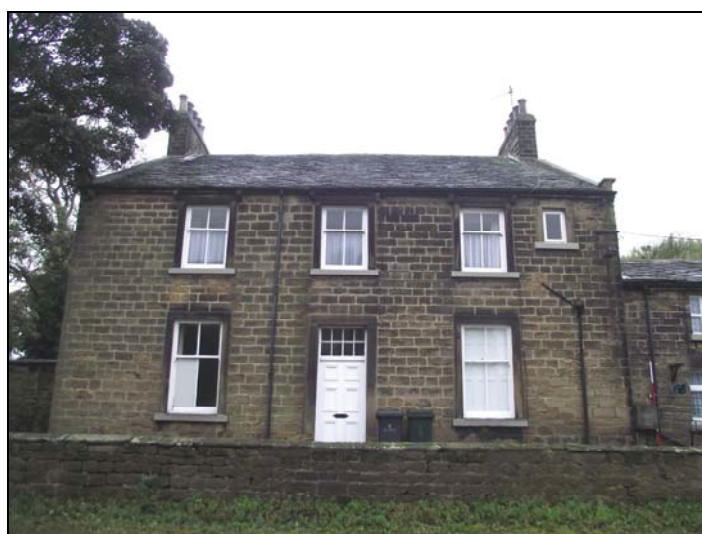
- 5.1.5 The rear, *Northwest Elevation* retains its classically proportioned Georgian architecture but rear door loses its splayed surround, represents a mirror image to the front elevation (**Figure 5: Plate 3, 136**), unaffected by the widening of the ground floor windows. The original fenestration is evident; flush ashlar surrounds with projecting cills and standard widths, but with taller ground floor windows. The first floor sash windows are all vertical sliding sashes and appear to be all original, apart from the inserted bathroom window (top right). In front of the elevation is a raised flagstone terrace (**Plate 4, 138**), which separates the house from the farmyard to the northwest, by a low sandstone wall. Built into this wall is a stone mounting block (**Plate 5, 139**).

Plate 3, 136: View of the rear Northeast Elevation, from the northeast

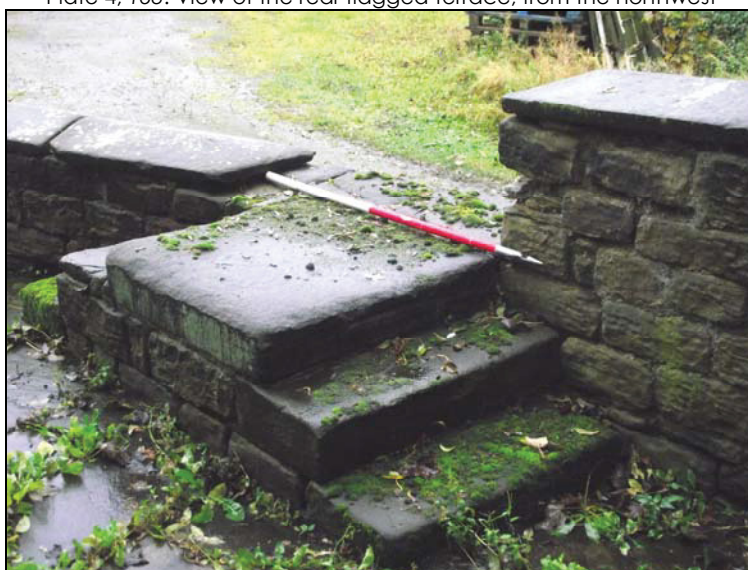
Plate 5, 139: View of the rear flagged terrace, from the southwest

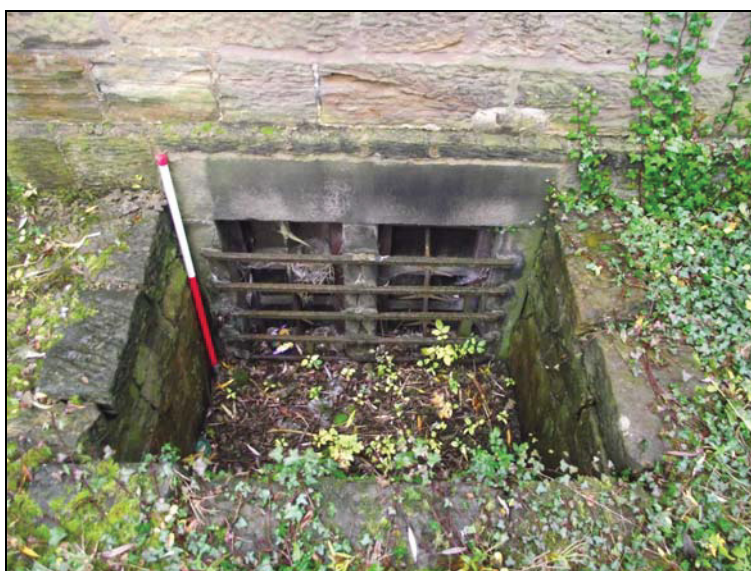
Plate 6, 155: Detail of the cellar window with defensive bars and spikes, from the northwest

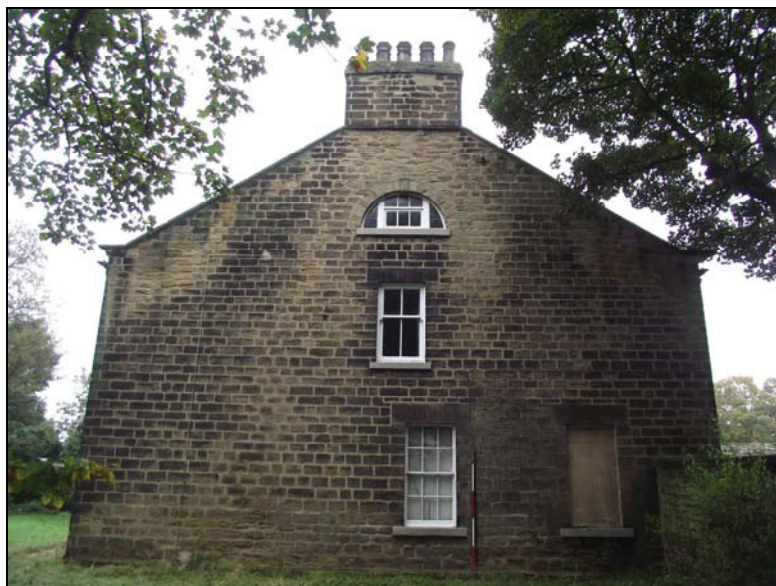
- 5.1.7 The *Northeast Gable Elevation* (**Plate 7, 162**) has not been affected by subsequent building, and the original fenestration is evident. This consists of two windows to the ground floor. The un-boarded window to the ground floor features a 12-light vertical sliding sash and contrasts with the 4-light Victorian window to the first floor. The chimney stack features the two string courses with 5 chimney pots, which mirrors the *South West Elevation*.

Plate 7, 162: The Southeast (gable) Elevation, from the southeast

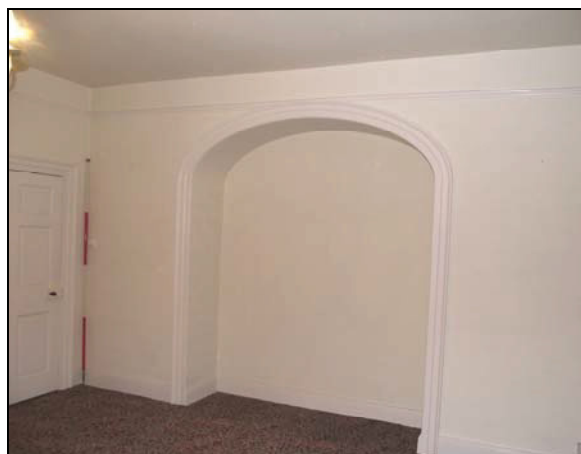
- 5.1.9 Room 2 (*l* 5.47 x *w* 4.58 x *ht* 2.8m) was one of the two principal rooms and probably served originally as the *Dining Room*. Access is from the hall via a type 1,¹ six panelled door. Type 1 doors are associated with the principal accommodation (e.g. ground floor rooms 1-3). There is no longer a fireplace but the chimney breast is still extant (0.4m) to the southwest wall. The original fireplace has been replaced by a 20th century tiled one. The room is well illuminated by the widened window (c. 1970/80) to the southwest wall. The northeast wall features an arched alcove (*w* 2m x 2.4m) (**Plate 9, 25**).

Plate 9, 25: General view of the *Dining Room* with the arched alcove to the northeast wall, from the south

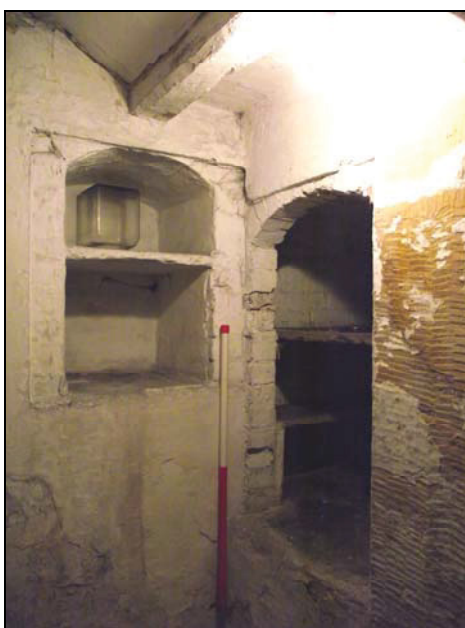
- 5.1.12 The *Cellar Stairs* (Room 5: *l* 3.7 x *w* 0.85 x *ht* 1.84m) feature a series of 12 worn stone steps that turn right into the two cellar rooms (6a & 6b). Towards the bottom of the steps to the southern corner are two arched recesses (features 1 & 2: **Plate 12, 34**), that probably served originally as lockable spirit cupboards and could be readily accessed without going into the main cellar.

Plate 12, 34: View of the arched alcoves originally probably representing lockable spirit cupboards [1-2], from the north

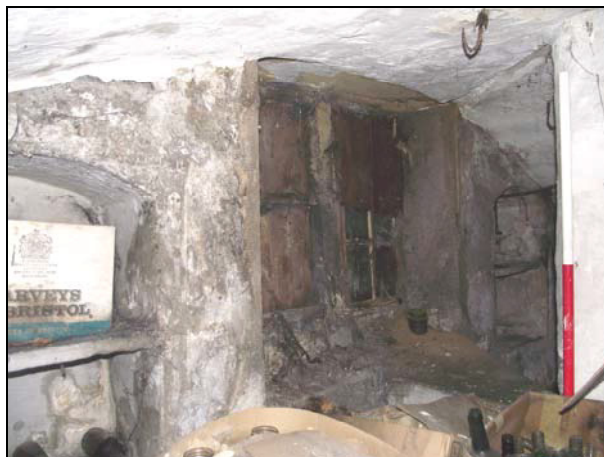
- 5.1.13 The *Cellar* (Room 6: *l* 4.42 x *w* 5.17 x *ht* 2.1m) features a vaulted brick ceiling supported by 0.38m deep sandstone walls. All the walls have been successively lime washed. The cellar is divided by a central brick wall with the remains of a doorway to the southeast end. There is a flagstone floor throughout and natural light is provided by the mullion window to the northwest wall **Plate 13, 36**). The entrance

Plate 13, 36: View of the mullion window, from the south

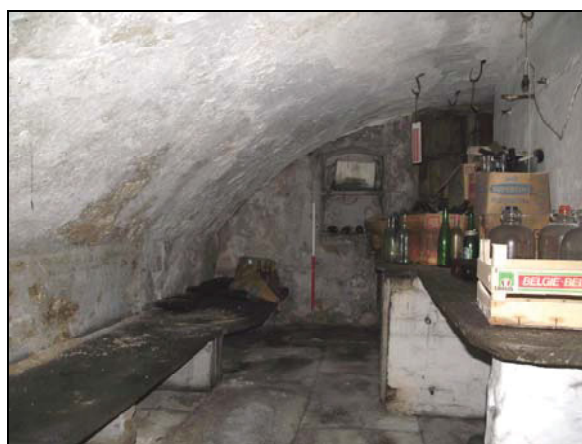
doorway no longer has its door but still features ashlar and chamfered sandstone masonry. There are a series of stone tables that rest on brick walls to room 6a (**Plate 14, 35**). The tables are higher along the northeast wall and these higher tables lie beneath a series of meat hooks. The cellar also features a series of arched alcoves [3-5], smaller than the spirit cupboards [1 & 2] with no evidence (wall scars) for doors. Since its initial construction the only modifications to the cellar appear to be the removal of the 2 internal doors and those to the spirit cupboards and the removal of one cold table to the southern corner of room (6a), everything else remains original and represents a significant survival.

Plate 14, 35: General view of the western cellar, from the southeast

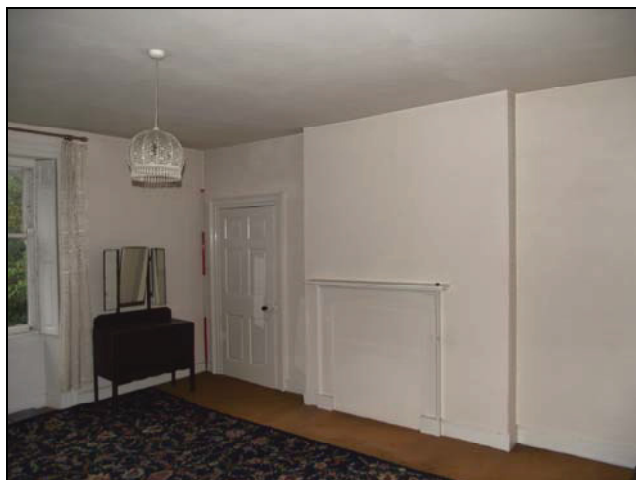
- 5.1.21 The *Principal Bedroom* (Room 14: l 5.1 x w 4.55 x ht 2.6m) is situated at the western corner of the building and is in good condition. Features include an original fire surround [7] with deep simple mouldings and a mantle piece with plain rounded corners (**Plate 19, 50**: w 1.2m x 1.2m ht). There are deep moulded skirting boards throughout the room. The fireplace is boarded up but the stone hearth is evident beneath the carpet. Also to the northeast wall is a recessed wardrobe with a type 1 door, featuring a horizontal batten at head height and six inclined notched wooden pegs. To the northeast wall are two further doorways, to a dressing room and to the rear hallway (Room 18, originally the service staircase). The dressing room is naturally illuminated by its relatively large sash window with over-painted and sealed in, three paneled bi-folding shutters. The main room also has an original window to the centre of the southwest wall.

Plate 19, 47: General view with fireplace [7] and recessed wardrobe [8]

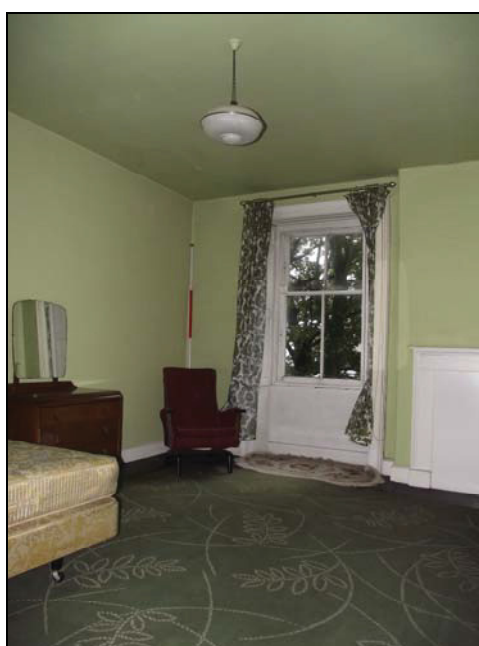
- 5.1.23 Room 15 is also accessed via the landing by a type 1 doorway and represents the smallest principal bedroom (l 4.6 x w 3.48 x ht 2.57m: **Plate 20, 53**). The type 1 door has been partially stripped indicating that the original finish was a dark mahogany wood stain. There is an original fire surround [11], to the southeast wall and this is very similar in design to the two other principal bedrooms (Rooms 14 & 13). The floor undulates and the original floor boards are visible (0.23m wide).

Plate 20, 53: General view, from the northwest

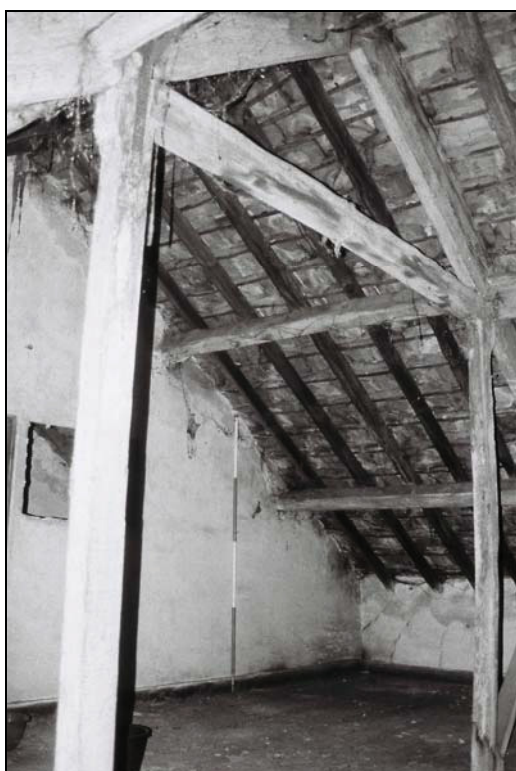
Plate 29, 74: Oblique view of the roof truss, from the southwest

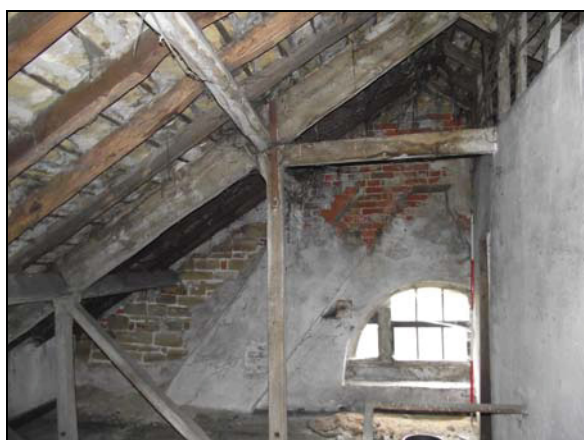
Plate 30, 83: General view of the store rooms and northwest gable wall, which reveals the brick chimney flues and solid rubble walls, from the southeast

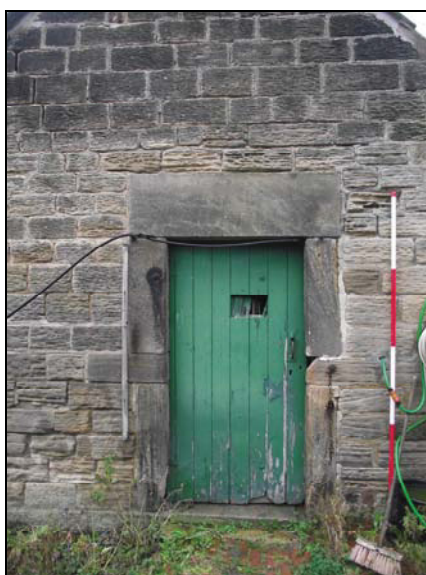
Plate 36, 105: Detail of the doorway [17] with its interrupted ashlar surround, from the southwest

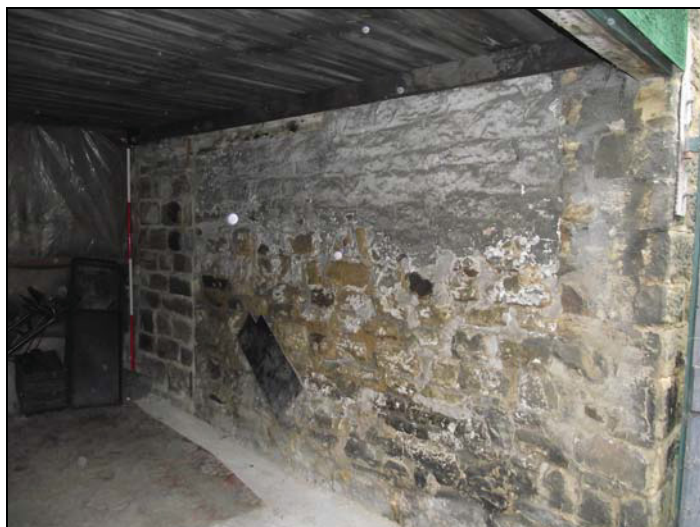
Plate 38, 114: General view of the northeast wall, with blocked doorway [18], from the south

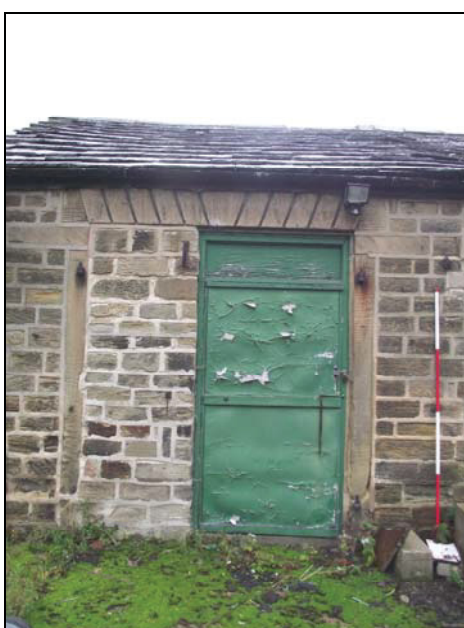
Plate 40, 112: Detail of the blocked cart door [19]

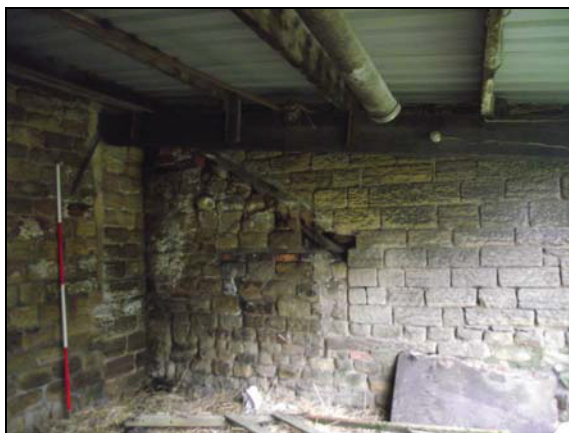
Plate 41, 106: General view of the once exterior walls of buildings C1 & C2, with inclined roof scar of former pigsties, from the north northeast

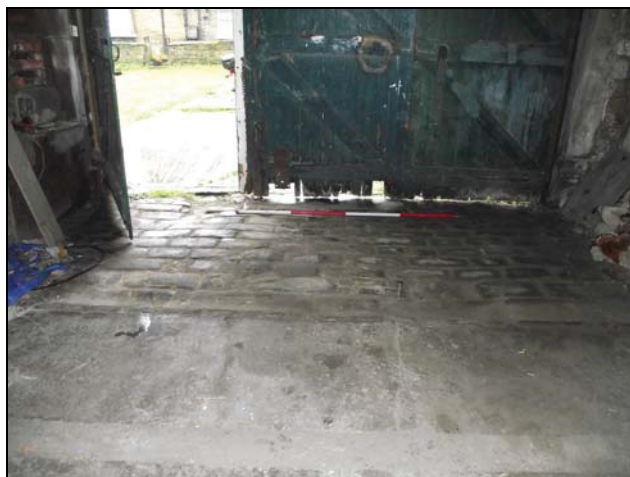
Plate 44, 118: View of the stone floor [20], from the northeast

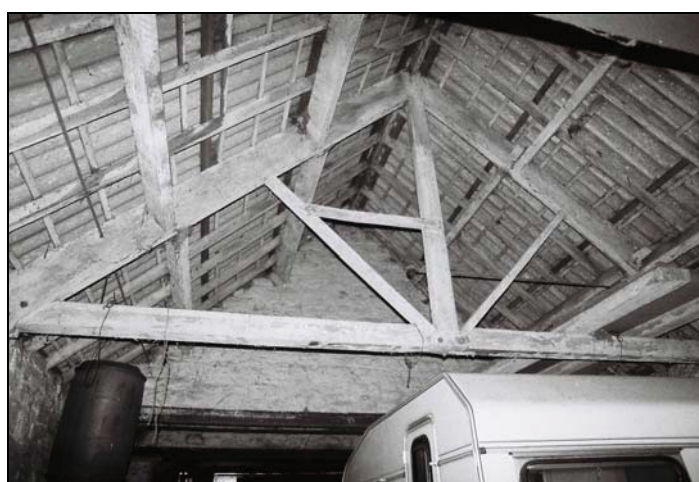
Plate 45, 126: View of the roof truss [21], from the east

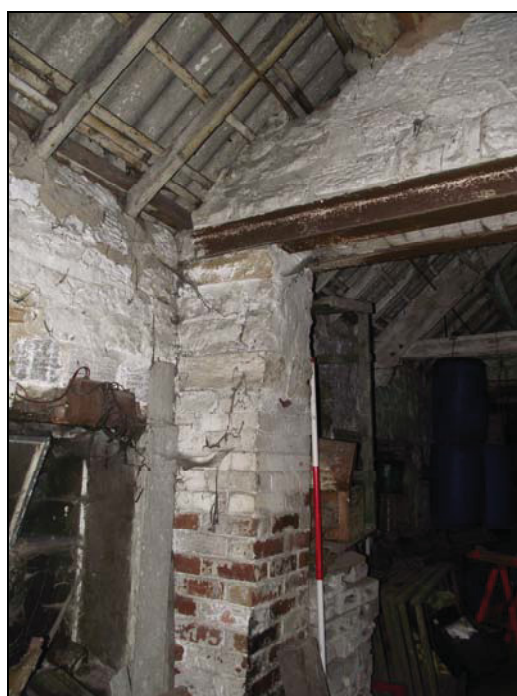
- 5.4.5 Room 38 (15.6 x w 4.8 x ht >4m) is illuminated by two windows to the southeast and northwest walls and would have originally been accessed via the part blocked doorway [26], now a window. The exposed roof allows a view of the strutted king-post roof truss [21]. The truss supports two sets of purlins butted and pegged to the principal rafter (**Plate 45, 126**). The room's original function is uncertain but may have been a large stable/loose box, no evidence for stalling or any internal division could be discerned. A truncated doorway [27] evidenced by a truncated wooden lintel was evident and would have originally linked rooms 38 & 39 (**Plate 46, 127**).

Plate 46, 127: Detail of the remains of an original internal doorway [24], from the north

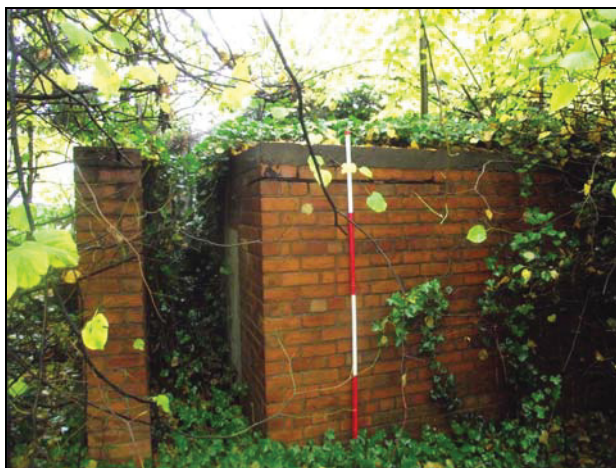
Plate 47, 167: General view of the external walls and blast wall, from the south

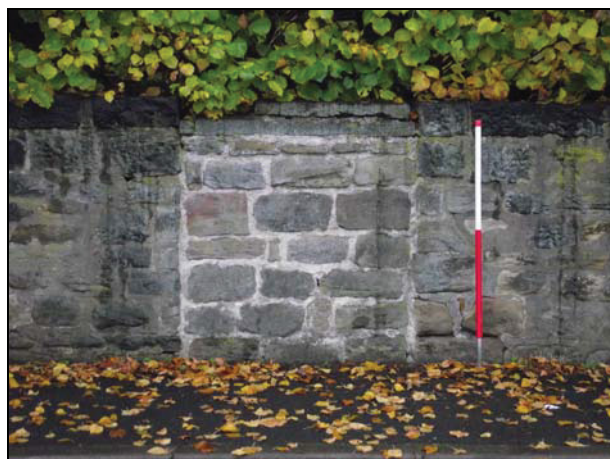
Plate 49: view of the block access point into the air raid shelter (Blg. H) from the southeast (Spring Lane)

- 8.1 Because of excessive overgrowth external photographs of the Air Raid Shelter (Blg. H) could not be taken. Therefore during initial site works, there should be opportunity to fully record this structure, which represents an important piece of local history.
- 8.2 Any ground works associated with the redevelopment of the amenity area, to the north of the PDA, could potentially affect known archaeological assets (Buildings E-F). A watching Brief is therefore recommended during any excavations within the area.
