# 8-9 HALL GATE, DONCASTER, SOUTH YORKSHIRE: AN ARCHAEOLOGICAL WATCHING BRIEF

**CS Archaeology**  
February 2013

**On behalf of:** Atherton & Godfrey Solicitors  
8-9 Hall Gate  
Doncaster  
DN1 3LU

**National Grid Reference (NGR):** SE 5771 0326

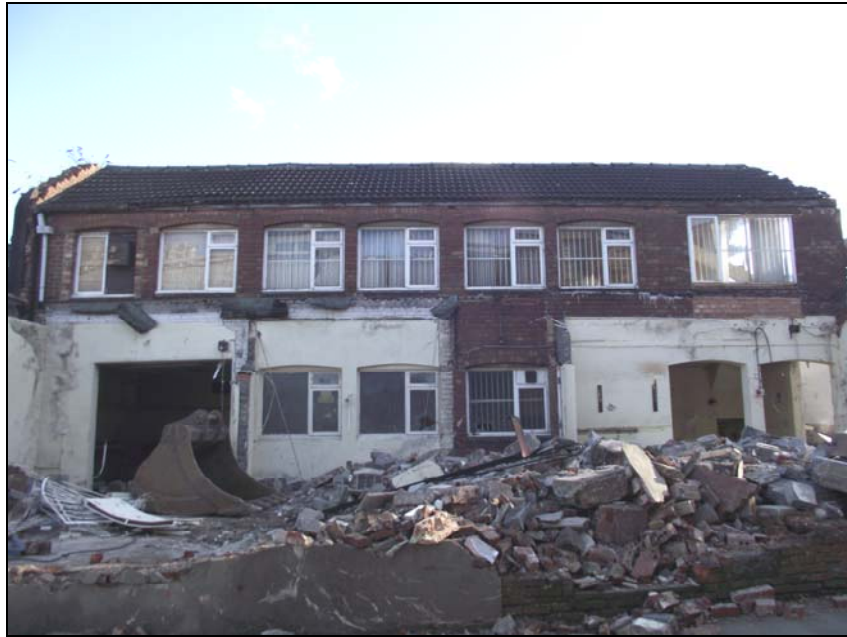
**Plate 1, 64:** View of Building A's, front, NW Elevation, from the northwest

- 4.2 Removal of the modern single storey buildings allowed unobstructed views of Building A, a 4 bay, two storey construction, with its original first floor and modified ground floor fenestration (**Plates 1, 64 & 2, 58**. Demolition revealed the original first floor timber clad ceiling (**Plate 3, 68**). As the demolition progressed one of the king post roof trusses was exposed (**Plate 4, 71**). No evidence for further fenestration was revealed to the north or east walls but a doorway [E] was revealed to the north wall, of the ground floor (**Plate 5, 75**).

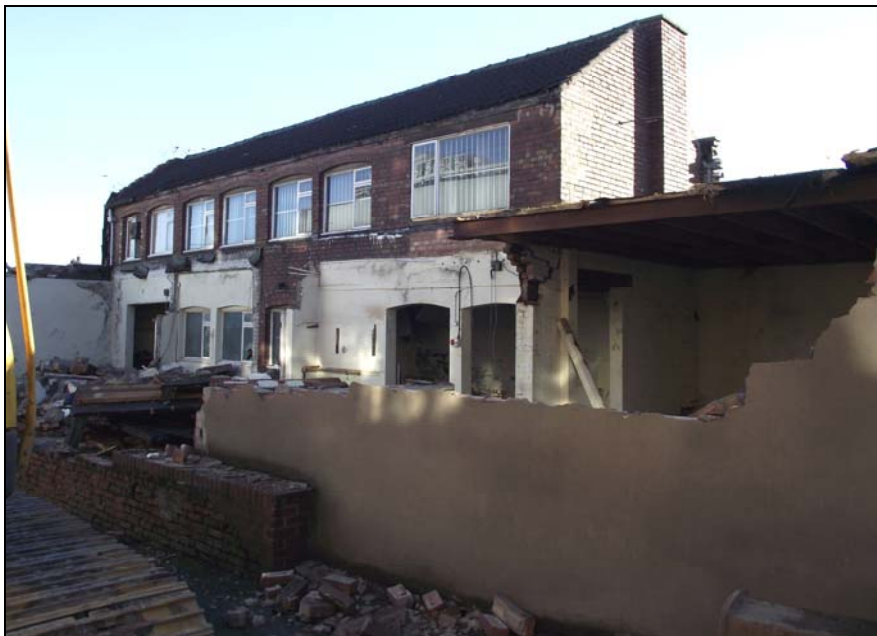
**Plate 2, 58:** Oblique view of Building A's NW Elevation, from the west southwest

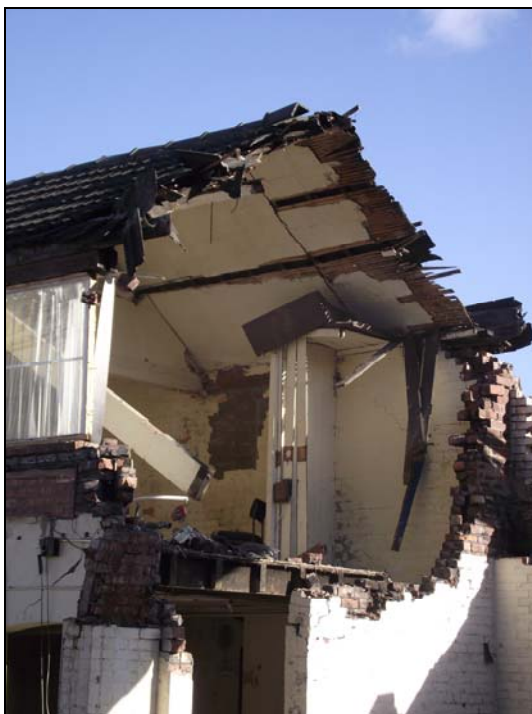
**Plate 3**, 68: Detailed view showing original first floor ceiling, from the southwest

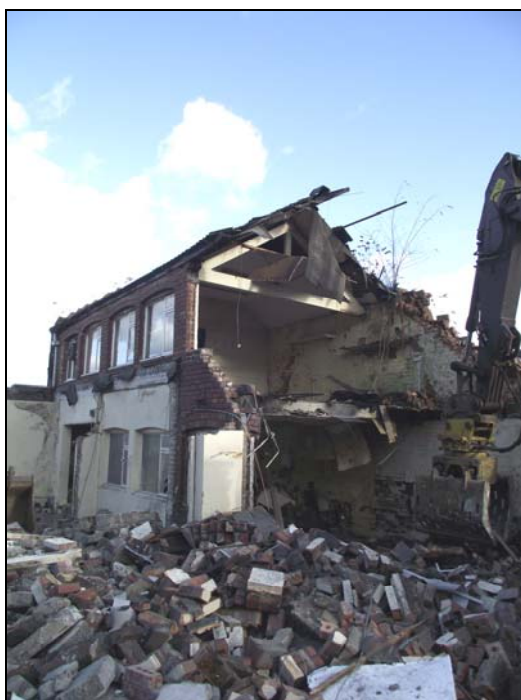
**Plate 4**, 71: General view of building A with King-post roof truss, from the southwest

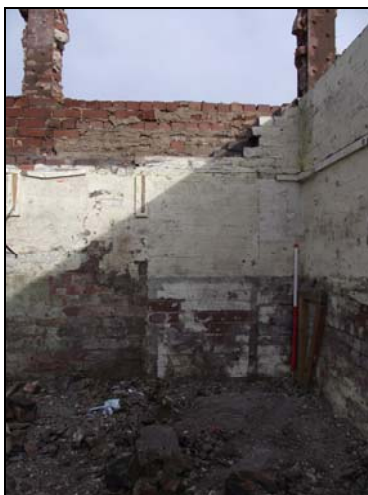
**Plate 5, 85:** Detail of blocked doorway [E] to the NE wall of Building A, from the southwest

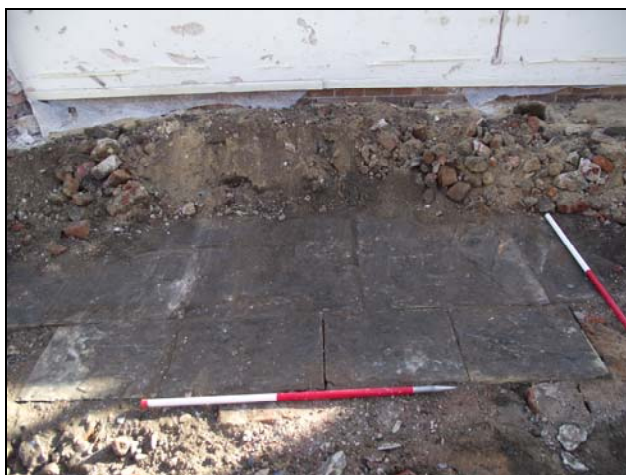
- 4.3 The first floor surface (area A: **Figure 3**) was recorded beneath room 16 (CS Archaeology 2008) and lay just below the modern concrete floor surface. The surface consisted of regularly laid thin flagstones (**Plate 6, 74**), after a record was made these flagstones were lifted to reveal a bed of sharp sand which was consistent with being laid relatively recently, probably as an exterior garden/terrace feature.

**Plate 6, 74:** View of the flagstone surface [A], from the northwest

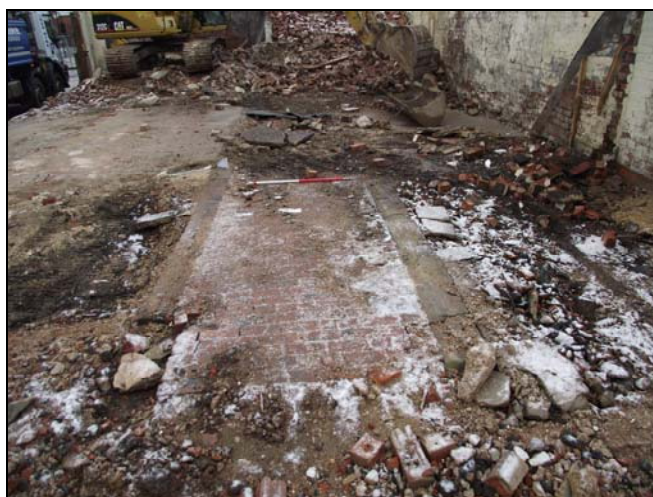
- 4.4 A further historic surface was recorded abutting Building A (Area B). This consisted of brick sets with a flagstone border along the eastern edge (**Plate 7, 77**). Along the western side the bricks were arranged in a double border. The bricks were 19<sup>th</sup> century moulded with the inscription 'SKIERS SPRING NR BARNESLEY' in relief, and were contemporary with Building A. The surface was 2m wide and around 4.5 long clear truncated at the southern end, probably during the construction of the modern single storey infill extension.

**Plate 7, 77:** View of the original brick set floor [B], from the southwest

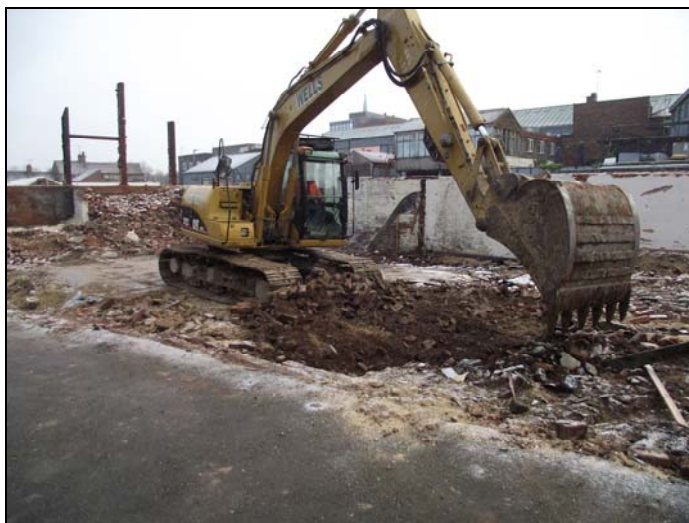
- 4.5 In general the site reduction was limited to 0.25m below the floor level. However the modern foundations were significantly deeper across the central PDA (**Plate 8, 80**). Depths of up to 1.5m were excavated in order to remove concrete strip foundations. As well as the modern foundations, surrounding dark brown garden soil was revealed overlying a light brown subsoil. 19<sup>th</sup> century earthen-ware bottles were recovered from the garden soil, and on one of these bottles 'Blacking Bottle' had been stamped. Significantly this appears to evidence early/19<sup>th</sup> century printing within the PDA, probably representing waste material dumped from Building A.

**Plate 8**, 80: General view of the excavation of the modern deep foundations [C] of the in fill buildings, from the southwest

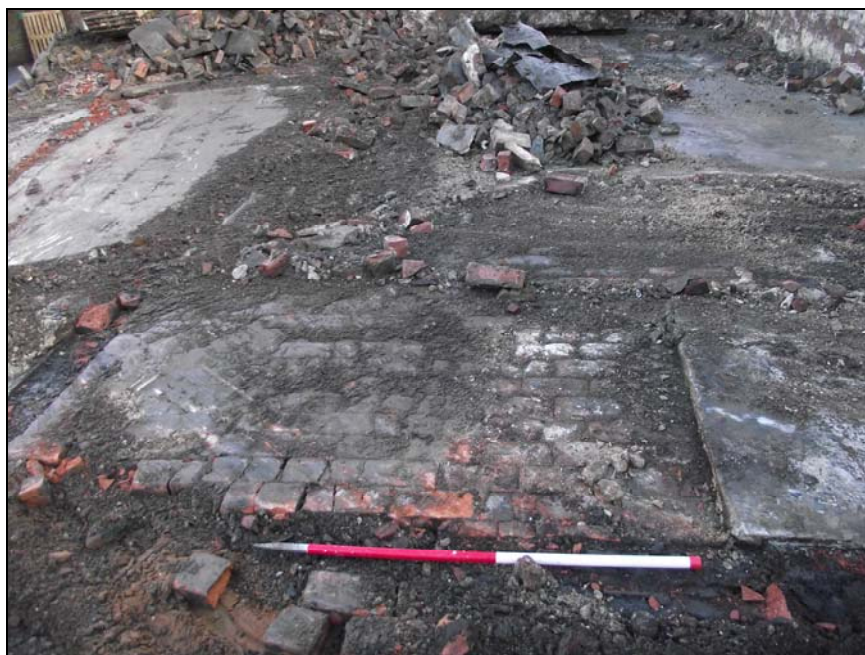
- 4.6 Perhaps the most significant floor surface which was revealed was associated with the floor of Building A. This brick set floor featured 'SKIERS' bricks which were laid in an imbricate pattern (side down: **Plate 9, 82**).

**Plate 9**, 82: View of Building A's original brick set floor [D], from the southwest
