**126 DONCASTER ROAD, TICKHILL,  
DONCASTER, SOUTH YORKSHIRE:  
AN ARCHAEOLOGICAL BUILDING RECORD**

On behalf of Mr B Choppin

**CS Archaeology**  
October 2013

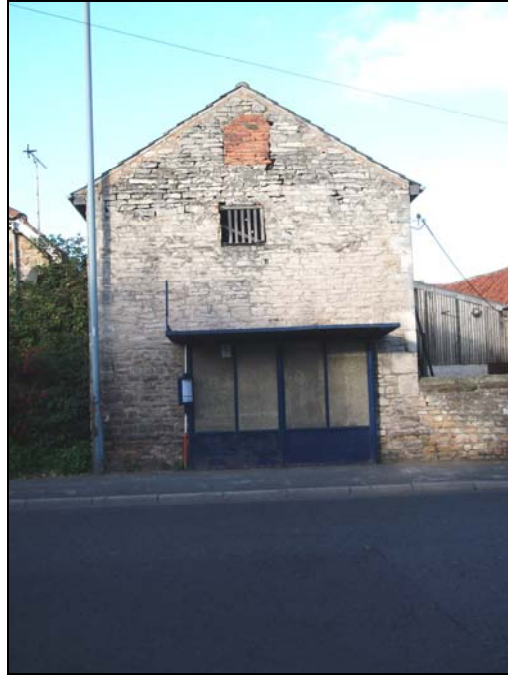
**Plate 1, 1:** view of the front gable wall of the stable (Blg B), looking west

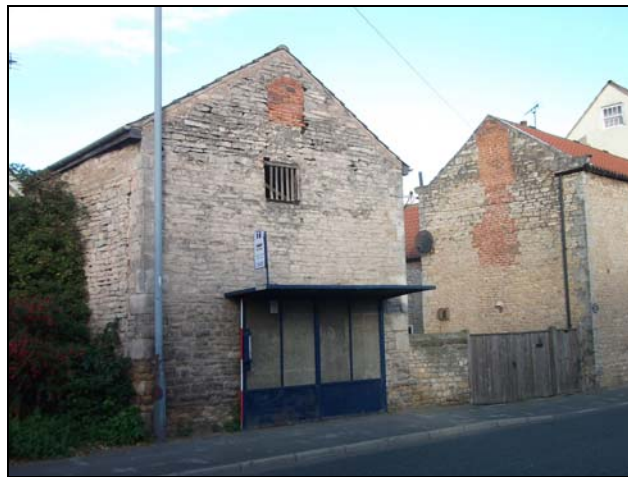
**Plate 2, 2:** oblique view of the front gable wall of the stable (Blg B), looking northwest

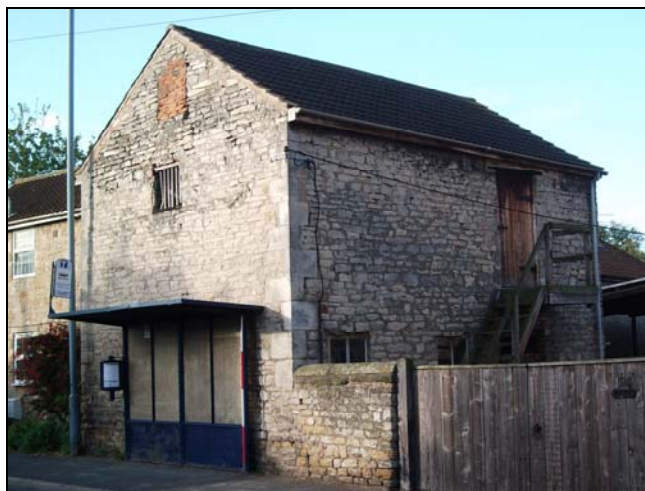
**Plate 3, 3:** oblique view of the front gable wall of the stable (Blg B), looking southwest

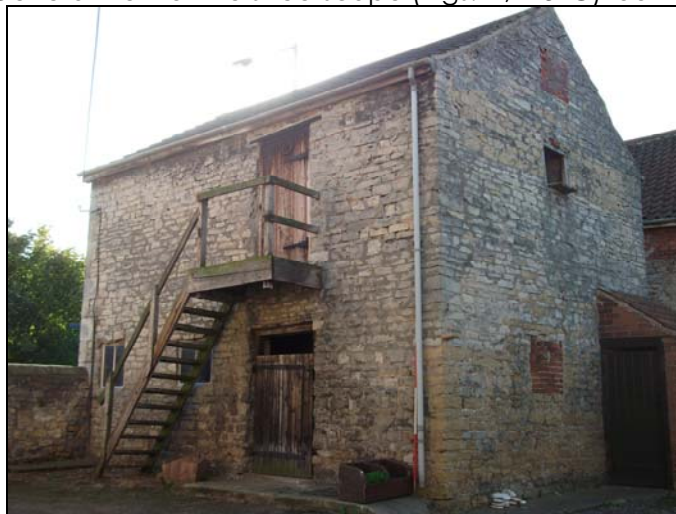
- 5.2.3 The original doorway and two windows to the ground floor of the north elevation were confirmed by examination of the internal splayed reveals. To the first floor is an original loading door way with a plan and batten door. This loading door has had a modern timber ladder and platform recently added to facilitate access. There is no evidence for an original method of accessing the first floor so probably hay may simply was unloaded directly from the top of a cart/wagon.

**Plate 6, 6:** Oblique view of the north elevation, looking southeast

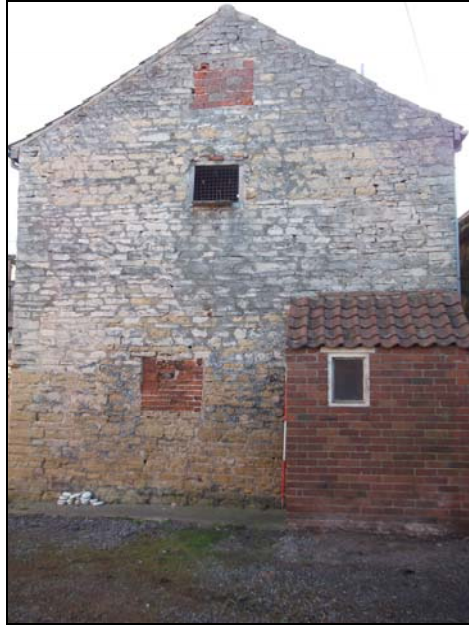
- 5.2.4 The western gable, relatively recently had a lean-to brick toilet added with a pantiled roof. The coursed walling featured two brick blocked openings to the attic and ground floor level, with an inserted opening to the first floor.

**Plate 7, 7:** view of the rear gable (Blg B), looking east

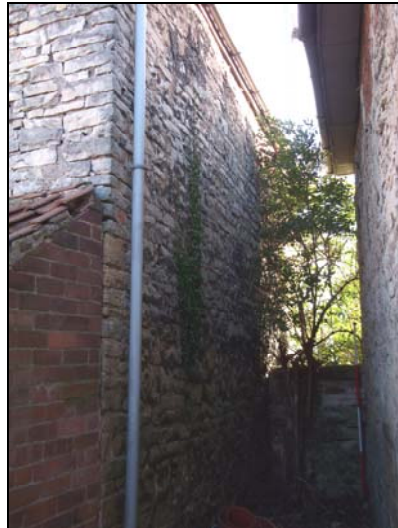
- 5.2.5 The stable's roof has been completely replaced, probably during the late 1980s, when the farmhouse was renovated.
- 5.2.6 The stable's southern elevation (**Plate 8**) appears to be completely blank, and this was confirmed internally and suggests that the neighbouring building predated its construction.

**Plate 8, 8:** acute oblique view of the south elevation (Blg B), looking east

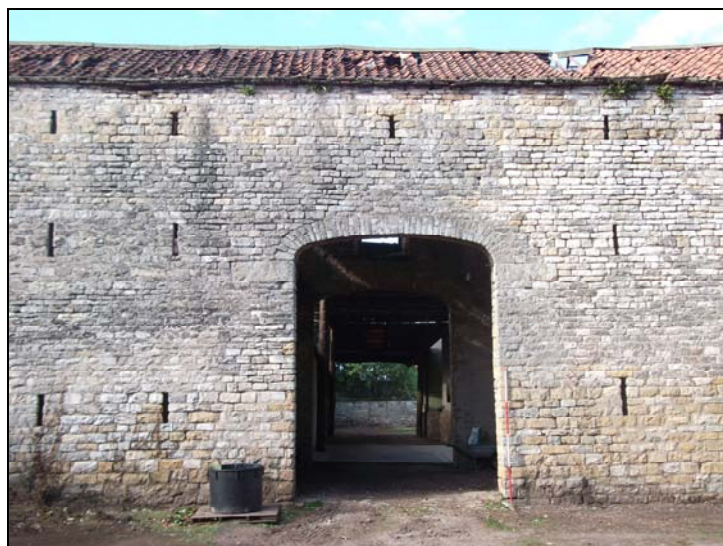
- 5.3 **Building C**, (c. 6.21m x 17.24m) the barn has a date stone with '1820' inscribed, this was positioned towards the top of the north facing (gable) elevation. '*... Hammer dressed stone. Pantiled roof. Stone slate eaves. Six rows of ventilation slits. Barn doors with elliptical head*'. (Internet Source 1). Today the barn is in a slightly dilapidated condition with holes to the roof but is structurally good with the roof timbers all surviving in situ. It is a six bayed barn with opposing offset barn doorways to the 4<sup>th</sup> bay (**Plates 9 & 10**). The doorways are very similar (4.16 ht. x 3.3m w.) and feature the remains of a threshing floor (4.3m wide) between them. The barn doors have been historically removed but simple iron hinges still remain in situ with a square plate with circular hole to the kerb of the threshing floor and a projecting bracket again with hole to the top of the jamb. To facilitate access to the eastern doorway is a limestone set ramp (**Plate 9**) for loading and unloading. Access to the top of the barn was provided by three square openings to the west elevation, which would have enabled the barn to be filled with wheat to the roof, NB the central opening is now blocked and obscured by a modern shed to the west (**Plate 11**). Interestingly there appears to be no subsequent evidence for mechanical threshing such as strategic holes for drive shafts. Internal features include two cross beams and five king post trusses.

**Plate 9, 9:** the front east elevation (Blg C), looking west

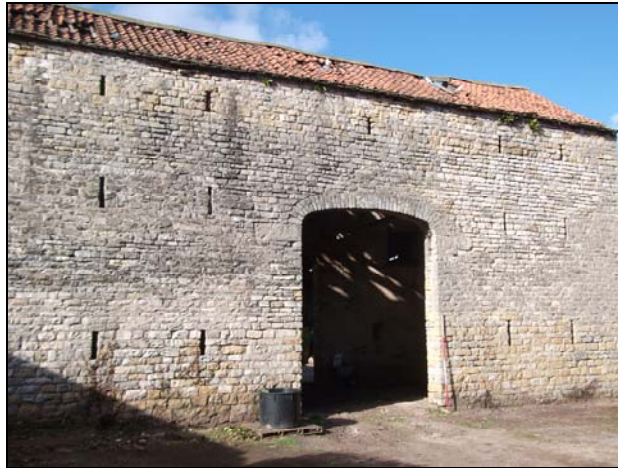
**Plate 10, 10:** oblique view of the front north elevation (Blg C), looking northwest

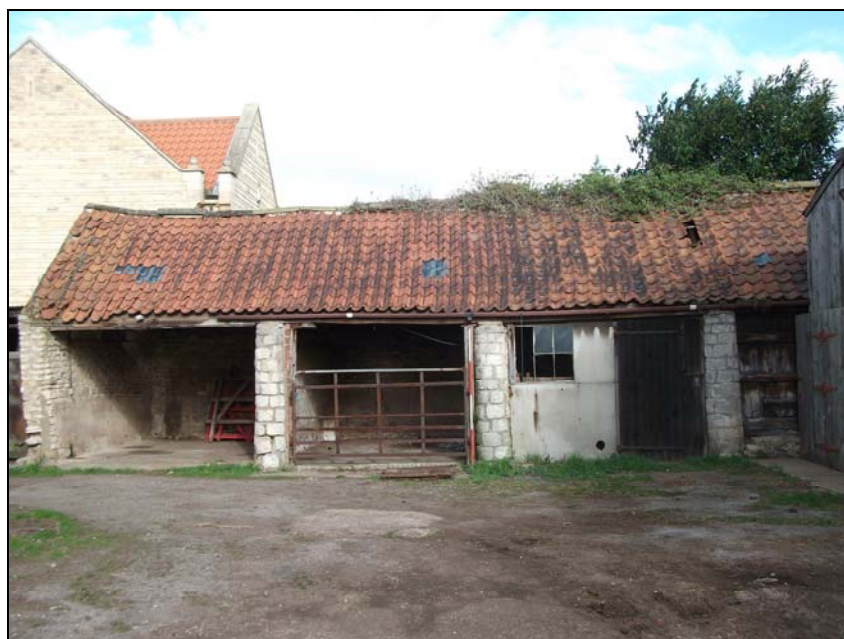
- 5.4 **Building D**, the shelter sheds, together with **Building E** form a continuation of the east west building range which features the farmhouse at the eastern end. Building D (c. 14.42m x 4.57m) is a four bayed shelter shed (**Plate 9**) featuring three composite limestone columns. The use of columns appears to reflect and aspire to the high status estate farms in the area e.g. Marr Hall Farm, Marr, owned originally by Lord Thellusson of Brodsworth Hall. The walls are of limestone rubble and the walls and the roof support the roof with its three king post trusses. The gabled roof features red pantiles with sandstone ridge pieces. Internally the building has been modernised.

**Plate 12, 12:** view of the shelter sheds front south elevation (Blg. D), looking north

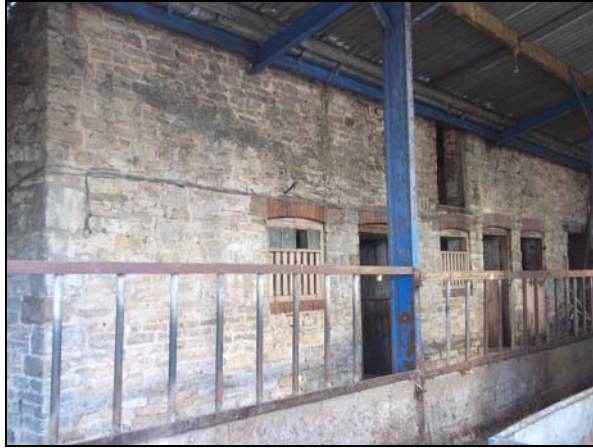
- 5.5 **Building E**, the stables (c.14.2m x 5.2m x 6m ht). This is a two storied building with limestone rubble walls and quoins beneath a gabled pantiled roof which, like the barn (Building. C), is finished with sandstone ridge pieces. The stables faces south, but its southern elevation is now largely obscured by the modern shed (Building. F) however it retains many historic features. To the ground floor is a series of three stable doors (**Plates 13 & 14**) two with associated glazed (4-light) 'open and shut' ventilators. Above the central doorway is a loading door to the hayloft which is

**Plate 13, 13:** oblique view of the front south elevation (Blg. E), looking northeast

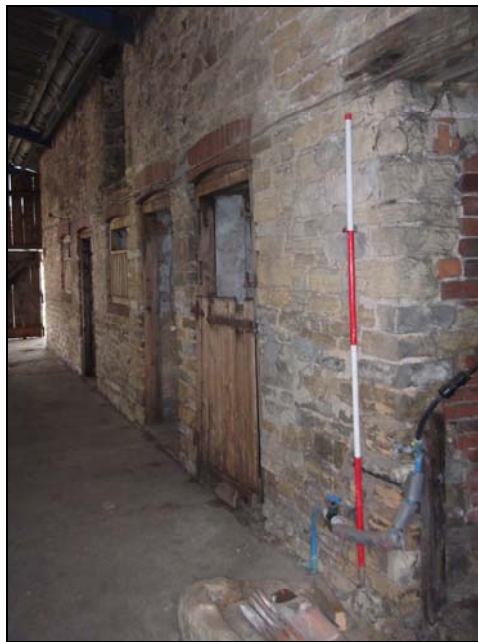
**Plate 14, 14:** oblique view of the front south elevation (Blg. E), looking west northwest

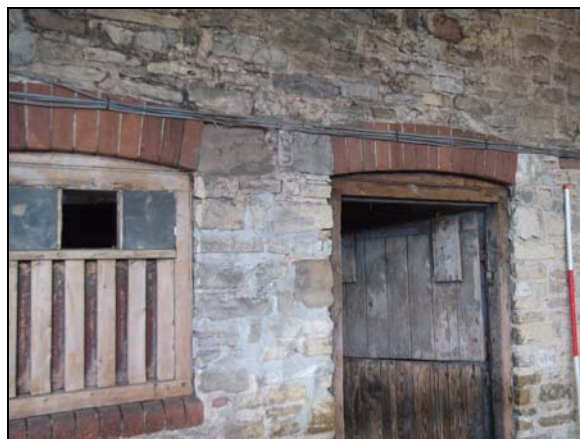
affected by the insertion of building F. The stable's internal layout appears to have been largely unaltered with the original doorways through the south elevation. The brick arch headed window and doors (**Plate 15**) appear to have been modified with the insertion of red brickwork to the window and door head and bull nosed bricks to the window sills. The early doors and windows, probably date to the late 19<sup>th</sup> century and are historic features retaining their original fittings. At the eastern end of the elevation is a wide opening marked by an inserted timber lintel. This opening may have been an enlargement of an original doorway which was modified to access a well towards the southeast corner of the stable. Internally features such as the feeding troughs and the king post trusses remain in situ and are in good condition but suggest that the roof could have been replaced.

**Plate 15, 15:** Detail of the stables modified fenestration (Blg. E), looking northeast

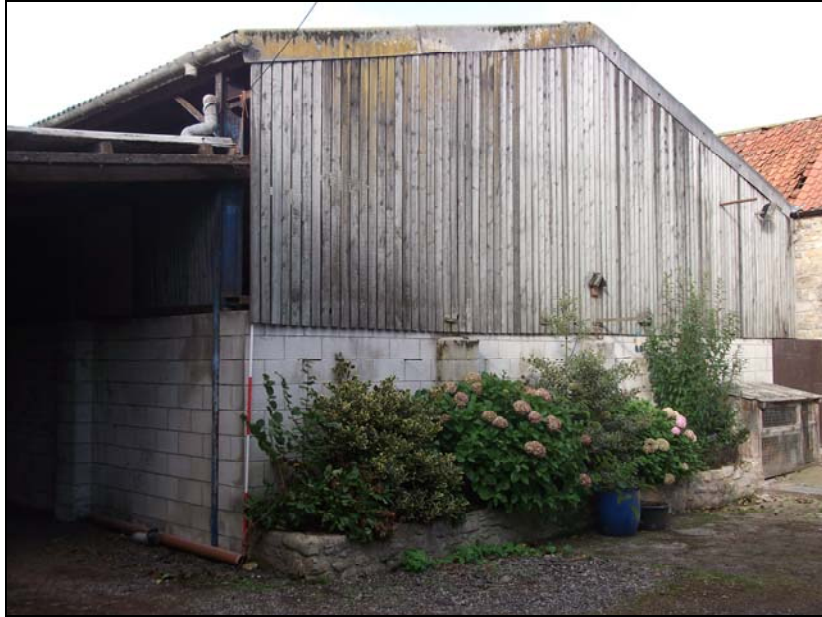
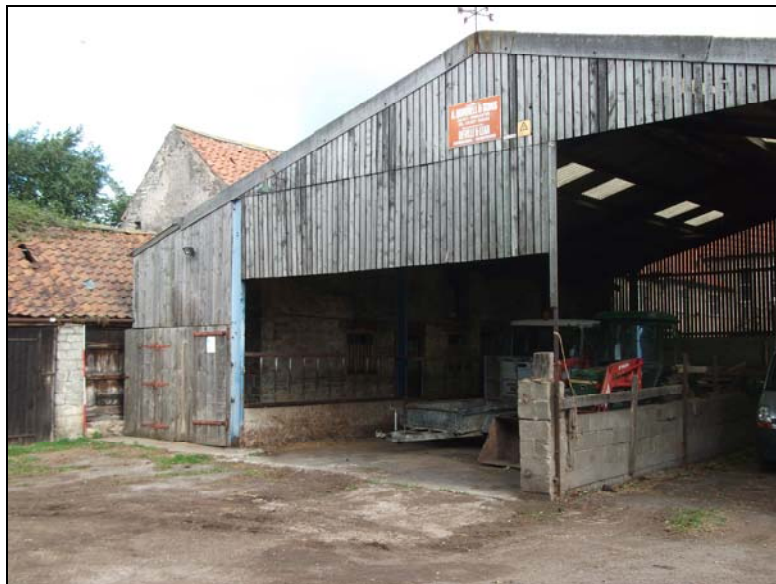
- 5.6 **Building F**, is a large modern barn (**Plates 16 & 17**: 12m x 16m). This is a steel framed building with a corrugated sheet roof. Its construction appears not to have damaged the adjacent historic stables (Building. E) and the farmstead's sense of historic place would be dramatically improved by its removal.

**Plate 16, 16:** General view of the modern barn (Blg. F), looking northwest

**Plate 17, 17:** General view of the modern barn (Blg. F), looking northeast

- 8.1 No further work is recommended at this stage.
- 8.2 Any future building recording should be undertaken once Building F has been removed.
