**THE JAPANESE GARDEN,  
HESLEY HALL SCHOOL, STRIPE ROAD, TICKHILL:  
AN ARCHAEOLOGICAL BUILDING RECORD**

Planning Application Ref. 14/01999/FUL

**CS Archaeology**  
February 2015

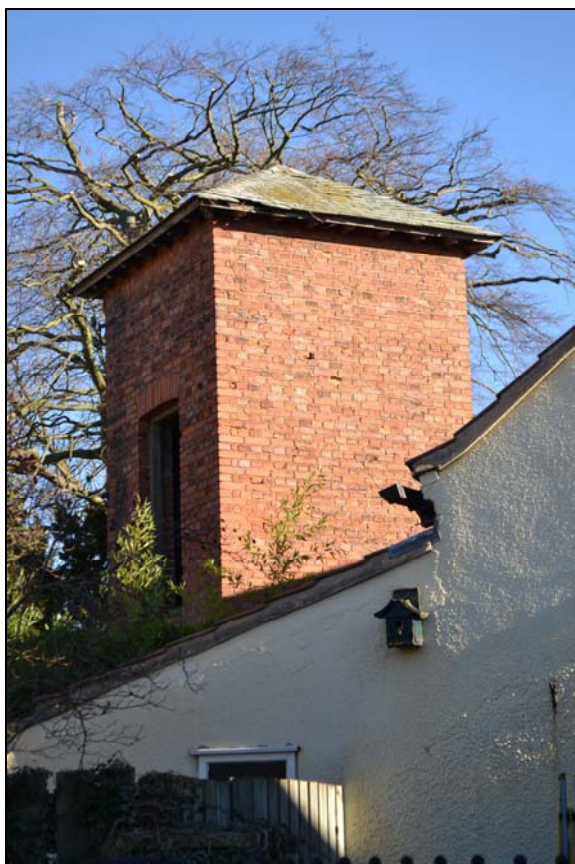
**Plate 1, 16:** the tower, distant view from in front of the former farmhouse, looking east

- 5.3 There is a projecting pyramidal roof (**Plate 1, 16**) that features ogee carved joists to the eaves. The slate roof is not graduated and the four side ridges do not feature ridge pieces. It was probably not originally ridged. The eaves do feature bracket scars from guttering and to the northwest elevation are further vertical bracket scars and a tell tale discolouration of the brickwork from the presence of a cast iron down comer (**Plates 2, 7 & 5, 3**).

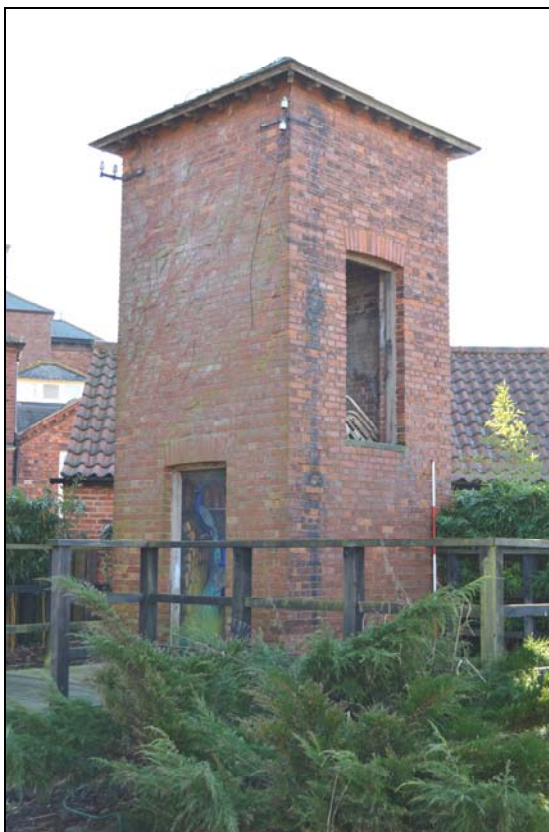
**Plate 2, 7:** the tower, general view, looking south

- 5.4 The tower has two arch headed doorways, the first [1] is at ground floor level of the northeast elevation (**Plates 2-4**) and the second [2] is at first floor level in the northwest elevation (**Plate 5, 3**). Each doorway features a stone thresh and moulded door frames. Doorway [1] is fitted with a modern door with a mural of a peacock marked 'May & Dawn 2007'. There are no other openings to the exterior of the building i.e. the southwest and southeast walls are blank.

- 5.5 Bolted to the tower's east and north corners are two electrical brackets each with its white insulator still in situ (**Plates 2-4**).
- 5.6 Internally the survey was limited to the ground floor and a glimpse of the first floor and attic, but this was sufficient to characterise the building.

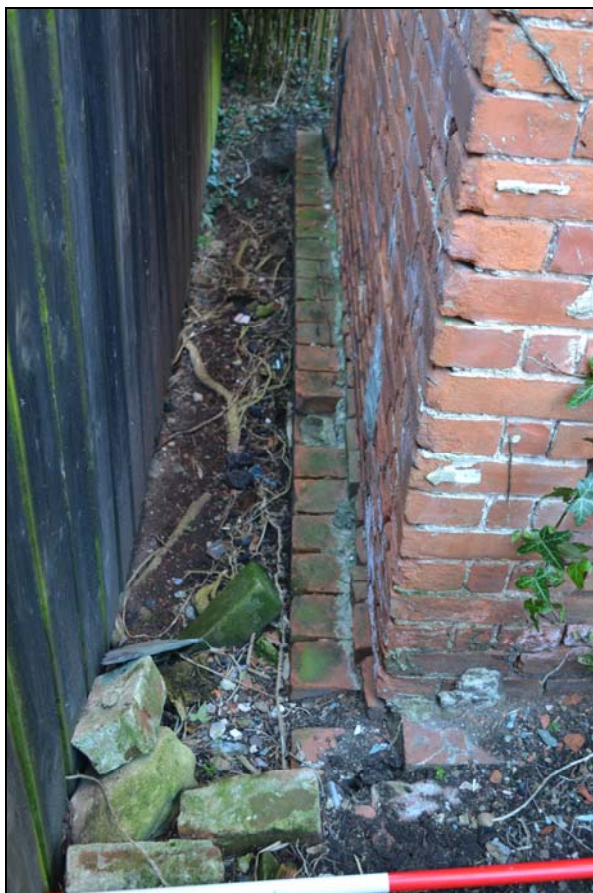
**Plate 7, 20:** the tower, view of the brick foundation plinth, looking northwest

- 5.9 At the base of the southwest elevation the brick foundation course was visible (**Plate 9, 20**).
- 5.10 Looking at the building's design and from the evidence cited above, it would appear the tower served as electrical generating tower. No evidence for the generator was visible, and it can be assumed that it was historically removed probably when the National grid was established after the electricity (Supply) Act of 1926. Evidence for the generator may be visible during the clearing out and demolition. The originally detached location and strength of the first floor and external restricted access to the first floor via the doorway [2] suggests it was built an

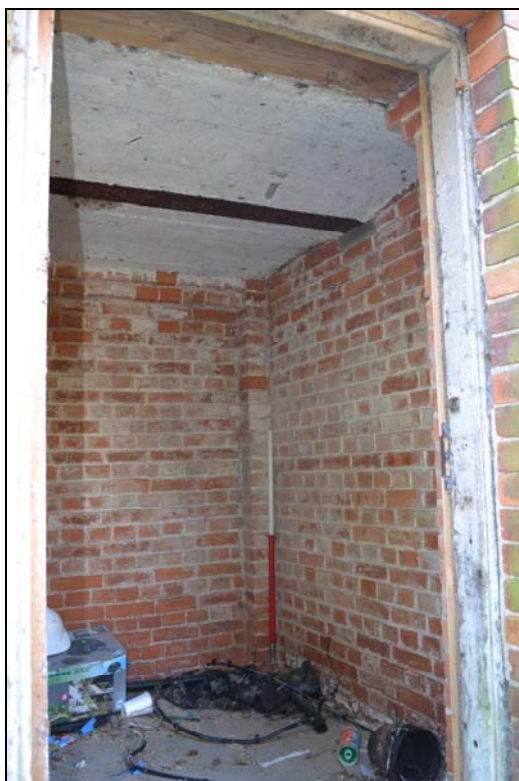
**Plate 8, 18:** the tower, internal view of the tower's ground floor, looking west

- 5.7 The ground floor consisted of a concrete floor, and exposed brick walls with a corbelled course beneath the ceiling (**Plate 6, 18**). The main feature of the room was a concrete ceiling supported by a cast iron beam (**Plate 7, 19**), which evidences the support of a considerable weight. NB no pipes or internal cabling were evident, indicating that the room only ever functioned as a storeroom possibly for fuel.
