**ACKWORTH OLD HALL FARM BUILDINGS,
PURSTON LANE, HIGH ACKWORTH, WEST
YORKSHIRE:**

**AN ARCHAEOLOGICAL BUILDING RECORD
AND WATCHING BRIEF**

**CS Archaeology
August 2008**

Project and report No.: 22

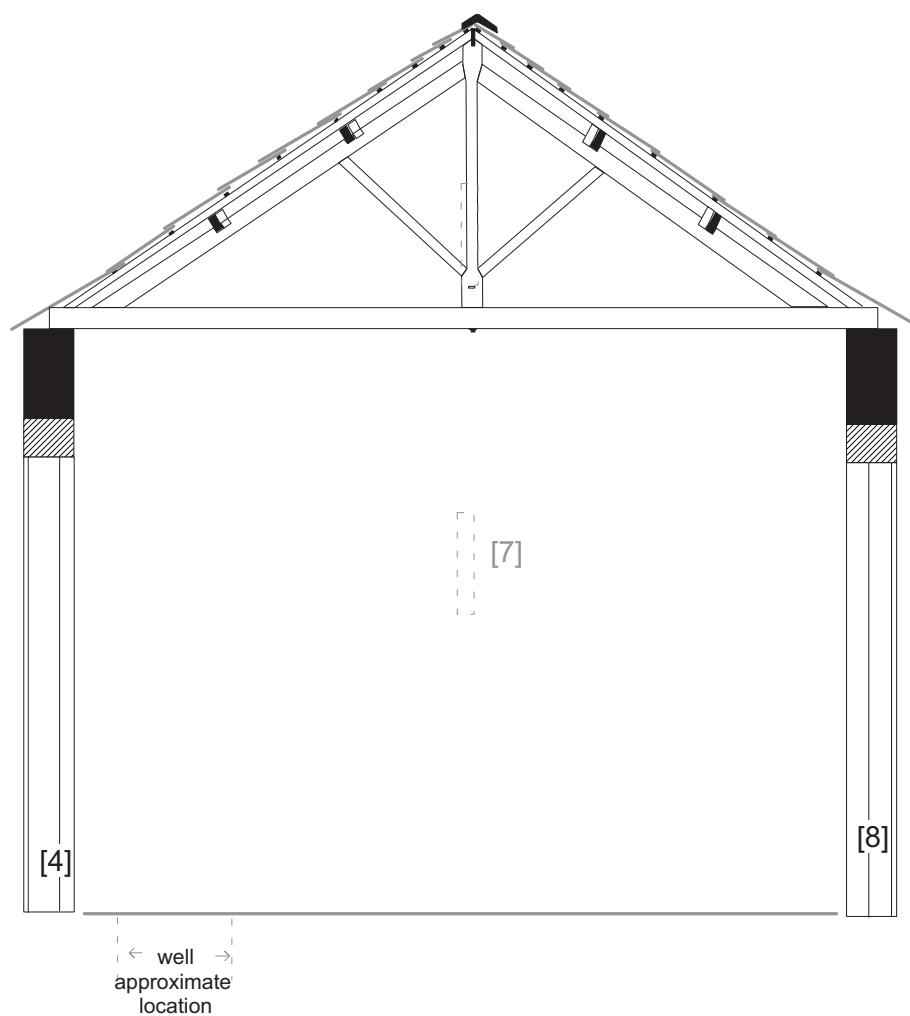
**Figure 8: Cross Section
of Building A**

*inserted timber lintels*

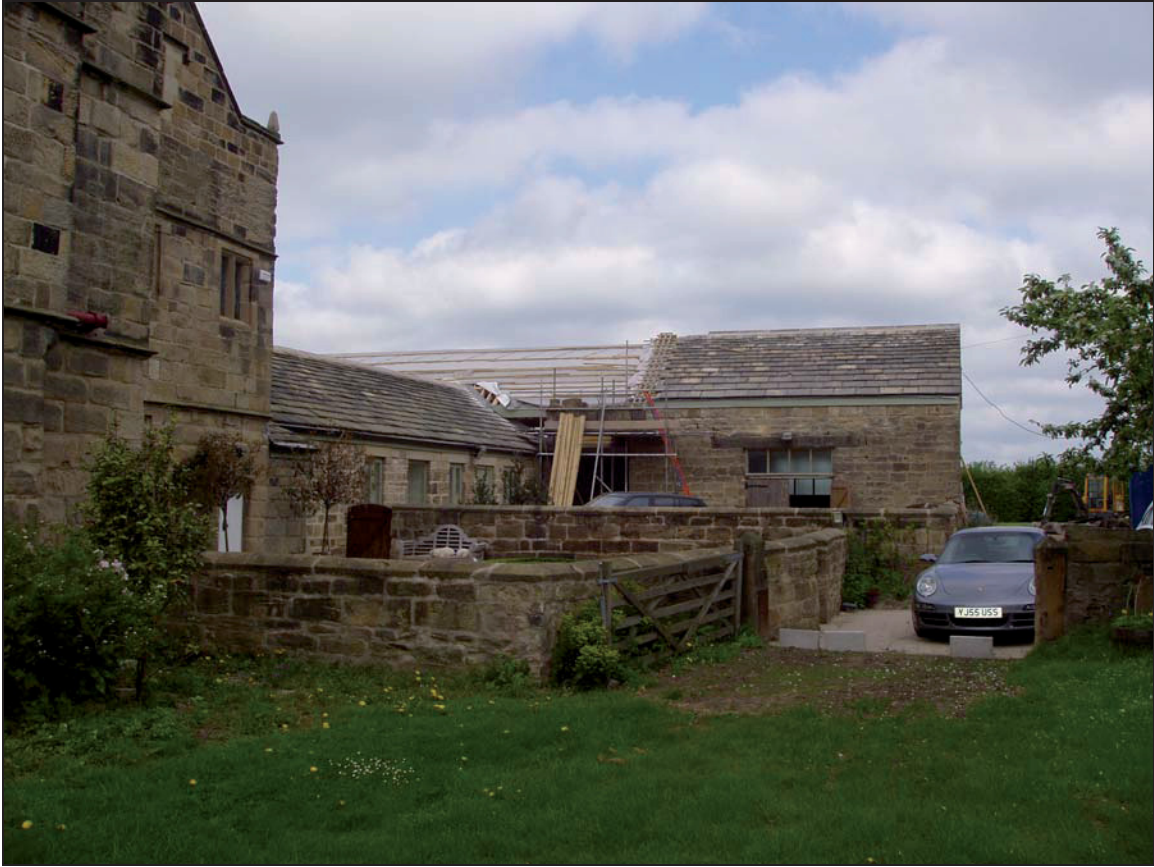
Plate 1: general view of Ackworth's Old Hall's L shaped farm buildings, from the south

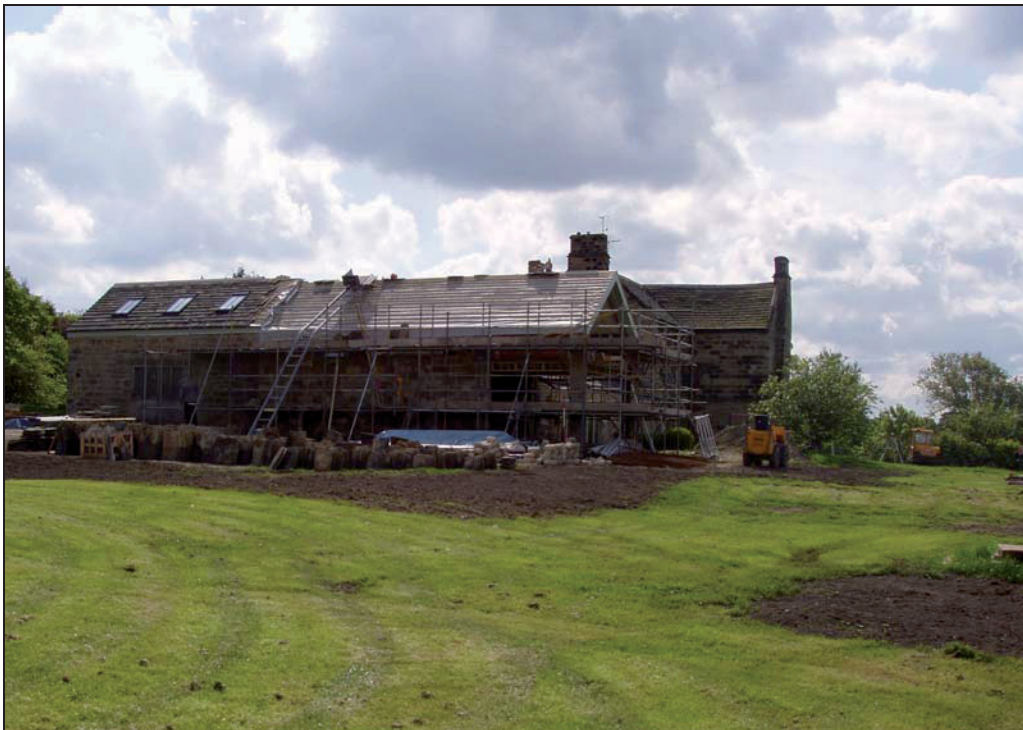
Plate 2 (8): general view of the barn with adjacent modern swimming pool under construction, from the north-west

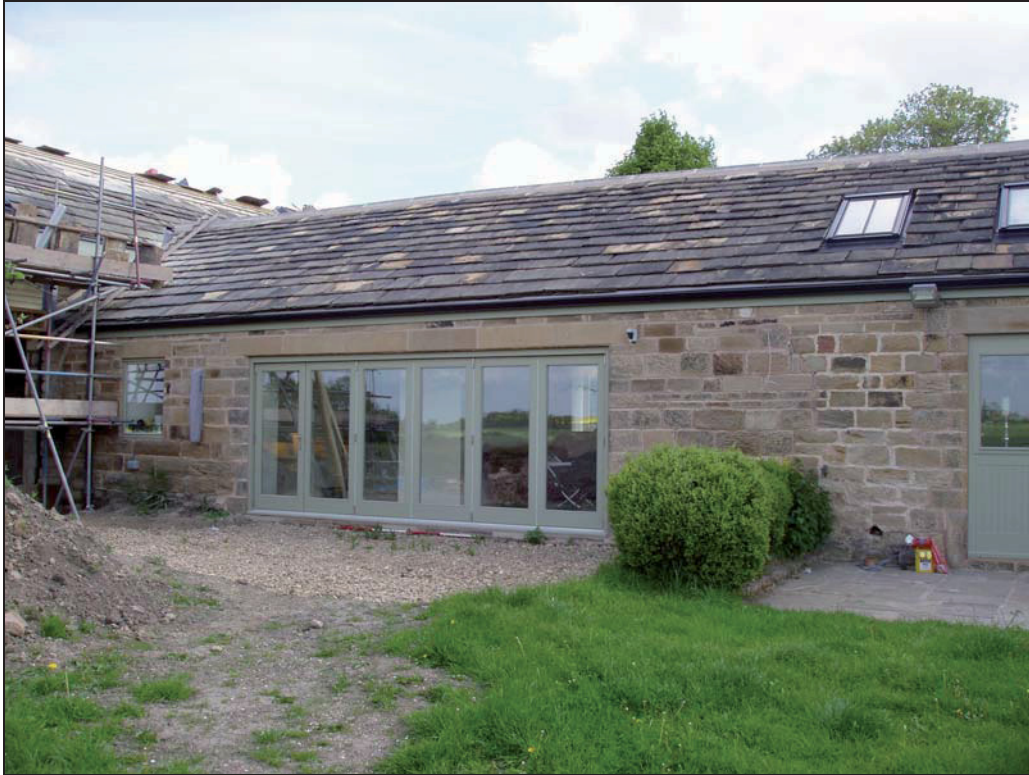
Plate 3 (9): view of the rebuilt stables/cow shed's south-west elevation (Building B),
from the south south-west

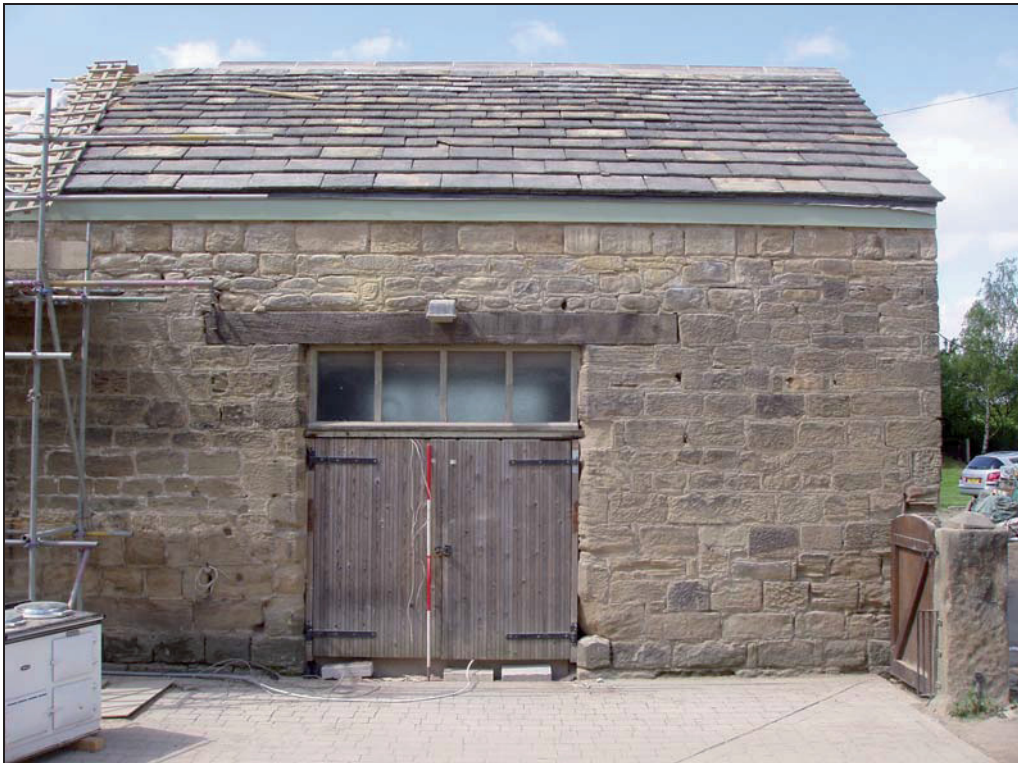
Plate 4 (4): the barn's front south-east elevation (Building A) which faces into the farmyard,
from the south-east

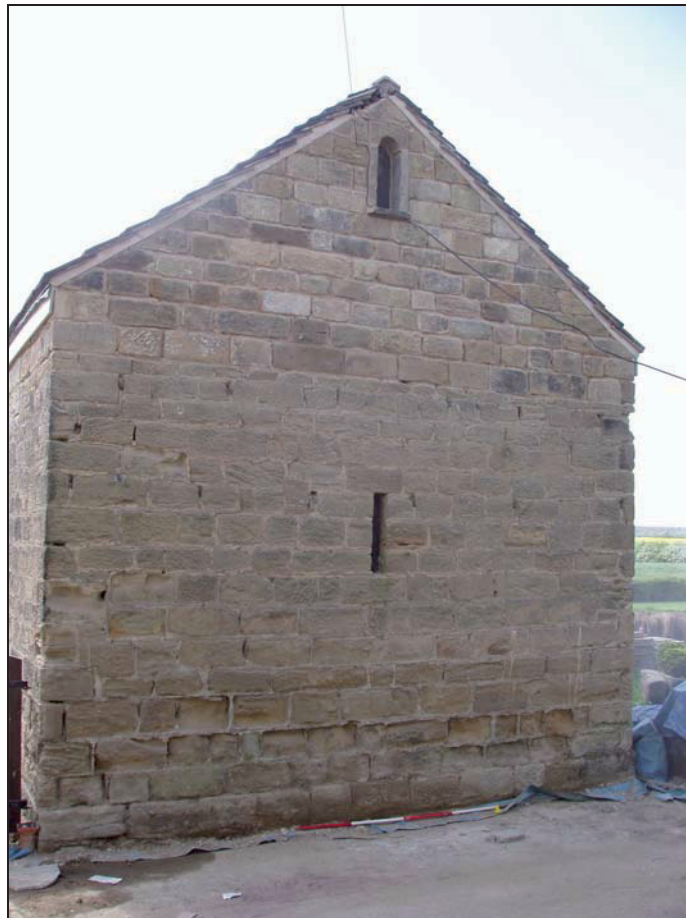
Plate 6 (3): view of the barn's north east elevation (Building A) with lower original ventilator [7] and modern repositioned ventilator above, from the north-east

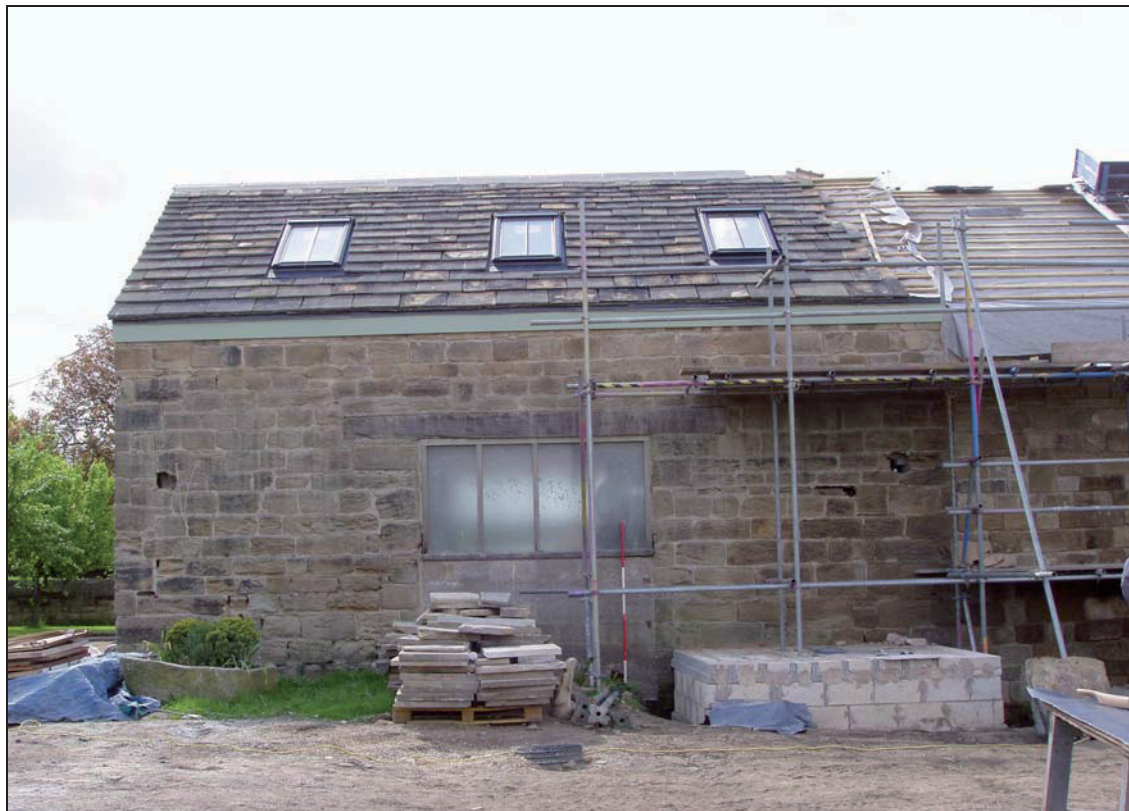
Plate 8 (7): view of the barn's north-west elevation (Building A), from the north-west

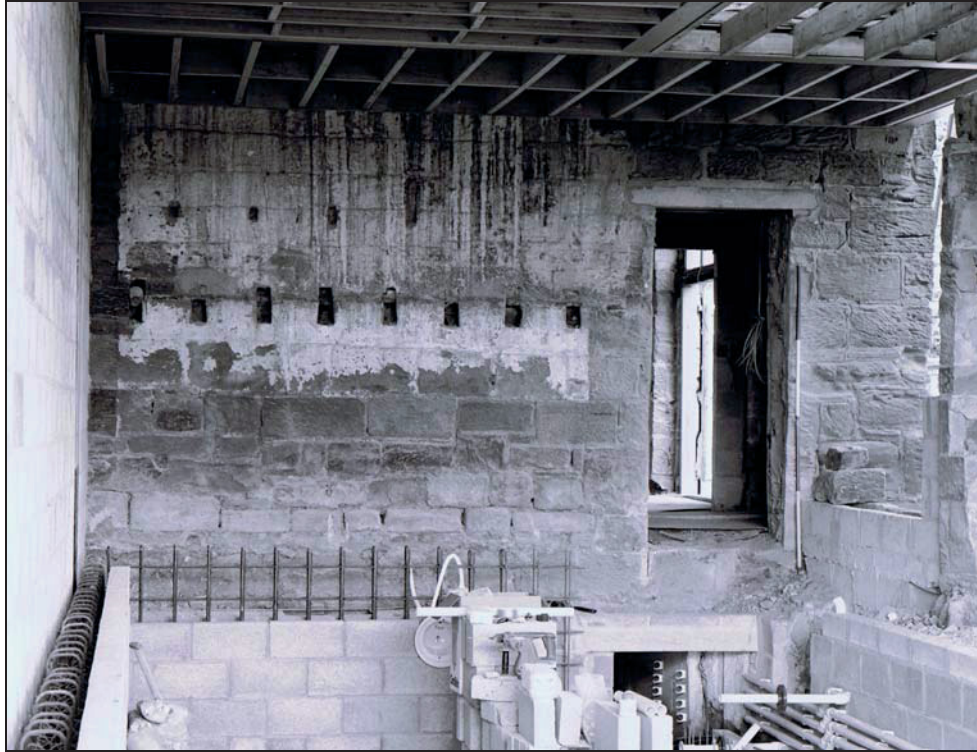
Plate 9 (14): view of the barn's lower south-west elevation (Building A) with the historically inserted floor joists [2] of Building C, from the south-west

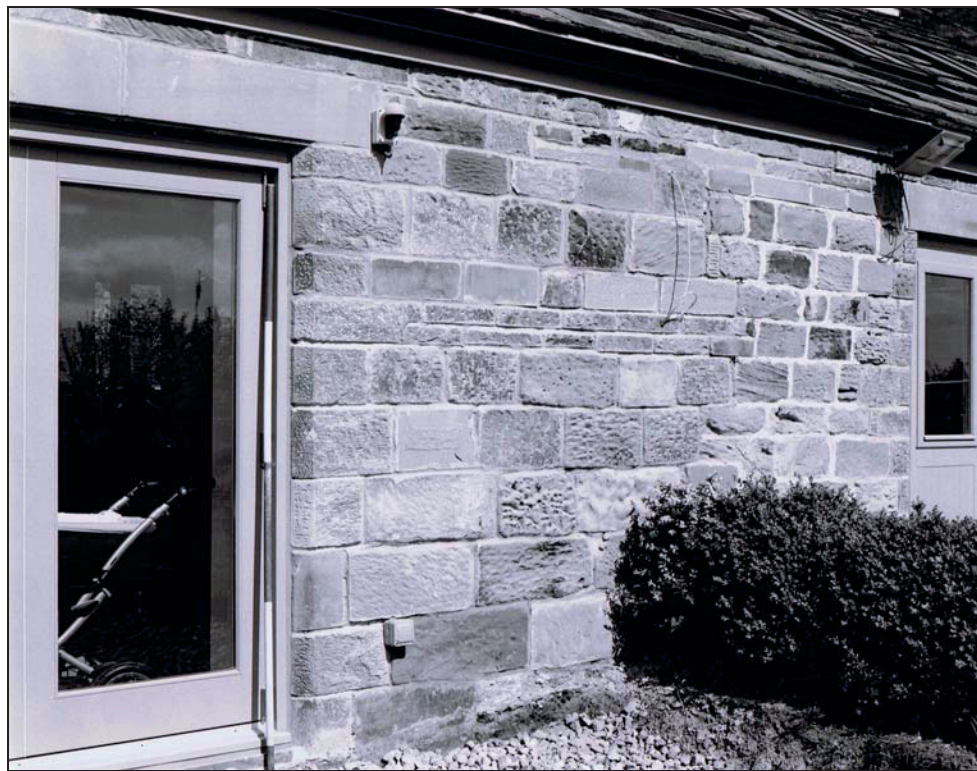
Plate 10 (11): view of the rebuilt stables/cow house's south-west elevation (Building B), from the north-west

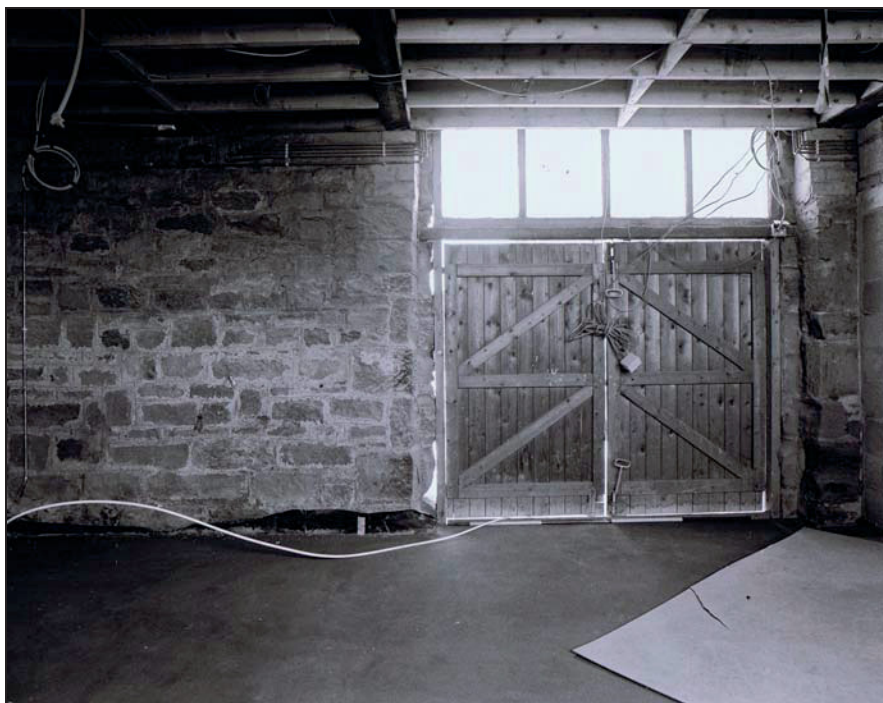
Plate 11 (19): view of the barn's south-east wall with barn door [4], from the north-west

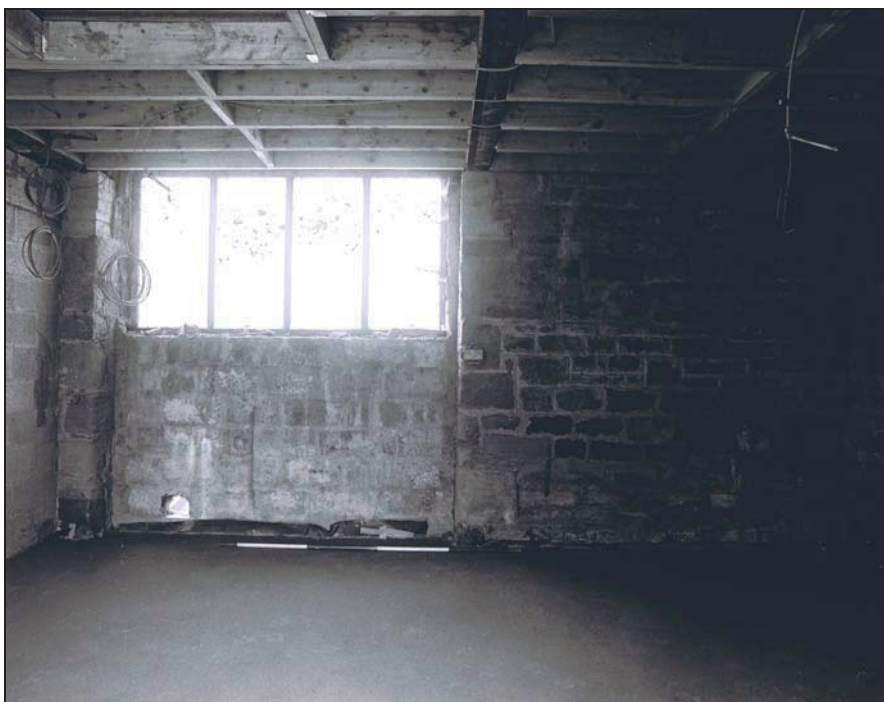
Plate 12 (18): view of the barn's north-west wall and barn door [8], and inserted window, from the south-east

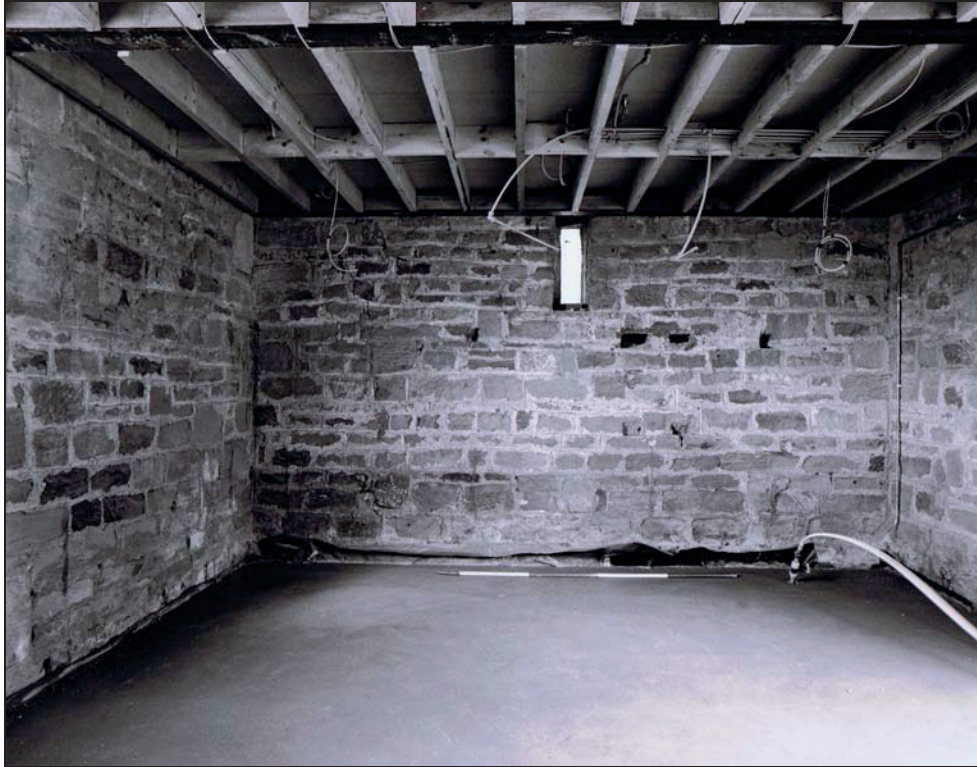
Plate 13 (20): view of the barn's north-east wall ground level slit ventilator [7],
from the south-west

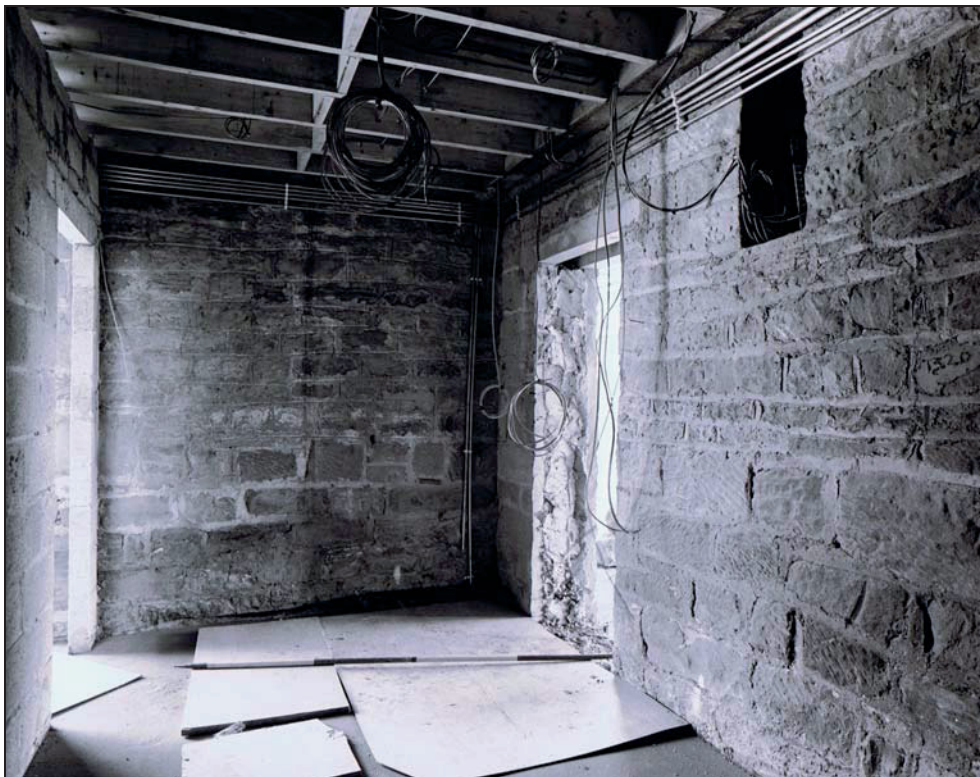
Plate 14 (21): view towards the south-east wall, with the original and historically blocked
slit ventilator [1] (above right), from the north-west

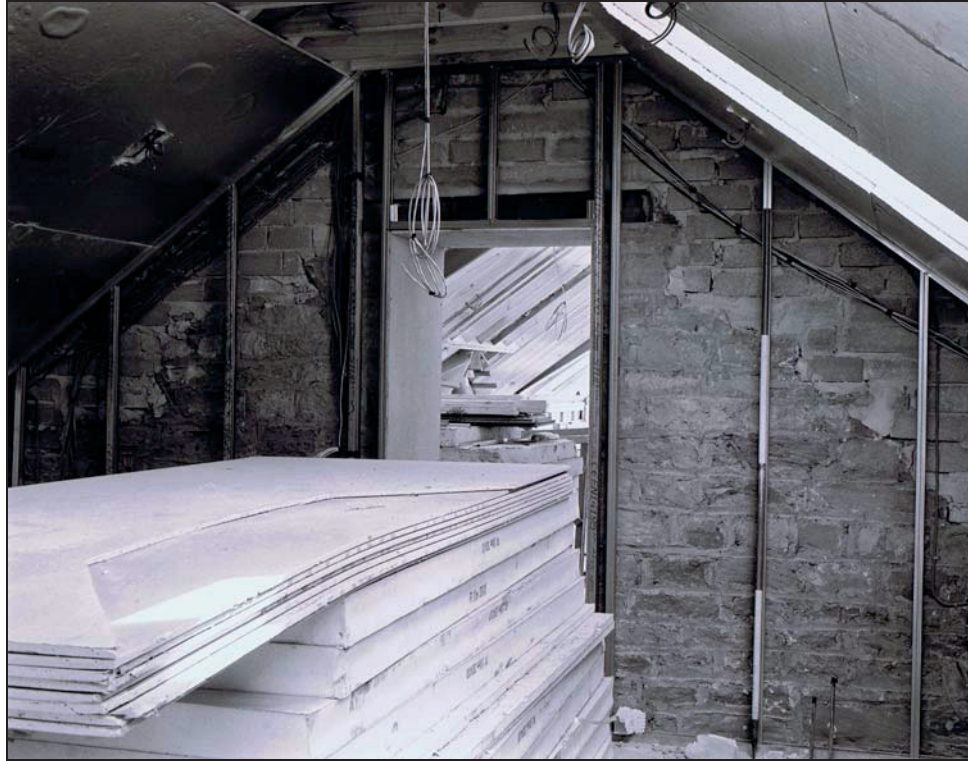
Plate 15 (15): detail of the barn's internal south-west wall at first floor level with modern inserted doorway , from the north-east

Room 2 had largely been obscured by modern plaster board (Plate 15). Recently (2007-2008) the roof had been entirely replace with a modern rafters allowing a useable first floor space. As a result the two king post trusses were removed from site to await re-use in a planned garage. The king post trusses (Plate 16) are typical 19th century and feature machine cut timbers. They post date the construction of the barn, and therefore evidence an historic roof replacement probably during the 19th century, though king posts can date from the 18th century. The approximate positions of the these trusses [3] are depicted in Figure 5.

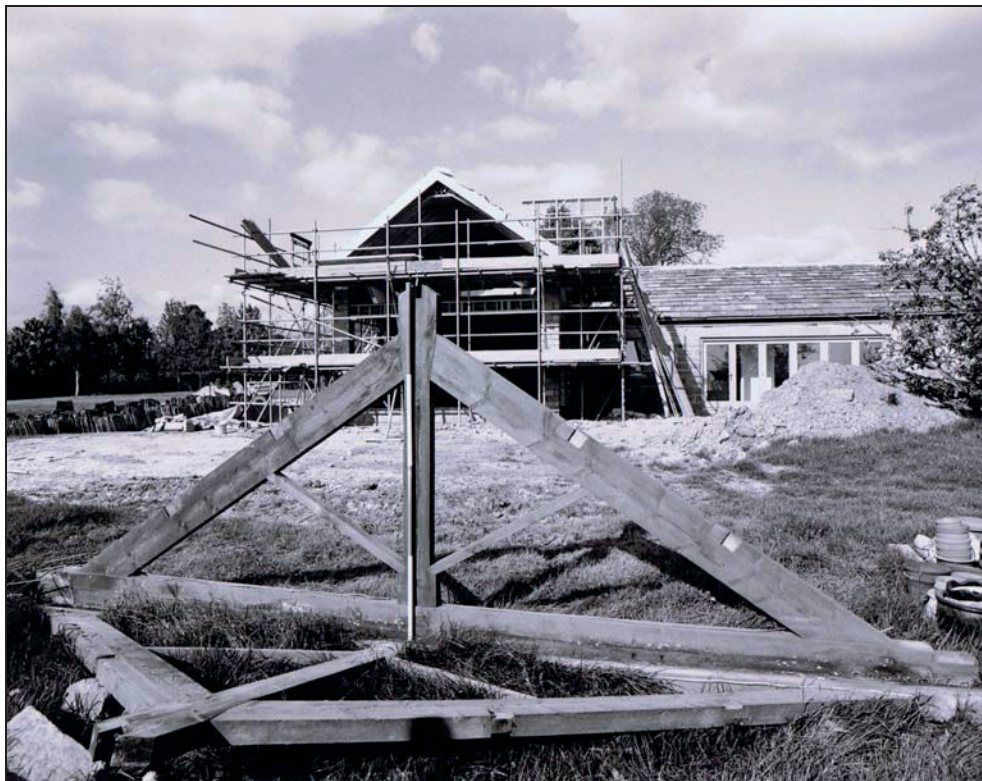
Plate 16 (23): view of barns removed roof trusses [3]

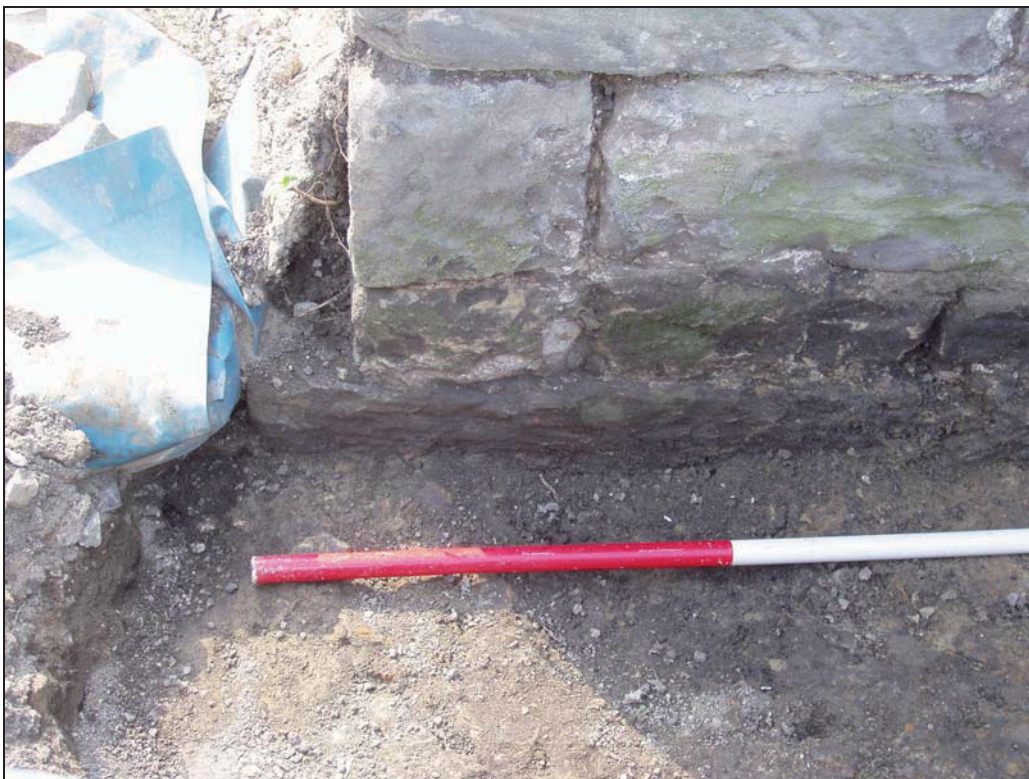
Plate 20: Trench 2, detail of the barn's (Building A) foundation course, from the north-west

8.2.4 The construction details of the barn included views of the barn's foundation course (**Plates 18, 20 and 21**) which protrudes up to 0.15m from the north-west elevation. It could not be ascertained just how deep the foundation extended. The foundation Trench was evident as a brown silt [013] and its continual cut line was offset from the foundation course by 0.08m, but was subject to less differentiation in sections.

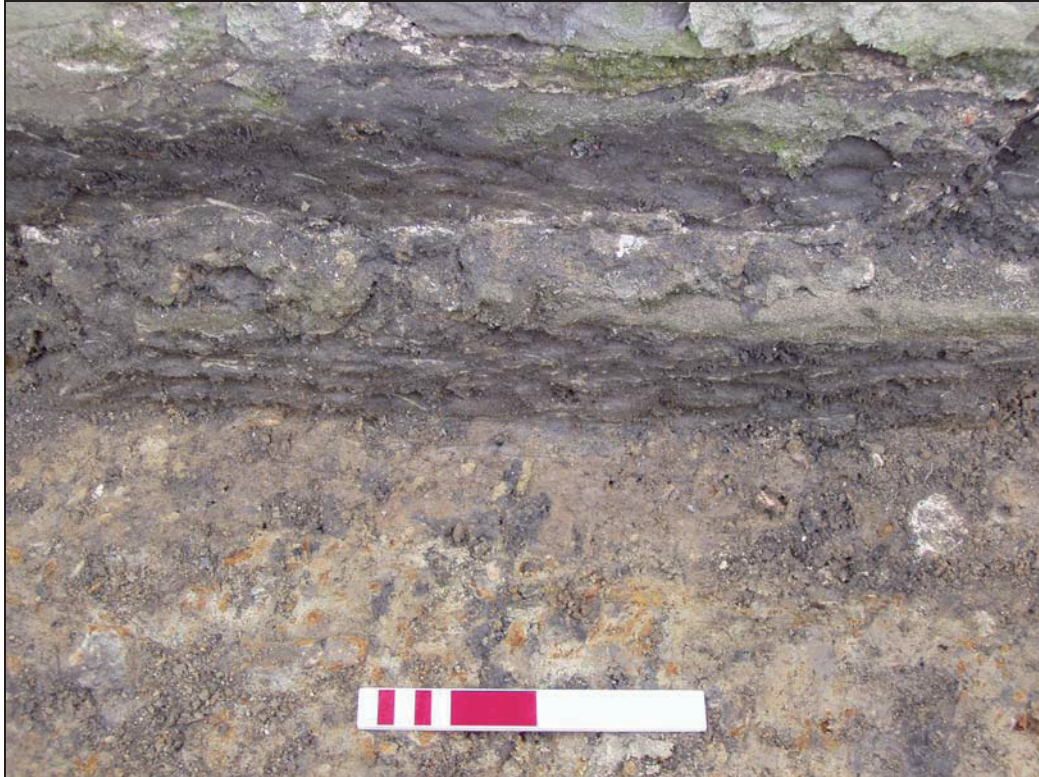
Plate 21: Trench 2, Building A, detail of the barn's original foundation trench revealed during re-excavation, from the north-west

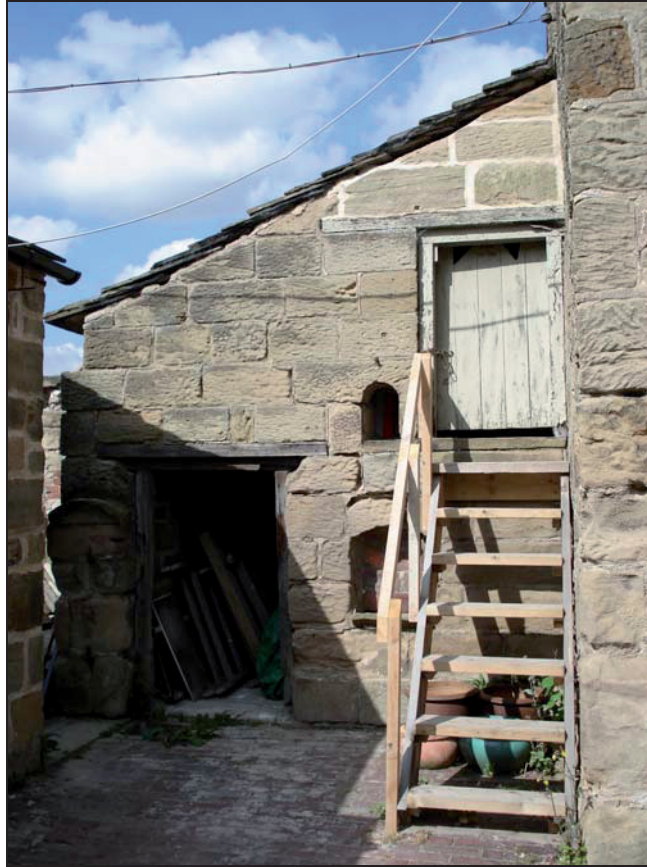
H3: The pigsty (Building C now demolished), with poultry loft over, from the south-east, c. 9/2007

external hood (H3) which may have offered weather protection. The poultry door (b) could also have been heightened and featured a narrow timber lintel below renovated masonry, its plank and batten door was still in situ (c. 2007). Adjacent to the poultry door (b) was a small arched poultry access (e). Above the arch was an iron rod which was originally the iron pivot for a small door which shut the poultry in at night. To the front of the elevation evidence was found to indicate the original presence of an exercise yard. This was in the form of a relict section of wall with a rounded capstone (d) and in situ brick sets (h). The rounded walling is still represented in the in situ farmyard wall.

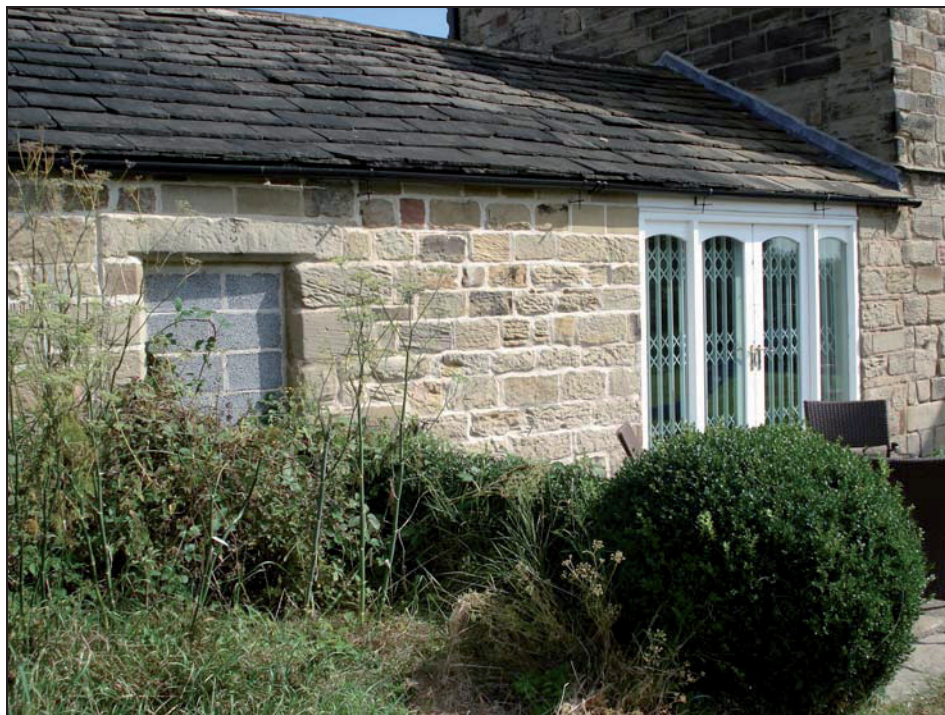
H14: Building B, external view of a repaired (narrowed) original doorway with a possibly inserted linel, from the west, c. 9/2007

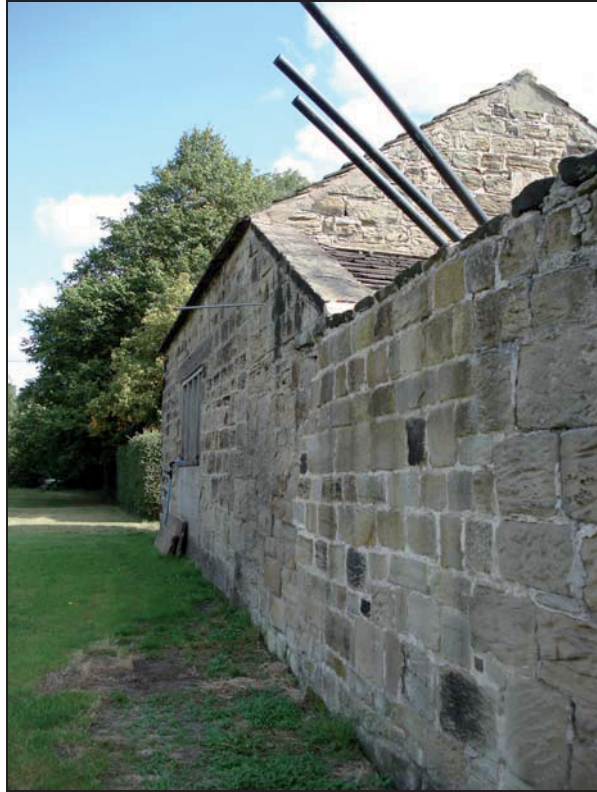
H15: Buildings D, C and A, oblique external view with the copings to Building C's north-west gable wall, from the south-east, c. 9/2007

Buildings C, D and E had been demolished. Building C the lean-to pigsty abutted the barn's north-west gable wall (H1 and H15) and featured a lean-to roof with inclined sandstone capstones. The wall between Buildings C and D had been

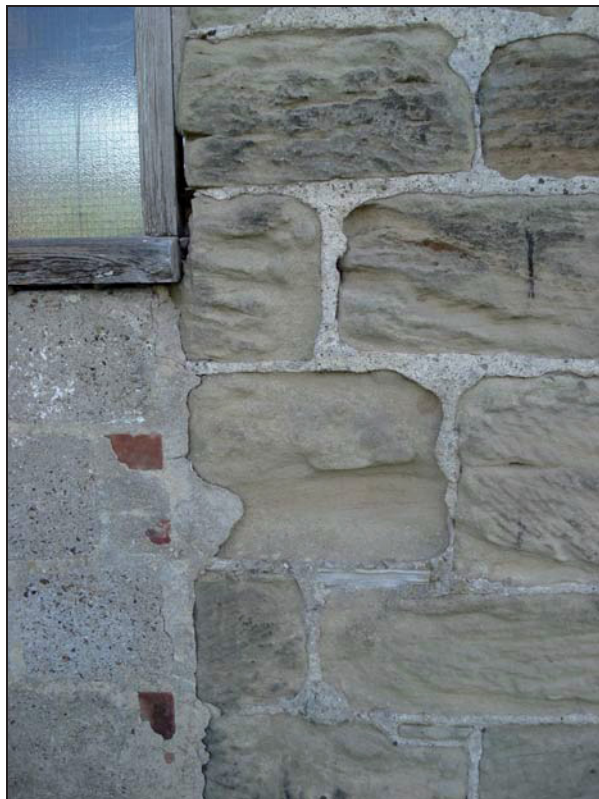
H16: Building A, external detail of the blocked barn doorway [8], from the north-west, c.?

The barn doorway [8] measured c.3m high x 2.5m wide and was very similar to the front doorway [4]. The opening had been blocked with concrete breeze blocks and a 4-light timber casement window inserted to the upper doorway. As with the barn doorway [4] to the south-west elevation the door jambs feature a vertical chamfer. The chamfer to door [8] measured 0.03m in width and was therefore narrower than the opposing front barn doorway [4] in the south-east elevation. No in situ hinges were noted (also internally) which indicates the use of door posts to hinge the original doors but these posts are no longer in situ. The lintel [10] is a later insertion and also showed no evidence for a hinge.

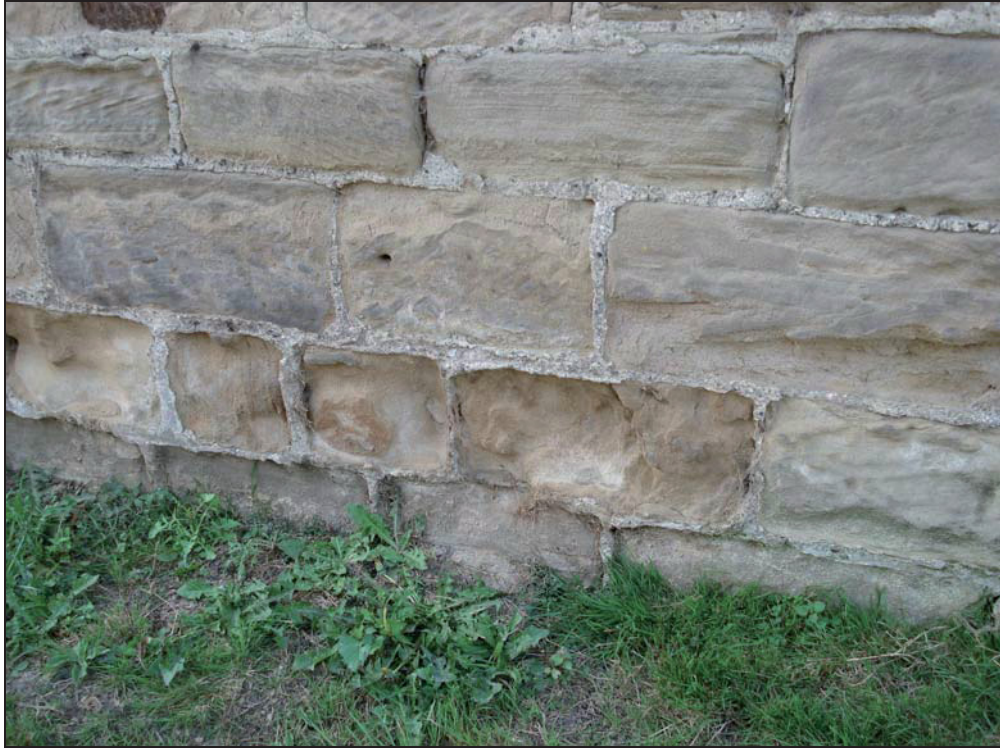
H17: Building A, external detail of the barn's coursed masonry to the lower north-west elevation, from the north-west, 9/ c. 2007

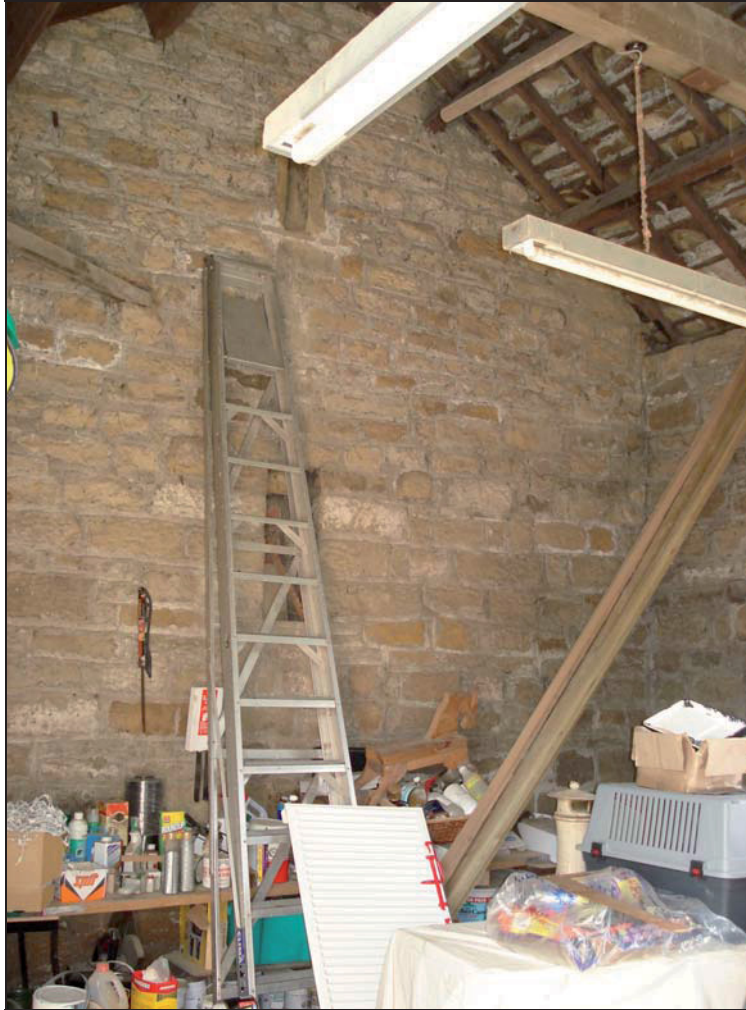
H29: Building A, general internal view with original arrangement of roof and ventilators to the north-east wall, from the south-west, c. 6/2006
