**CAUSEY HALL, HALIFAX,
WEST YORKSHIRE:
AN ARCHAEOLOGICAL WATCHING BRIEF**

CS Archaeology
January 2010

Fieldwork and report by: Chris Scurfield

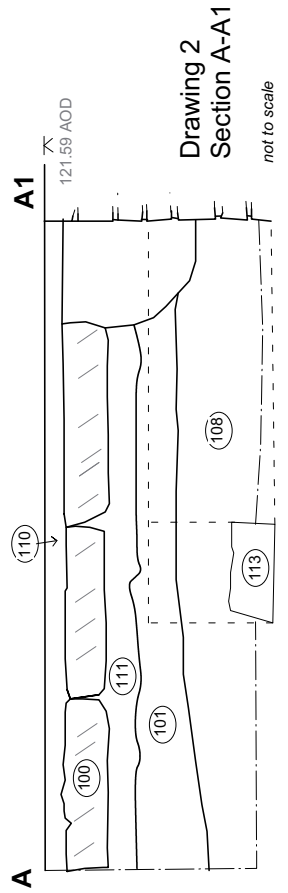
Figure 5: Trench 1
Plan and Section

- 6.1.2 During the excavation the stone wall [100] was retained to provide a section through the middle of trench 1 (**Figure 5**).
- 6.1.3 Either side of the wall [100] was a spread [101] of dark brown sandy silt with frequent lime mortar and flagstone fragments. Finds included a large quantity of large (mature) oysters. The northern half of the trench soon came down onto a reddish brown natural sand with 5% rounded stone [103]. Cutting this natural deposit, drain [106] was revealed (**Plates 2 and 3**). Drain [106] consisted of flagstone top/covers above two parallel brick walls. Each brick wall was two courses high, in a decayed lime bonded mortar, 0.23m apart and was built onto a series of lower abutting flagstones. The drain would have flowed to the east and still consisted of a dark organic silt deposit. Stratigraphically this drain was the earliest feature in the excavations and was truncated by the later building associated with wall [105] the present east wall of Causey Hall (**Figure 5**).

Drawing 1
Plan of Trench 1
scale 1:125

Drawing 2
Section A-A1
not to scale

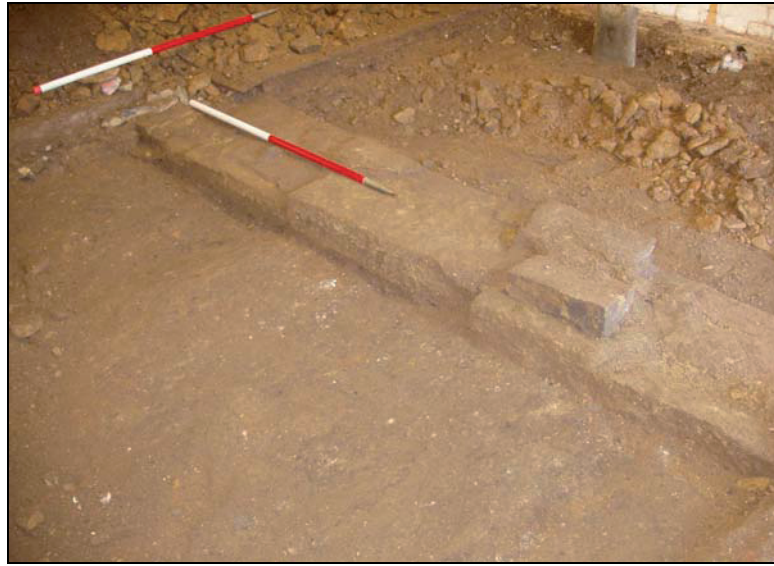
Plate 1: oblique view of the central wall [100], from the southeast

- 6.1.1 After removal of the concrete floor [110] a stone east-west aligned wall [100] was revealed (**Figure 5: Plate 1**). Most of the wall had been removed prior to the insertion of the modern concrete floor. This foundation course was 0.48m wide by 0.17m deep. It extended at least c.2.4m and was positioned above a layer of ash mortar and rubble [111]. The foundation stones were roughly hewn and had diagonal chisel marks to the sides but there was no other decoration. The upper surface of the wall featured a remnant sandstone course, bonded in a dark ash mortar with in situ impressions of the second course of stone work. The lower foundation course [100] remained in situ.

- 7.1 The watching brief has been able to show that the cloister court was originally divided into two parts. The lower course of this wall was revealed in trenches 1 and 4. This was aligned east/west, at the centre of the building dividing the original entrance lobby. Evidence of the original entrance lobby was removed probably during renovation c. 1970. This original dividing wall in the school probably represented a division of the cloister court for girls and boys.

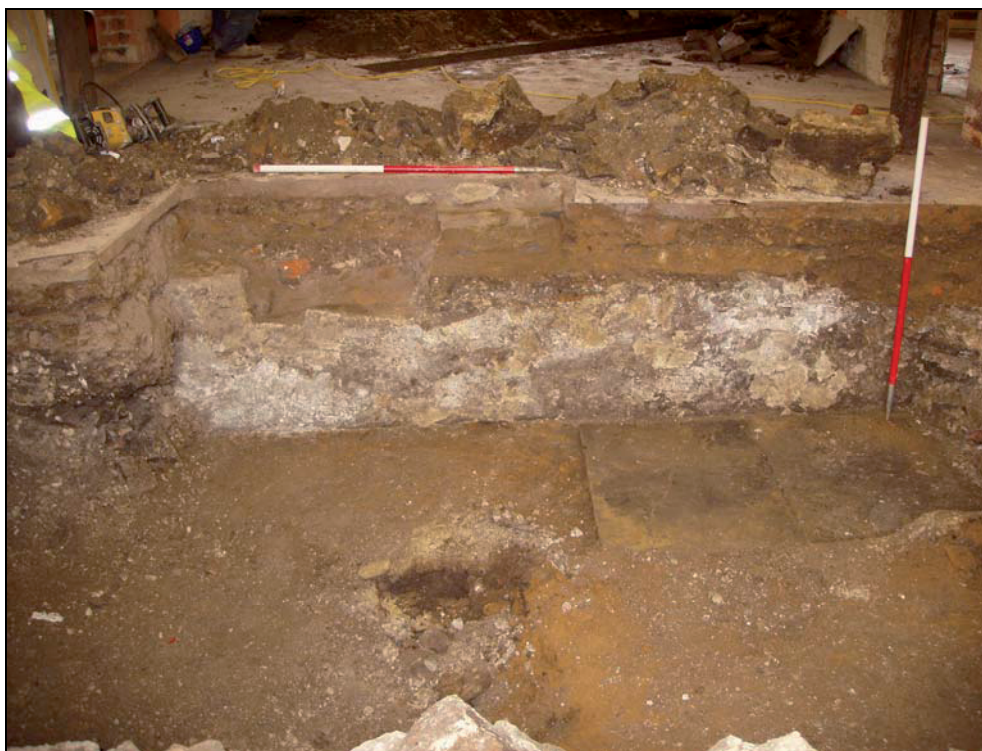
Plate 4: Trench 1, post excavation view of the internal east facing wall [104], from the east

- 6.1.4 As trench 1 was being reduced, an internal wall, with adhering plaster and lime-wash was identified facing east. At the end of the watching brief the east facing section was fully revealed (**Plate 4**). Set into the northwest corner of the trench was an in situ flagstone floor [112] (**Plate 5**) 0.8m wide. Floor [112] was defined by the contemporary internal walls [104 & 105].

- 7.2 Beneath the dividing wall remains of an earlier building was recorded within trench 1. This consisted of two internal walls that probably represented a corridor with a possible flight of stone steps to the north. These walls consisted of a single face and were built into the natural geology, reminiscent of a cellar. The location of the PDA to the historic map (**Figure 3**) and the documentary evidence suggests that these structural remains probably relate to the buildings of the Workhouse rather than the Alms Houses. In addition the east wall (east façade) of the present building was found to have been constructed directly onto the earlier building.

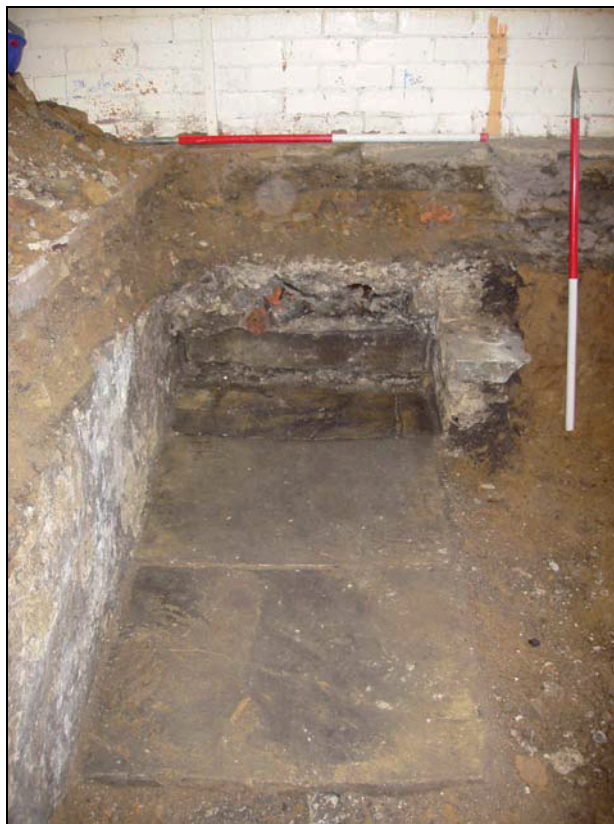
Plate 5: Trench 1, General view of the flagstone floor [112] with worn step in the section, from the south

- 6.2.5 The north and south sections of the trench were defined by inserted brick walls, these walls annexed the original ground floor space. The stratigraphic sections below these inserted walls were devoid of features and were characterised by similar levelling deposits [101 & 108] as encountered within trench 1 and represented by section 1 (**Figure 5**). The south and north walls were inserted into the building in c.1970 as evidenced by newspapers packing the doorways associated with the inserted brick walls. The south wall is of brick and was built upon a concrete foundation in contrast to the north wall which was built directly onto the original flagstone floor which was subsequently screed with concrete [110].

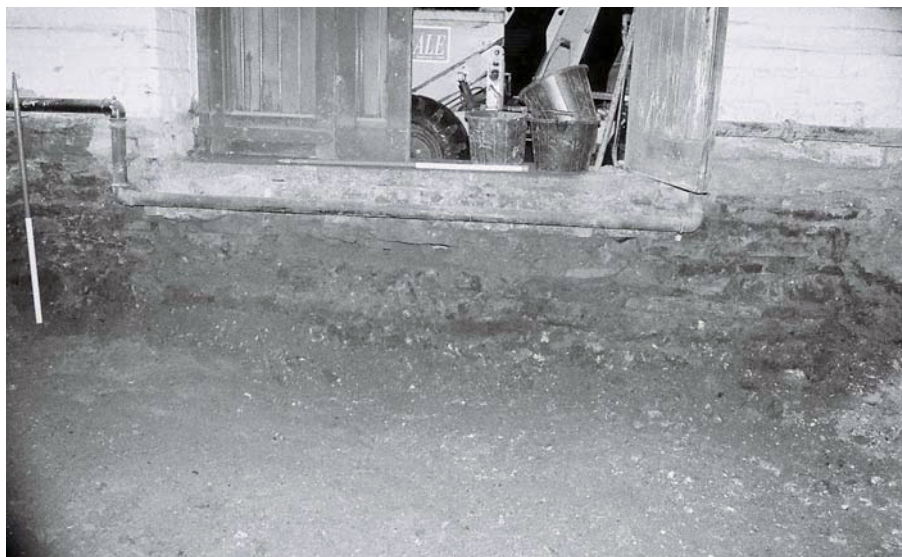
Plate 6: Trench 1, General view of the flagstone floor [112] with worn step in the section, from the south

- 6.2.6 Regarding the east wall the working hypothesis was that this probably represented the front elevation of the former alms houses/work house. When the wall was revealed there was an absence of diagnostic features such as fenestration and access arrangements (**Plate 6**). However, close examination of the wall did reveal

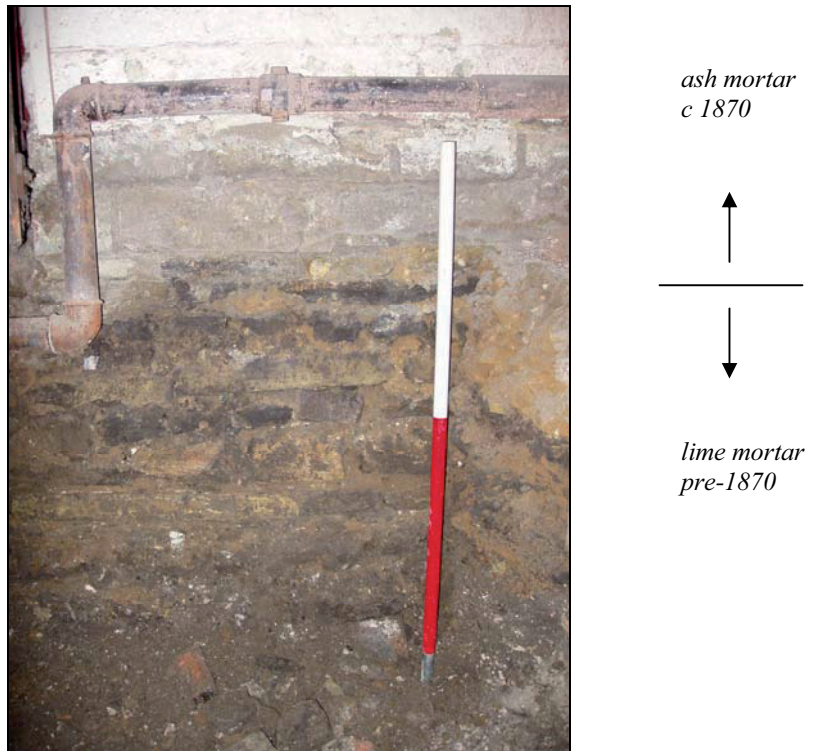
Plate 7: Trench 1, detail of the east wall showing 2 phases of construction, as evidenced by the different use of mortars, from the west

a change in the mortar that suggested the east wall was constructed in 2 phases. This suggests that the 1870 school wall was built directly onto a pre-existing building either the alms houses/work house.

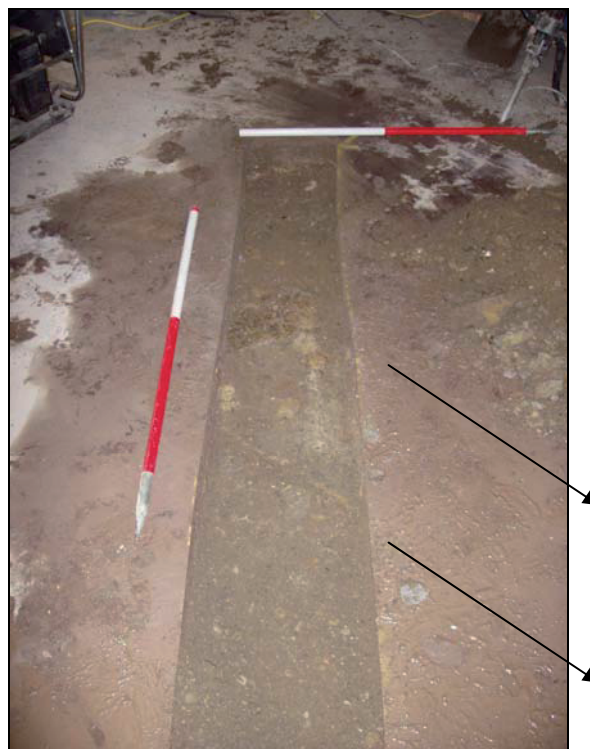
Plate 8: Trench 4, Post excavation view showing the continuation of wall [100], from the northwest

6.4.1 The watching brief was able to confirm that the central wall [100] continued towards the west wall of the former school, suggesting that originally the design of the cloister court was divided into two sections.
