THE RIVERSIDE INDUSTRIAL PARK, CATTERALL, GARSTANG, LANCASHIRE: AN ARCHAEOLOGICAL WATCHING BRIEF

CS Archaeology
March 2011

National Grid Reference (NGR): SD 49234 43040 (centre)

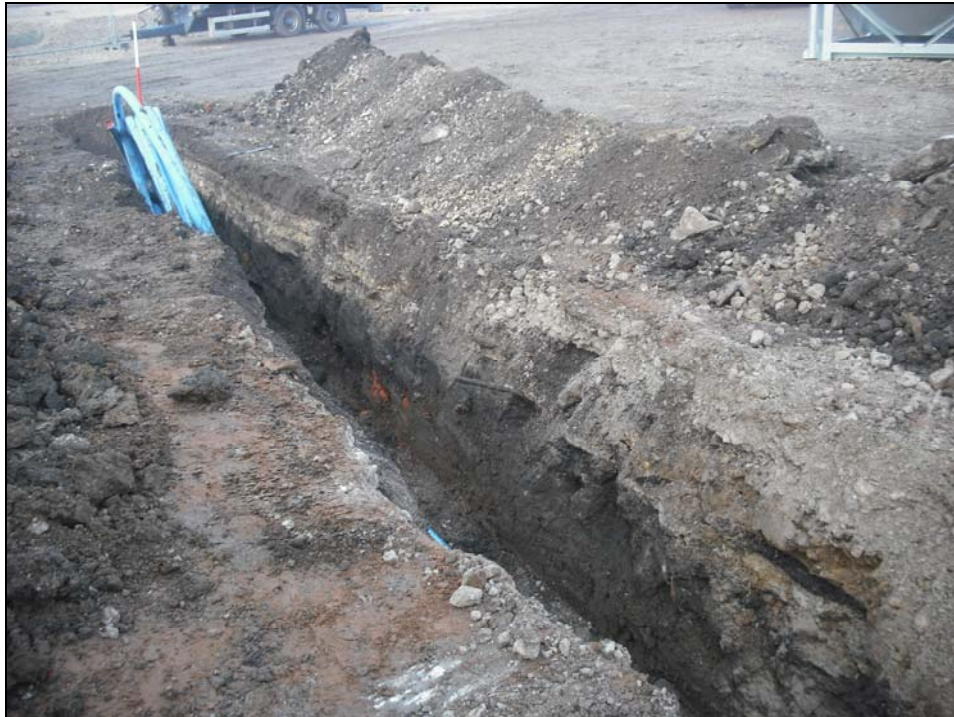
- 5.3 Trench 2 (39.7m x 1.4m) was aligned east-west and linked the washing facility (Building D) to the man-hole (drainage hub). No archaeological features were revealed but a sequence of made ground levelling deposits were recorded throughout the trench (Plate 1).

Plate 1, 43: trench 2, general view, from the southeast

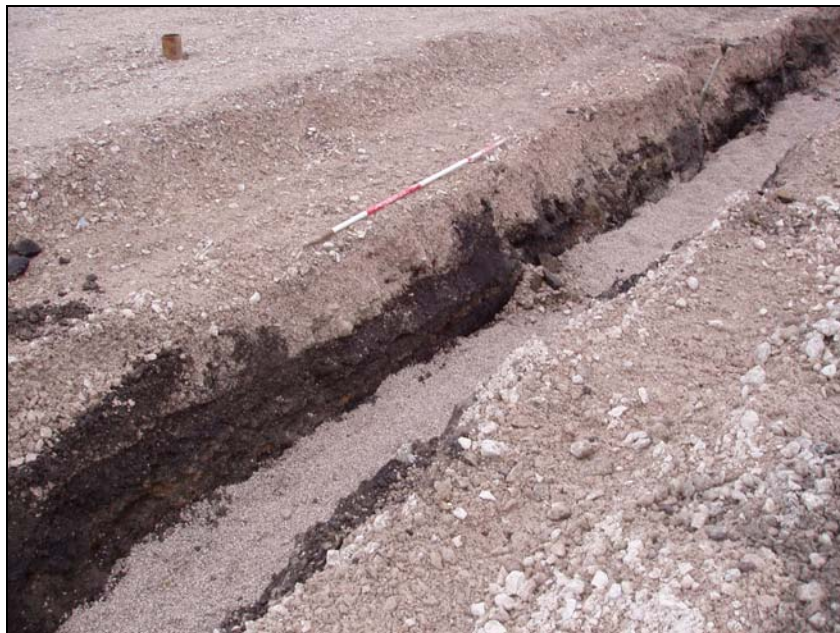
- 5.4 Trench 3 (47.3m x 1.4m) was also excavated prior to the watching brief but the trench sides were able to be inspected. Trench 3 was excavated in order to insert a north-south drain along the side of the proposed building A ([Plate 2](#)). Broadly the trench was able to be divided into two parts. The northern end with relatively high natural deposits of red clay, which extended south by 4.8m ([Figure 2](#)). The red clay natural was overlain by aggregate, a crushed cinder/slag with angular stone. The southern end of the trench (36m) contained various made ground deposits characterised by levelling deposits with the remains of a sandstone faced wall (Structure 1). Structure 1 ([Plates 3-4](#)), had been truncated by trench 3, which revealed three courses of faced sandstone, bonded with lime mortar. Abutting the masonry was an inner brick wall. To the sides and above the structure was a deposit of crushed brick with occasional stone fragments containing modern pottery and plastic. Above were three further deposits of aggregate (0.25m deep) then a layer of clinker (0.06m) with an overlaying layer of tarmac (0.04m). Structure 1 was on a north-west to southeast alignment, and probably represented a cross wall of the building which was demolished early in 2010. The return of the wall in the east facing section could not be detected and may have been removed prior to the archaeological watching brief.

Plate 2, 60: trench 3, general view, from the south southeast

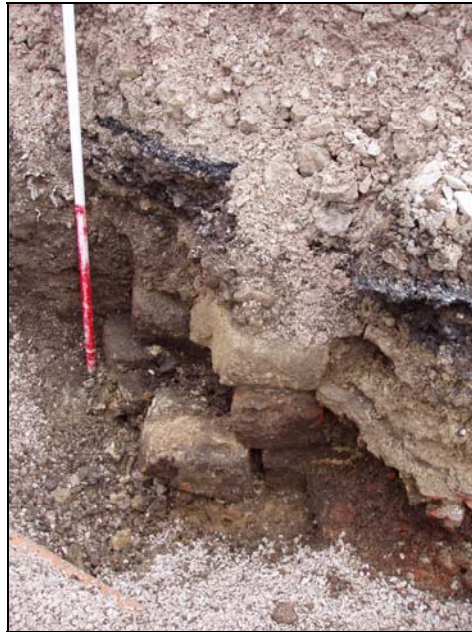
Plate 3, 66: trench 3, view structure 1, from the southwest

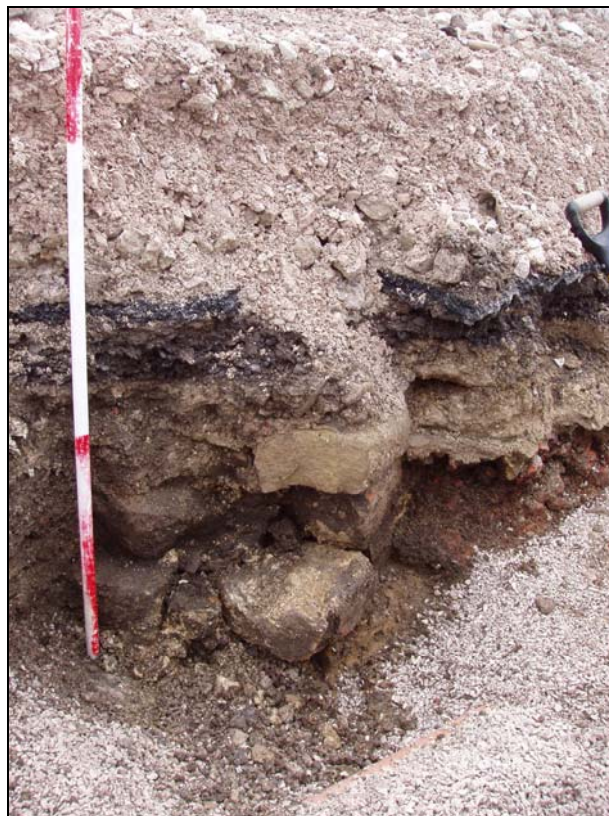
Plate 4, 67: trench 3, view structure 1, from the northwest

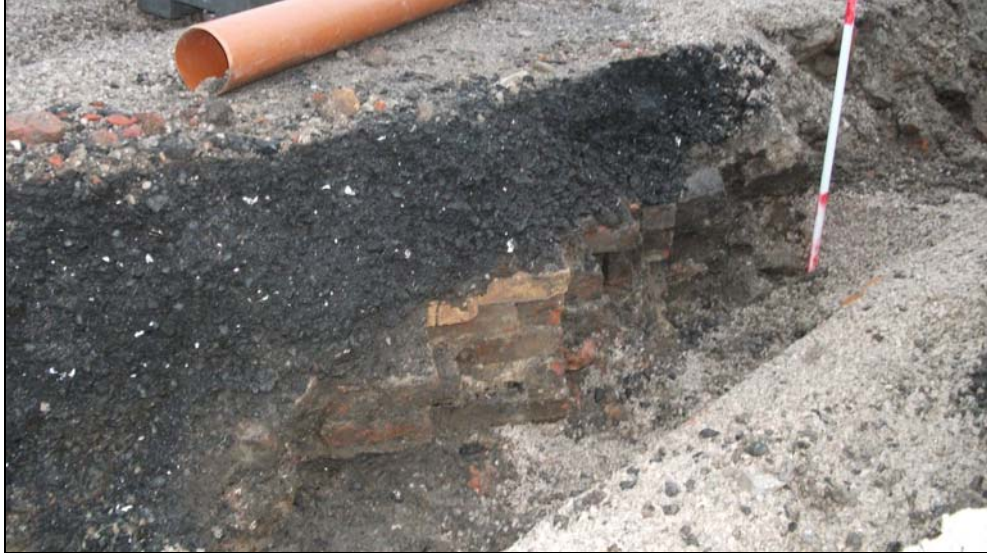
- 5.5 Trench 4 (30.2m x 1.4m) was excavated at a tangent to Trench 3 and was designed to provide drainage from the silo store. It revealed a section of brick work, structure 2 ([Plate 5](#)), towards the southwest end of the trench that was probably related to structure 1, and also some modern rubbish pits northeast of structure 2. Structure 2 consisted of up to 4 courses of brick, cross layered and bonded with lime mortar. Structure 2 represented a section of trench 4 which was 1.12m long and was not reflected in the southeast facing section, suggesting that the structure had been truncated at its northern end. The construction of structure 2 is consistent with a raised internal floor area which would have provided a damp free floor.

Plate 5, 75: trench 4, view of structure 2, from the north

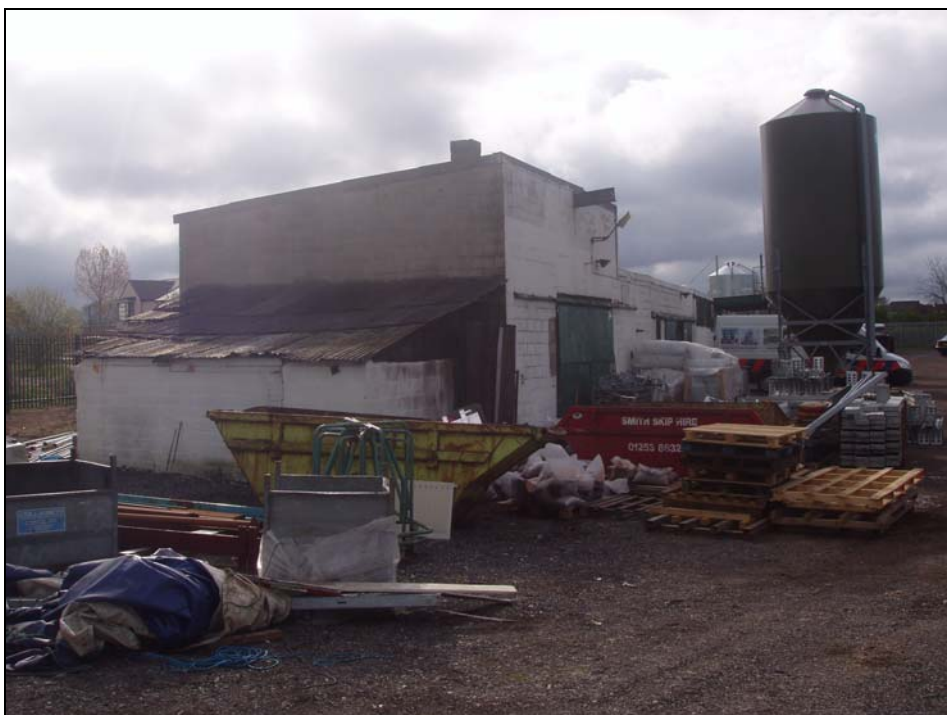
Plate 1: general view of the extant former slaughter house, from the northwest

- 1.3.1 No known archaeological work has been undertaken within the PDA. Following a site visit (30/4/2010) no significant stone buildings were observed within the PDA. The extant single storey building (**Plates 1 & 2**) forms a northwest to southeast aligned range, which is characterised by block concrete walls and corrugated metal sheet roof. A small section of sandstone wall was identified to the lower rear wall of the present building (**Figure 1: Plate 3**) and suggests a correlation between the 19th century ancillary tannery buildings and the footprint of the present building. Internally (**Plate 4**) the building, fixtures and fittings are consistent with a 20th century date, and are consistent with the building's penultimate use as a slaughter house, commonly referred to as the 'Knackers Yard'.

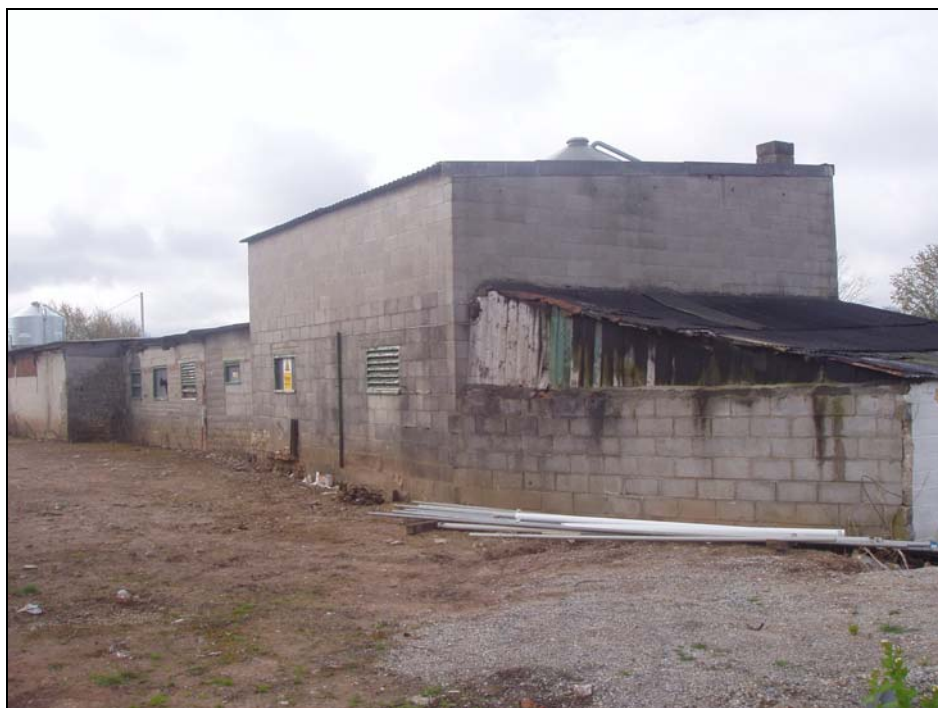
Plate 2: general view of the extant former slaughter house, from the north

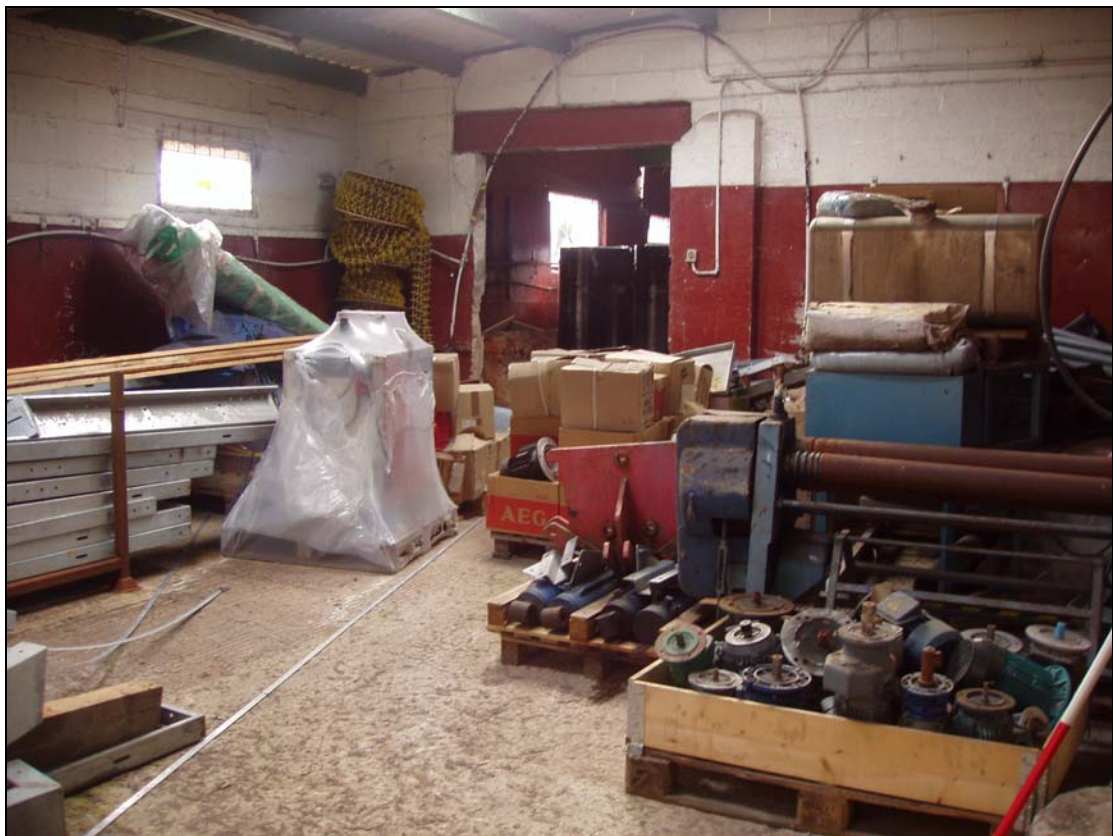
Plate 4: internal general view of the former slaughter house, from the northwest
