Historic Building Photographic Survey

**Hecadeck Cottage, no. 2a, Church End,
Nether Broughton, LE14 3ET**

Report Date: March 2011

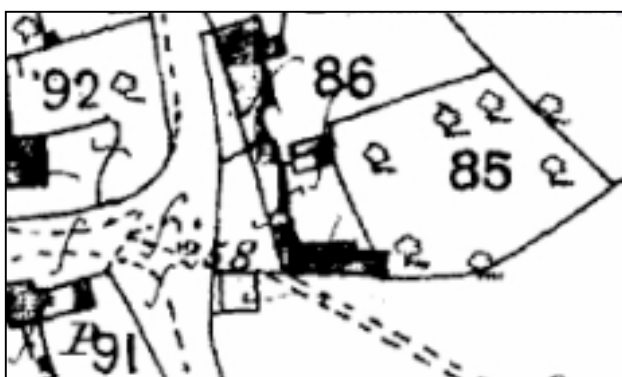
Map 1: Extract from 1885 Ordnance Survey map

5.9 The 1885 Ordnance Survey map suggests that this building was the corner section of a larger L-shaped range although the adjoining buildings appear to have been demolished by 1900 (see Maps 1 & 2). However the front wall of the outbuilding does project forward of the side wall indicating that this wall had extended further into the site (Plate 17).

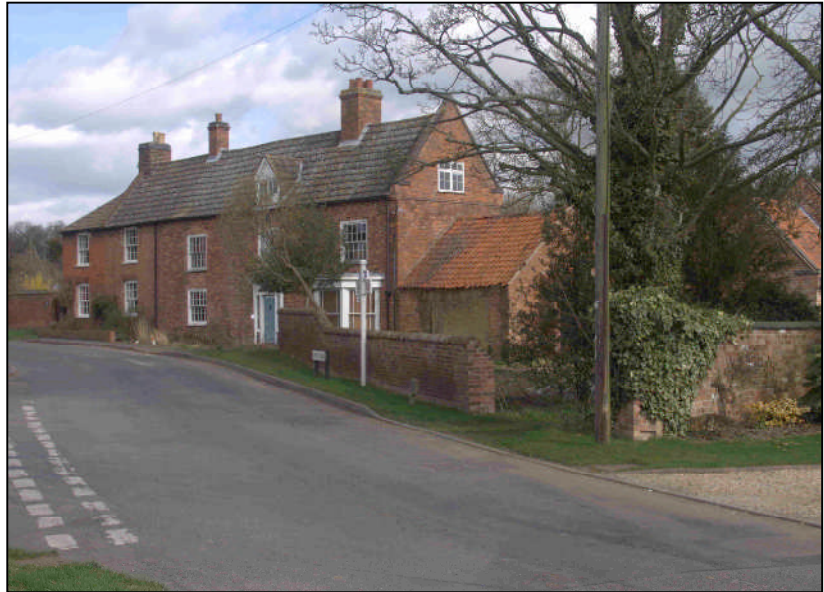
Plate 1:

View looking north along the Church End across the frontage of Hecadeck Cottage with the single storey annex to the centre right

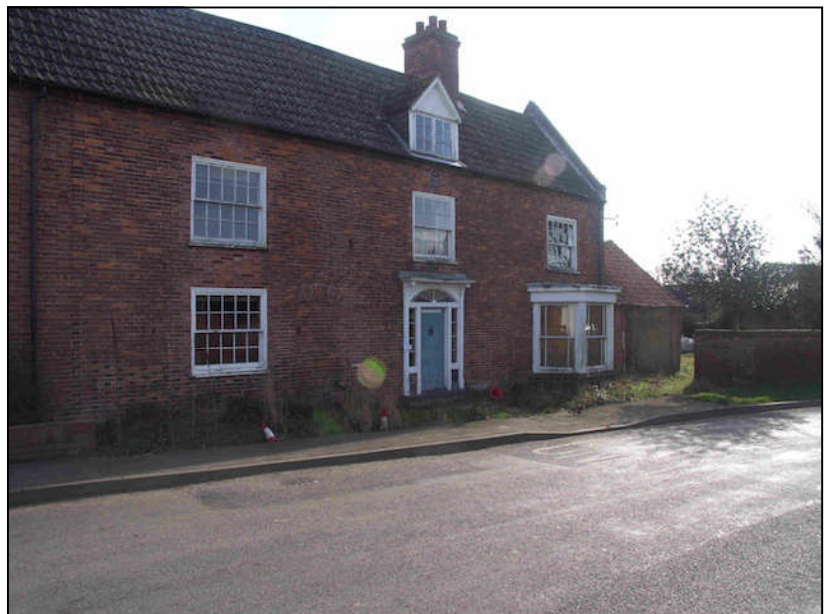
Plate 2:

5.7 There are no surviving fixtures or fittings to indicate its original function and no dating evidence for the annex although the main house has a painted datestone below the front dormer window inscribed 1762 (Plate 2).

View looking south along Church End across the frontage of Hecadeck Cottage with the single storey annex to the right

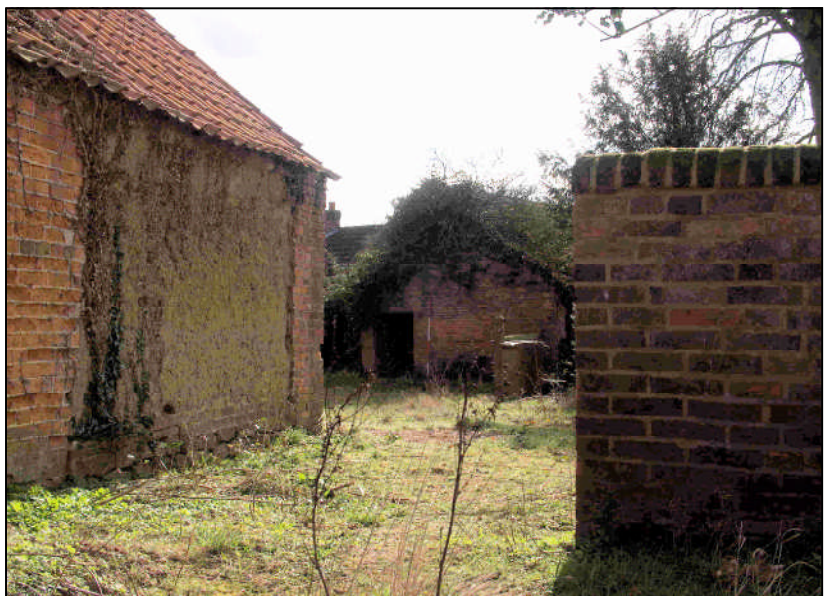
Plate 3:

View looking south along the front of the single storey annex towards the detached outbuilding showing the spatial and visual relationship between the two buildings

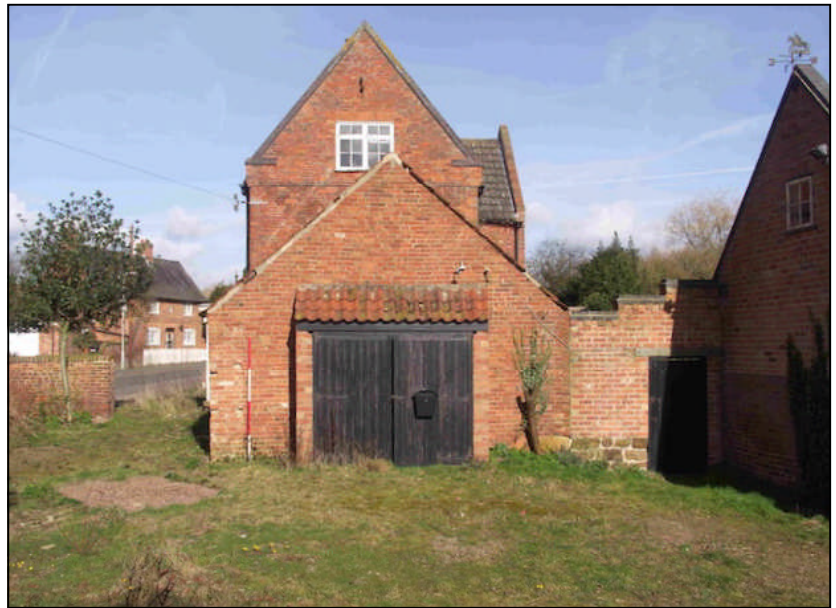
Plate 4:

5.4 The gable wall is built of red brick with a random bonding pattern (Plates 4 & 5) and whilst it is tied into the brick panel within the front wall it is not tied into the rear cob wall, as shown by the clear vertical joint in the internal corner between the two walls (Plate 13). A small projecting bay with double doors has been added to the gable wall (Plates 4 & 5) that is constructed in Imperial-size common bricks that are larger than the bricks in the gable wall and this bay is not tied into the main gable wall. The internal opening through the original gable is defined by a concrete lintel.

View looking north towards the gable end of the single storey annex and Hecadeck Cottage

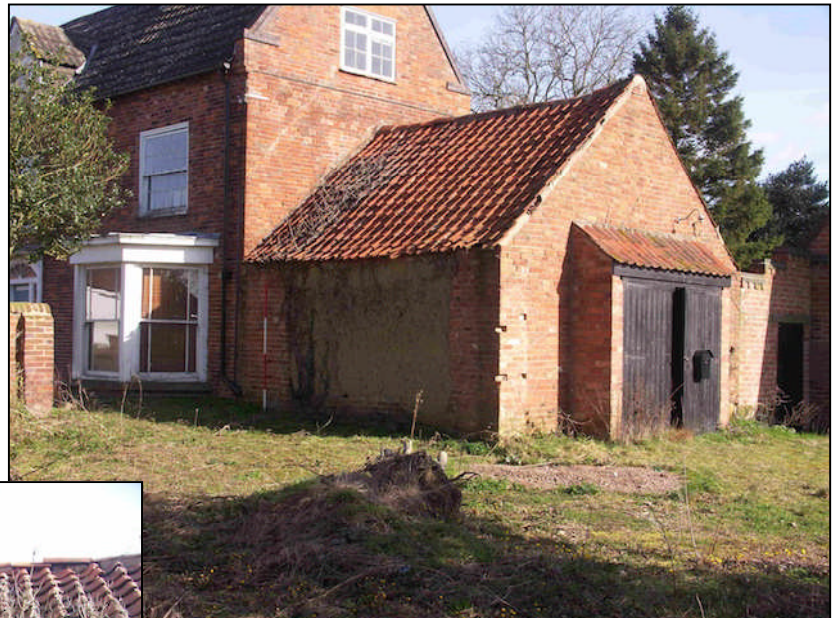
Plate 5:

View looking north-east towards the front wall and gable elevation of the single storey annex

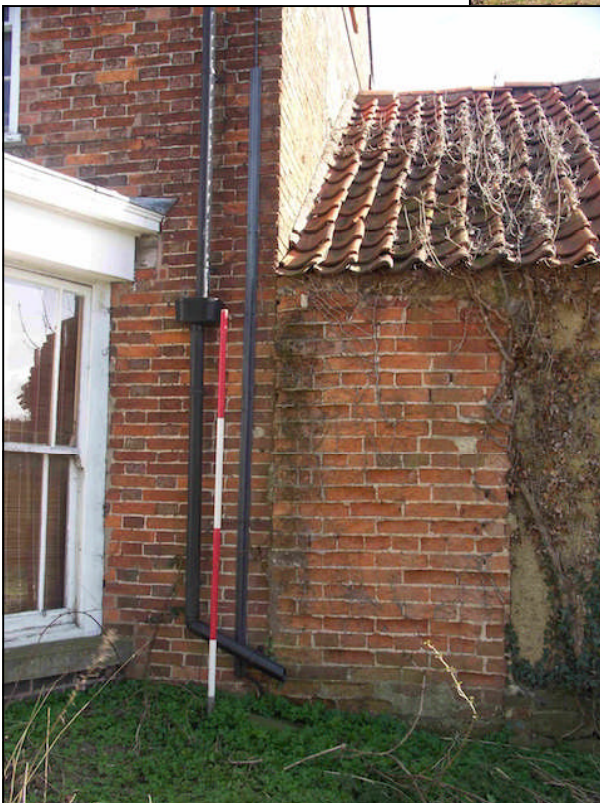
Plate 6:

View looking east showing the vertical joint between the front wall of Hecadeck Cottage and the single storey annex and the vertical joint between the brick pier and the central section of cob wall

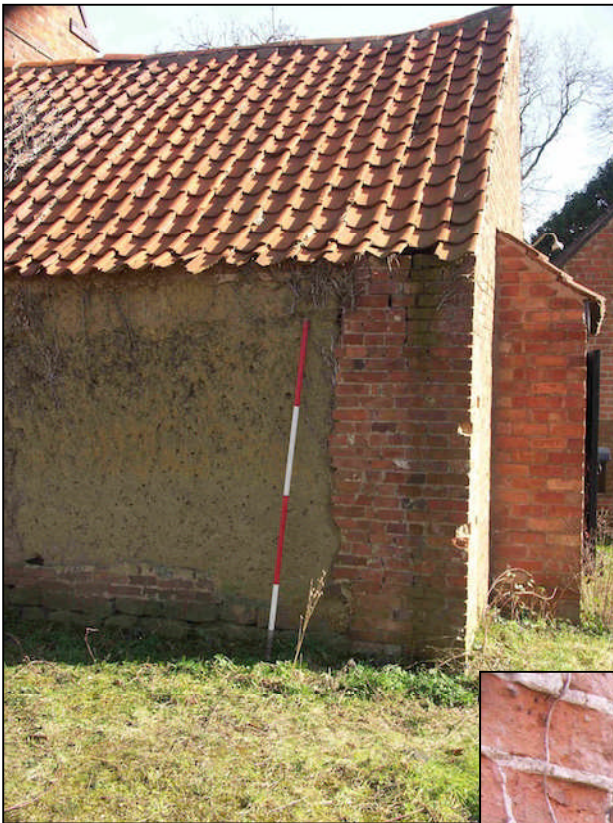
Plate 7:

View looking east towards the front corner of the single storey annex showing the vertical joint between the corner brick pier and the central section of cob wall

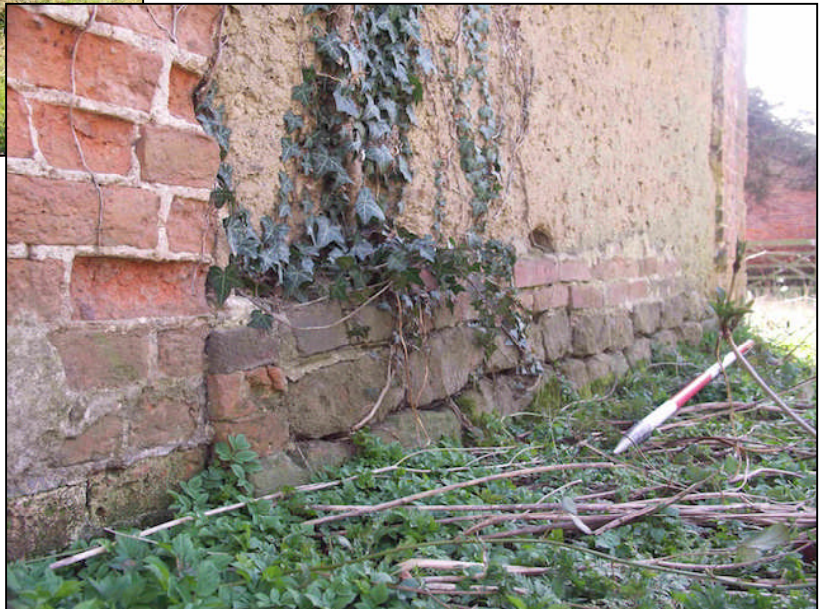
Plate 8:

Detail of the coursed stone plinth supporting the section of cob wall in the front wall of the annex

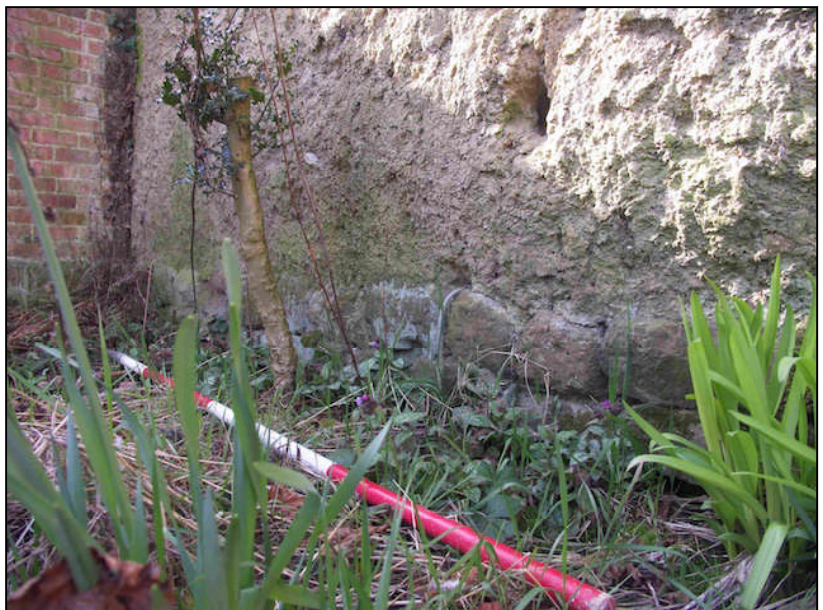
Plate 9:

Detail of the coursed stone plinth supporting the cob wall in the rear wall of the annex

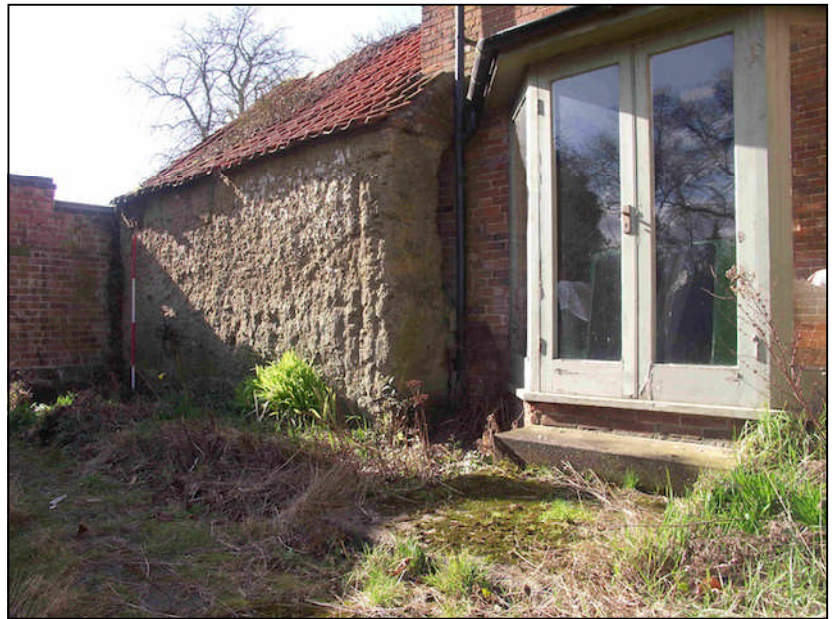
Plate 10:

the depth of the cob wall (Plate 10).

View looking south towards the rear cob wall of the single storey annex projecting forward of the rear elevation of the main house

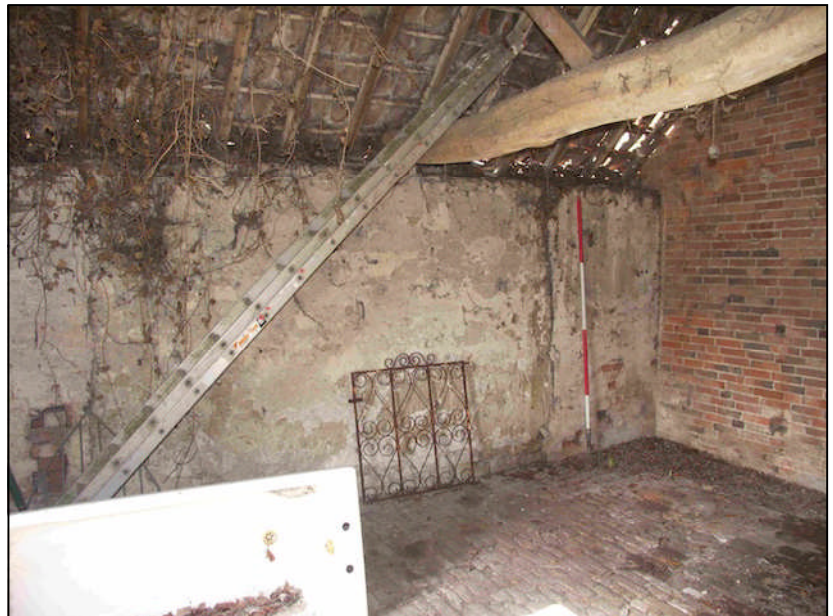
Plate 11:

5.6 Internally the floor is brick paved and the walls are covered in a limewash (Plates 11 & 12).

Internal view looking west of the front wall of the single storey annex, showing the brick paved floor and rough hewn timber beam

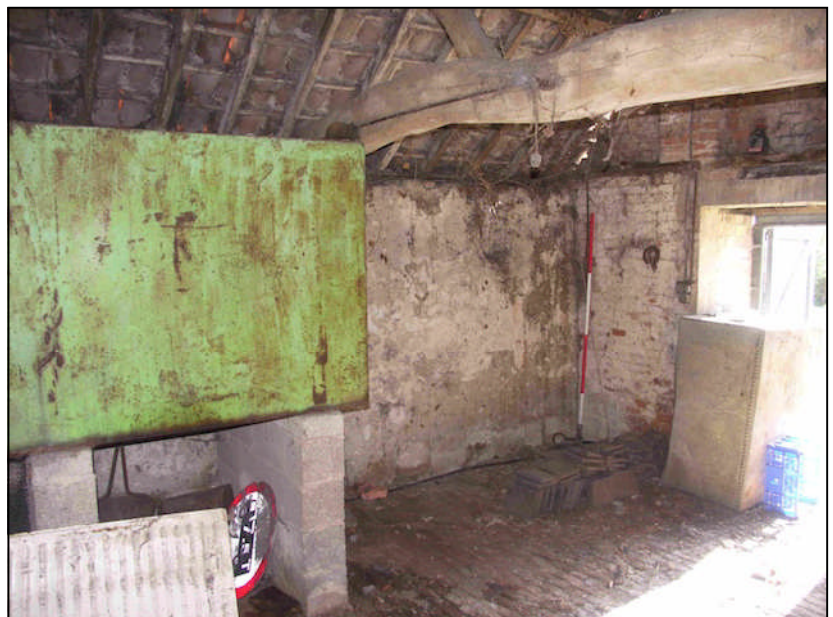
Plate 12:

Internal view looking east of the rear wall of the single storey annex, showing the brick paved floor and rough hewn timber beam

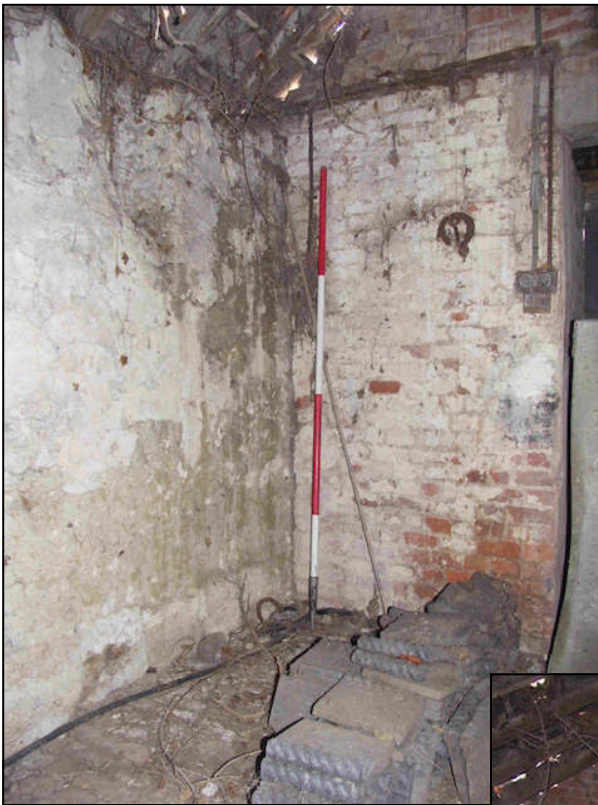
Plate 13:

View of the south-east corner of the single storey annex showing the vertical joint (to the left of the ranging rod) between the rear cob wall and brick gable wall

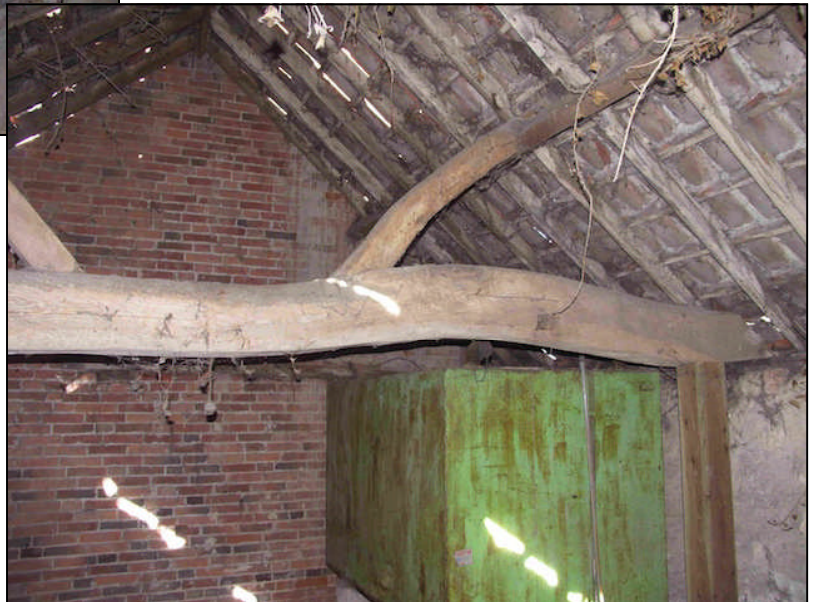
Plate 14:

5.5 The roof of the annex is covered in pantiles (Plates 1 & 5) and is supported by a single truss with a rough hewn tie beam spanning the building between the front and rear walls with two angled struts supporting the purlins (Plates 14 & 15).

View looking north-east showing the rough hewn timber beam and strut with supporting timber post

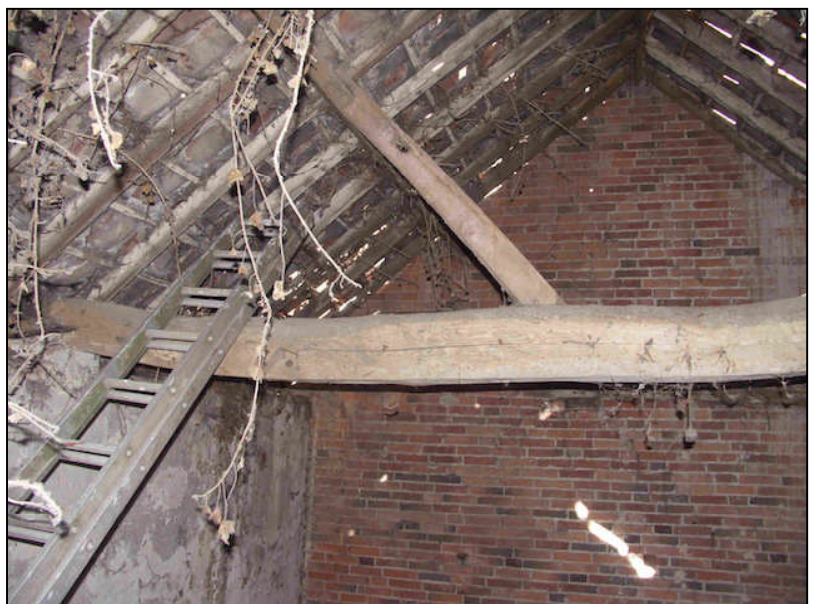
Plate 15:

View looking north-west showing the rough hewn timber beam resting on the front wall of the annex and strut

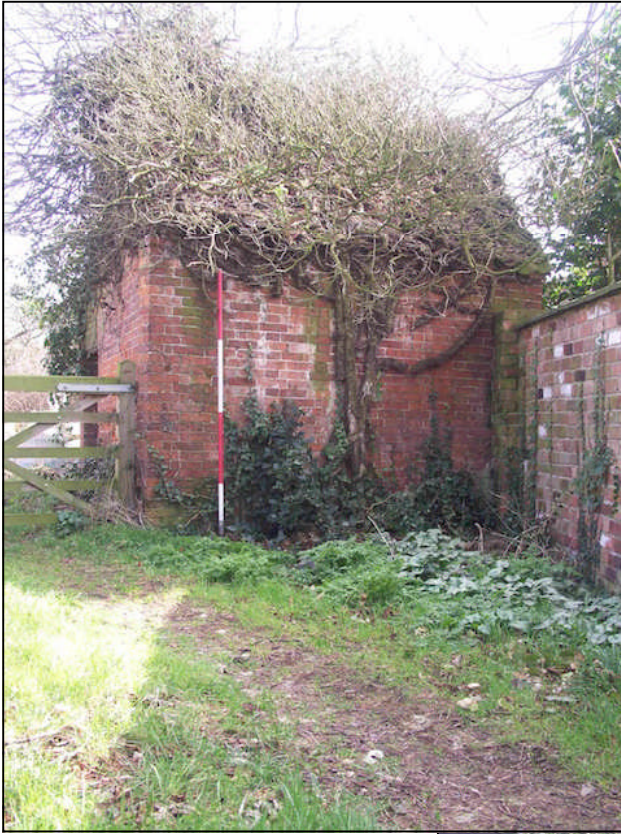
Plate 16:

5.10 The roof of the building is covered pantiles although it is now overgrown with vegetation and is in a parlous condition (Plate 16 & 17)

View looking east towards the front elevation of the detached outbuilding

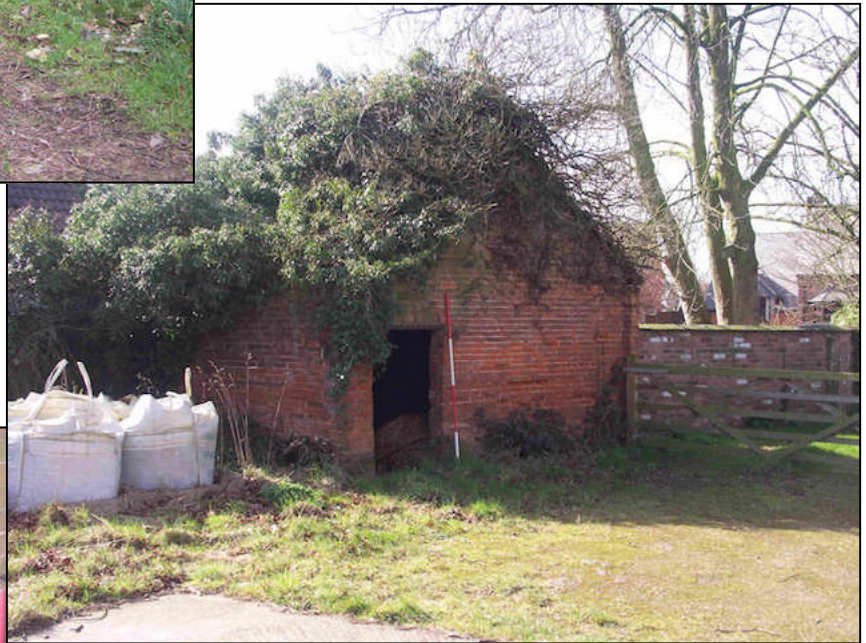
Plate 17:

View looking south towards the side elevation of the detached outbuilding showing the low doorway

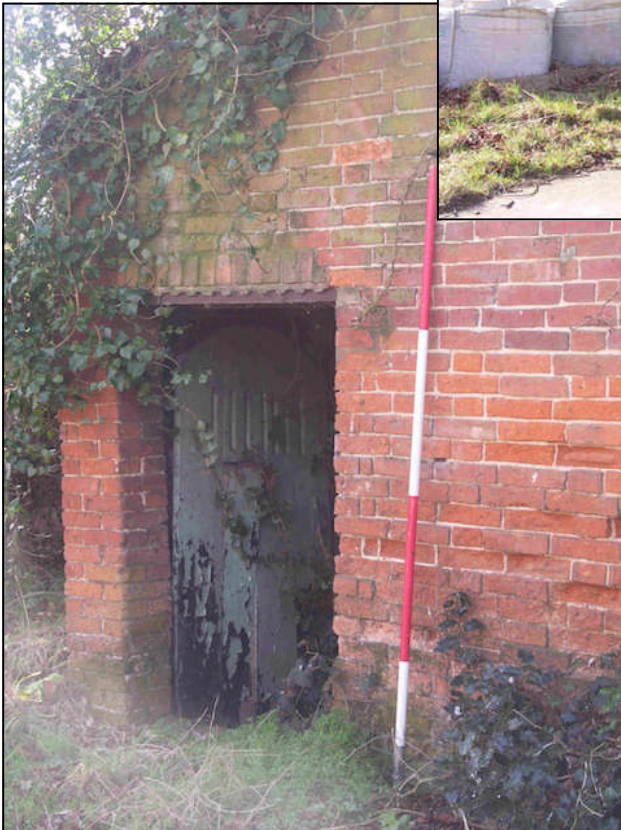
Plate 18:

View looking south-east showing the low entrance door and the surviving timber door in more detail

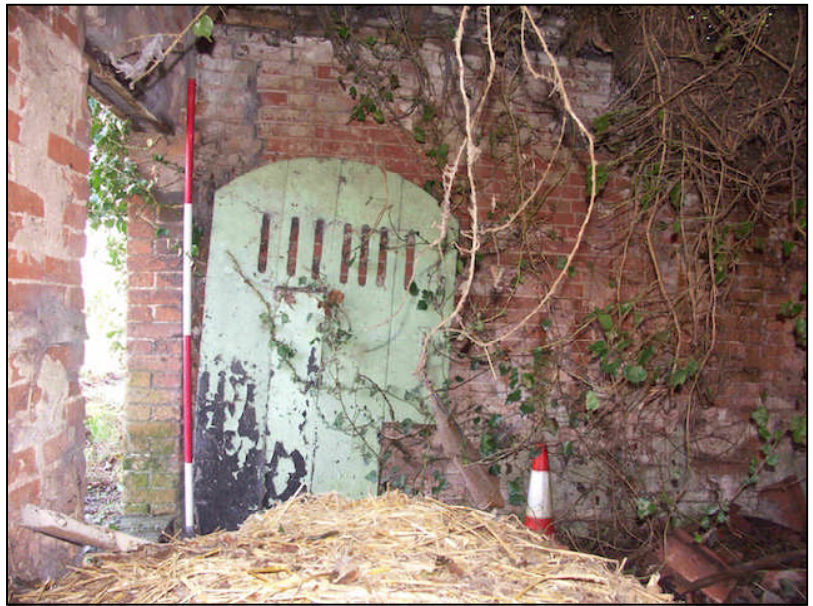
Plate 19:

Internal view within the detached outbuilding showing the surviving timber door standing against the rear wall

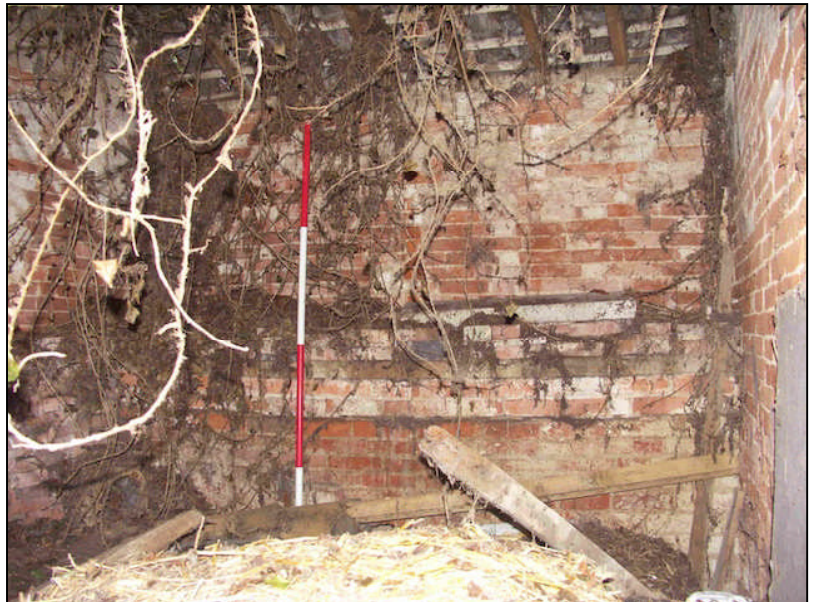
Plate 20:

to the front wall suggesting that the building has been used as a loose box for cattle or as a pig sty (Plate 20).

Internal view within the detached outbuilding showing the brick trough standing against the front wall
