SIX ACRES,
17, THE RIDGEWAY,
ROTHLEY

HISTORIC BUILDINGS
APPRAISAL
(LEVEL 2 SURVEY)

TRIGPOINT CONSERVATION & PLANNING LTD.

REPORT DATE: SEPTEMBER 2009

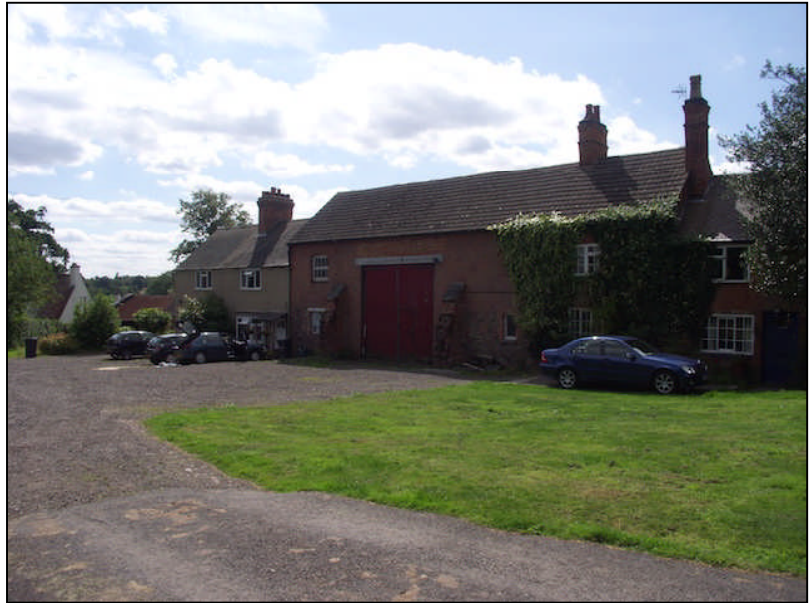
Plate 1: East facing elevation with farmhouse to the right of the threshing barn and cottages to the left

5.27 A pair of two storey, two-up/two-down cottages stand to the south of the barn and it is likely that these were built to house farm workers [Plate 1].

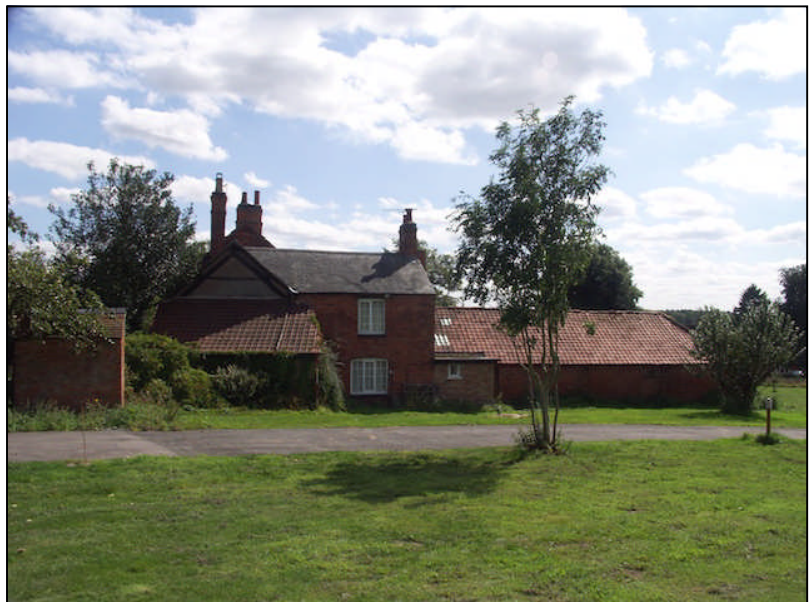
Plate 2: North facing elevation of farmhouse, showing two storey extension at right angles to timber frame cell and pantile roofed lean-to extension

5.17 The farmhouse is constructed of red brick, laid in a Flemish Garden Wall bond (three stretchers between each pair of headers), with a granite rubble plinth on the front elevation of the barn unit [Plates 2 & 6]. The roofs of the main building are covered in Welsh slate while the lean-to and kitchen extension are covered in pantiles [Plates 2, 7 & 12].

5.18 Whilst now faced in brick, the lower, two storey section may originally have been of timber frame construction. There is an exposed timber frame in the end gable above the lean-to extension and also the possible faint outline of a timber frame within the wall of the back

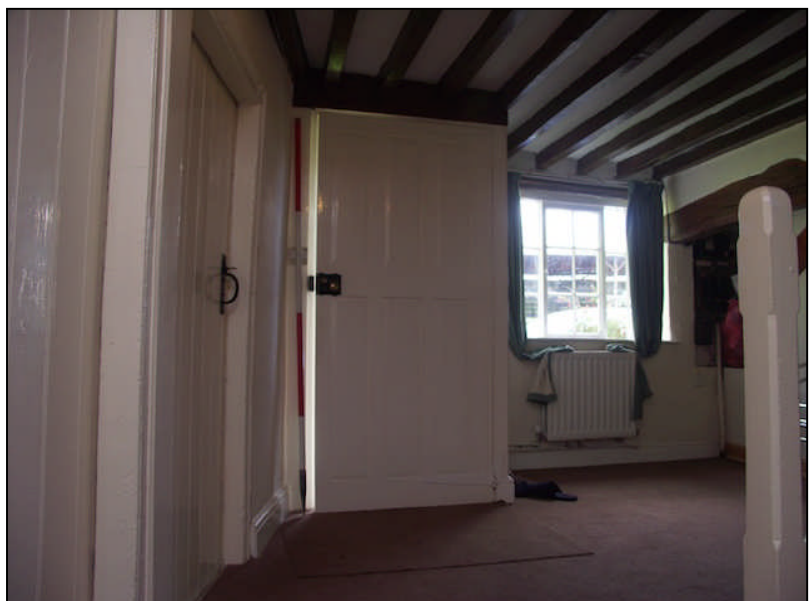
Plate 3: Internal view of the entrance hall

5.22 There are also good surviving timber panel doors on the ground floor and a number of ledged plank doors with surviving cast iron door latches [Plates 3 & 4].

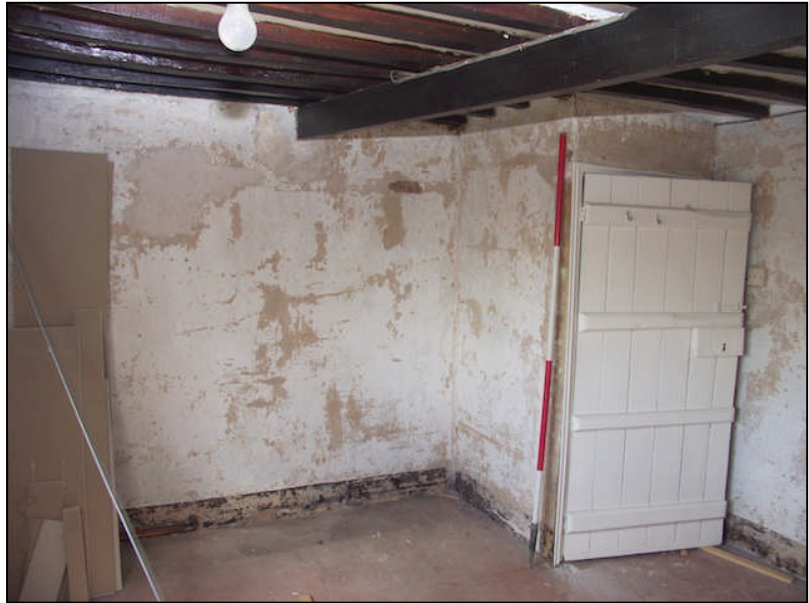
Plate 4: Exposed gypsum plaster floors in the rear bedroom and faint outline of a timber frame within the rear wall

5.19 The ground floor appears to be timber while on the first floor there are gypsum plaster floors (also known as lime ash floors) as shown by the exposed floor in the rear bedroom [Plate 3].

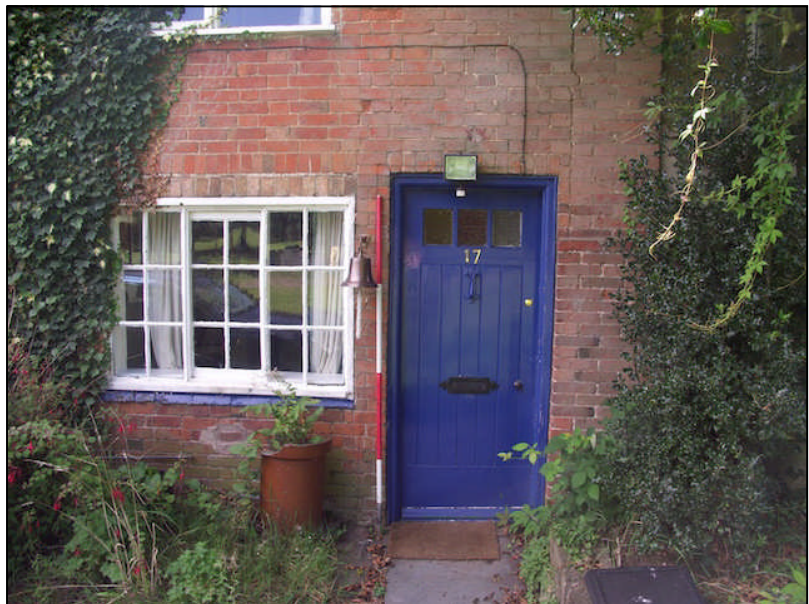
Plate 5: Surviving vertical sliding sash windows and timber ledged and braced front door

5.20 Whilst most of the windows have been replaced there are still some surviving examples of the original vertical sliding sash windows, such as in the front (east) elevation into the hall, alongside which is a surviving timber ledged and braced door. [Plate 5].

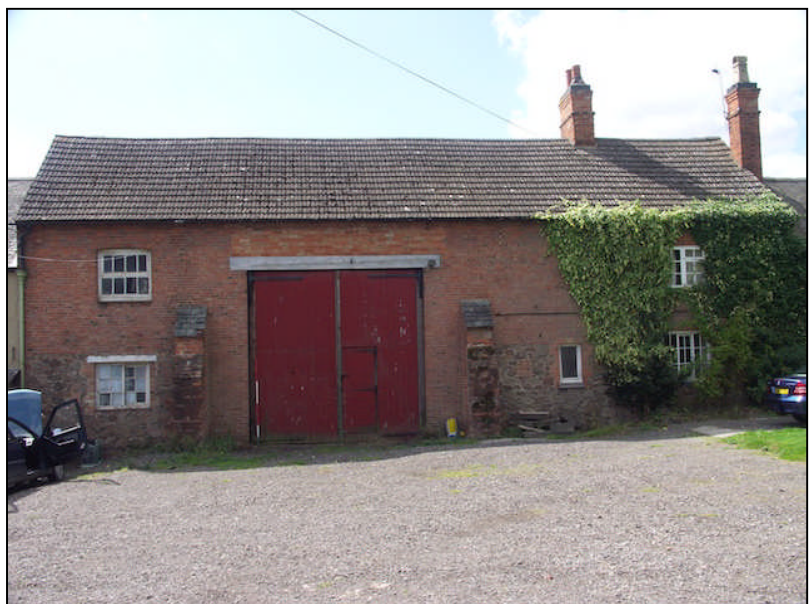
Plate 6: East elevation of the threshing barn

5.24 The barn is constructed of brick, laid in a Flemish Garden Wall bond with a plinth course of random granite rubble on the front elevation [Plate 6]. The roof is covered by modern concrete roof tiles supported by a series of king post trusses. Internally there is a solid brick-paved ground floor and a raised timber mezzanine floor in the lower bay.

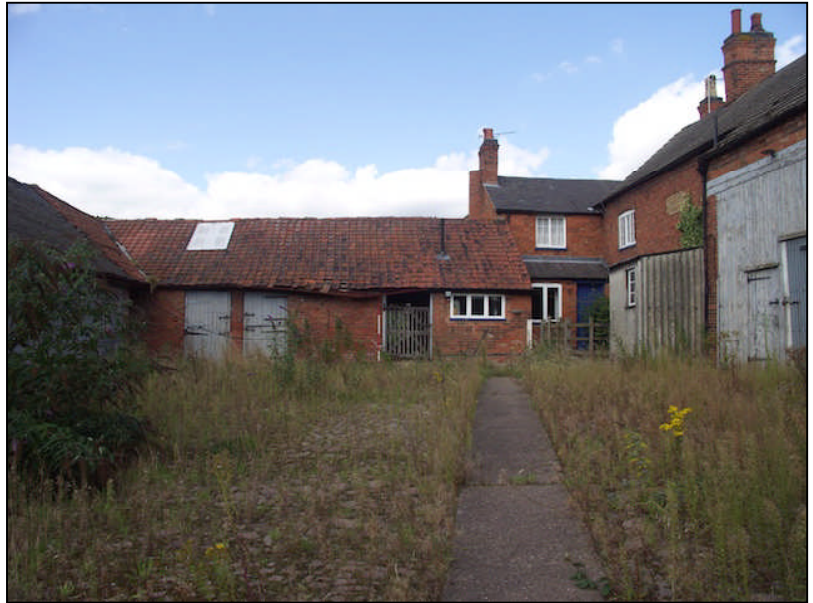
Plate 7: Rear elevation of the farmhouse and barn into the internal farmyard

5.25 The eastern front elevation of the barn is supported by two brick buttresses built either side of the double height door. The height of this door appears to have been reduced by the insertion of ten courses of common bricks [Plate 6]. The full-height double door is then repeated on the rear (west) elevation although the doors project forward of the rear elevation to afford a degree of shelter to the threshing floor if the doors had to be open [Plate 7].

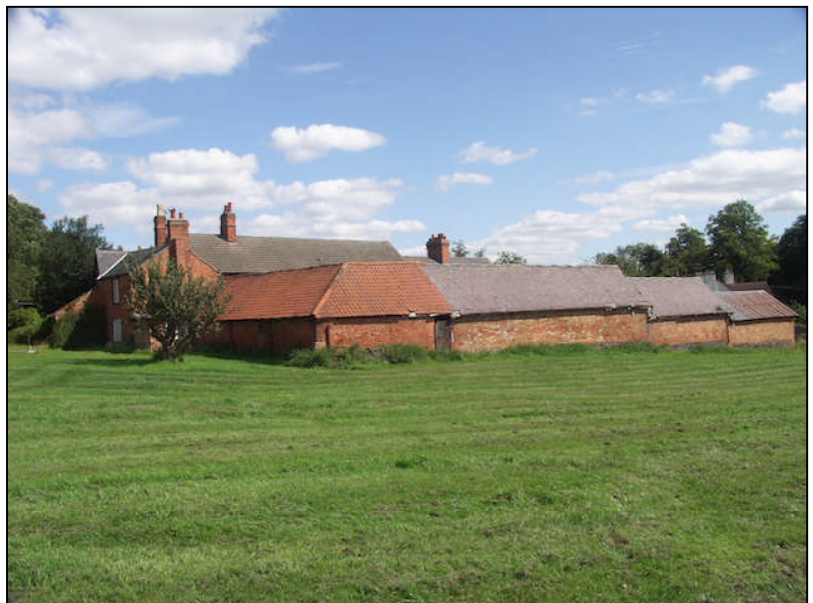
Plate 8: West facing elevation of the stock shed range

5.33 Running along the western side of the farmyard is a range of cattle sheds that step down the hillside that is reflected in a series of stepped rooflines and changes of floor levels [Plate 8]. The upper two units were built in 1881 and comprised as a cow shed, open shed and a loose box [Figure 2]. The lower unit appears to have added between 1881 and 1904. The open shed has subsequently been enclosed and all three buildings have been combined to form a single, linear milking shed, albeit with changes in the floor levels and dividing cross walls.

5.36 The milking sheds are also constructed of red brick, laid in a Flemish garden wall bond over a granite rubble plinth on the rear elevation [Plate 8]. Whilst the external brickwork runs through the length of the rear (east) elevation, a distinct vertical joint marks the break between

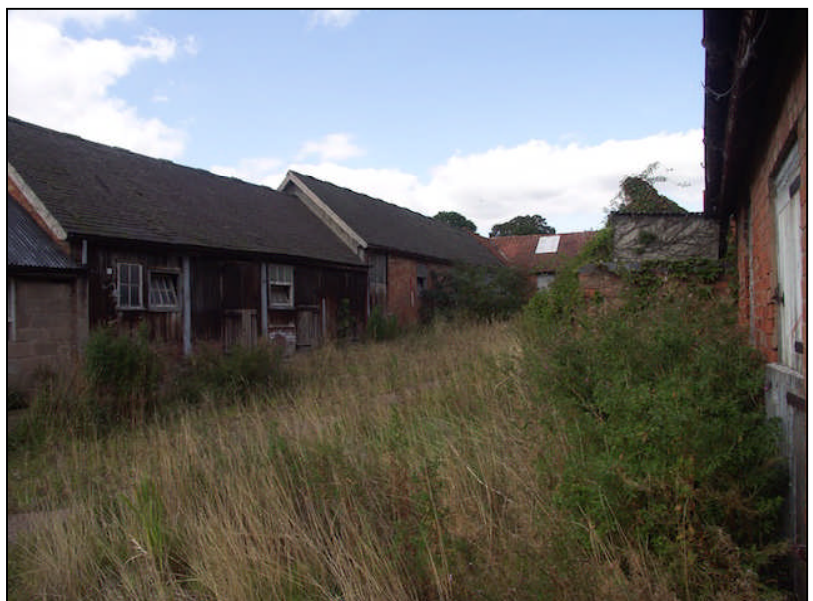
Plate 9: Internal farmyard elevation of the cow sheds

- 5.37 The 1881 building drops down the hillside with one break in its roof line mid-way along the original building. The exposed gable at this break is finished with timber boarding while the original gable end is built up in brick with the date of '1881' marked in the brickwork in the apex of the gable [Plate 10]. The original open farmyard elevation of this building has now been infilled with timber panelling although the original structure of timber posts on stone plinths is still discernible [Plate 11], while the farmyard elevation of the later extension has been infilled by breeze blocks [Plate 9].

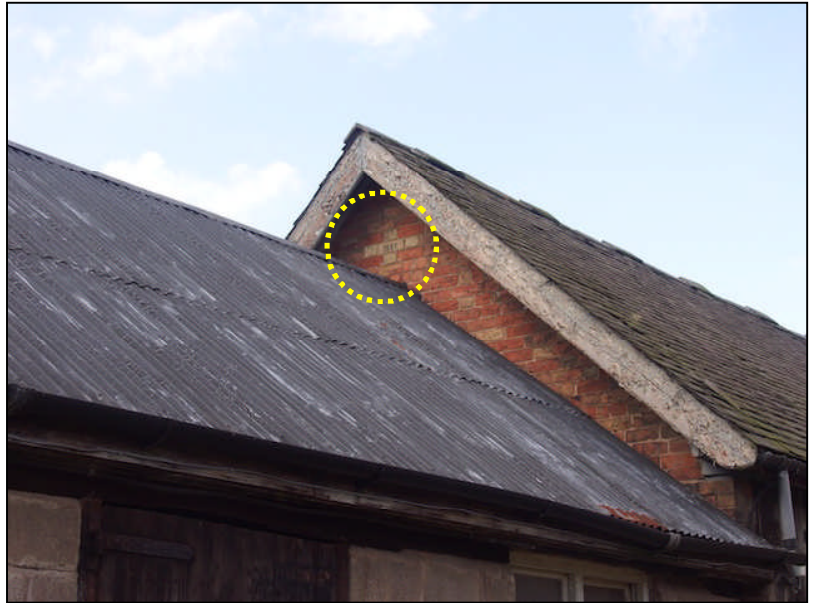
Plate 10: 1881 date marked in the brickwork in the apex of the gable

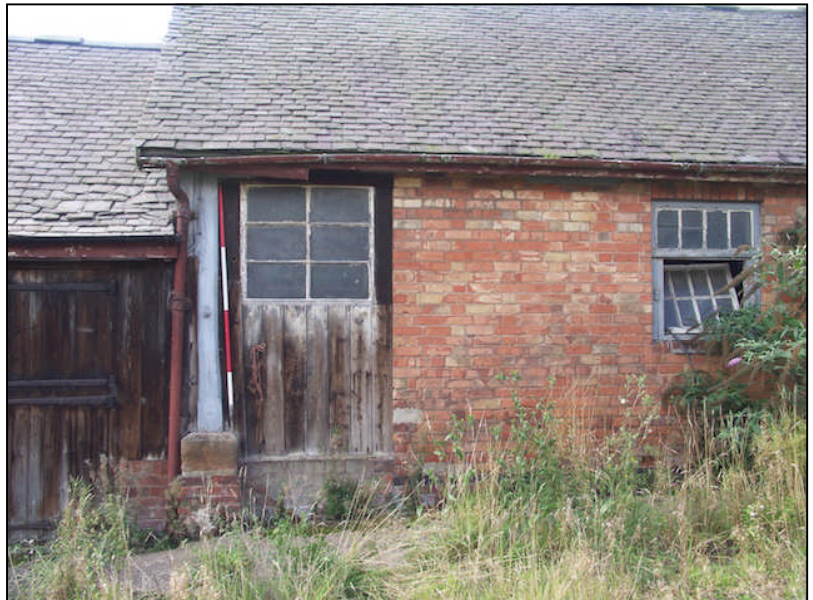
Plate 11: Original timber posts on stone plinths to cow sheds

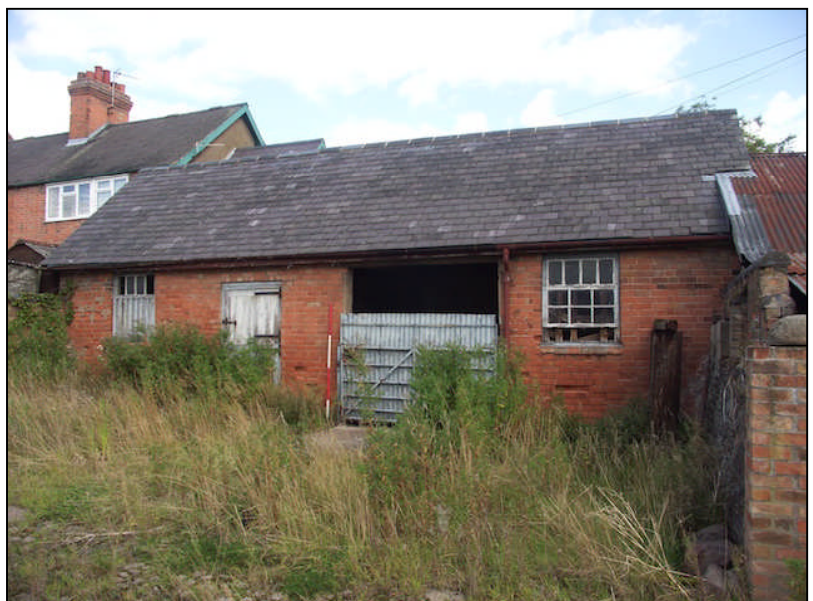
Plate 12: Front elevation of stable block with 'hit and miss' ventilator windows

- 5.39 On the opposite side of the farmyard is the stable block which is constructed of brick with a Welsh slate roof [Plate 12]. To the side of the stable block is a rudimentary cart shed constructed of timber posts and clad in timber weatherboarding.

- 5.40 Internally the cow sheds and stable block have concrete floors, with drainage channels set in the concrete that drain directly through the front walls of the respective buildings into the farmyard [Plate 14]. The farmyard itself is surfaced with random blocks of Mountsorrel granite [Plates 7 & 12].

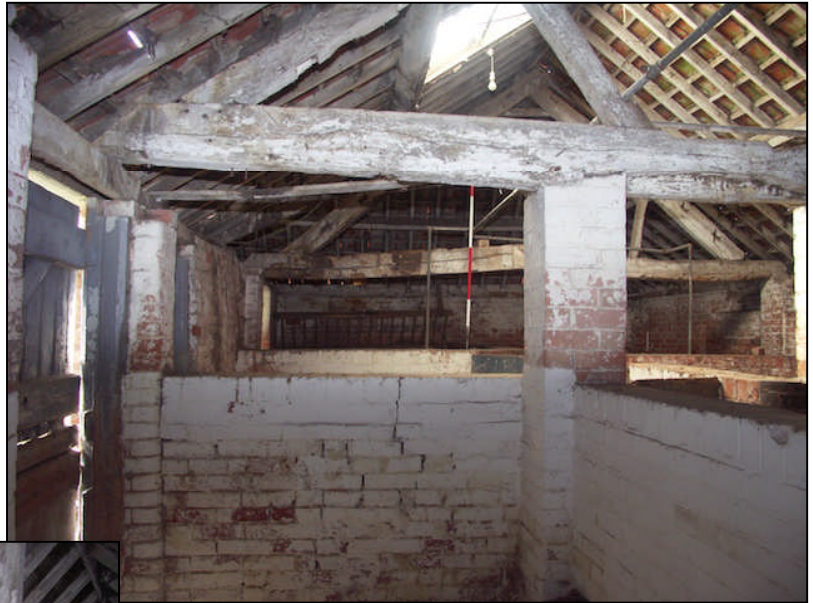
Plate 13: Internal view of stock pens

5.32 The original purpose of this building is somewhat complicated. The 1885 OS plan indicates an open structure rather than a building and the structural evidence of rounded brick piers spaced along the main elevations indicates that the building may have been used as an open cart shed or a shelter shed, particularly as there are surviving timber mangers on each of the inner gable walls. This building was then subsequently enclosed, leaving three doors in the (south) farmyard elevation, two doors opening direct onto the farmyard and a further door opens into a passageway between this stock building and the 1881 milking sheds. The building is now divided into smaller stock pens by a series of internal walls [Plate 13].

5.35 The stock pens are built in a pier and panel style combining distinctive rounded bull nose brick piers with (different) red brick panels and a pantile roof supported by a heavy timber queen post trusses [Plates 2 & 13].

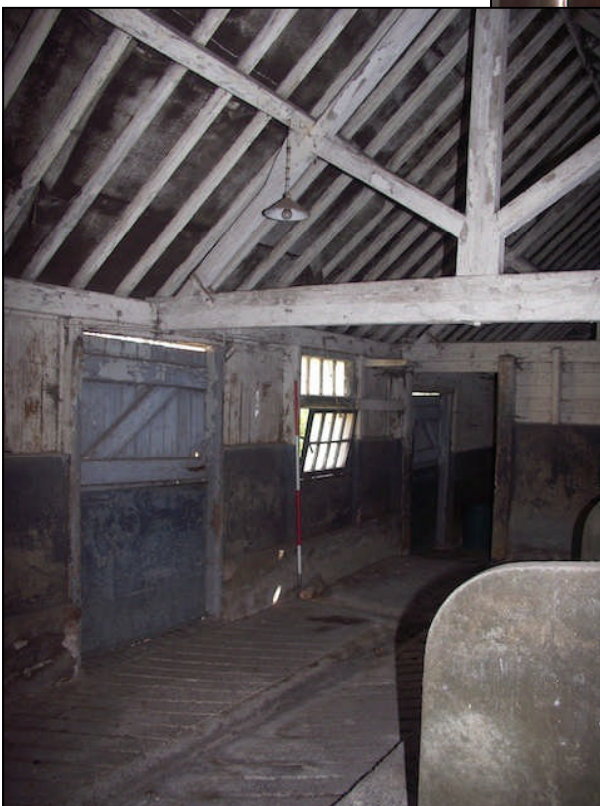
Plate 14: Internal view of cow sheds with modern concrete fittings

- 5.38 The roofs of the 1881 building are covered in Welsh slate while the later extension has a corrugated metal sheet roof and the roof throughout is supported by a series of timber King post trusses [Plate 14].

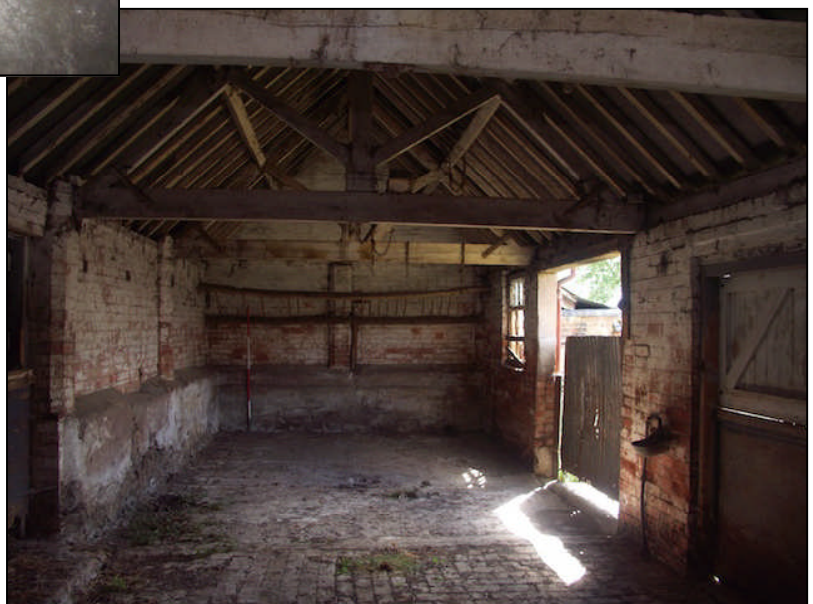
Plate 15: Internal view of stable block

- 5.41 The external north and west facing elevations have no surviving openings save for the clay pipe ventilators tucked into external walls just below the eaves while the farmyard elevations have a range of doors and bottom-hung ventilator windows [Plates 11 & 15]. Internally the milking sheds have been largely 'modernised' with concrete stalls located against the back wall and a concrete floor [Plate 15].
- 5.42 The stable block has a pair of timber 'hit-and-miss' ventilator windows either side of the original stable door and internally there are the remains of two wooden mangers attached to each gable [Plates 14 & 15].

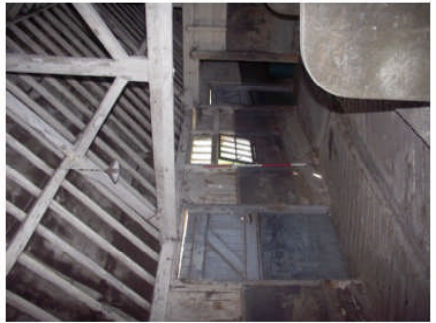
PICT18.MRW

Digital File Name (Pict - -.MRW.)	Plate Nos. in Report	Description	Direction Of Shot
18	14	Internal view of cow sheds with modern concrete fittings	E
19		Internal view along the length of the cowsheds	SE
20	15	Internal view of the stable block	SE
21		Internal view of stock pens	NE
22	13	Internal view of stock pens	SW
23		View of the Inglenook fireplace	E
24	3	Internal view of the entrance hall	NE
25		Dining room with surviving four panel door	SW
26		View of the staircase in the hall	WNW
27		View of the fireplace in the living room	SW
28	4	Exposed gypsum plaster floors in the rear bedroom and faint outline of a timber frame within the rear wall	WNW
29		Internal view of barn showing king post truss and internal mono-pitch roof	NW
