HOME FARM, HALL LANE,
OSBASTON

HISTORIC BUILDINGS
APPRAISAL
(LEVEL 2 SURVEY)

TRIGPOINT CONSERVATION & PLANNING LTD.
REPORT DATE: MARCH 2010
ACCESSION No. X.A37.2010

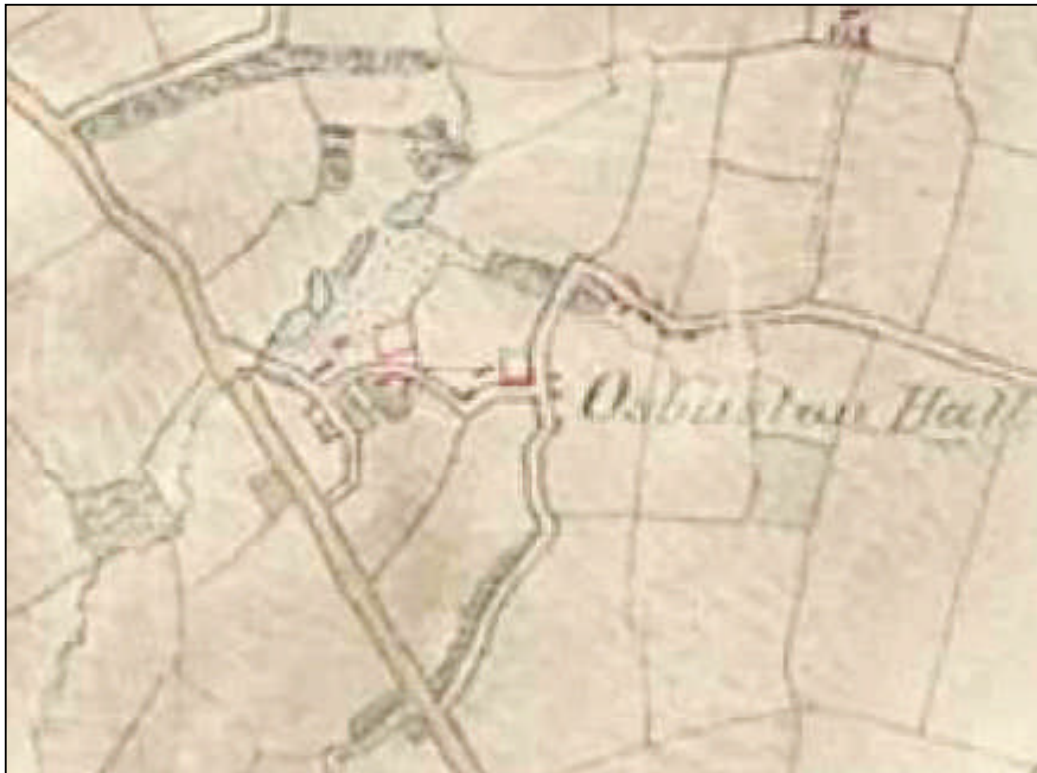
Map 1: Extract from 1814 Ordnance Survey Drawings (Original map Map scale ratio: 2 " : 1 Mile)
[Source: <http://www.bl.uk/onlinegallery/onlineex/ordsurvdraw/h/002osd000000012u00219000.html>] [Accessed 10 March 2010]

4.2 Early Ordnance Survey (OS) drawings from c.1814 [Map 1] show a small complex of farm buildings, L-shaped in plan, fronting the two adjacent lanes. These buildings appear to correspond to the existing farmhouse that fronts Hall Lane and the single storey range that is attached to the rear (north-east corner) of the farmhouse that presents its rear elevation to Osbaston Lane [Plates 1 & 2].

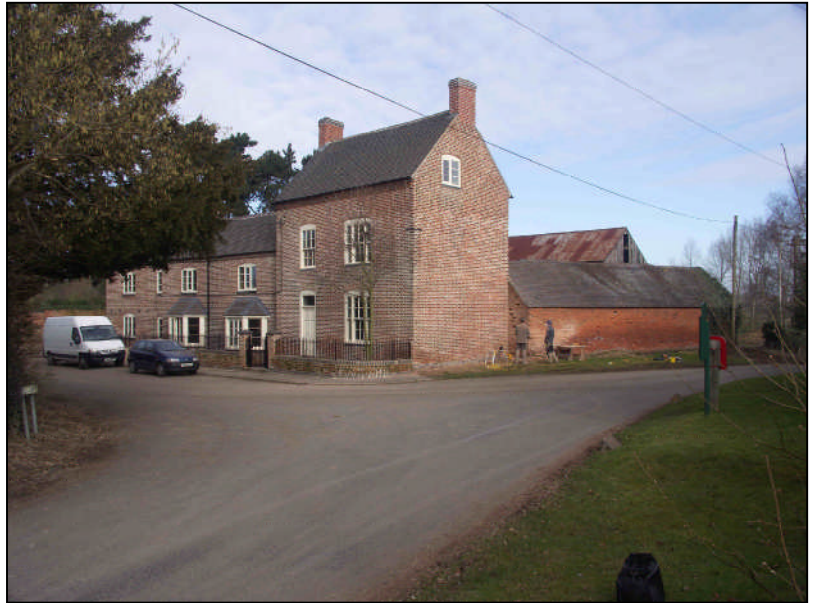
Plate 1:

View looking north-north east towards junction of Hall Lane and Osbaston Lane showing front elevation of the farmhouse and rear elevation of the stock building

- 5.12 Attached to the back corner of the farmhouse and with a rear elevation to Osbaston Lane is a single storey range of buildings that is rectangular in plan [Plates 1 & 2]. The building is subdivided by a number of cross walls to provide a series of loose boxes to accommodate horses or cattle, each individually accessed by a door off the front elevation and all unlit except for the largest bay at the northern end of the building which has a single window and roof light to the front elevation [Plates 17 & 18].

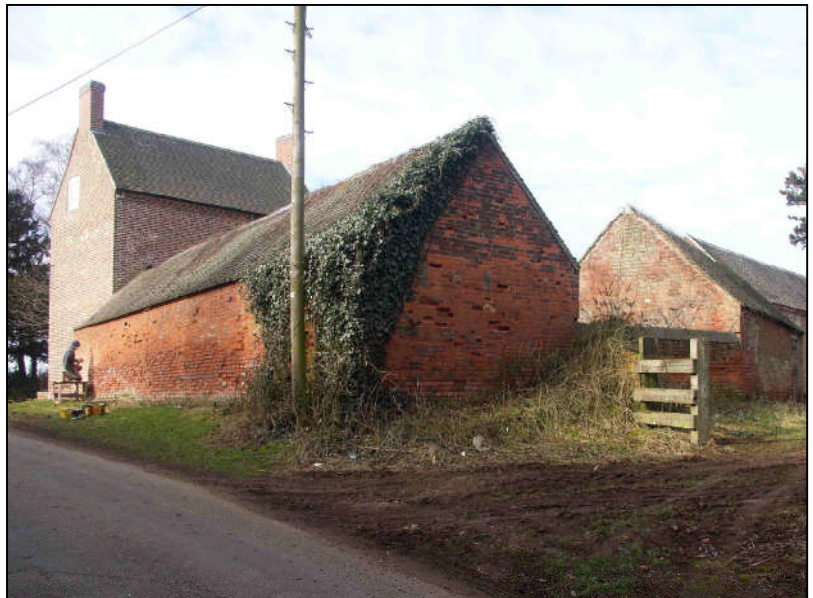
**Plate 2:**

View looking south west towards junction of Hall Lane and Osbaston Lane showing rear elevation of the stock building and the gable of farmhouse

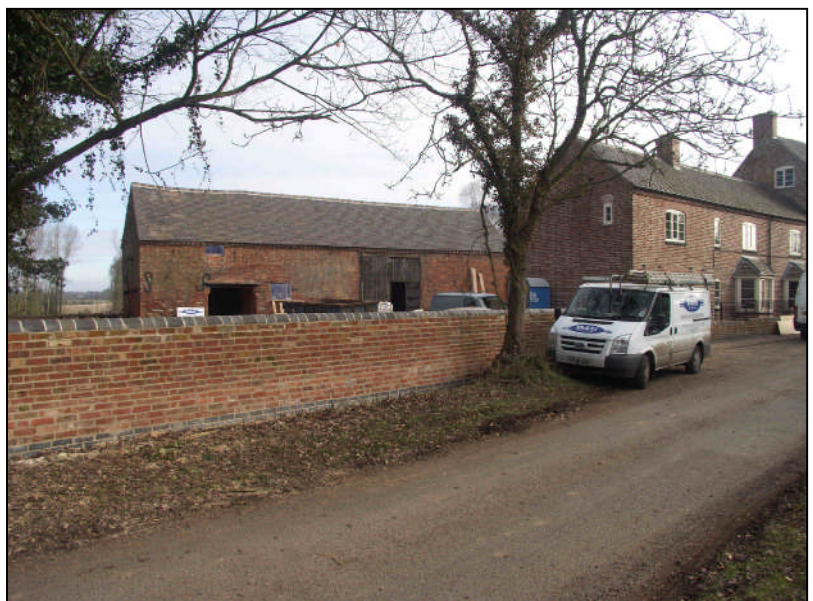
**Plate 3:**

View looking east along Hall Lane showing the front elevation of the farmhouse with the threshing barn to the rear

- 5.2 Along the northern side of the farmyard is a four bay double height threshing barn, rectangular in plan, with a mono-pitched lean-to attached to its eastern gable [Plates 3, 5 & 7]. The off-centre double height threshing doors lead to the main threshing floor which has a single storage bay on its east (right) side and two storage bays on its west (left) side and internally the individual bays appear to have been partially sub-divided by brick buttress walls [Plate 11]. While the threshing bay and the bay immediately to its left (west) are open to the roof, the two end bays are split by a first floor and loft space.

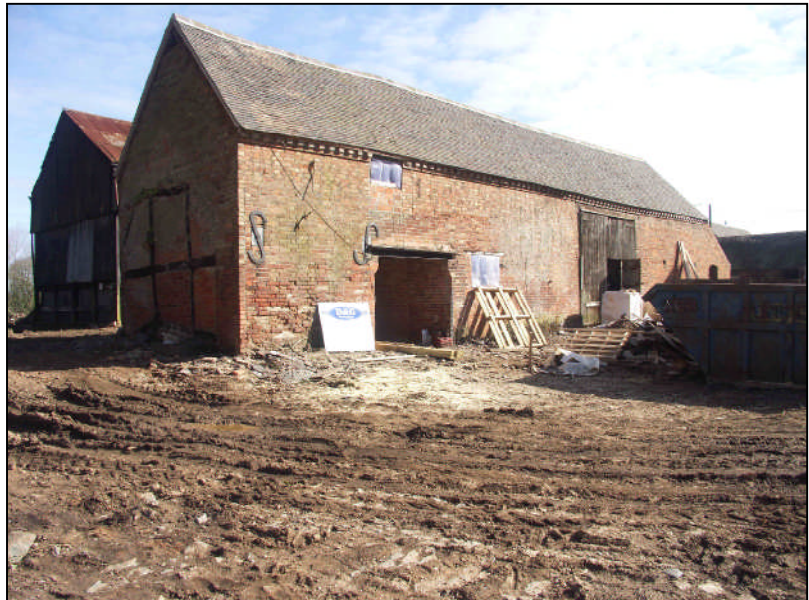
Plate 5:

View looking north-east across the front elevation of the threshing barn showing the original double height doors and remnants of timber framing in the gable end

- 5.3 The barn is constructed of brick, laid in a Flemish Garden Wall bond (three stretchers between each pair of headers) with a brick dentil course at the eaves [Plate 5]. The modern roofing materials indicate that it has recently been renewed but it is covered with reclaimed tiles and there is one surviving king post truss within the middle bay [Plate 11]. The floors within the barn are brick-paved.

- 5.5 At the western end of the front elevation is a double width, single height opening that appears to be a later opening as indicated by the structural I-beam lintel over the door and the use of common bricks to infill the internal space between the opposing buttresses below the height of the loft floor [Plate 5].

- 5.6 There is also some faint evidence of infilled ventilation slits on the front elevation, most noticeably to the left of the single height door, and two windows, one to the ground floor and a further window at the first floor onto the internal mezzanine floor. Neither of which appear to be original and the brick infill panel below the first floor window would suggest that this was originally a loft access door [Plate 5].

- 5.7 Of particular architectural and historic interest are the remains of timber framing now trapped in each gable end of the barn. [Plates 5 - 10 & 12]. The surviving frames do not span the whole width of the barn or reach the height of the existing gables suggesting that these are the remnants of earlier buildings and whilst there is map evidence for a building attached to the west end of the barn there is no evidence for a building attached to its east end.

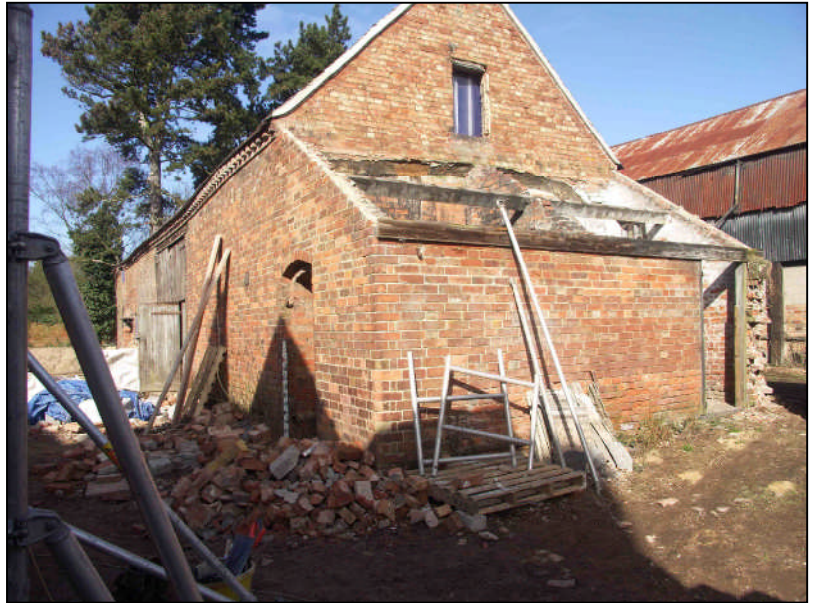
Plate 7:

View looking north-west across the front elevation of the threshing barn showing the single storey lean-to and remnants of timber framing in the gable end

- 5.4 The double height opening in the front elevation of the barn retains its timber doors [Plate 4] but the similar opening on the rear elevation has now been infilled in brick. At the eastern end of the front elevation a single width door with a segmental brick arch provides access to the front section of the lean-to extension and a door in the side wall provides access to the rear section [Plates 7 & 8].

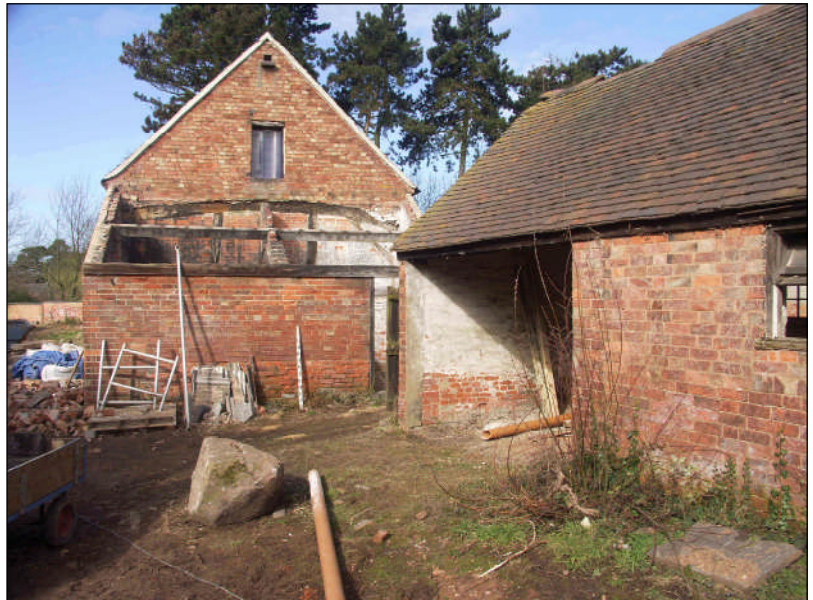
**Plate 8:**

View looking north-west towards the gable end of the threshing barn showing the single storey lean-to and remnants of timber framing in the gable end

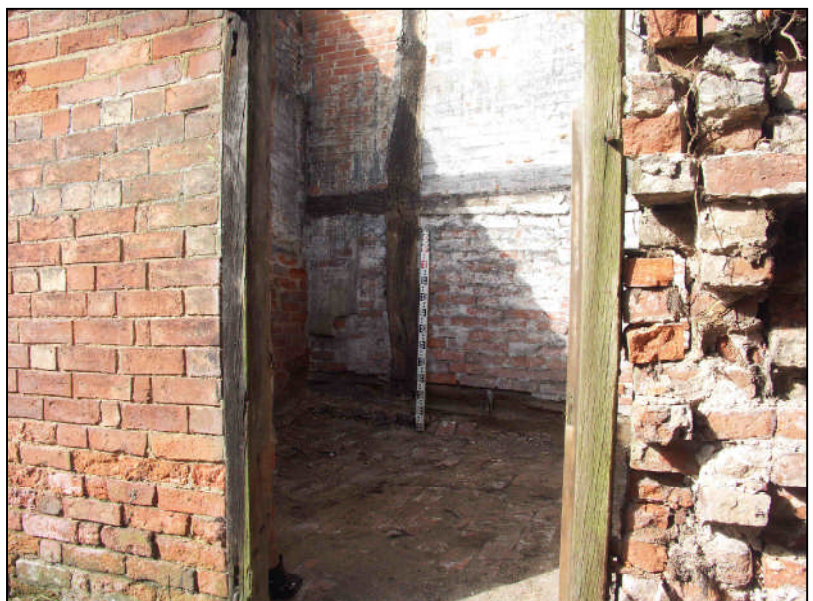
**Plate 9:**

Detail view of timber framing in the eastern gable of the threshing barn

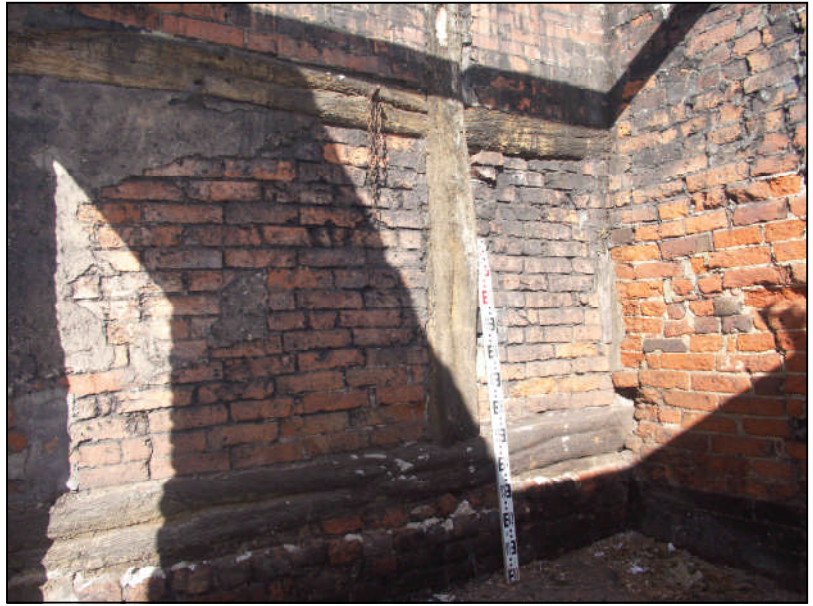
Plate 10:

Detail view of the timber framing and narrow bricks in the eastern gable of the threshing barn

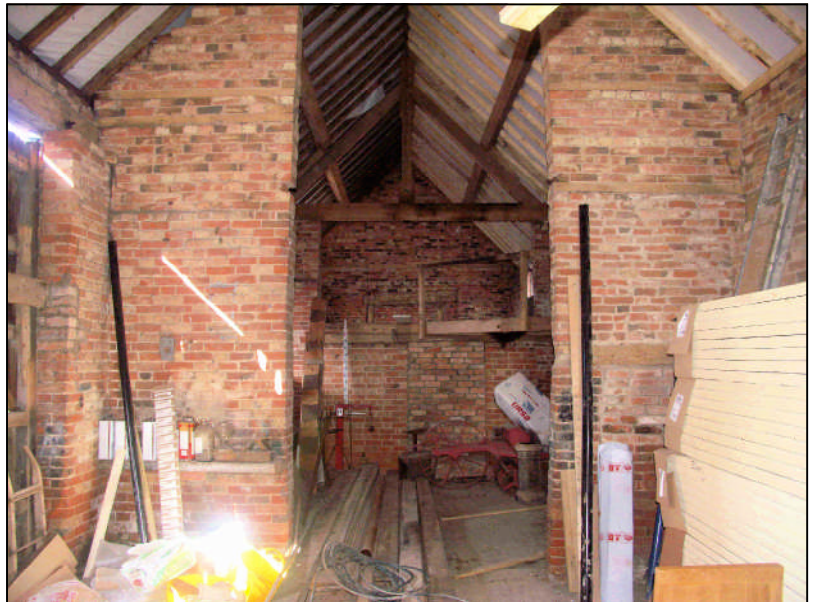
Plate 11:

Internal view of the threshing barn showing internal buttress walls and king post truss

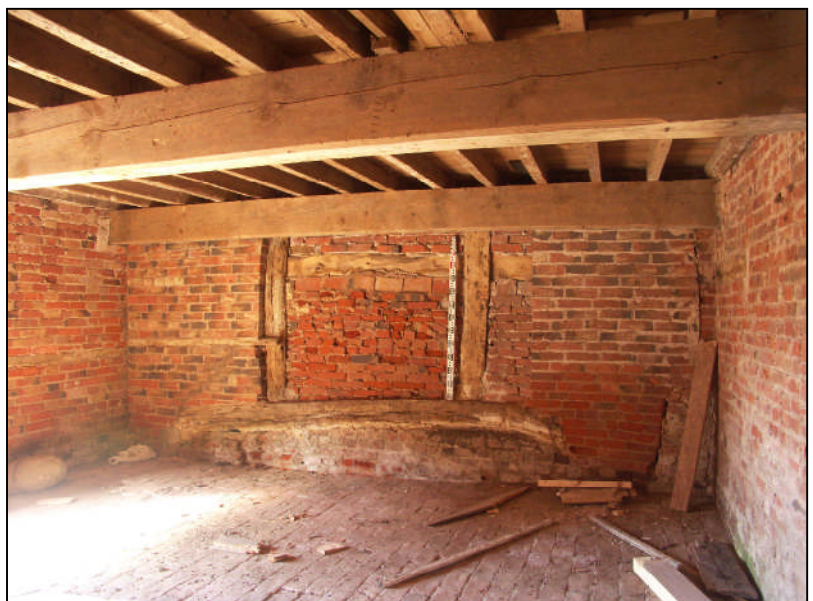
Plate 12:

Internal view of the timber framing in the western gable of the threshing barn

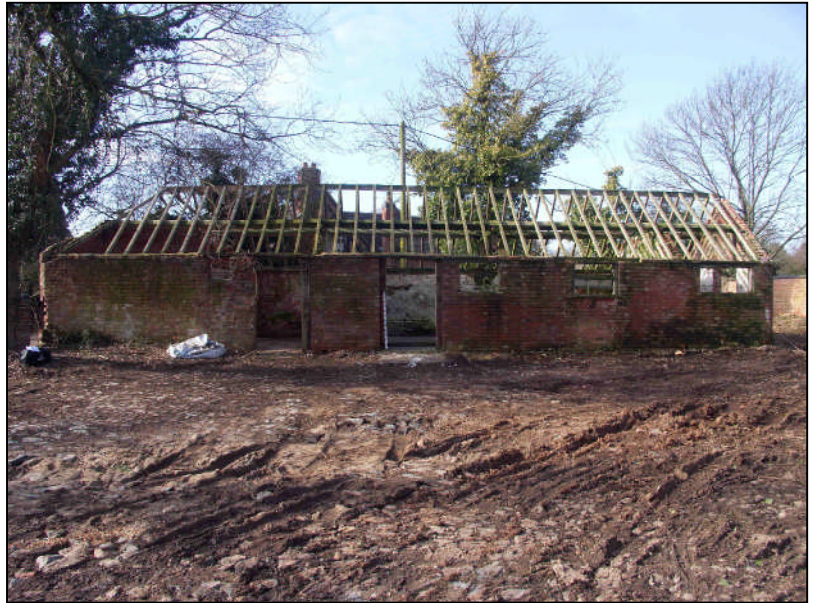
Plate 13:

View looking west towards the front elevation of the cow shed

- 5.8 A single storey building, now detached and isolated from the existing buildings, stands in the western corner of the farmyard [Plate 4]. Internally the building is divided by a cross wall into two separate cells each accessed by a door off the front elevation [Plates 13 & 14]. The central recessed channel in the concrete floor suggests that this building was used to house cattle and possibly used as a milking parlour given that it was well lit by three windows in the front elevation [Plate 13].

- 5.9 The building is constructed of red brick, laid in a Flemish Garden Wall bond but has now lost its roof covering leaving timber roof structure exposed [Plates 13 & 14]. The main bay to the left has a concrete floor with a central recessed channel for the removal of slurry.
- 5.10 The remains of the original cobbled farmyard survive in the area immediately to the front of this building [Plate 13].

- 5.11 There are no surviving architectural details except for one of the timber window frames, which indicates that the windows had a fixed bottom light and an inward opening top light [Plate 13].

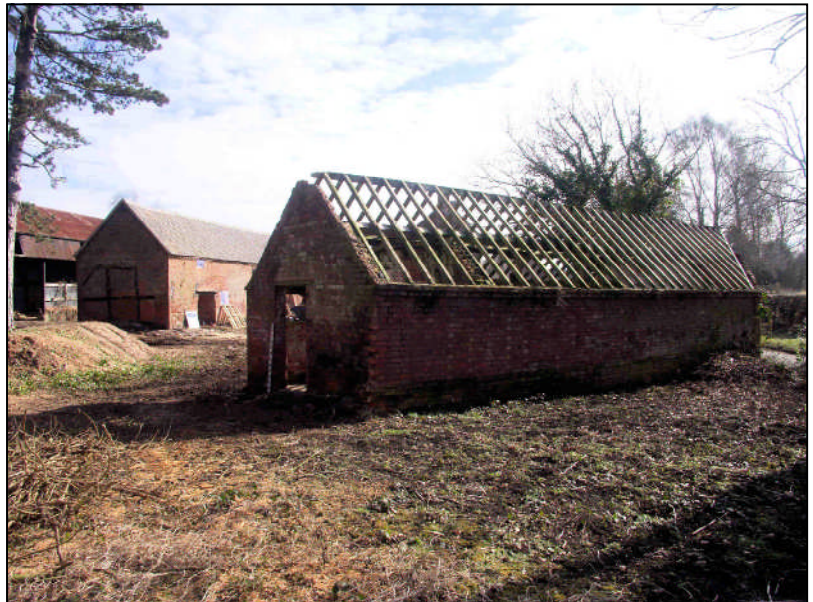
Plate 14:

View looking east towards the side and rear elevation of the cow shed

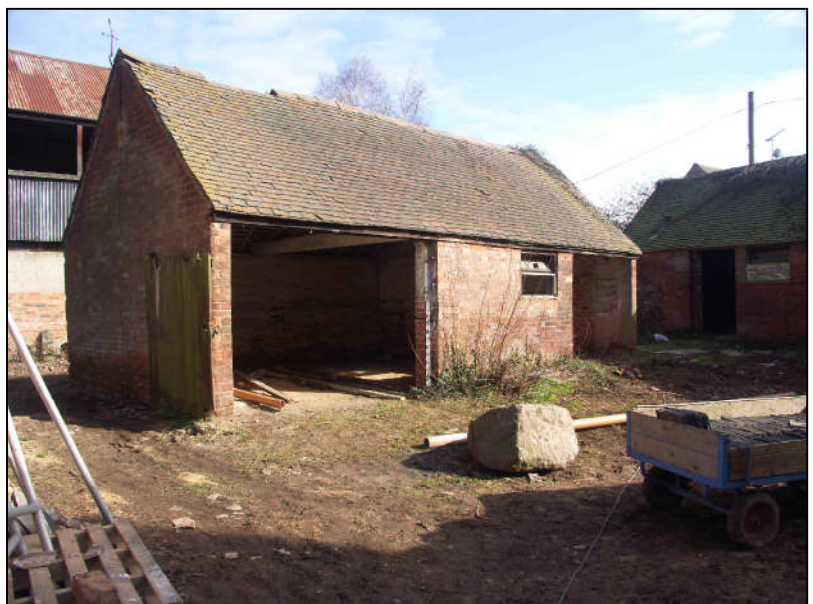
Plate 15:

View looking north east towards the front elevation of the cart shed

- 5.16 To the rear of the farmhouse, between the barn and the stock building, is a detached single storey building, rectangular in plan, with two bays separated by a brick cross wall [Plate 15]. The wide openings in the front elevation would appear to suggest that this was used as a cart shed.

- 5.18 There are few surviving details, other than the king post roof truss and the remains of the timber windows within the front and rear elevations [Plate 15].

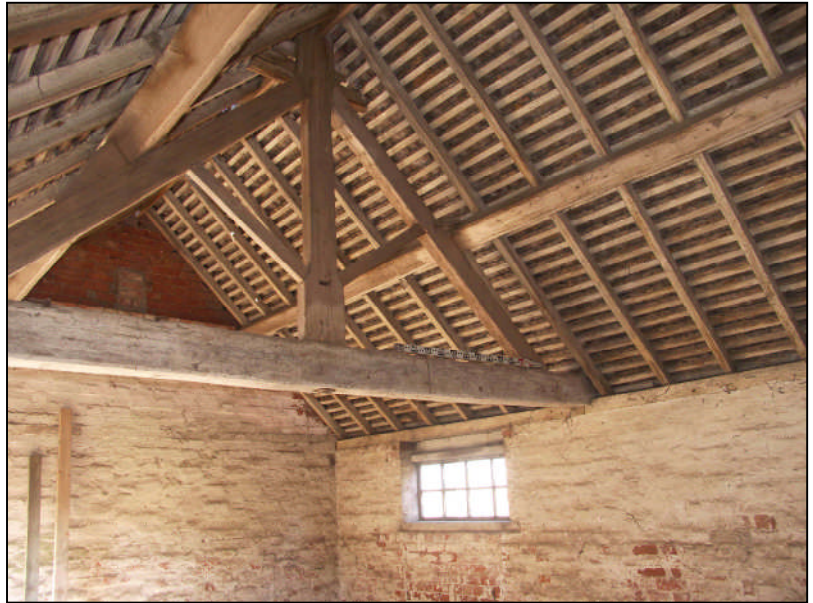
Plate 16:

Internal view of the cart shed showing the king post truss

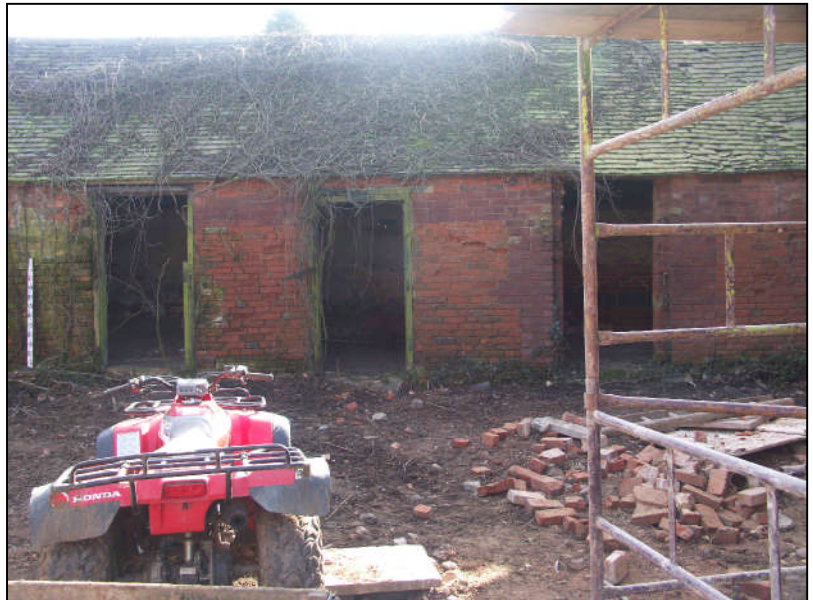
Plate 17:

View looking south east towards the front elevation of the stock building

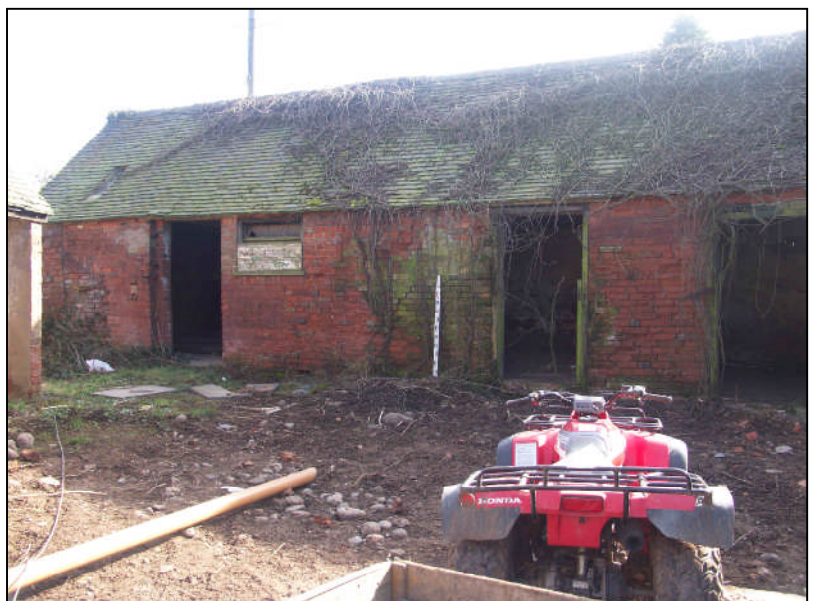
Plate 18:

View looking east towards the front elevation of the stock building

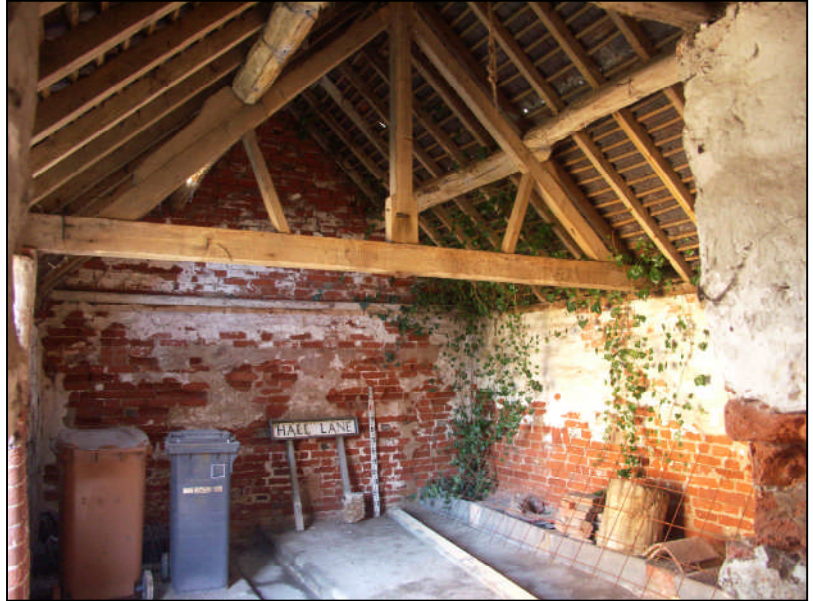
Plate 19:

Internal view of the loose box showing a king post truss and ground level water troughs against the rear wall

- 5.13 This building is constructed of red brick, much of which is in a poor condition, laid in a Flemish Garden Wall bond, with plain tiled roofs supported by a timber roof structure with one surviving king post roof truss. [Plate 19].
- 5.14 Internally the two largest loose boxes at the northern end of the building have concrete floors, with drainage channels set in the concrete [Plate 19], while the remaining bays have brick floors laid on the earth.

- 5.15 There are few surviving details, although the two bays at the northern end of the building have a range of ground level water troughs and a single metal hay rack survives in the middle bay [Plates 19 & 20].

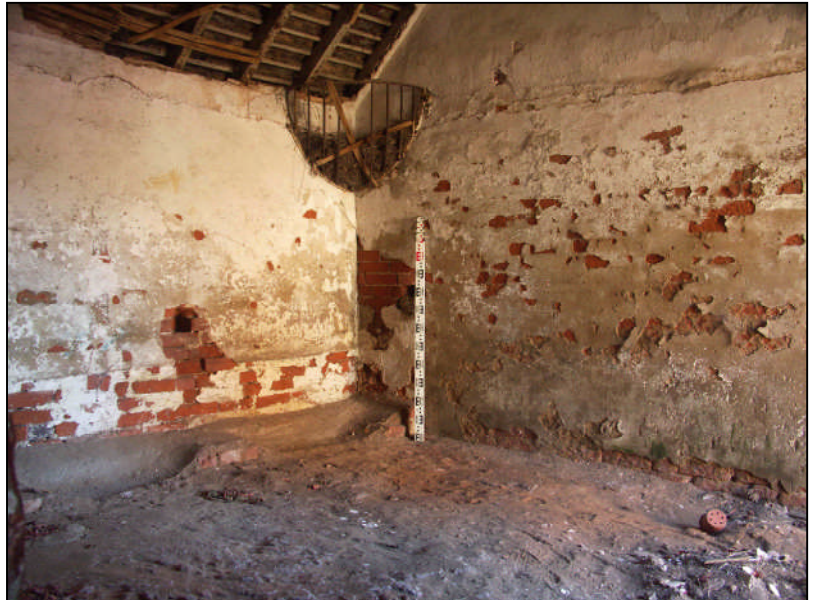
Plate 20:

Internal view of the loose box showing the surviving metal hay rack
