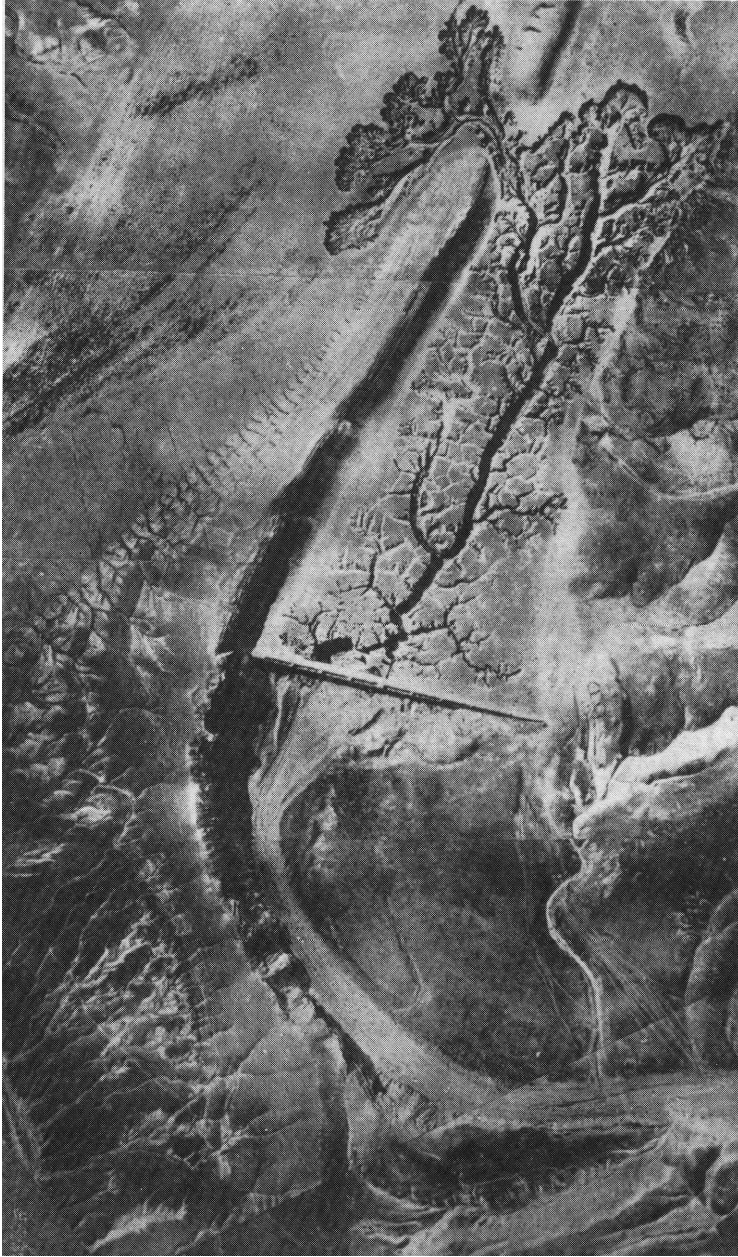
Fig. 4.13: Aerial photo of the Harbaqa dam, Syria, showing the extent of the silting of the reservoir in the 1930s [Poidebard 1934, plate 34].
