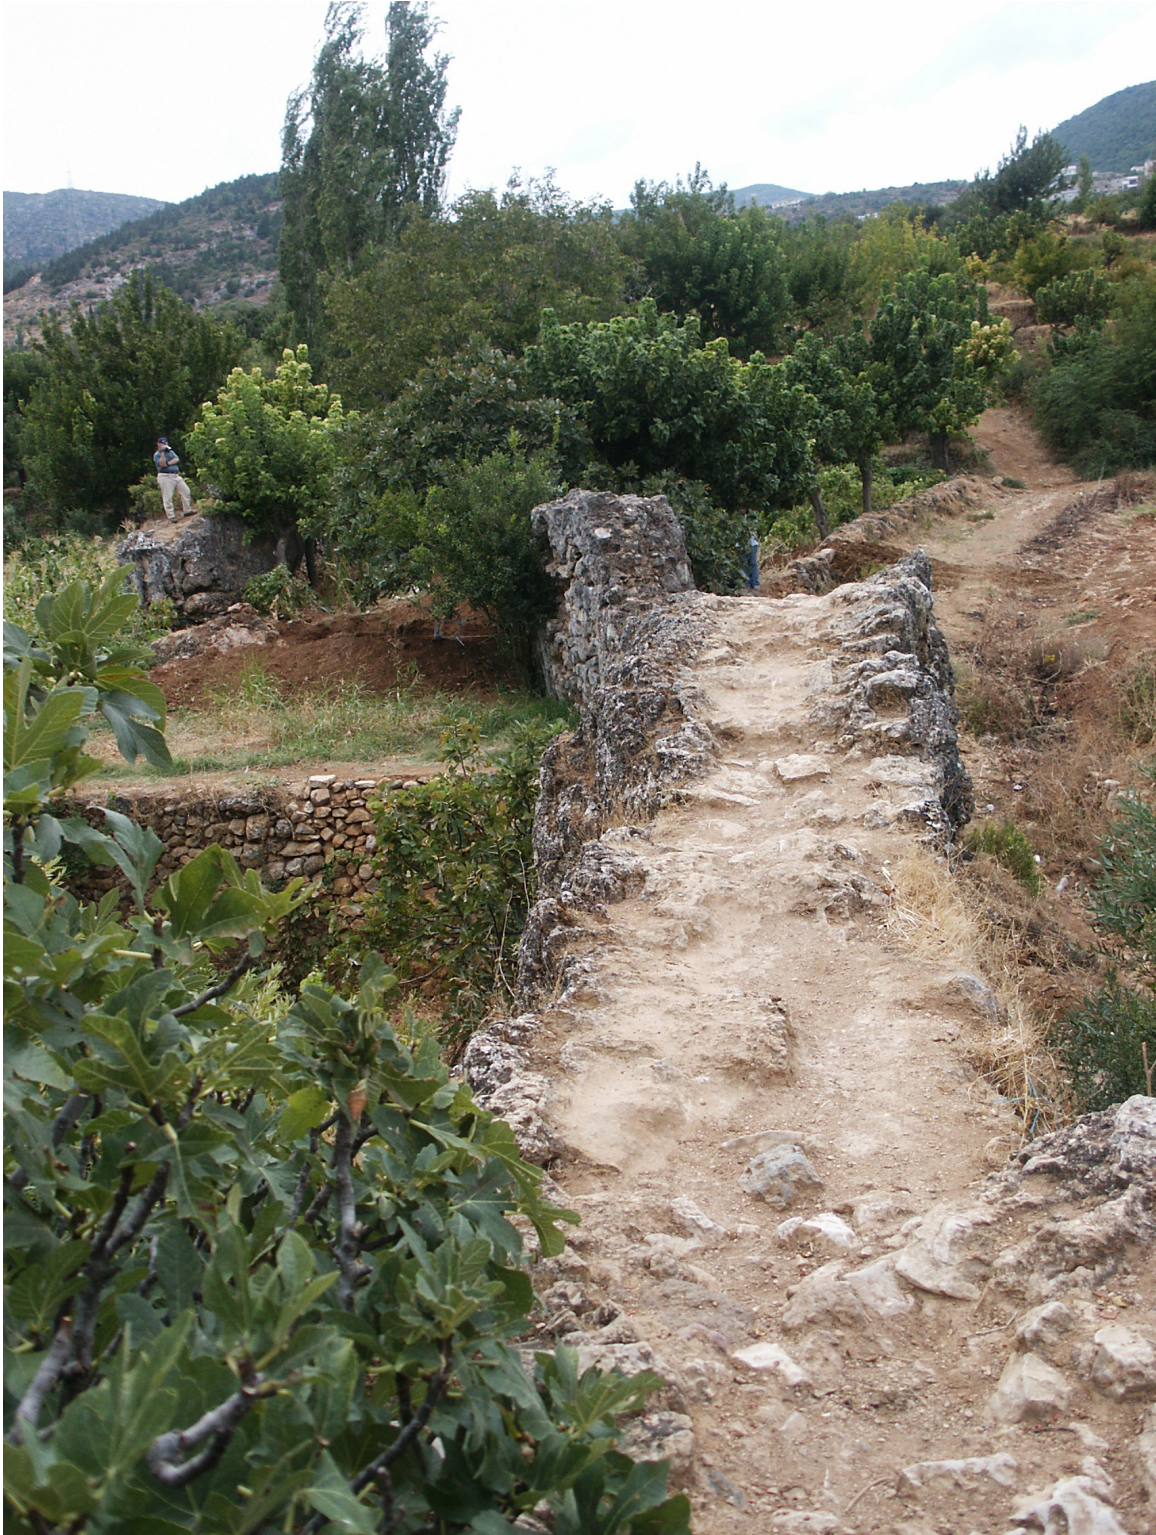
Fig. 6.29: Earthquake damage at the Misyaf aqueduct, Syria; the figure in the background is standing on the section of the aqueduct that has shifted [photo: author].
