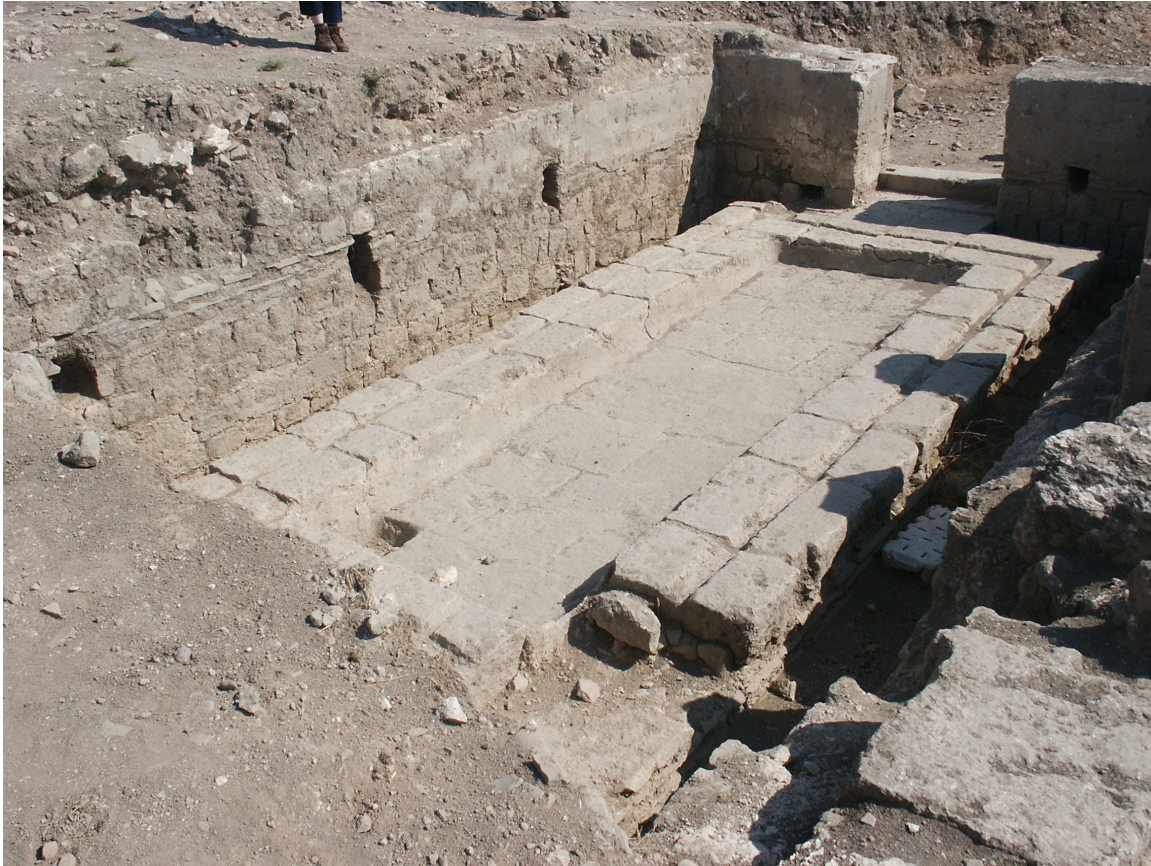
Fig. 8.2: Latrine #702, Apamea, showing the drain, gutter and basin in floor [photo: author].

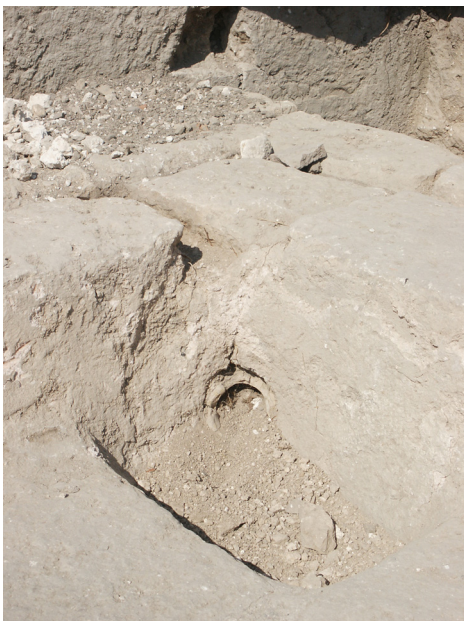
Fig. 8.3: Detail of basin in latrine floor, Apamea [#702] showing gutter entering from top and pipeline leaving at base [photo: author].
