Project Report 1166.1(2)

Archaeological Desk-Based Assessment at Rowland, Bakewell, Derbyshire.

April 2008

ARCUS were commissioned by Everard Pick (Architects, Engineers and Surveyors) to undertake an archaeological desk-based assessment of land at Rowland, Bakewell, Derbyshire. The assessment was required to support a planning application for the construction of a new foul sewer in the village.

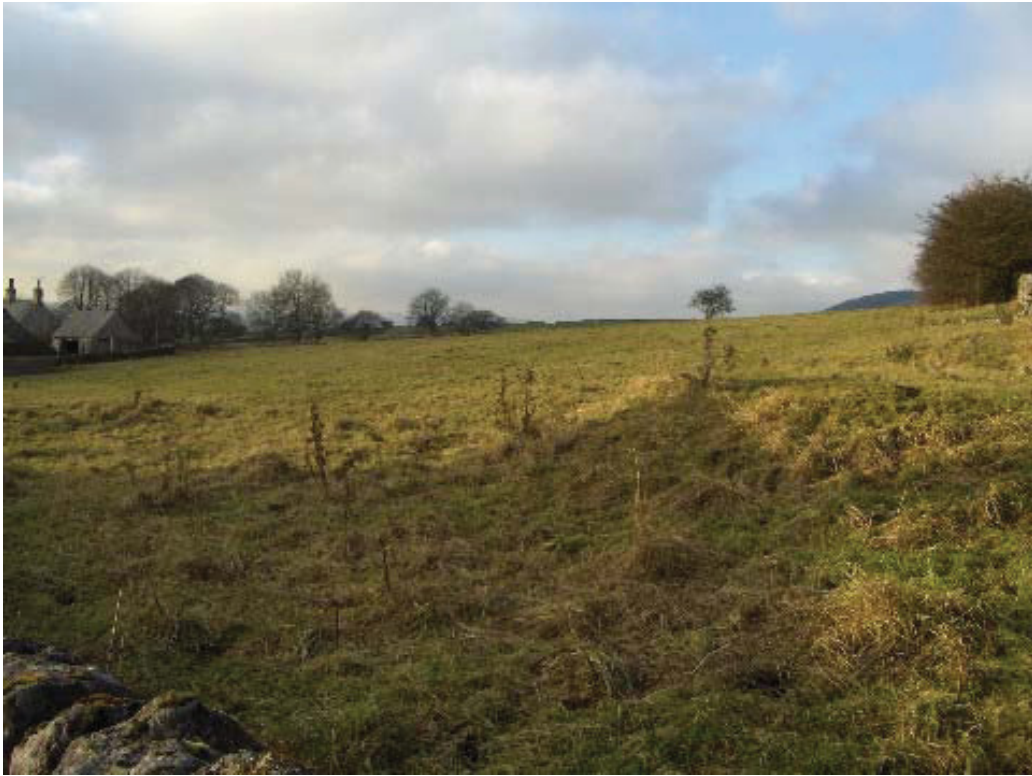
Plate 1. View looking south-west from north end of village along line of projected temporary road with earthwork mound of possible former lead mine in foreground.

The extensive remains of lead mining in the area (Barnatt, 1993; **illustration 3, J-T; plate 1**) represents activity which was probably taking place on a small scale from at least the sixteenth century and which was carried out more systematically during the eighteenth and nineteenth centuries. It was probably also no later than the early sixteenth century that a packhorse route was established through the village, part of a north-south route between Bakewell and Calver (Dodd & Dodd, 1974). Hearth Tax returns record the presence of nine houses in the 1660s. Two of the families recorded, Brightmore and Bland, were still present in modern times.

By 1898 the trees along the road to the village from the south appear to have been felled, but the layout of houses in the village stayed essentially the same (**illustration 6**). The boundary to the east side of the 'village square' is shown as a hedge with a footpath to its east side. The field boundary which is to be followed by the projected sewer, running south from the village, is shown as a stone wall. A small feature is shown on the Ordnance Survey map where a hillock, tentatively identified as a relic of lead mining, was identified during the walk-over survey (**illustration 3, O; plate 1**).

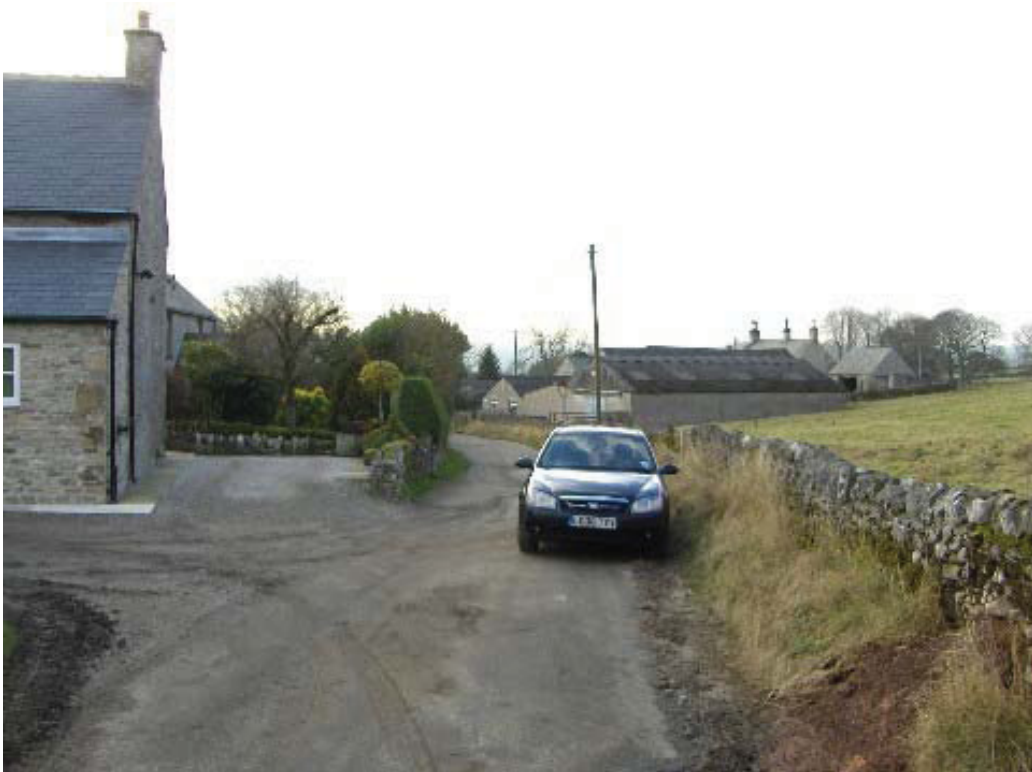
Plate 2. View looking south along proposal route from High Tor Cottage.

From the north, the proposed new sewer starts at High Tor Cottage and keeps to the line of the road (**illustration 3; plates 2-4**) until the road turns sharply westwards, here the pipeline continues south across fields. No known archaeological features have been identified as being potentially disturbed by the portion of the sewer in the road.

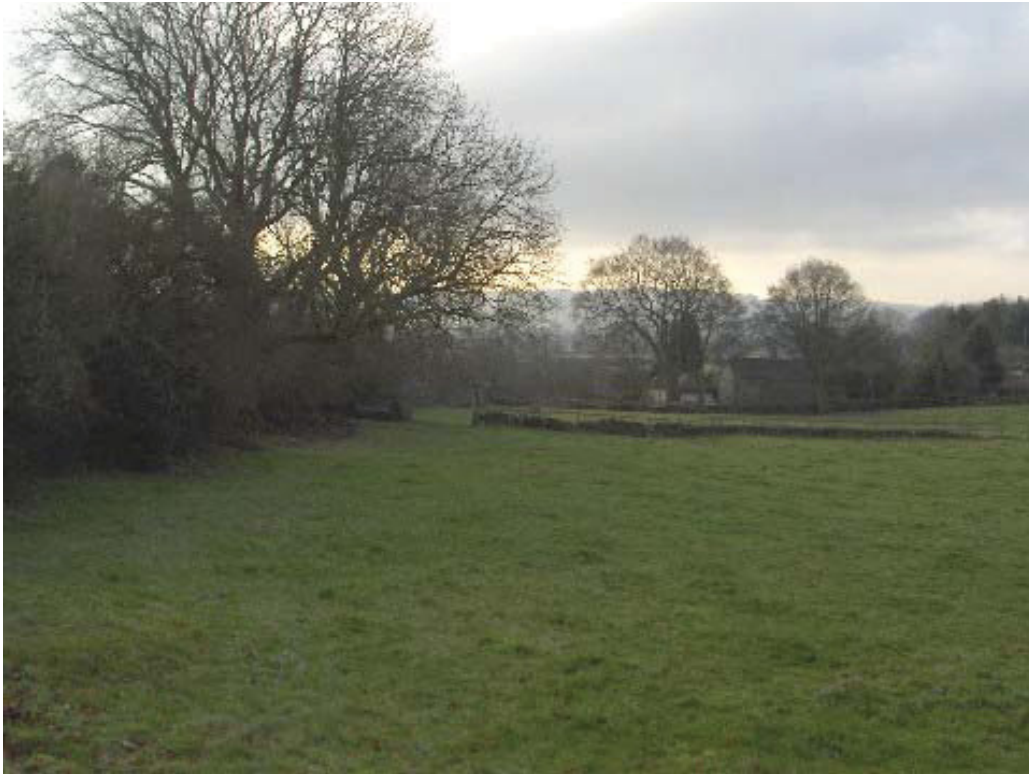
Plate 5. View looking south along eastern boundary of 'village square' towards Tissington Cottage.

The section of the sewer heading south traverses the 'village square' parallel to its eastern boundary (**plates 5 and 14**). At the point where it leaves the road the walk-over survey has identified an earthwork bank (**illustration 3, H**) and mound (**illustration 3, I; plate 6**) which might be added to those surveyed in 1993 and identified as possible evidence of village shrinkage (**illustration 2, site 2; illustration 3, A-G**). The presence of these earthworks was confirmed by the walk-over survey. As the pipeline heads south it will run adjacent to a further bank (**illustration 4; B**).

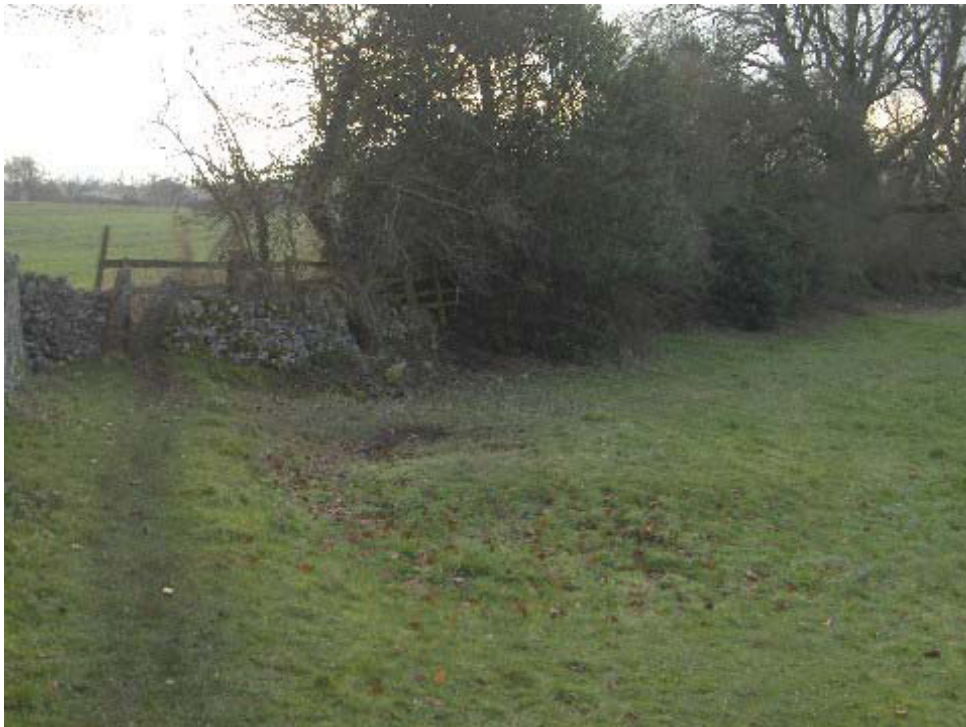
Plate 6. View looking south-east from same position showing earthwork bank to left and mound at centre.

carried out in 1993 (**illustration 3, A-G**). Additional earthworks were identified during the course of the walk-over survey conducted for the present report (**plate 6**).

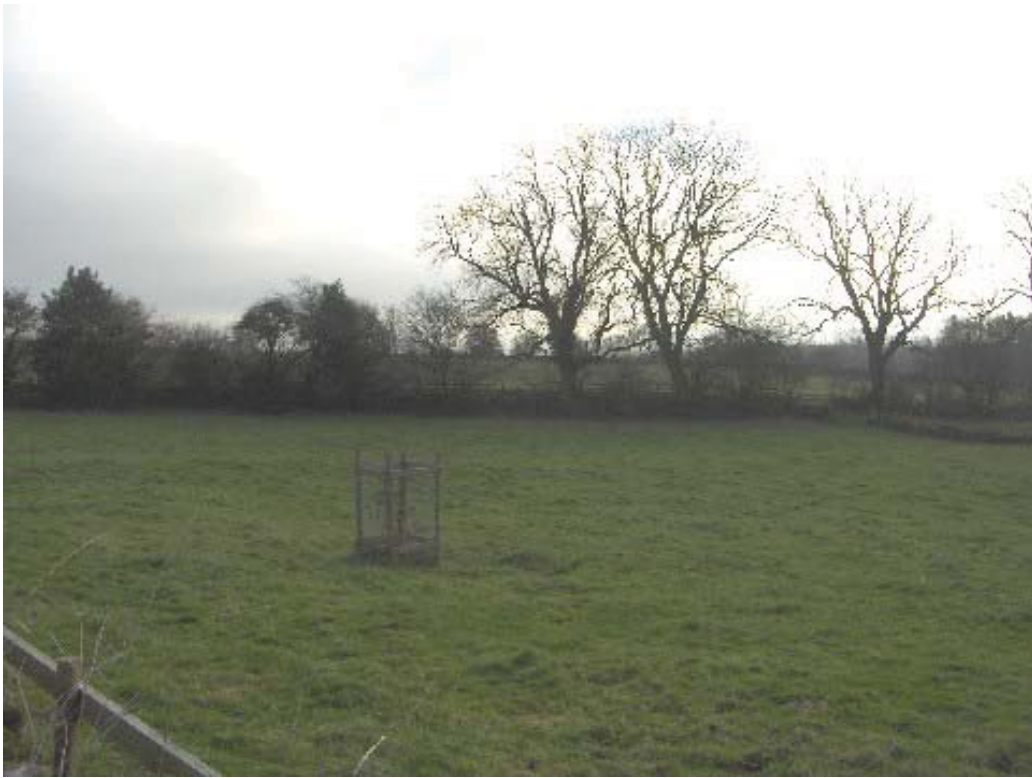
Plate 7. View looking south-east across the 'village square' towards projected route of sewer with earthwork bank 'B' in centre.

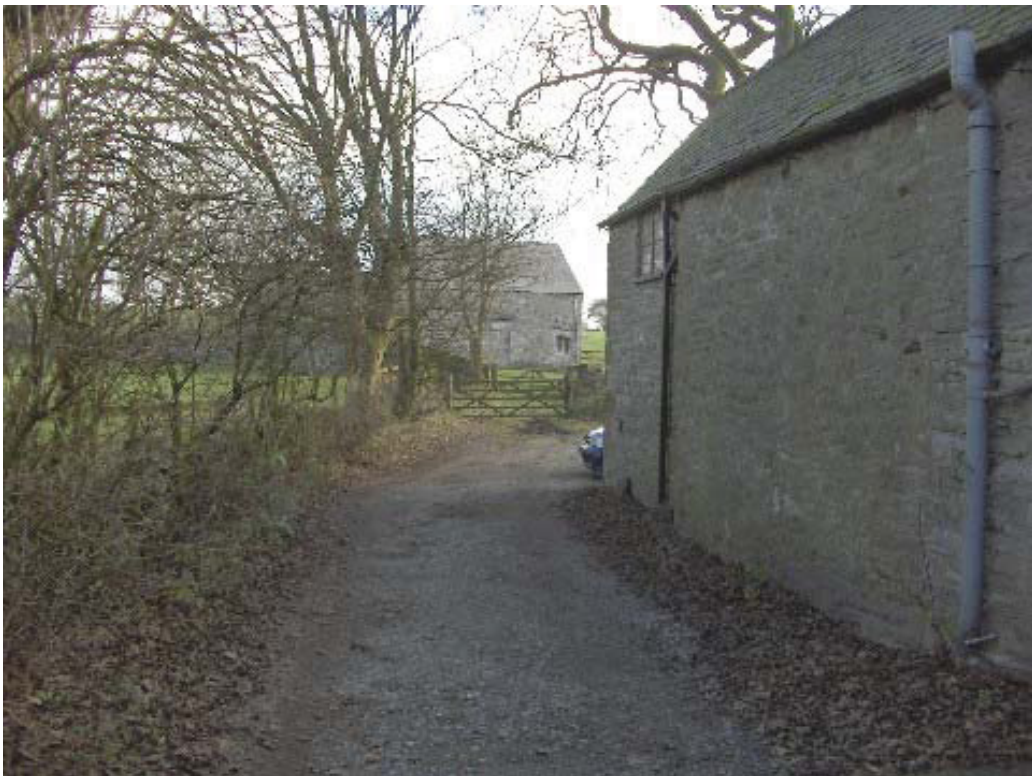
Plate 12. View looking east further along lane towards field barns in background.

Having passed in front of the barns at the east end of the lane (**plate 12**), identified as being of nineteenth-century date (Barnatt 1993, 22), the sewer then passes close to the earthwork features (**illustration 3, T**) identified in 1993 as the site of a lynchet and a lead-mining mound. Both of these features are likely to be extant, though it was not possible to ascertain this at the time of the walk-over survey. Their situation is to the left of the middle ground in **plate 15**. The rest of the course of the proposed sewer, towards the treatment works, does not pass through any sites of known archaeological significance.

There are two side branches from the sewer. The northern branch runs from the main line west to Sycamore Cottage This run will cross bank B. The southern branch will run from just south of the field barns (**plate 12**) heading west inn the field south

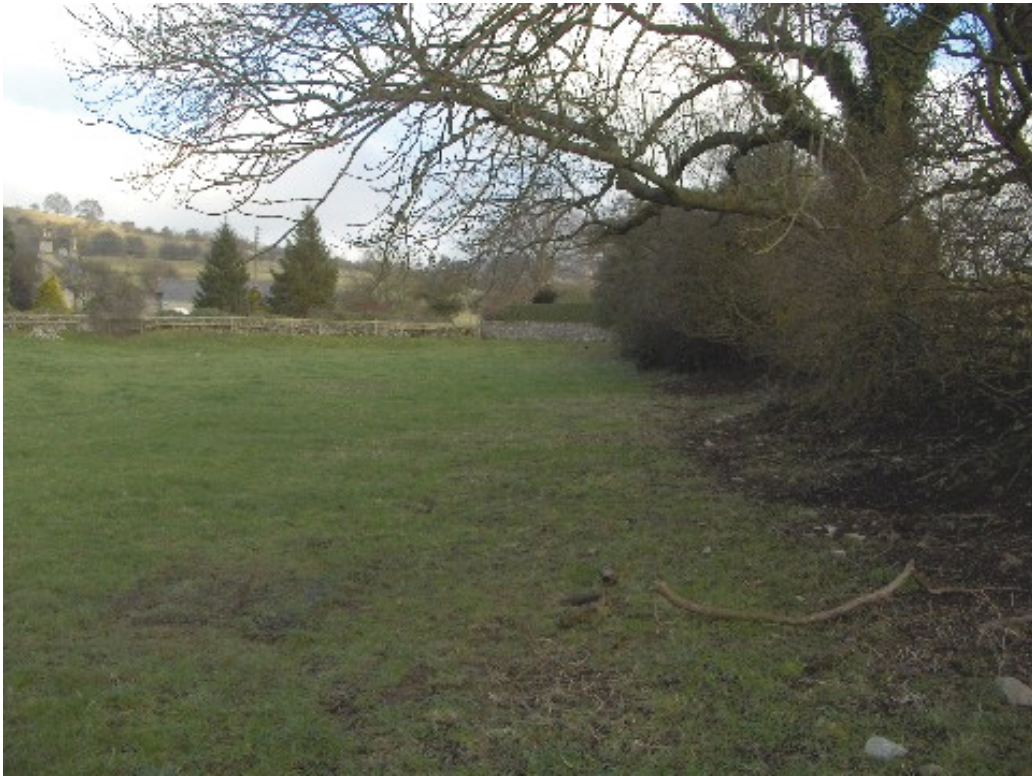
Plate 14. View looking north-east from field boundary bisecting proposal route across the 'village square'.

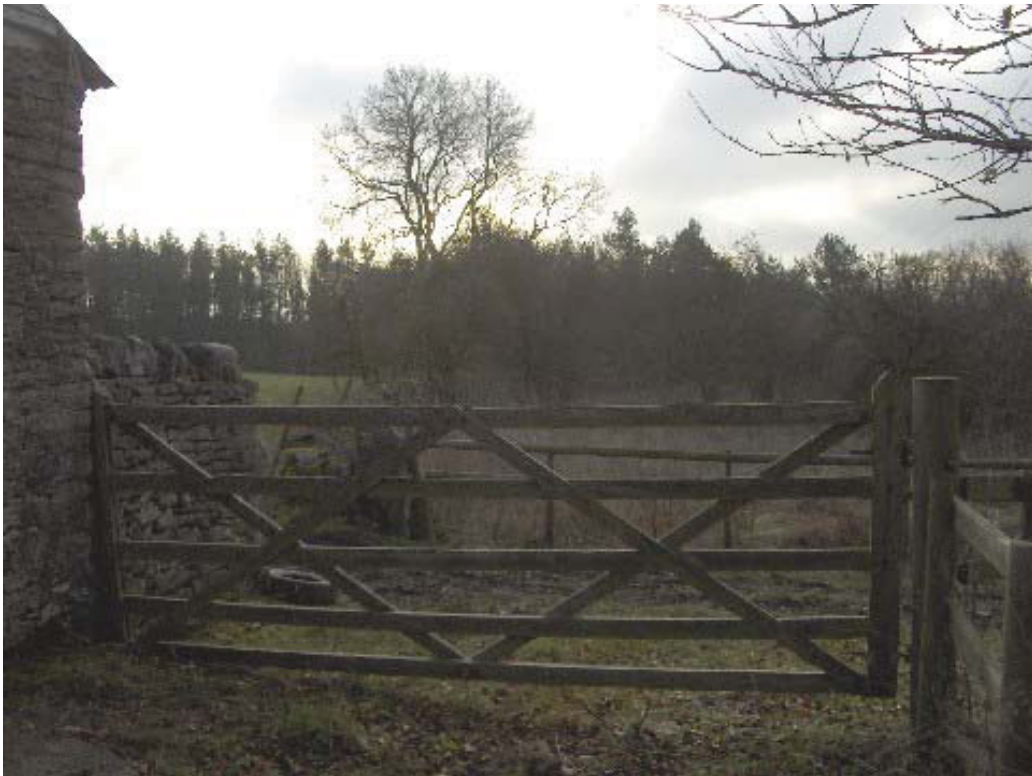
Plate 15. View looking south along proposal route towards sewage works; earthworks 'T' are behind the wall to left.

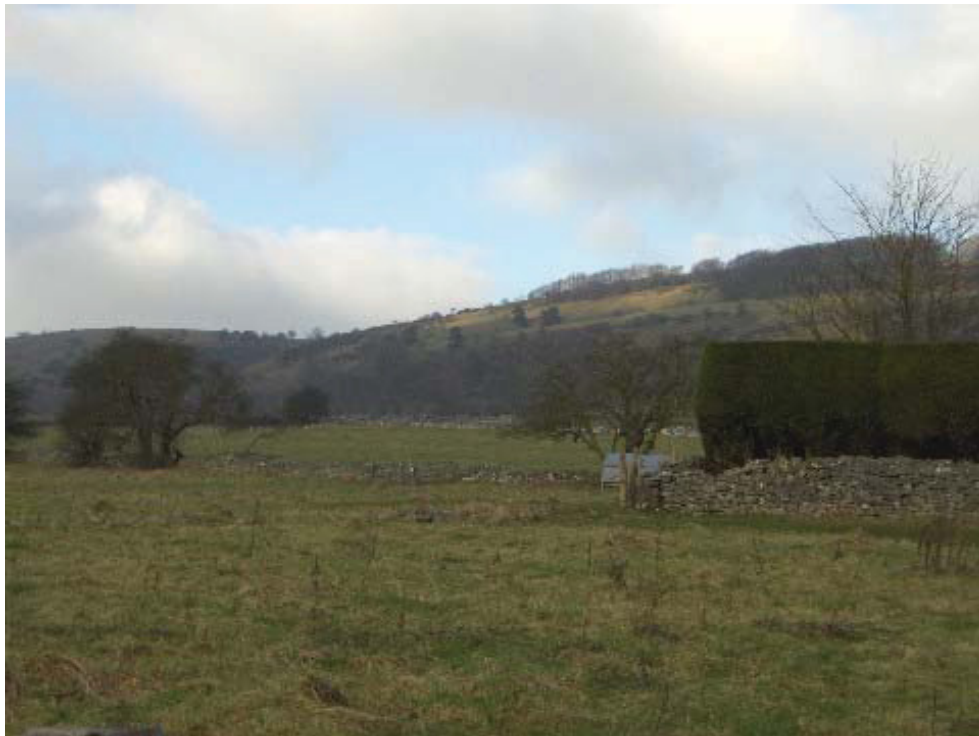
Plate 16. View looking north-west along line of projected temporary road with property boundary of Silverdale House to right.

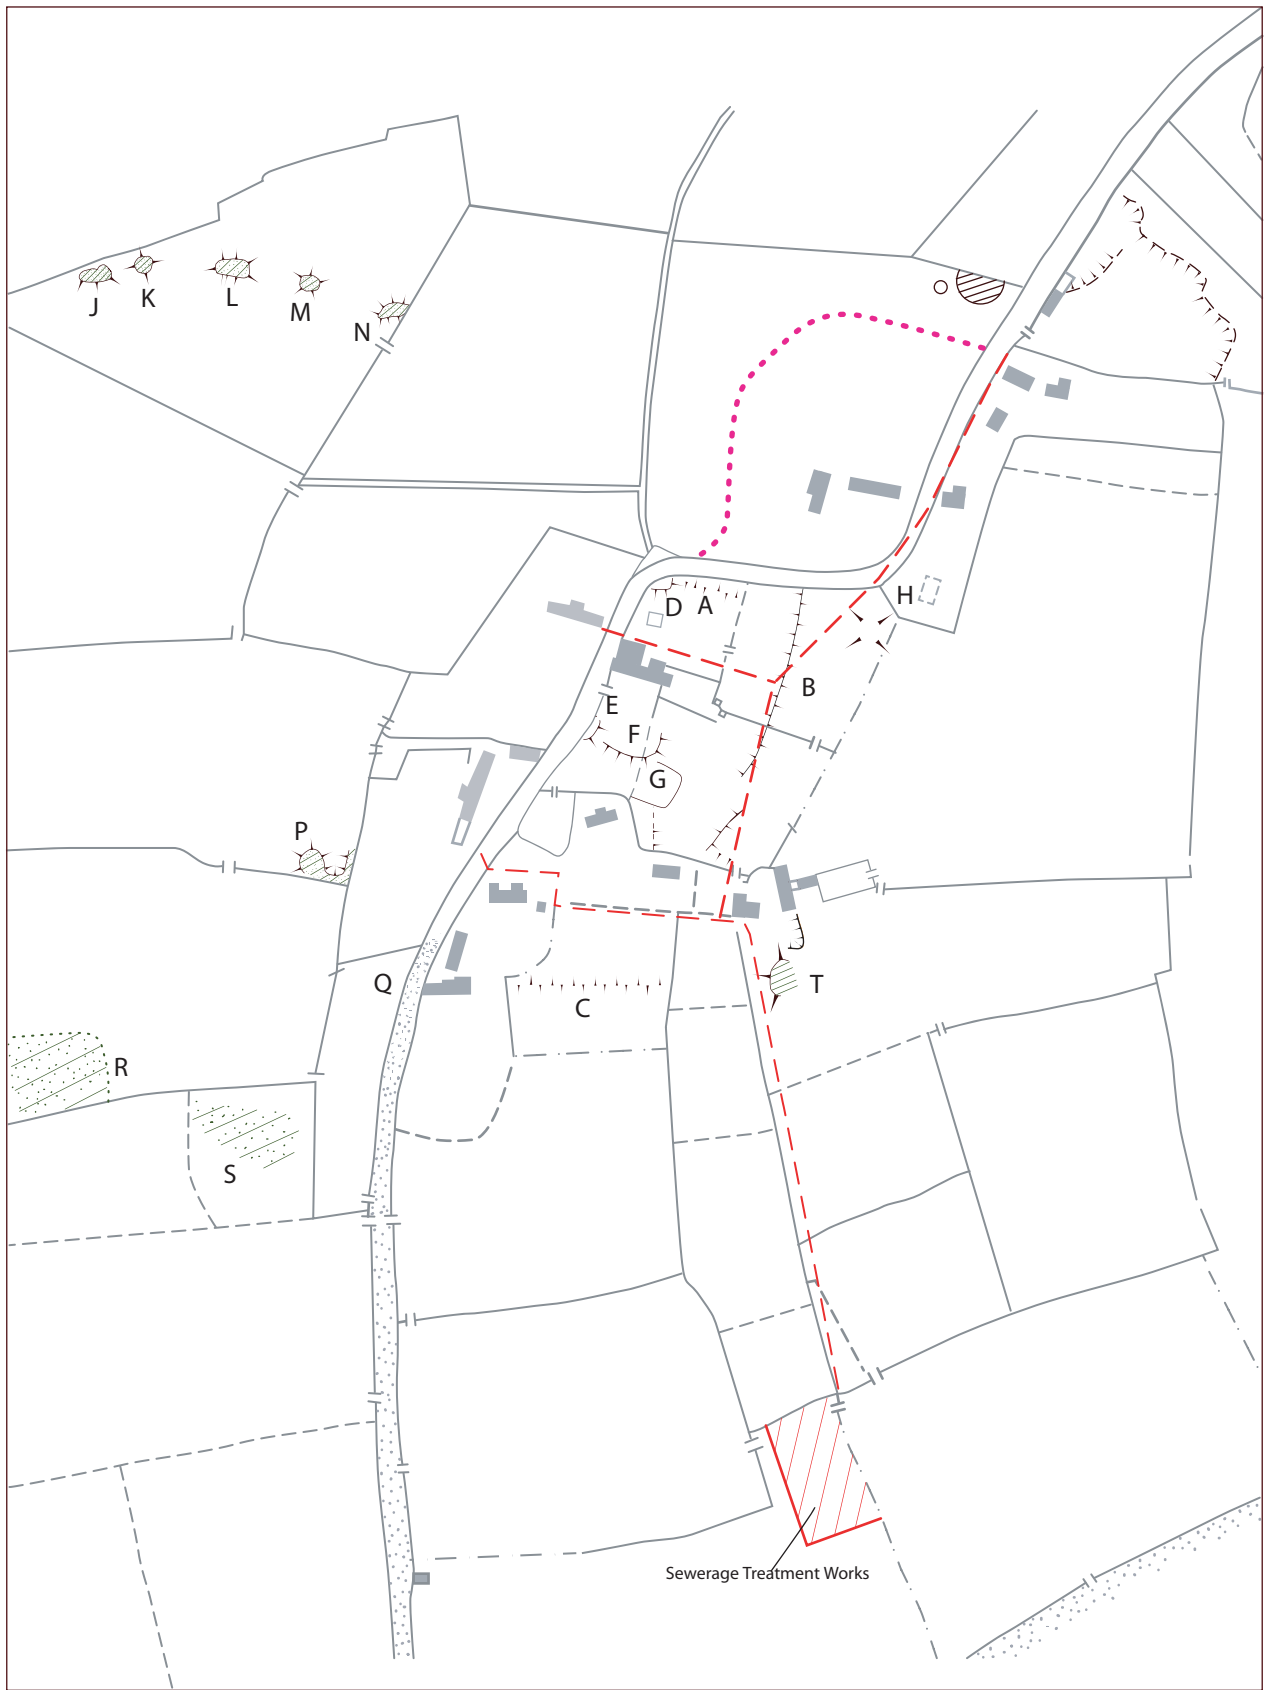
- Former boundary removed since 1880
- - - - Bank
- ⋈ Lynchet
- ⋯ Proposed temporary road
- ▨ Probable site of lead mine
- ⊛ Mound
- - - Proposed course of sewer

Project. Rowland, Bakewell	Project No. 1166	NGR. SK:421419 372421	Scale. N/A
Title. Sketch plan of Rowland village showing Historic Earthwork Features (Based on Barnatt, J. (1993) with modifications)	Illustrator. Jo Mincher	Date. January 2008	Illustration No. 3

This section presents a summary of the archaeological and historical background of the site and its immediate area. Historic maps and plans of the area from the eighteenth century to the present were consulted, including the Ordnance Survey series. Primary and secondary published sources relating to the proposal area were also consulted. A list of sites and find-spots within 1km of the site was compiled from Derbyshire Historic Environment Record (HER). This is presented in Appendix 1 (**Section 13.1**) with the locations of the sites shown in **Illustration 2**. Specific earthwork and other above-ground features are also shown in **Illustration 3**.

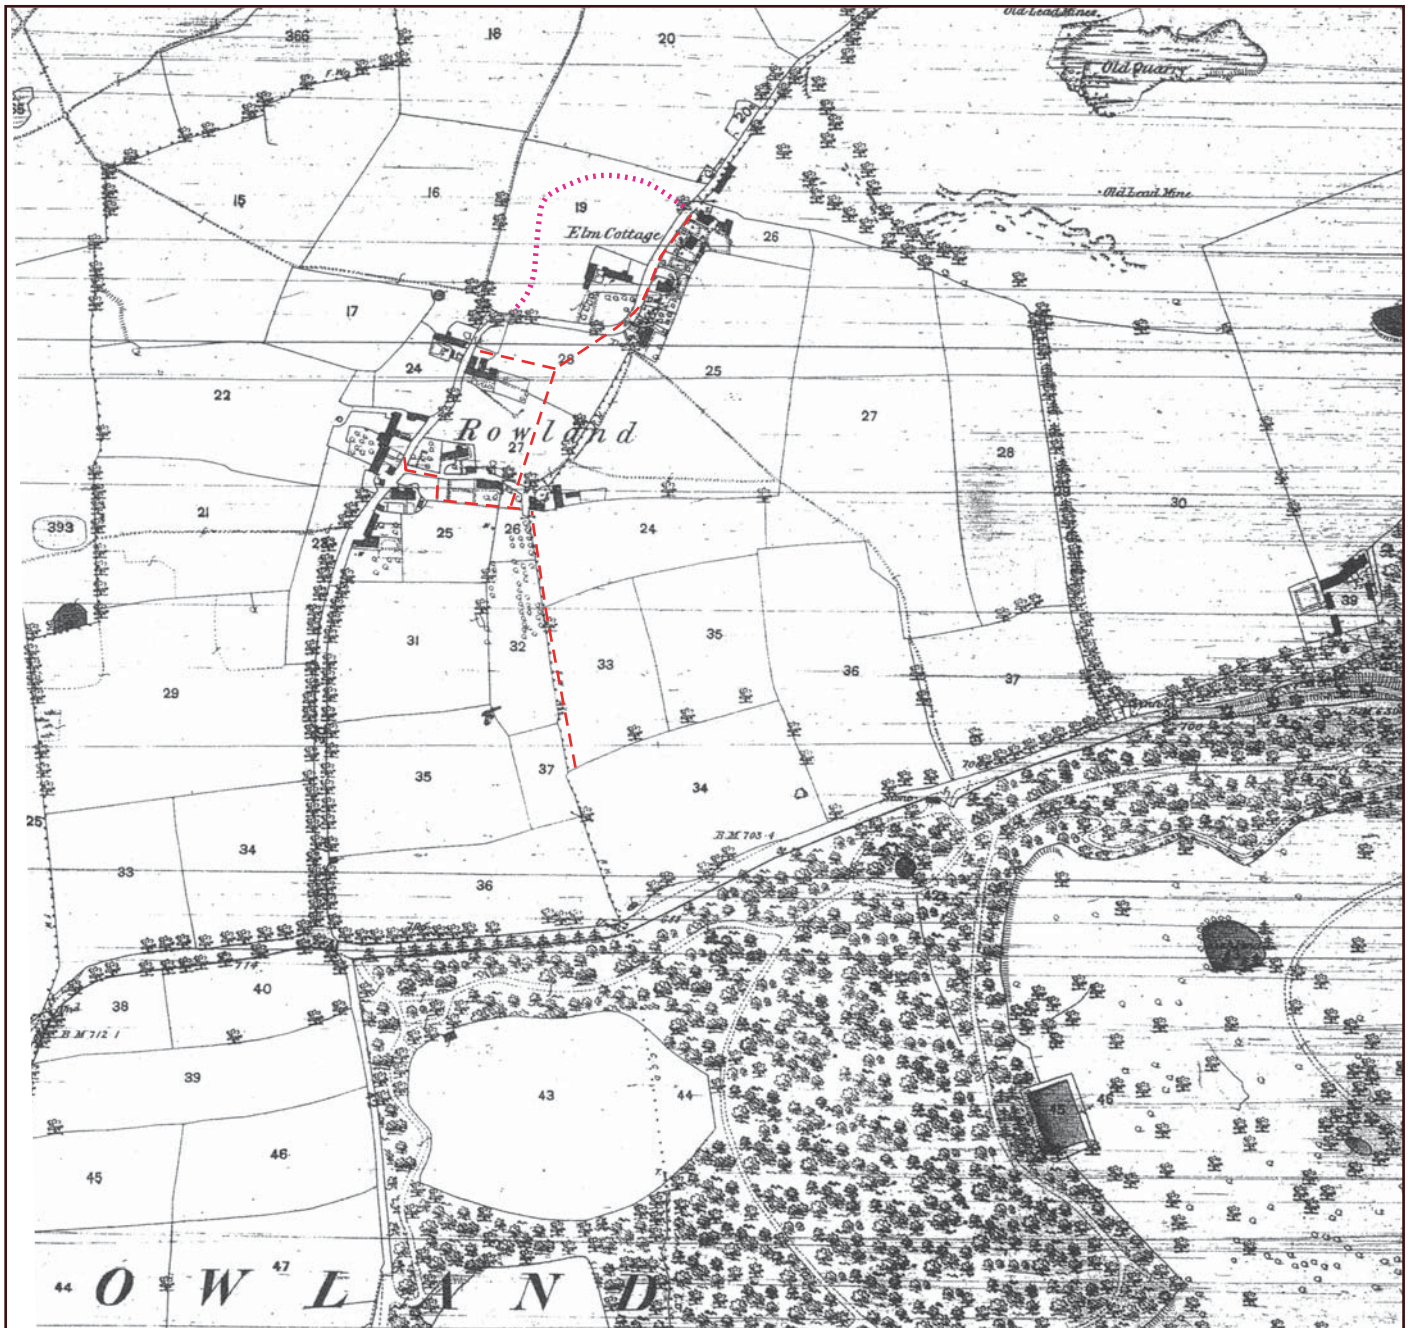
Project.	Rowland, Bakewell	Project No.	1166	NGR.	SK:421419 372421	Scale.	N/A
Title.	1879 OS map 25 inch to 1 mile, sheet 23.3	Illustrator.	Jo Mincher	Date.	January 2008	Illustration No.	5

The 1879 Ordnance Survey map shows the village layout essentially unchanged, with the addition of what is now called Silverdale House to the south-west of the village centre (**illustration 5**). The road leading to the village from the south is shown as lined on both sides with trees. Further contraction of the village population appears to have taken place by this time as a contemporary survey lists 68 residents now distributed between only nine households.

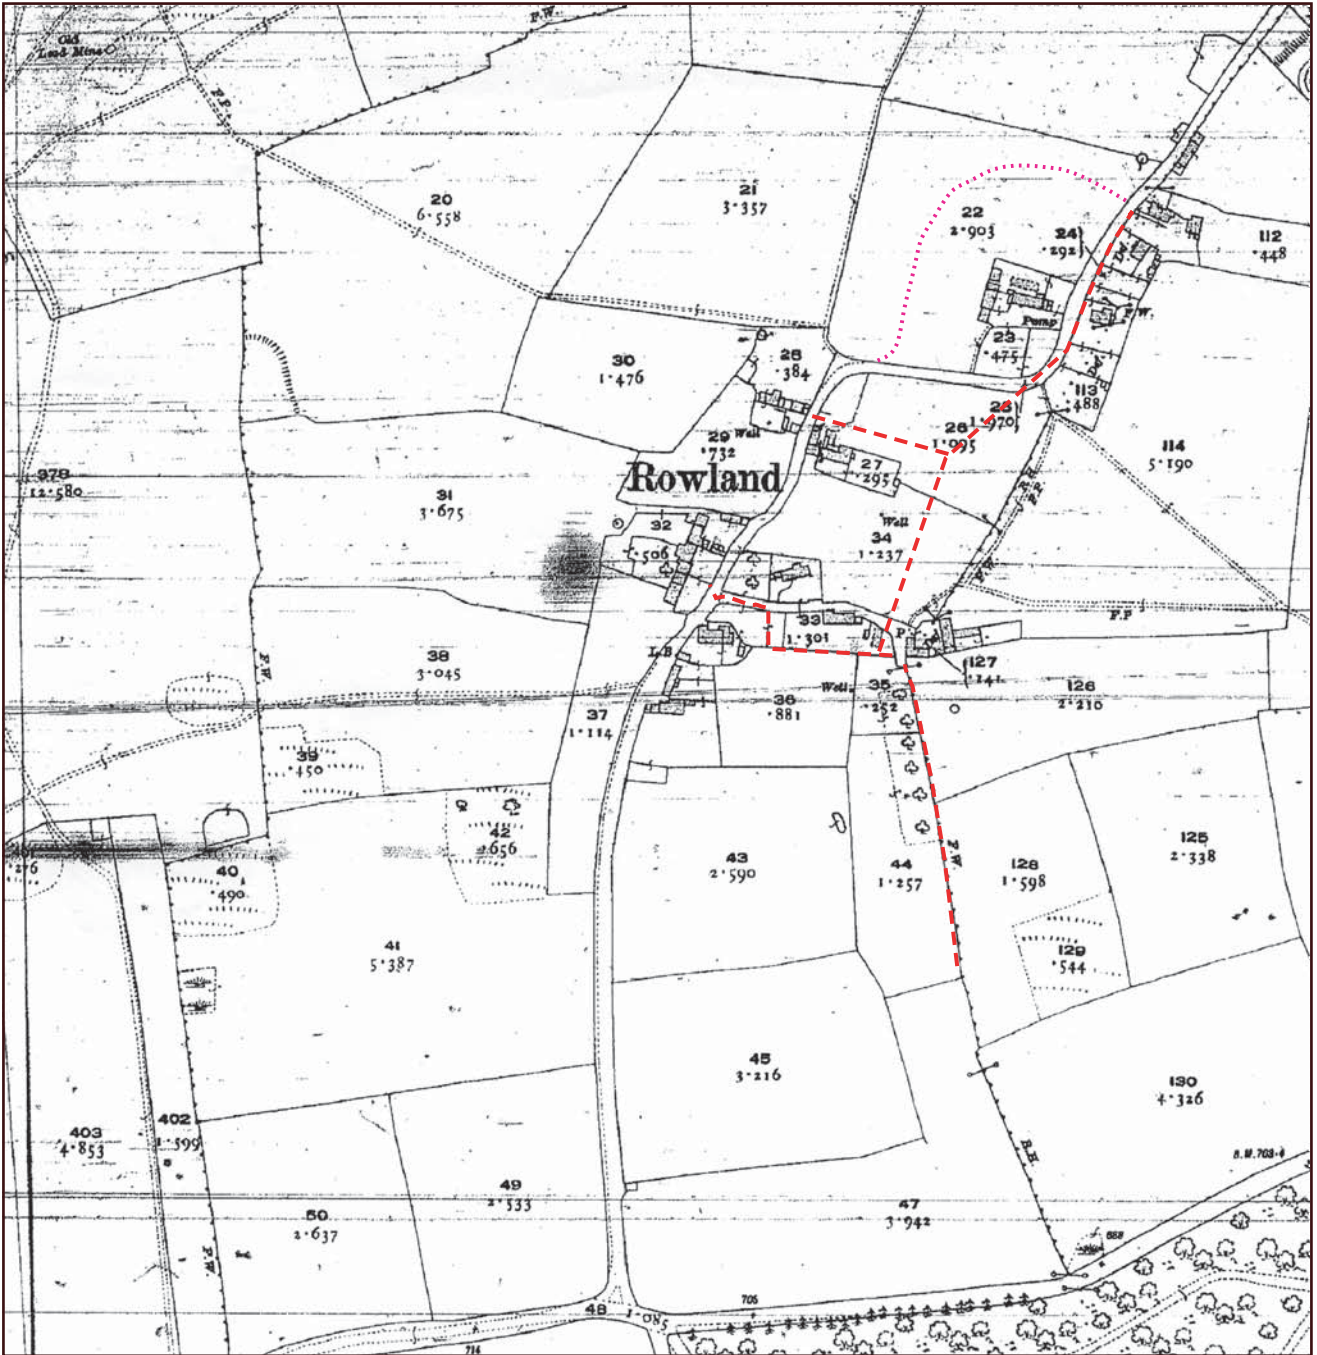
Project.	Rowland, Bakewell	Project No.	1166	NGR.	SK:421419 372421	Scale.	N/A
Title.	1922 25 inch to 1 mile OS map, sheet 23.3	Illustrator.	Jo Mincher	Date.	January 2008	Illustration No.	7

By 1922 a reservoir had been constructed to the east of the lane running north from the village and a well is shown inside the 'village square' (**illustration 7**). A line of trees are shown to the west side of the wall leading south from the 'village square' for the first quarter of its route. Otherwise, the layout of the village remained essentially unchanged from that of the mid-nineteenth century. This was still the case by the middle of the twentieth century (**illustration 8**) but later decades saw some changes being made to field boundaries in the vicinity of the southern section of the proposed sewer route.

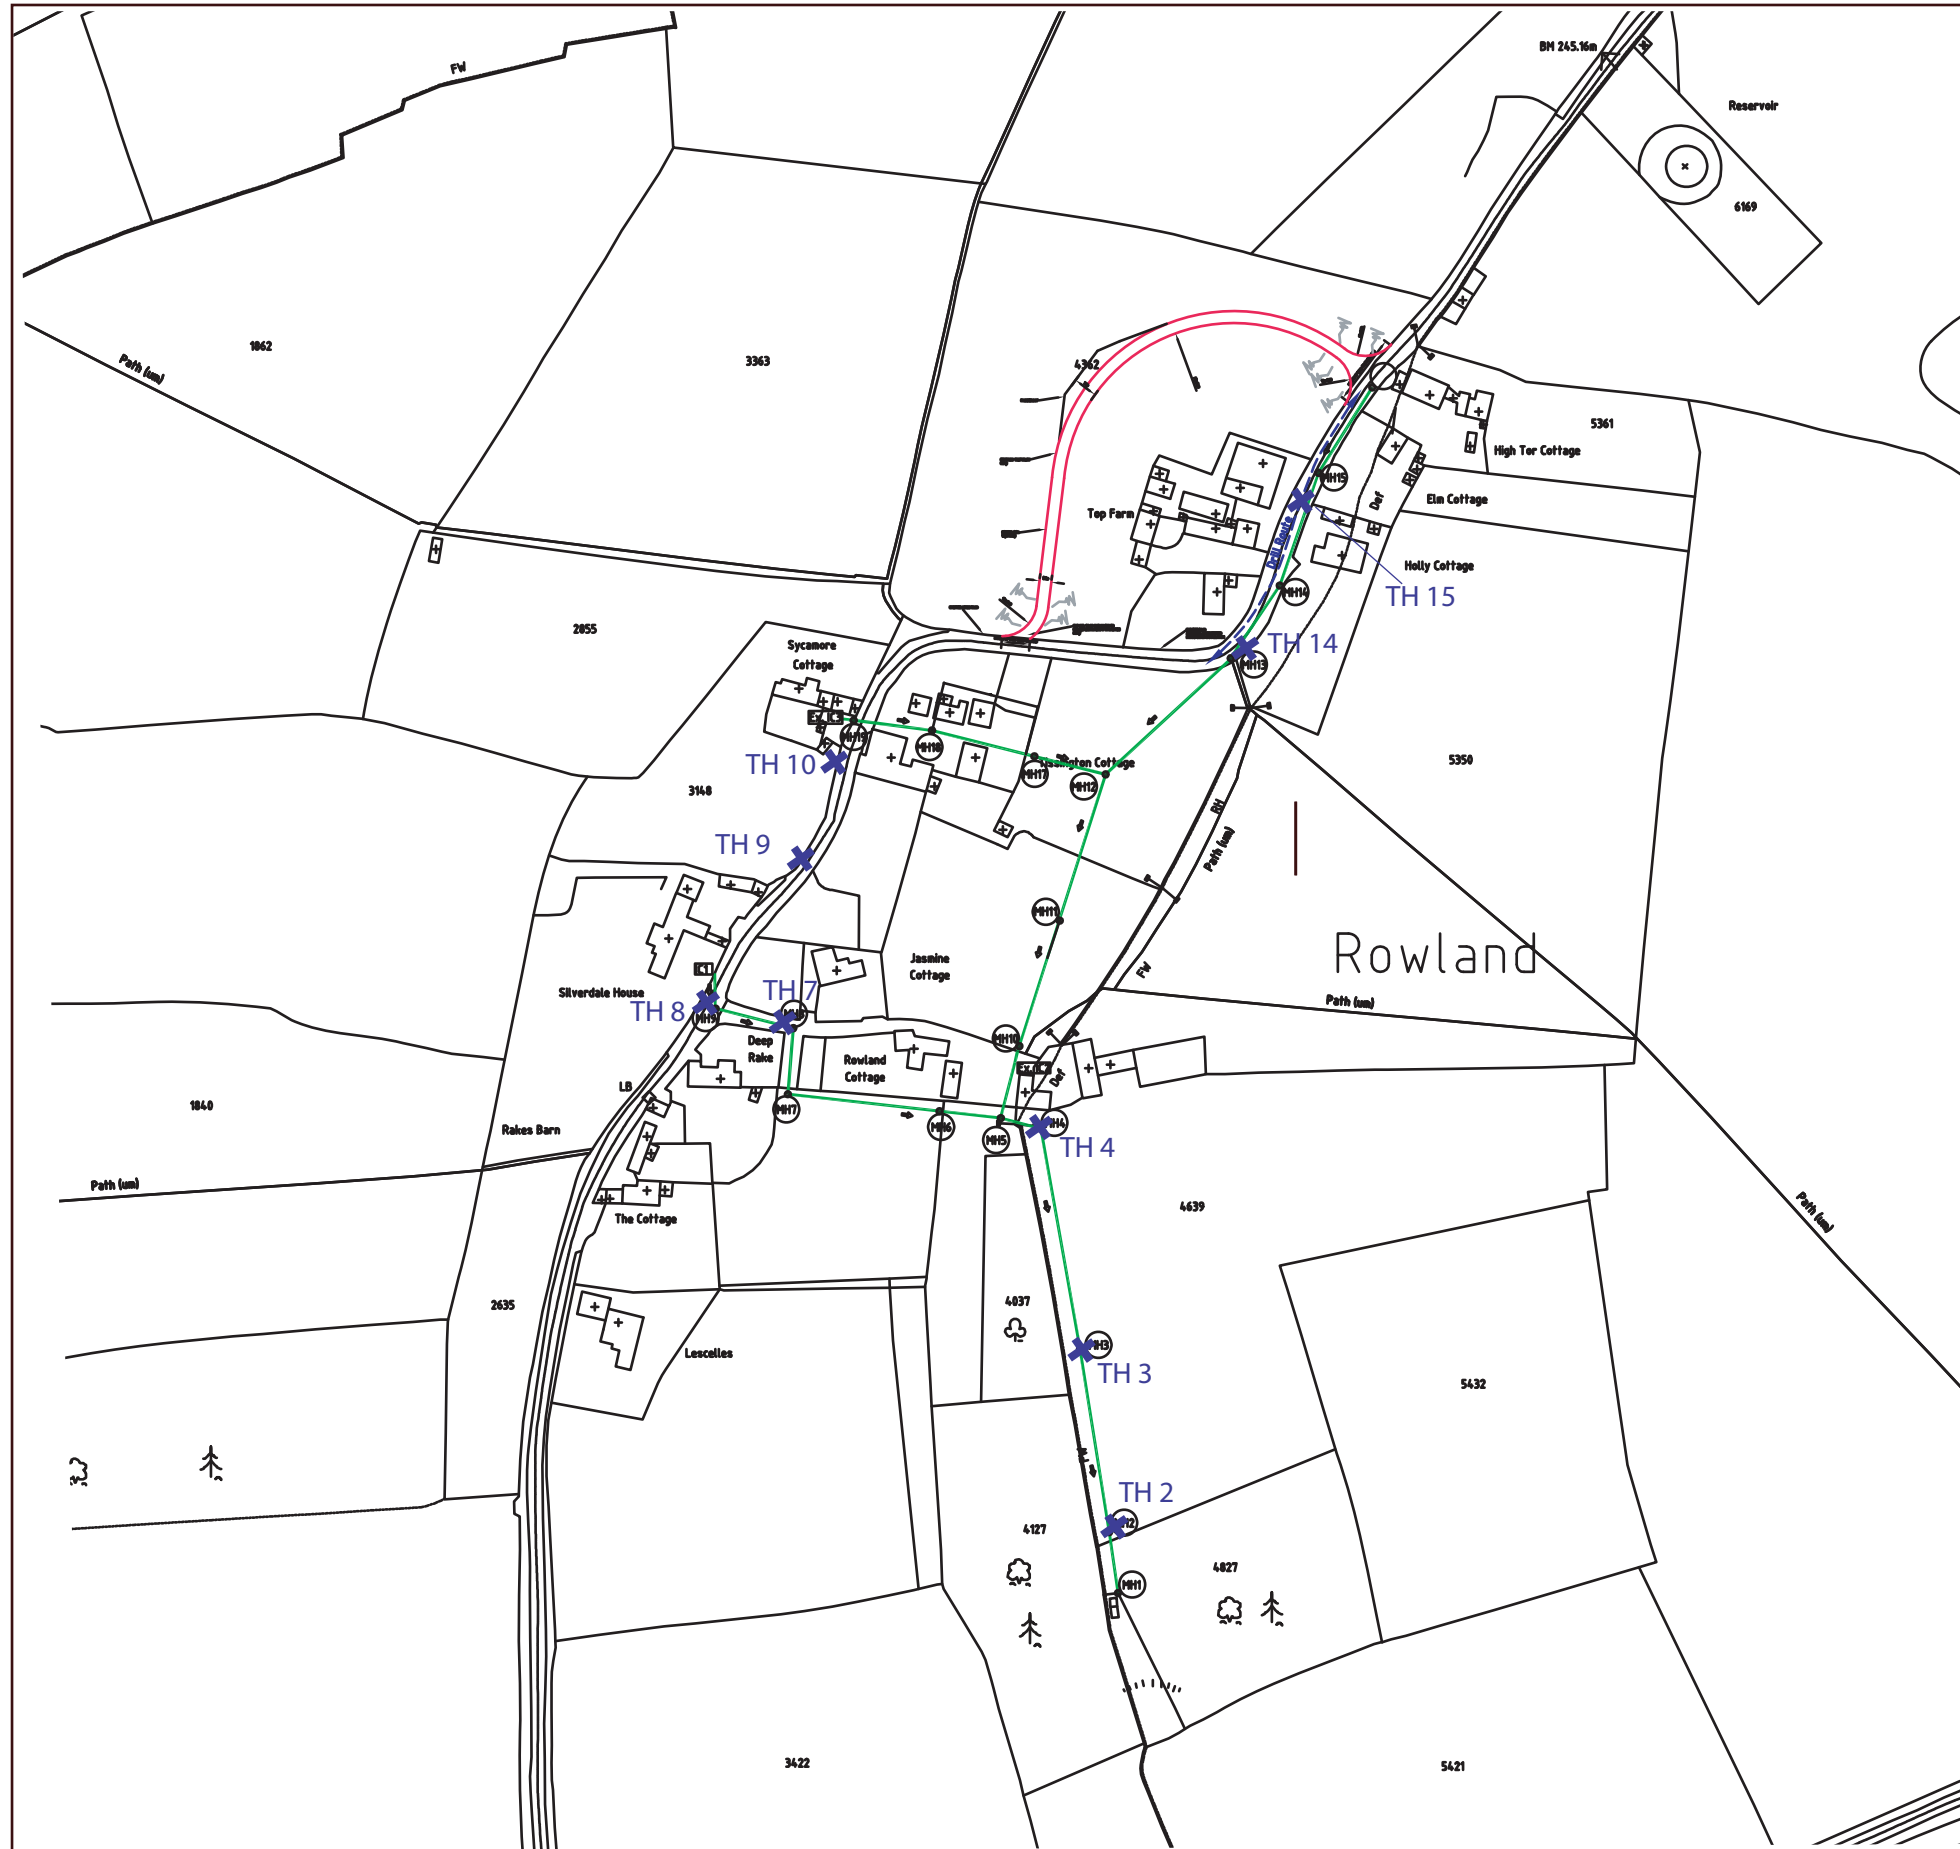
A number of geotechnical trial holes have been excavated along the route of the pipeline to inspect the existing pipes and investigate ground conditions. These were not archaeologically monitored but information was made available for archaeological assessment. The trial holes are shown on **illustration 9**.

Trial Hole No.	Depth	Description
TH2	1.1 m	Soil and clay on to stone at 1.1m
TH3		clay and soil going onto stone
TH4	1.12 m	topsoil over clay
TH7	1.2	stone on top, clay and stone down to 1.2m on depth
TH8	1.2	stone 0.6 over clay 0.6
TH9	1.2	stone down to rock
TH10	1.1	clay and stone down to rock at 1.1m
TH14	1.1	rock and clay
TH15		rocky clay onto rock

The limited soil descriptions available do not allow a detailed interpretation of the trial hole data but a few general observations can be made. Soils are generally clayey and bedrock were identified is at around 1.2 m. The trial holes on the western and northern sides of the village generally contain significant quantities of stone, however, this probably relates to there location on or next to roads in the most built up parts of the village. This stone may well relate to modern construction activities from the roads and houses currently in the village but it could also contain the remains of earlier phases of activity on the site.
