# Cathedral Green, Full Street, Derby, Derbyshire.

## **Watching Brief** **Report 1085c.1(1) © ARCUS 2008**

PROJECT DETAILS		
OASIS identifier	Arcus2-39524	
Project title	Archaeological Watching Brief Cathedral Green, Full Street, Derby, Derbyshire	
Short description of the project	<p>Following a phase of evaluation test trenching ARCUS undertook an archaeological watching brief on re-landscaping of a public area adjacent to the River Derwent in the area known as Cathedral Green, Derby. Reduction of the ground level revealed that much of the remains relating to the former silk doubling mill of John Lomb, established during the 1720s, had been removed during the construction of deep water tanks associated with the 20<sup>th</sup>-century power station. However, the brick footprint of sections of the shop floor and enclosing walls were encountered and proved to have been laid upon a series of wooden sleepers and piles. The rotting of these last features probably resulted in the eventual collapse of the mill.</p> <p>Human remains (minimum of two individuals) recovered on the site following completion of the watching brief are probably derived from a nearby burial ground. The burial

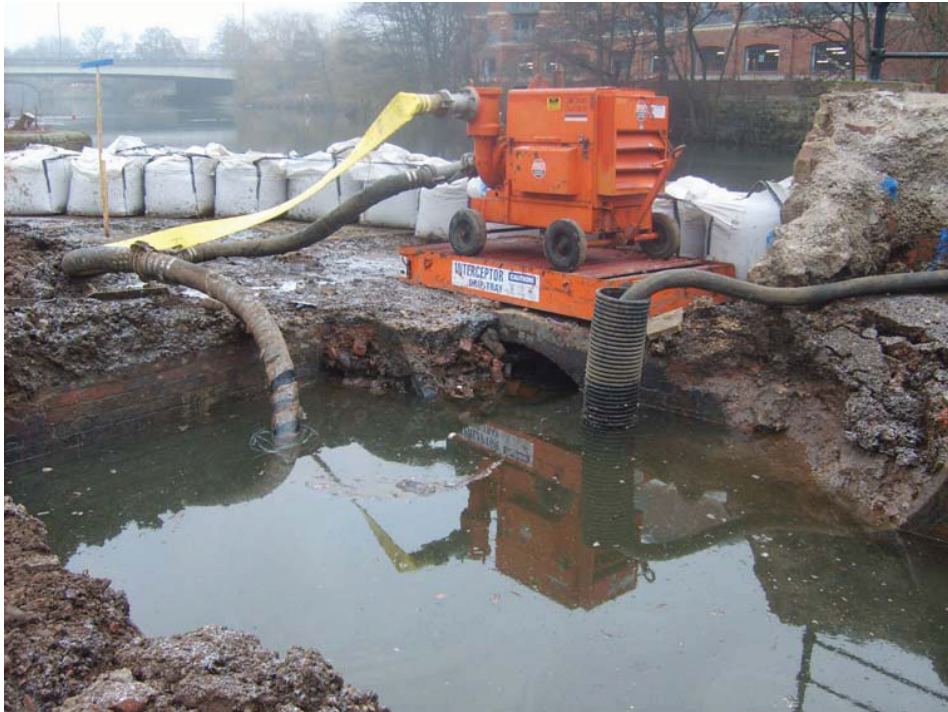
Plate 1: Deep tank associated with the early 20<sup>th</sup>-century power station, beneath the raised southern end of the island. Note the brick arched outlet beneath the pump. View north-east.

Groundworks on the raised southern end of the island area adjacent to the River Derwent were monitored. The raised area, corresponding to Trial Trench 4 in the earlier evaluation (Baker 2007), was lowered by 2m, with brick and concrete footings below this level removed to permit unimpeded piling.

The watching brief in this area confirmed the results of Trial Trench 4, that much of the raised area at the southern end of the island consisted of made ground inserted during the 20<sup>th</sup> century. This material proved to be backfilling two tanks, each 2m deep, associated with the early 20<sup>th</sup>-century power station on the site (**Plate 1**). Brick arched conduits to the river were identified and presumably related to water intake from, and outflow to, the Derwent. The tanks were constructed of 3-inch blue brick with rectangular frogs set within a hard cementitious mortar. Excavation of these tanks had completely removed any remains of the silk mill doubling shop in this area. To the south of this zone of disturbance, however, the brick footings of the extreme southern end of the doubling shop survived. Beyond this point further excavation was undertaken but reduction of the ground level was not sufficient to encounter any other remains relating to the former silk mill or associated structures.

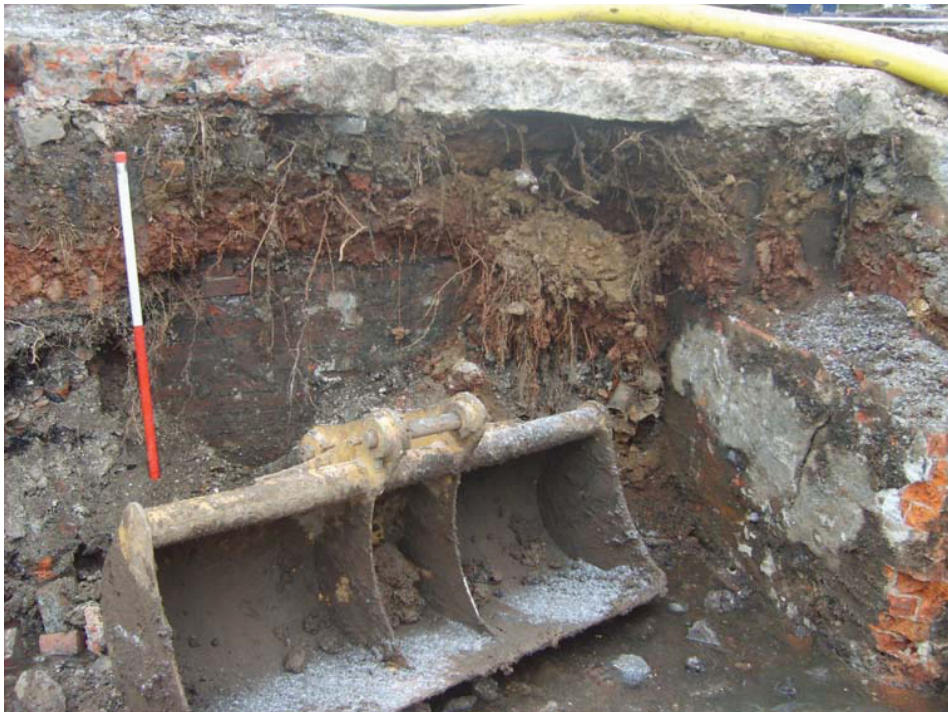
Plate 2: South-western corner of the doubling shop, visible in trench baulk. View south-west

To the south of the tanks, the extreme southern end of the doubling shop was represented by a section of each of the side walls, approximately 2m in length, visible within the edge of excavation (contexts 008 and 009, **Plate 2**). Construction was in a plain, hand-made orange-red brick, 6cm/2¼ inch thick, and the side walls were four skins thick in a hard pale brown lime mortar. The uppermost surviving course of these structures was 0.71m below the ground surface in the raised southern area of the island. No internal floors survived, and there was considerable disturbance from later concrete bases and from the high-voltage cables immediately to the south. The internal width of the building at this southern end was around 6m, considerably broader than the internal width further to the north. This is probably due to the stepping-out of the structure towards the southern end, shown on historic maps. Further to the south of this wall reduction of the ground level was not sufficient to

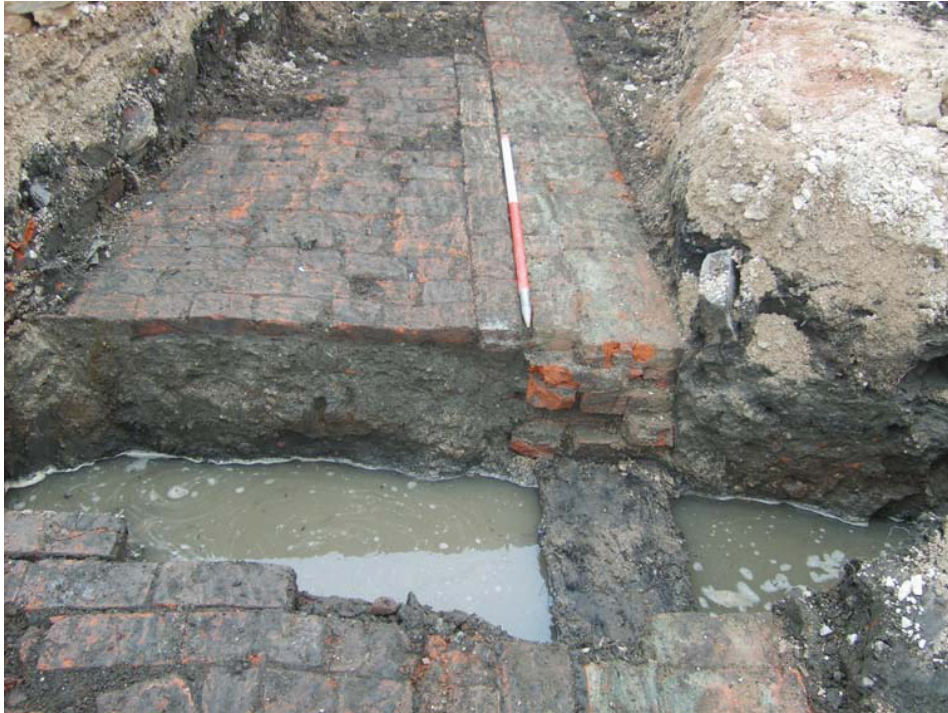
Plate 3: East wall of doubling shop (001), with section of internal brick floor (004). Note the wall footing rests on a wooden sleeper foundation (002). View North

To the north of the two power station tanks, a 14m length of the doubling shop survived. At the southern end, this was restricted to the wooden sleeper beam footing of the eastern wall (context 007), and also the wooden piles beneath, one or two of which were seen briefly in sondage before water levels rose (**Plate 3**). Preservation increased northward, and 9.40m of the brick structure was preserved across its entire width, with both wall footings and a section of internal brick floor surviving (**Plates 4 and 5**).

The walls at this point (contexts 001 to the east and 006 to the west) were three-skins thick, in the same 2¼-inch brick as the southern end (dimensions 24cm x 11.5cm x 6cm), set in a pale, almost greenish-brown sandy lime mortar with charcoal flecks. The specialist report indicates that such bricks were of early 18<sup>th</sup>-century origin and corroborates the date for the construction of the doubling shop sometime during the 1720s (see Section 6 below). The eastern wall survived flush with the internal brick floor, and a sondage revealed five courses above the level of the timber footing. The flooring consisted of a rectangular-section sleeper 0.33m wide and 0.15m thick. Because of water ingress from the river it was not possible to enter sondages to fully record the underlying wooden piles driven into the river silts. These were directly below the sleeper beam, and appeared to be of sub-circular section, spaced approximately 0.40m apart. The western wall of the building (also encountered in Trial Trench 3 during the 2007 evaluation), was better preserved, with a maximum of 7 courses (0.46m) surviving above the level of the internal brick floor.

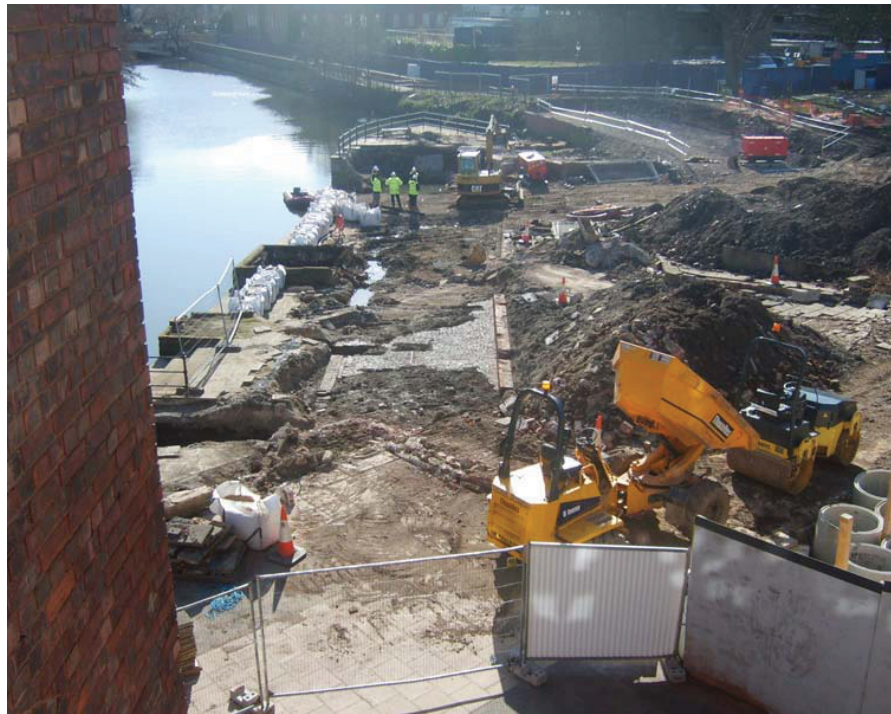
Plate 4: High level view of doubling shop site, showing the surviving footings and floor (centre). View south.

The internal floor (context 004), 4.68m wide from wall to wall, was composed of a single layer of bricks laid flat directly onto the underlying river silt, a homogenous grey-brown sandy silt. An edging course against the eastern wall lay at a slightly lower level (2cm below the rest of the internal floor), and may have been used for drainage. This edging course was also in a different style of brick from both the walls and the internal floor, being a rough, plain hand-made red brick 3 inches thick (dimensions 23.5cm x 11.5cm x 7.5cm), and was laid longitudinally against the eastern wall (context 003). The specialist report indicates that the brick sample from this context may be of a later date, 18<sup>th</sup>- to 19<sup>th</sup>-century, and the structure may consequently represent a later internal modification of the building. The remainder of the internal floor was in offset courses laid end-to-end and running transversely across the width of the doubling shop. The floor was in a plain hand-made red brick only 2 inches thick (dimensions 23cm x 11cm x 5cm). In this instance the brick sample appears to be indicative of a late 17<sup>th</sup>-century date and probably indicates the re-use of material in the initial construction of doubling shop.

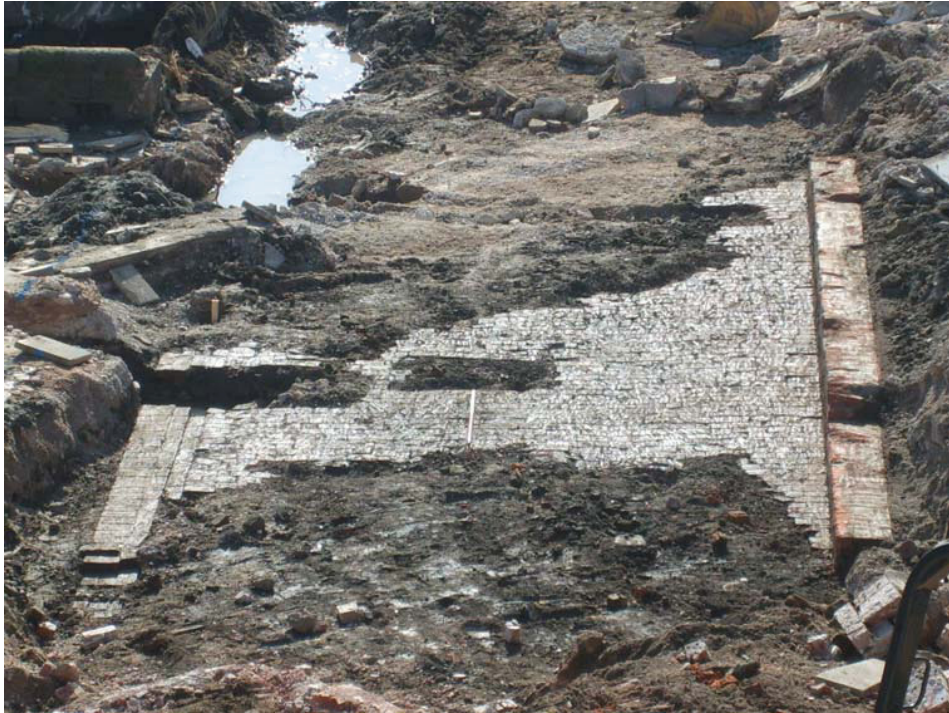
Plate 5: Doubling shop floor and footings. View south.

The floor was disturbed in patches, presumably during landscaping of the site during the 1980s, when the new paved surfaces came very close to the floor level of the doubling shop. Further to the north, the zone of preservation was interrupted by more landscaping disturbance, and a concrete-lined pipe trench cutting across the entire building.

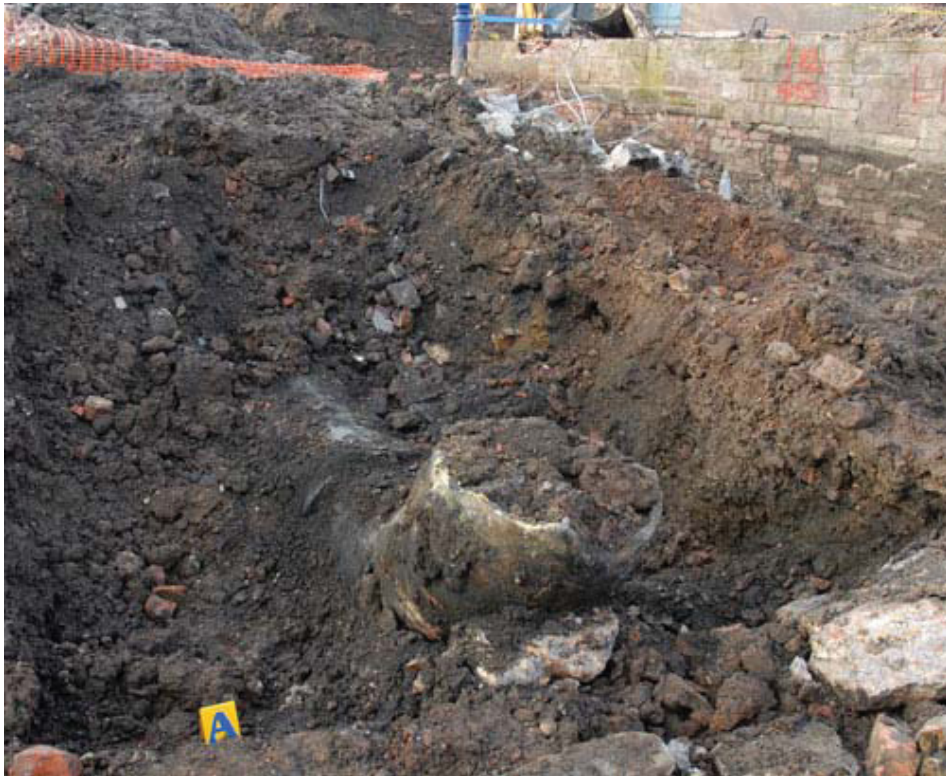
Plate 6: Location (marked with 'A') of uncovered bones

Animal and human bones were uncovered during development works carried out following completion of the watching brief. The remains are thought to have been discovered during the removal of an iron cast pipe in the south-western corner of the site (marked red on **Illustration 1**). The assemblage comprised fragmented animal and human bones displaying a poor state of preservation. The bones were collected

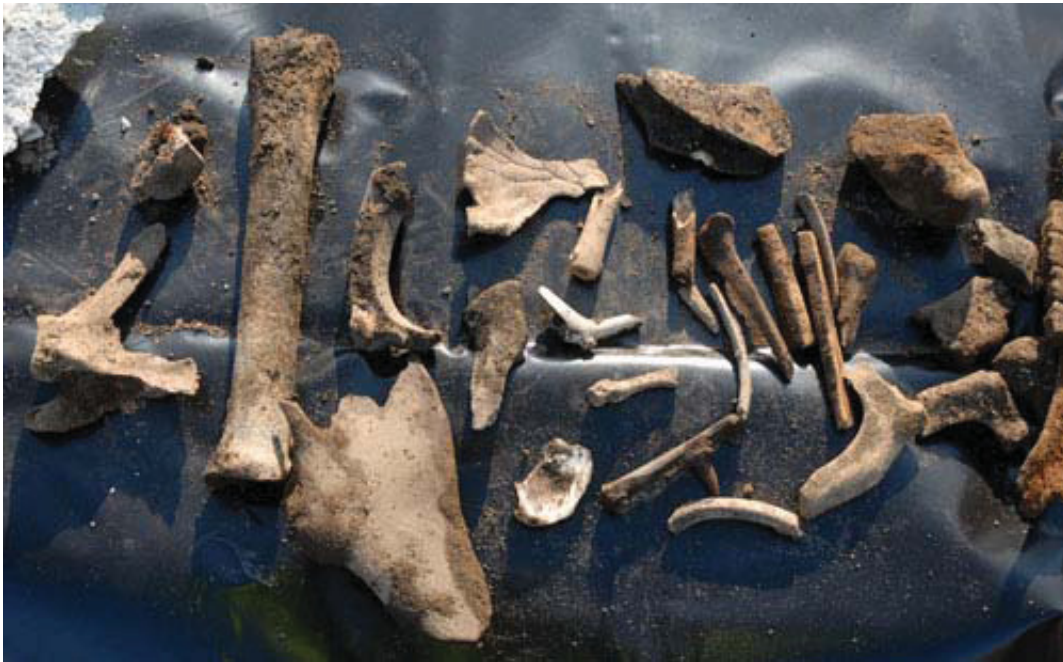
Plate 7: Part of bone assemblage recovered from development site
