Project Report 1198b.1(1)

## Archaeological Evaluation at Hanson House, Normanton, West Yorkshire

National Grid Reference: SE 388 224 (centred)

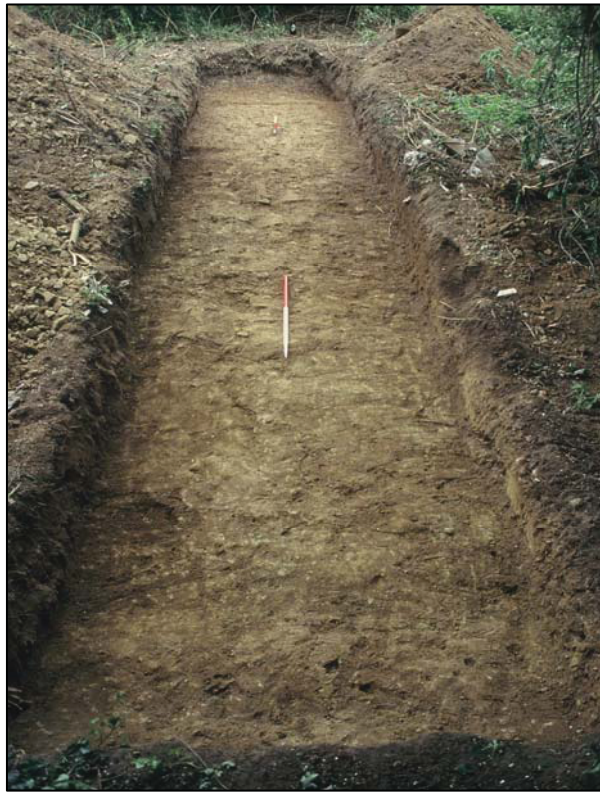
Plate 1: Trench 1, east-facing.

The underlying natural [102] was exposed in the centre of the trench, due to a natural outcropping above the level of the surrounding subsoil (**plate 1**). Deposit [102] comprised a sandstone shale deposit, of weathered sand and approximately 35% loose platy sandstone fragments. The trench was archaeologically sterile.

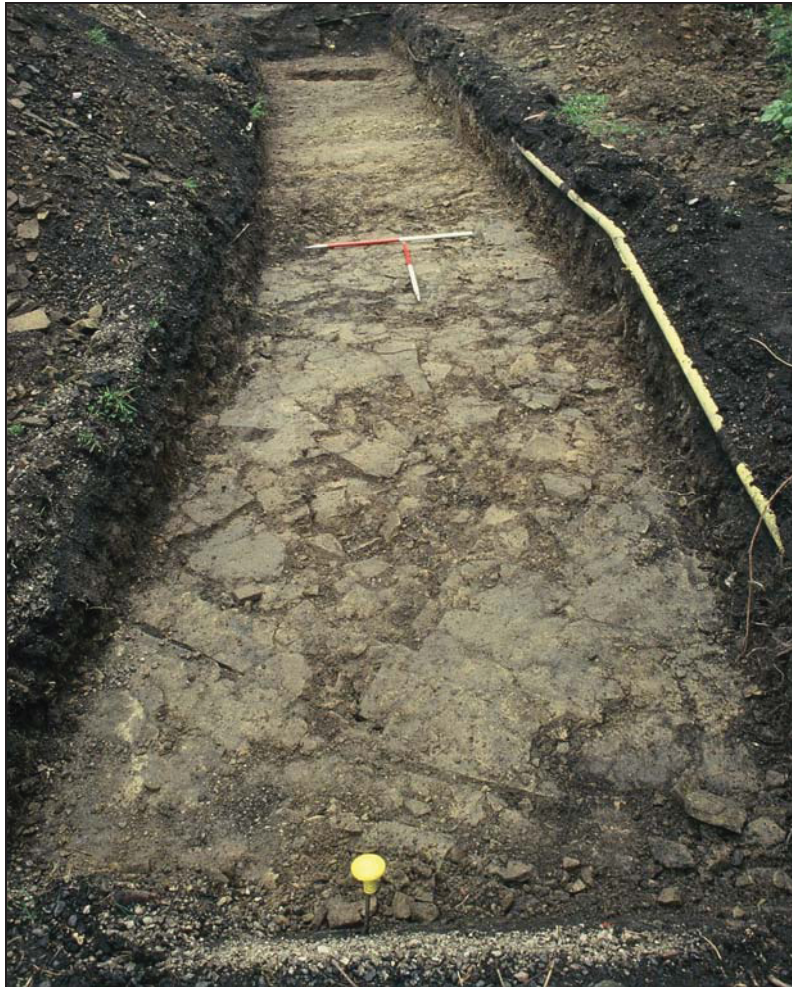
Plate 5: Trench 5, west-facing.

Mechanical excavation continued down into the subsoil [503], which comprised a mid orange-brown sandy-silt context, with approximately 20% inclusions of platy sandstone chunks, typically 5-15cm in size. This deposit measured 0.2m in thickness. The high stone inclusion concentration in this subsoil is explained by the corresponding nature of the local substrate. The natural deposit [504], beneath subsoil [503], was almost exclusively composed of sandstone aside from a natural sand lens, which outcropped in the centre of the trench (**plate 5**).

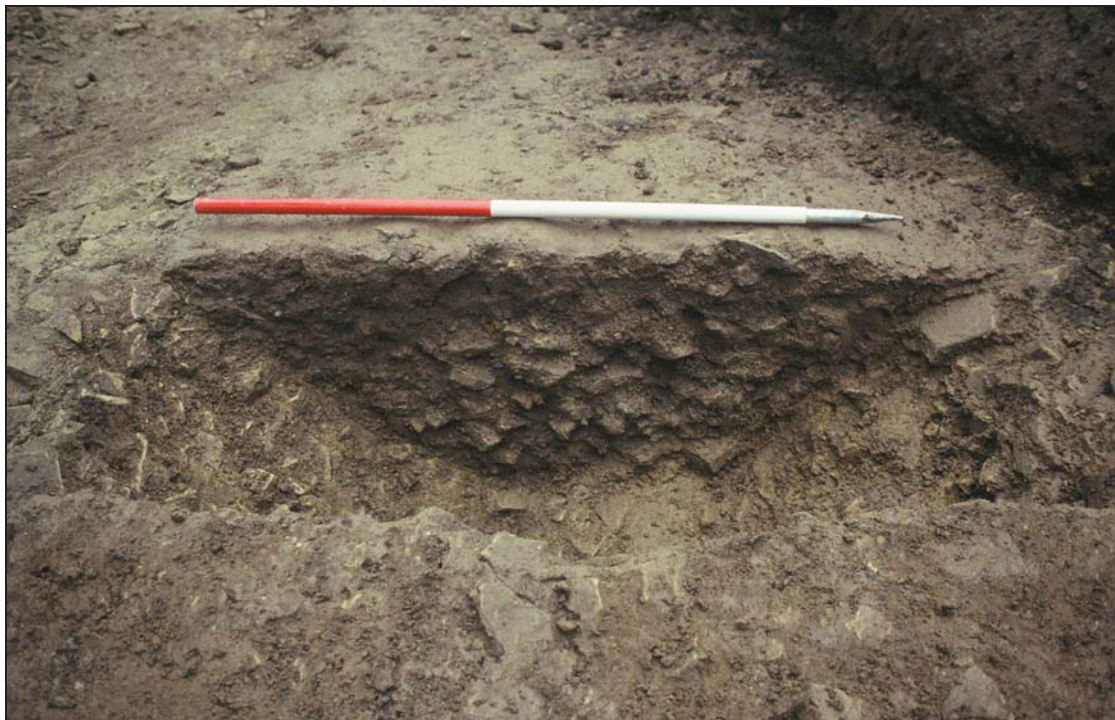
Upon the completion of cleaning by hand, a potential linear feature was observed at the south-west end of the trench. The feature was differentiated from the surrounding natural [504] by the significantly lower stone content and the pale brown fill colour. A sample section of the feature was excavated by hand, and the section was drawn at 1:10 (**illustration 6a**) and photographed accordingly. The context number [502] was ascribed to the cut, and context number [501] was ascribed to the fill. On excavation, the cut was shown to be of a gently sloping profile with a slightly u-shaped base (**plate 6**), which measured 1.4m wide and 0.4m deep. The linear appearance in plan led to the interpretation of [502] as a ditch. Feature [502] had been cut directly into the solid bedrock, and then gradually filled up with deposit [501] over time. The

fill was probably generated by natural weathering from the sides of the cut, due to the close similarity in colour and texture of the fill to the underlying substrate. Fill [501] contained approximately 40-60% medium-sized sandstone inclusions which were irregularly distributed through the section. The ditch fill was sampled according to standard guidelines. The samples were then removed from site for subsequent specialist analysis (see **section 4**).

Plate 6: Section through ditch [502], east-facing shot.

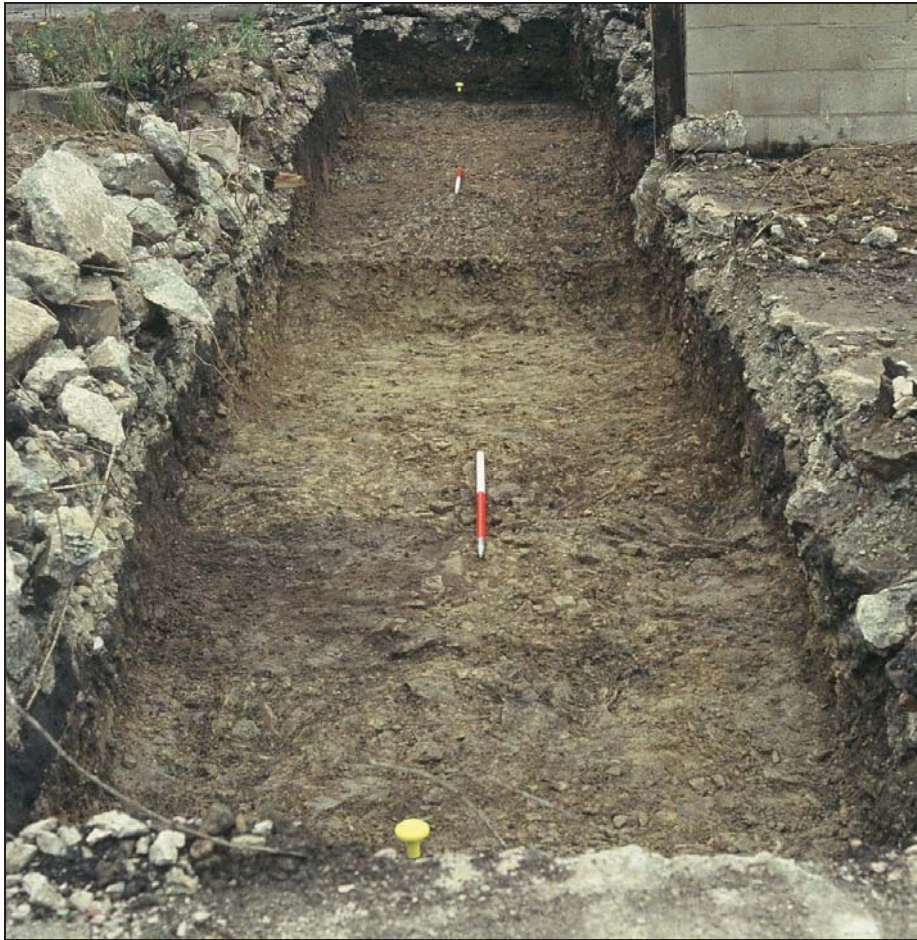
Plate 7: Trench 6, north-facing.

Upon the removal of context [603], the top of the underlying natural was cleaned by hand (**plate 7**). During cleaning, the existence of a cut feature became apparent. The feature comprised a sub-oval cut [602], filled by mid-brown sandy silt with 10-20% sandstone pebble inclusions [601]. The upper 80 percent of the feature was only visible by virtue of a slight colour differentiation between the surrounding subsoil [603] and fill [601]. In totality the feature measured 1.4m in length and 0.5m in depth (**illustration 6b**). The base of the feature was cut into the natural bedrock to a depth of 0.1m. The feature was not fully visible in plan, as it continued on into the north-east facing section (**plate 8**). The width of the feature from the north-east facing section measured 0.9m. No artefacts were recovered during the excavation of [601], although the fact that [603] was cut through the existing subsoil implies the date of the feature is considerably later than the ditch features in Trenches 5 and 8, which were sealed by a similar subsoil deposit.

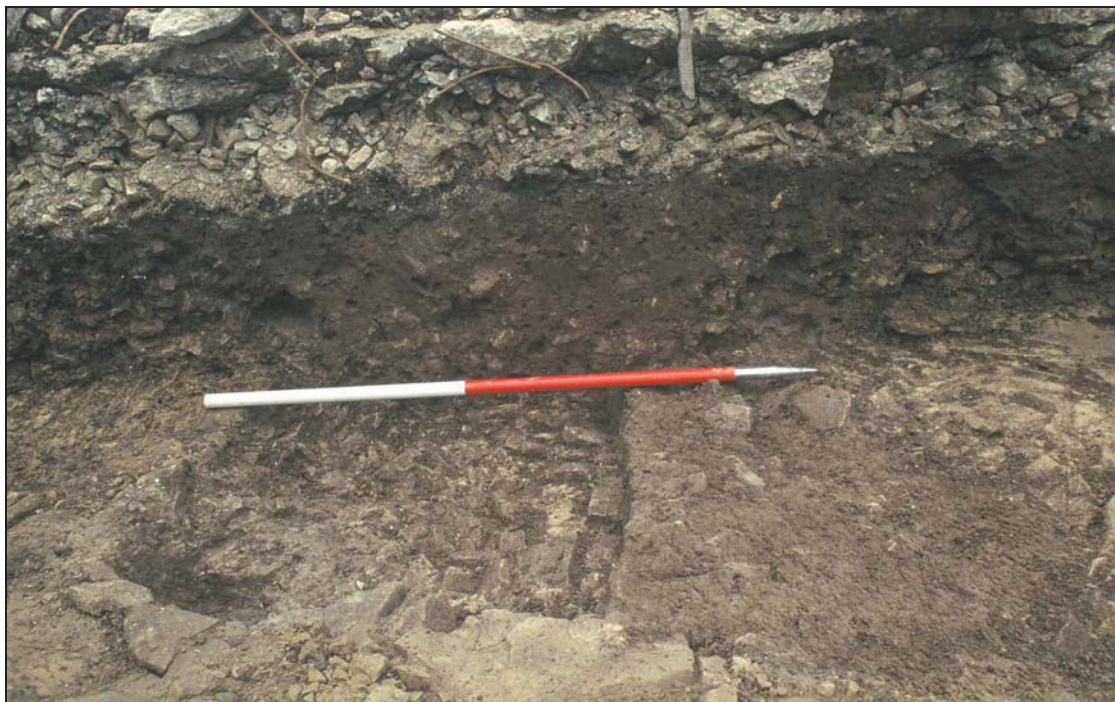
Plate 8: Trench 6, east-facing section through feature [602].

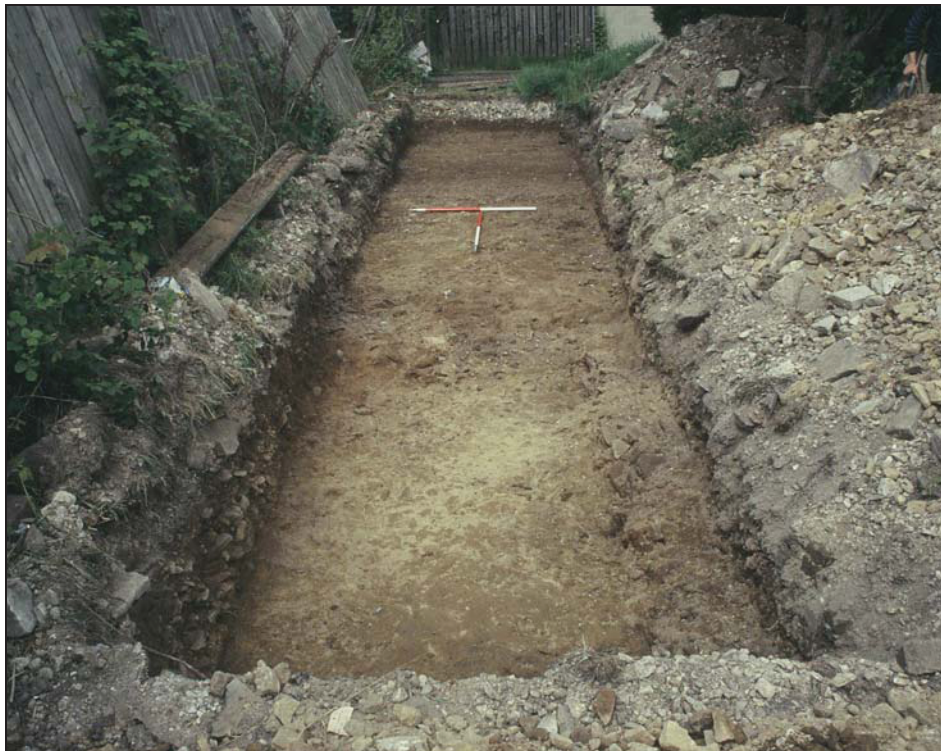
Plate 10: Trench 8, north facing.

The trench was then cleaned by hand and photographed (**plate 10**). The presence of two cut features in the base of the trench became apparent during cleaning. Cut [803], located close to the south-east end of the trench was sub-oval in plan, measuring 1.16m in length, 0.91m in width and 0.35m deep. Excavation of the feature exposed an intact and articulated pig skeleton (**plate 11, section 4.2**). The fill [804] comprised a deposit of dark brown sandy-silt with frequent orange-brown mottles. The context also contained substantial quantities of lime, which was persistent enough to form a discrete layer around the skeleton (**illustration 7b**). The lime had undergone a chemical change whilst *in situ*, forming concretions of such density that judicious use of a small pick was required to loosen the deposit. A single small fragment of pottery was recovered during the excavation of the feature; although this fragment was probably medieval (**section 4.1**), its small size and abraded condition suggests the possibility of residual inclusion within the feature.

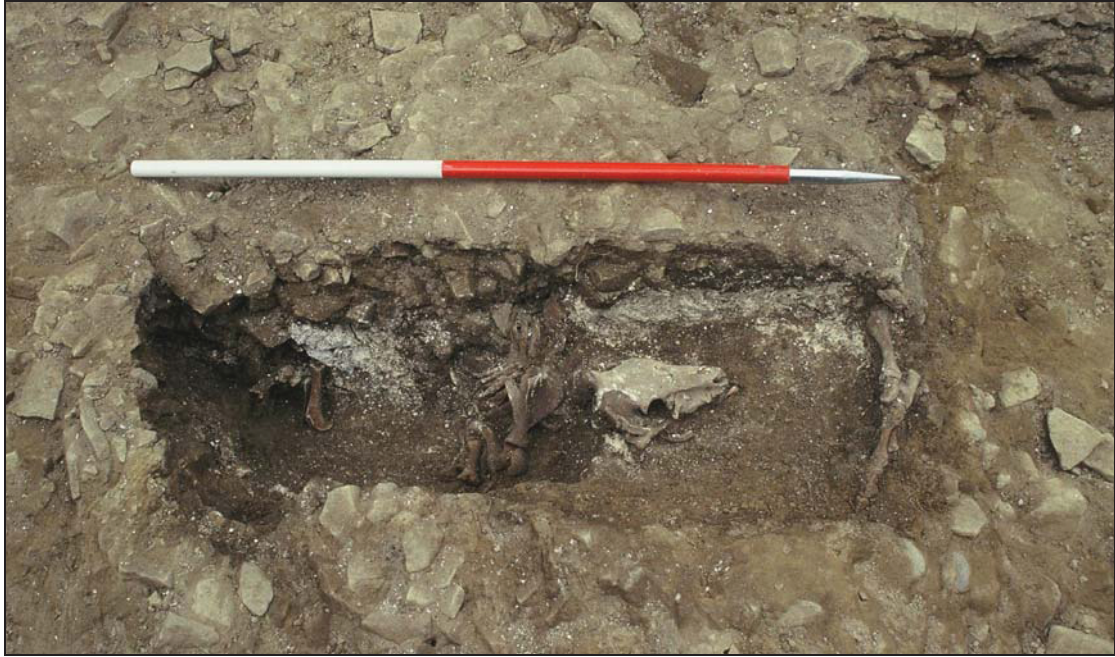
The elements examined were all identified as pig (*Sus scrofa*) and indicated that two individuals were present within context [804]. These are summarized in **Table 2**. Both individuals were fairly young with none of the long bone elements bearing completely fused epiphyses. The inclusion within the assemblage of four, separate unfused scapula (bicipital tuberosity), proximal radius and pelvis (acetabulum) indicate that both individuals were less than one year old at the time of death. The skulls of the two individuals showed different states of fusion and this, along with the presence of a partially fused distal humerus, would indicate that one of the individuals was slightly older than the other. One set of long bones also appeared to be slightly smaller than the other.

Plate 11: Pig skeleton in cut [803], Trench 8.

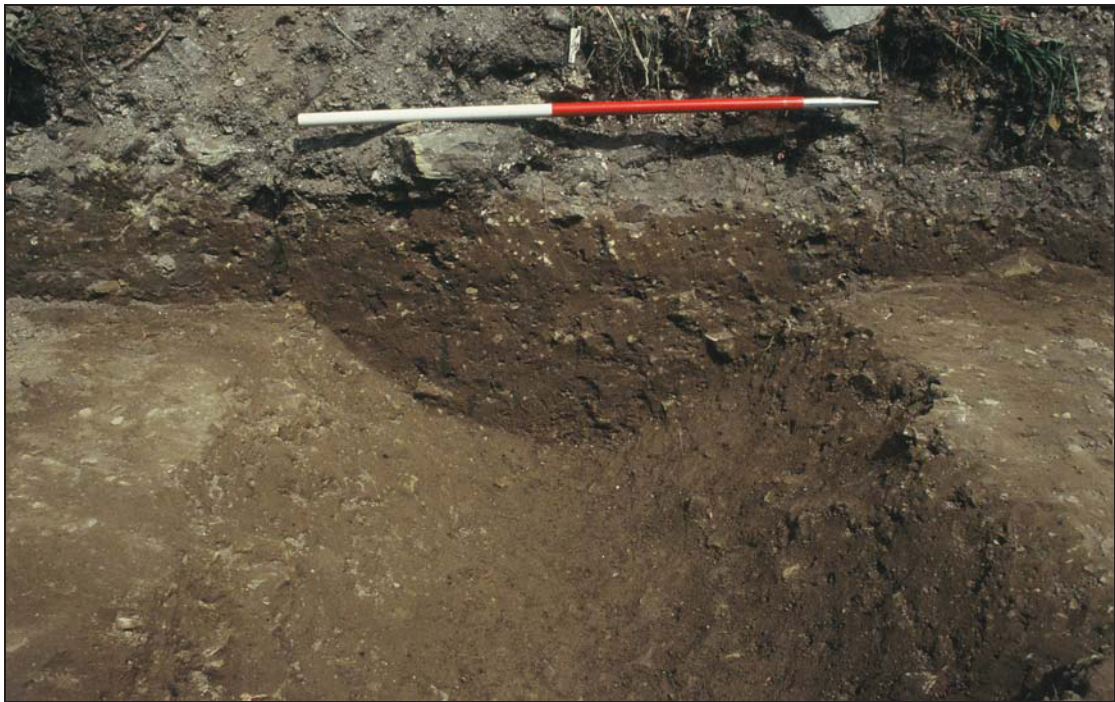
The other feature in Trench 8 was situated at the north end of the trench, and was orientated east-west. The feature was linear in plan and ascribed context number [805] for the cut, and [806] for the fill. The cut was gently sloping in profile with a dished base (**plate 12**). Fill [806] comprised a mid brown clay-silt, which was mostly homogenous with a thin pale lens interposed between the main fill and the base of the cut. Deposit [806] was sampled according to standard guidelines. The samples were then removed from site for subsequent specialist analysis (see **section 4.3**). The ditch measured 1.4m wide and 0.4m deep (**illustration 7a**). Three sherds of pottery were recovered from the base of the fill. These sherds had a secure stratigraphical provenance from the base of the ditch fill [806], and were subsequently identified as Hllam type ware and Buff gritty ware. Both of these types date from the late eleventh century to the early thirteenth century, but the individual sherds are likely to pre-date the thirteenth century (see **section 4.1**). A single sherd of ceramic was also recovered from within the top 0.05m of the fill as excavated. Although this sherd was identified as Cistercian ware or possibly an early type of late Blackware (see **section 4.1**), it can be interpreted as a stray artefact from later use of the site which subsequently became incorporated into the top of the ditch fill.

Plate 12: Section through ditch [805], Trench 8.

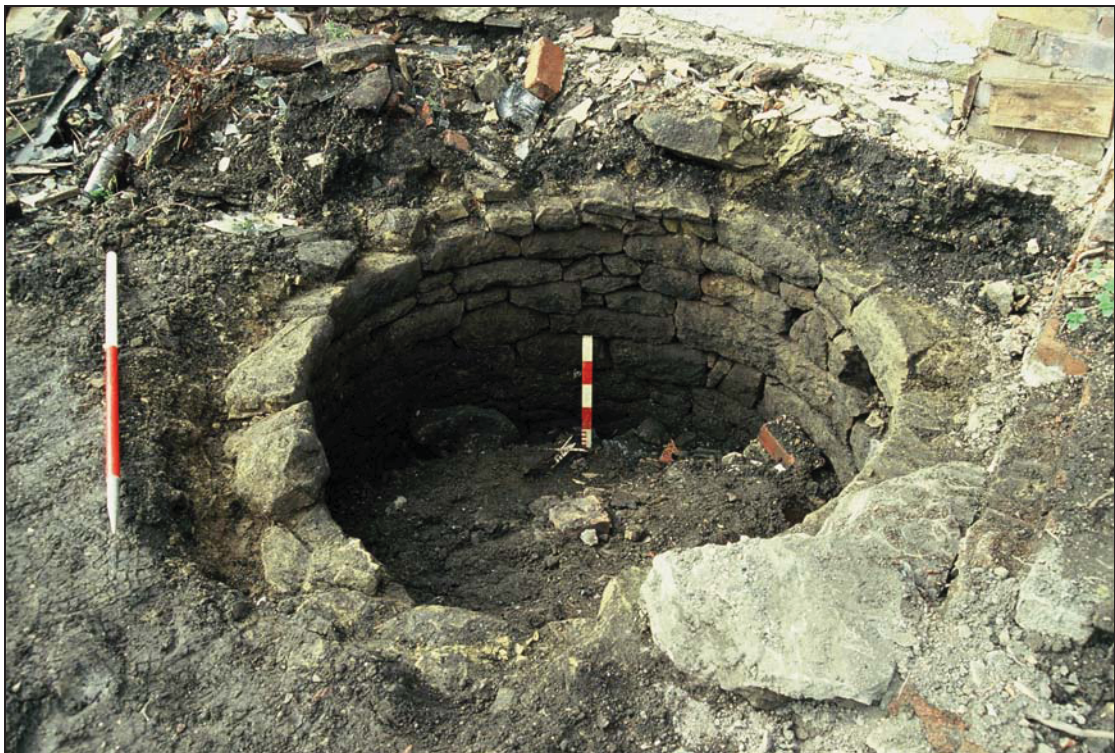
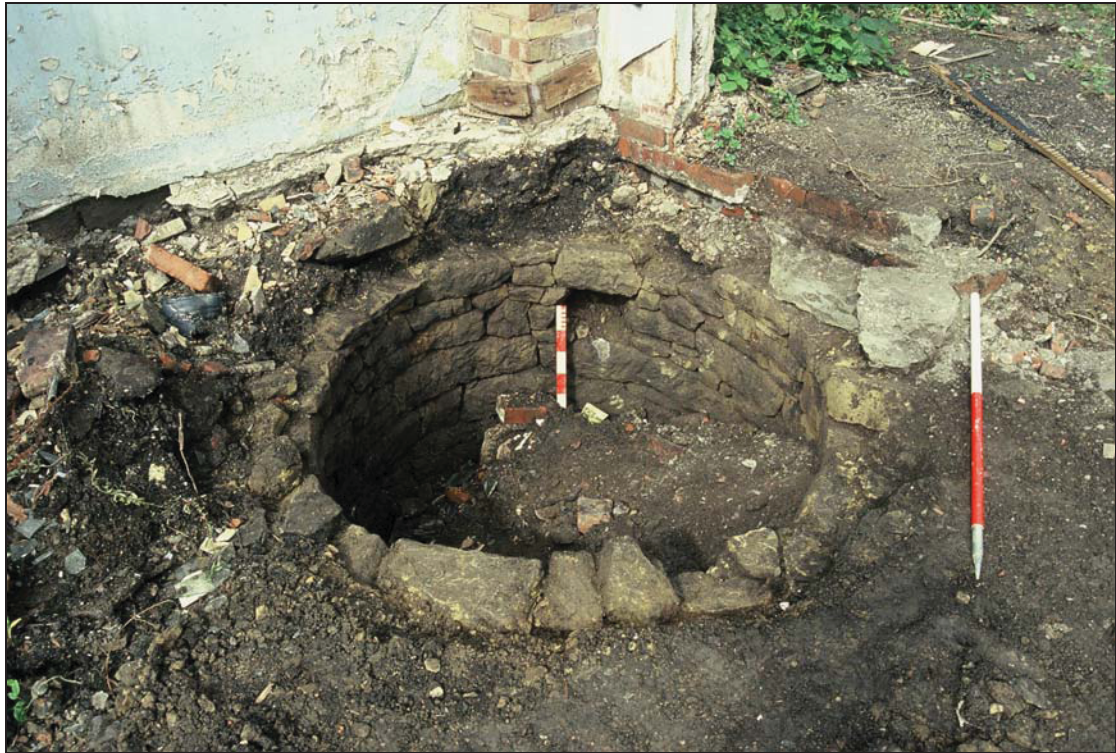
A stone-lined well [505] was exposed by the demolition of the red brick workshop abutting the east end of the barn (**plates 15 and 16**). This well was recorded (**illustration 10**) and assessed with an auger to a depth of 3.1m at which point a consistently solid surface was encountered. The fill of the well [506] comprised mostly modern rubble backfill, although the basal 0.4m of fill consisted of fine grey silt which evolved a strong odour of hydrocarbons on excavation. The well was interpreted as a feature that may be contemporary with the original structures, although later and modern use of the well entailed the inclusion of pollutants which have rendered further analysis impossible. Given the inclusion of modern rubble with the backfill [506], it is highly likely that the augered deposits are representative of the latest use of the well as a drain or soak-away.

Plate 16: Well [505], southwest facing.

Plate 17: Well [505], northwest facing.
