# The former Monk Bridge Iron Works, Leeds, West Yorkshire

## Archaeological Assessment Report

**Report 971b.2(4) © ARCUS 2008**

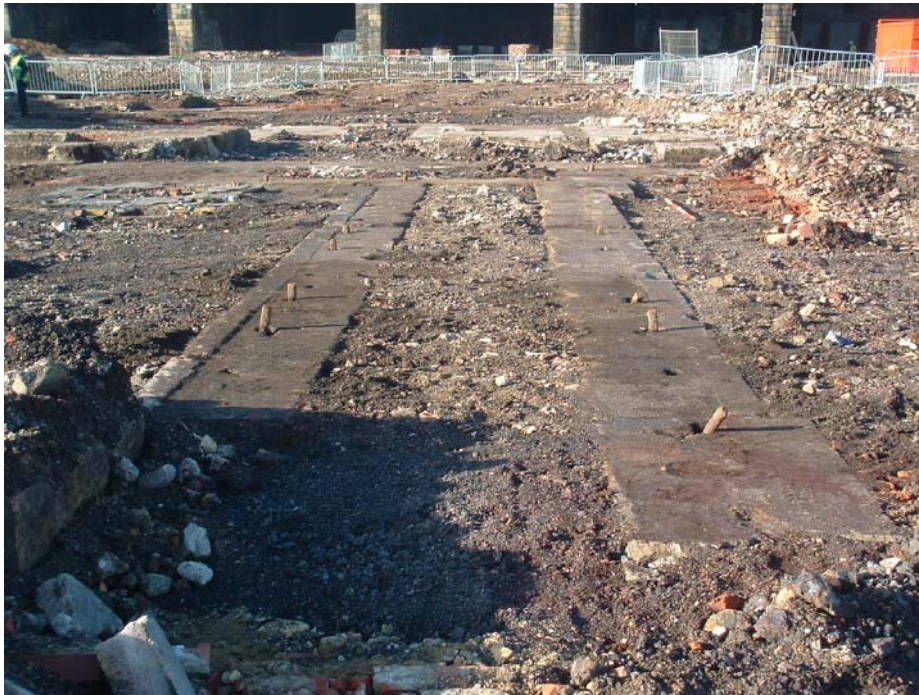
**Plate 1:** Facing site N, showing engine mounting [6099] exposed during the strip and record on Area 3. This mounting was located almost centrally within Building E1 and may well have had three separate machines above it. Note that the large crane base was located in the lower left corner and the open sided engine house from trench B3 was located just to the northeast of the scale.

Trench A was targeted on an area of small cell-like structures shown on the first detailed 1923 factory plan (**Illustration 4**). The excavation revealed the southern extent of a chain of interlinking cranes and engine mountings [6099] that centred on the middle of the former building. The crane bases in Trench A were probably functionally connected with the transportation of materials associated with a gas regenerative furnace [6191] (see Strip and Record below **Section 5.2.5**), the brick trough/celled features found in Trench A and a very large engine or machine mounting [6099] found in the Strip and Record Area 3 (**Plate 1**).

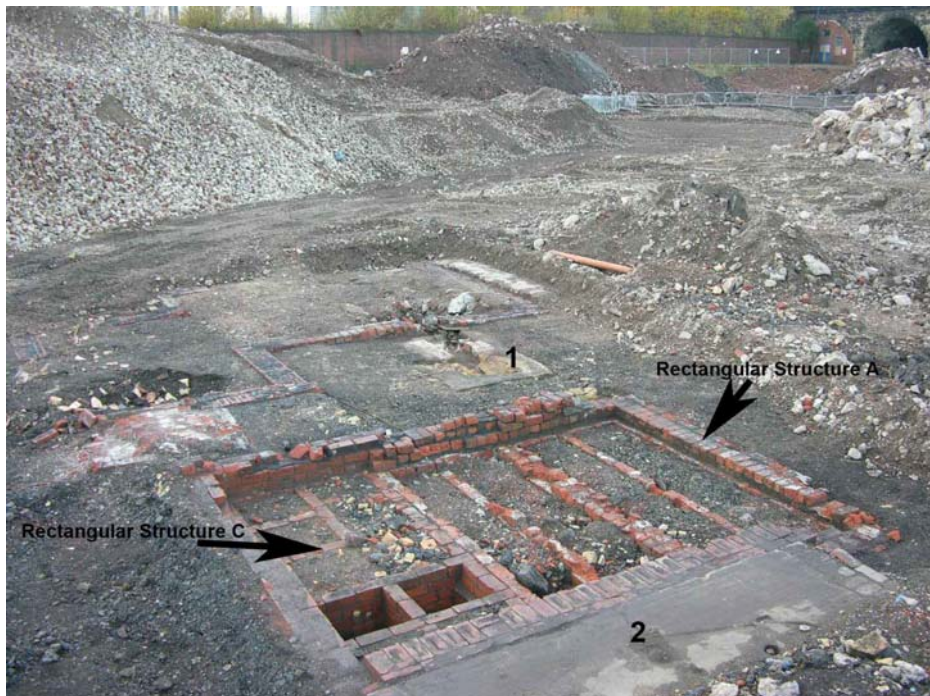
**Plate 2:** Trench A, facing site WNW. Showing the partially excavated U-Shaped building. Note the earlier long rectangular troughs (A) of phase 1 with the overlying phase 3 brick 'cells' (C) to the left foreground. Note the locations of the small crane base (1) and the large crane base (2).

Trench A (**Illustration 7, Plate 2**) was located within the southern end of former RPS Building E1, located to the north of the office and ancillary ranges fronting Whitehall Road (**Illustration 3**). Its purpose was to investigate a U-shaped cellular structure shown on the 1923 factory plan, proposed as the upper part of a possible crucible furnace by Fitzgerald (2004). On excavation the initial interpretation of the cells was found to be erroneous. The structure, however, remains enigmatic and the results of the excavation are listed below.

The first phase of activity was represented by a large block of sandstone 1036 measuring 1.3m square and its sandstone foundation 1127. A slight squared recess of 0.6m x 0.45m and a small fixing bolt suggest its use as some form of machine mounting. Its location precisely overlay a crane base shown on the 1923 historic map. The crane had a reach arc of around 5.25m which encompassed the locations of structures A and B (see below) and possibly the southern end of a exceptionally large sandstone engine or machine base 6149 uncovered to the north west during the strip and record exercise (**Illustrations 4, 7 and Plate 2**).

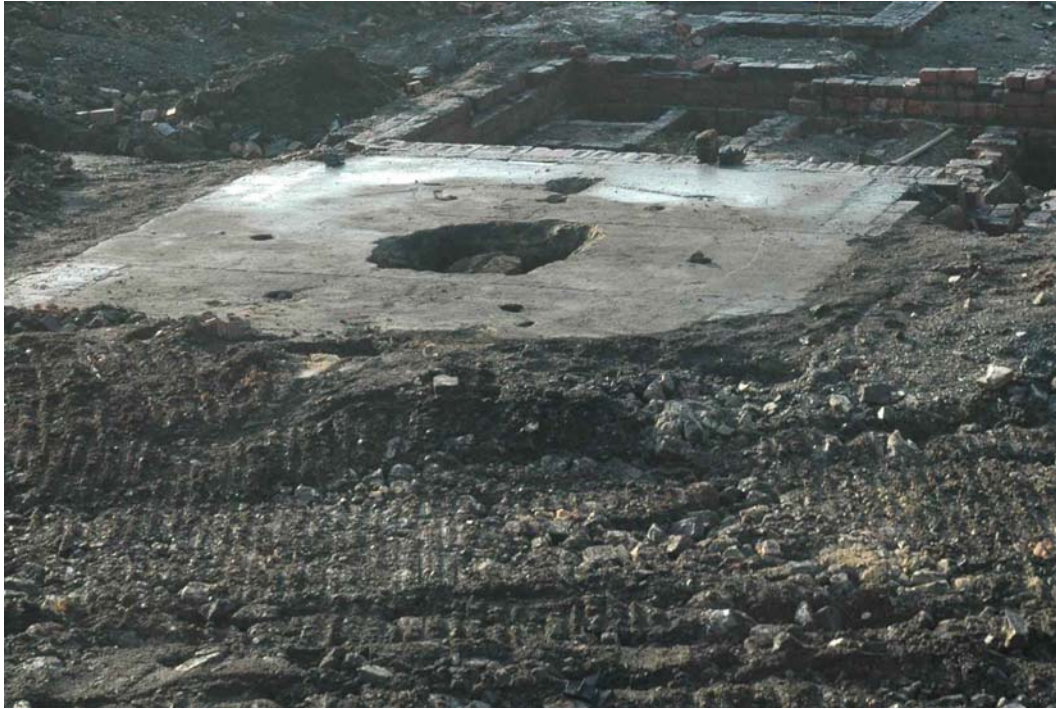
**Plate 3:** Facing site WSW, showing the large crane base in Trench A. Note the circular groove and fixing bolts.

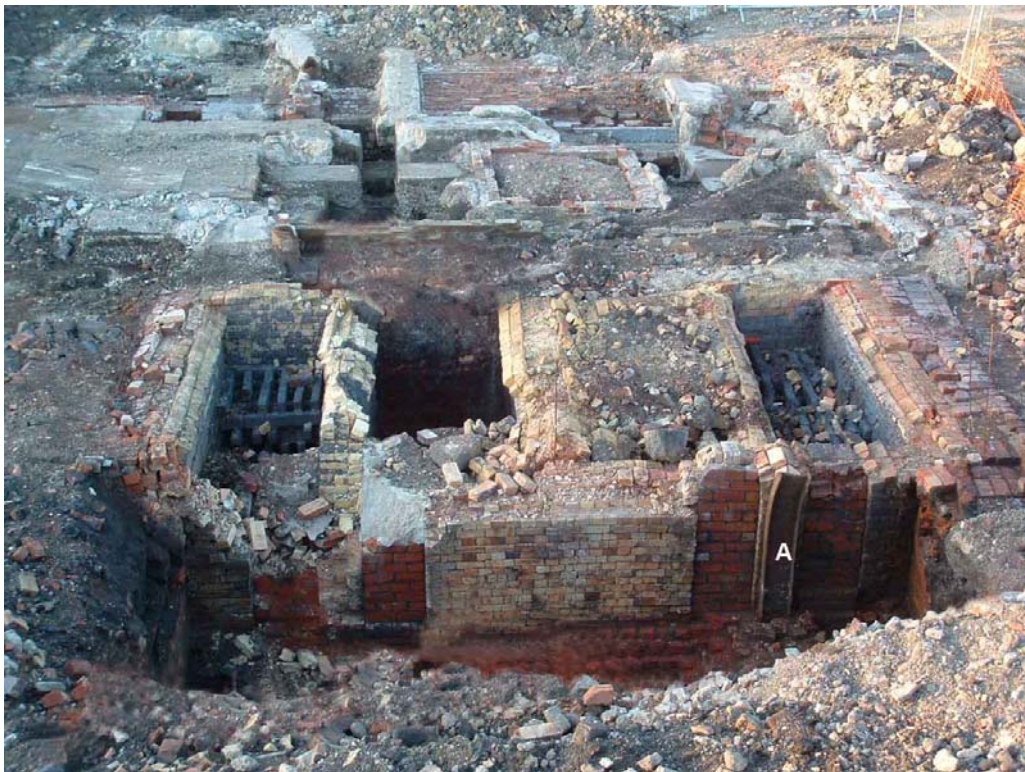
**Plate 4:** Facing site N. Showing the gas regenerative furnace in trench B3 after excavation. Note the four chambers. The two outer 'hot air' chambers were narrower and showed a higher degree of vitrification than those of the 'cold air' chambers in the middle. The in/out-let flue cellar was located in front of the furnace and the engine room was located immediately beyond. Note the structural support girder (A).

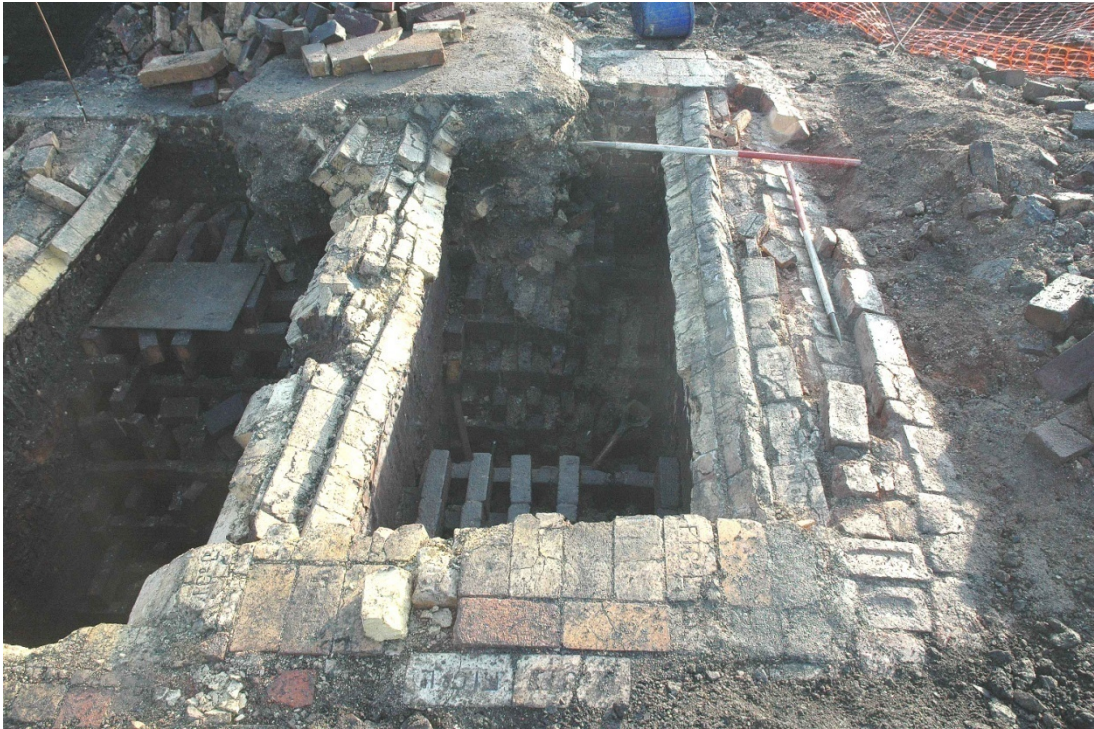
**Plate 5:** Facing site S. Showing the lattice or 'checkerboard' bricks within the western cold and hot air chambers.

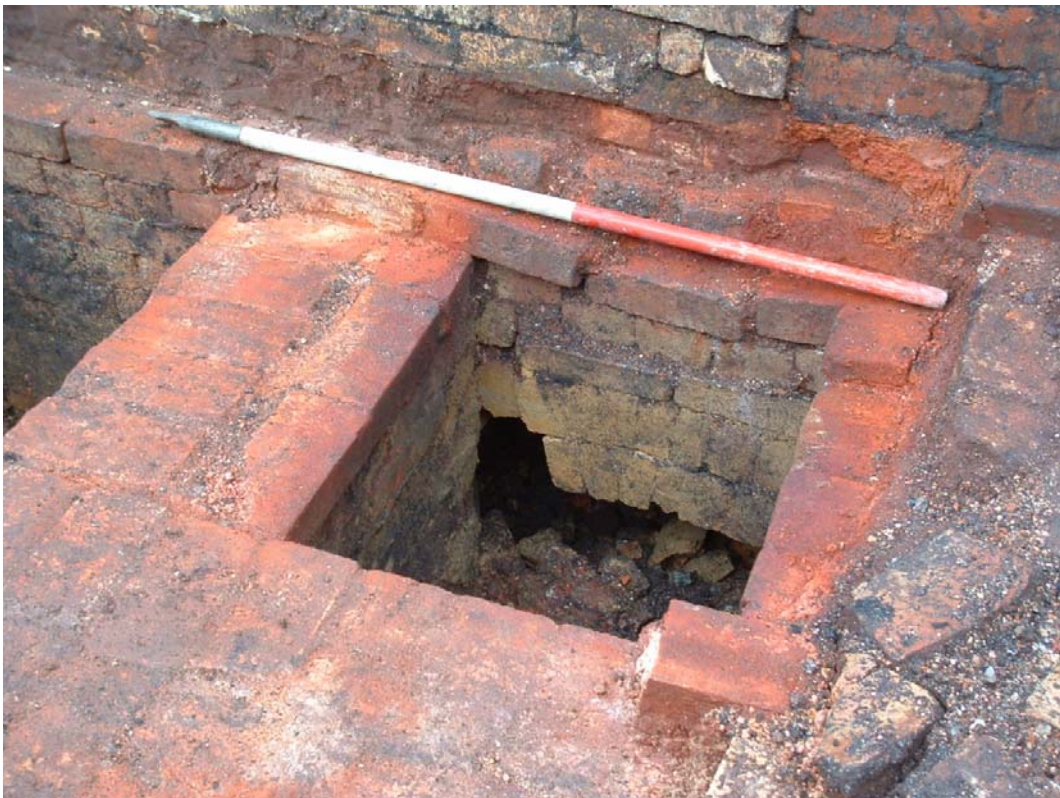
**Plate 6:** Facing site NW. Showing one of the flue voids entering the gas regenerator's eastern cold air chamber from the flue cellar. Note the arch built into the fabric of the connecting wall.

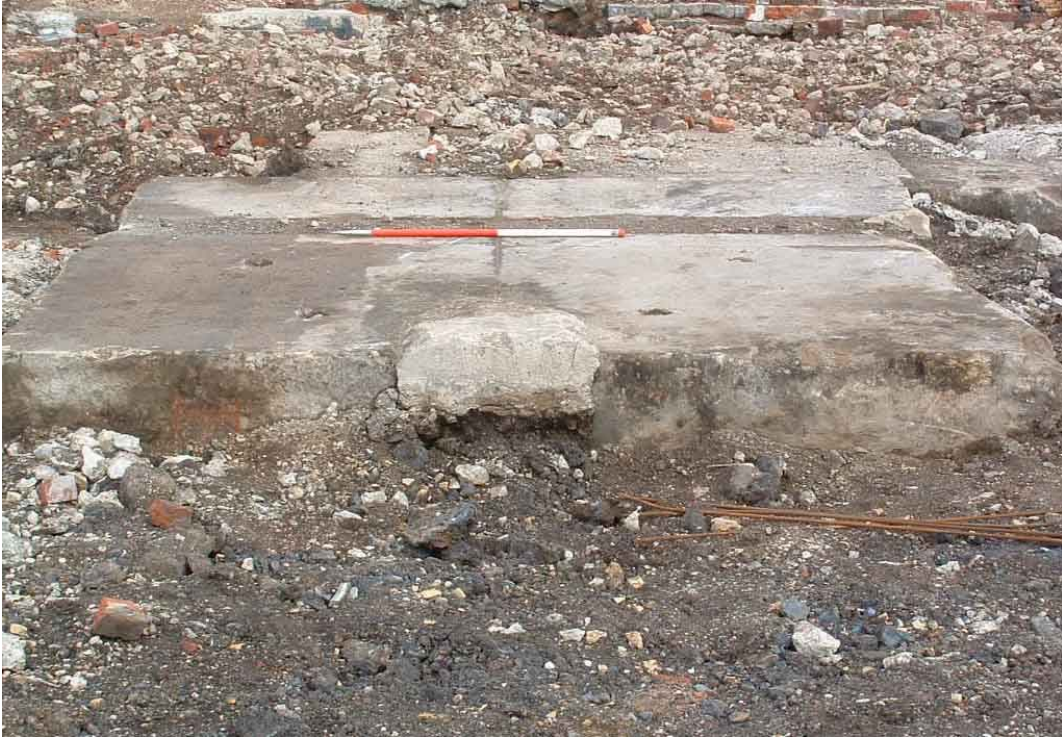
**Plate 7:** Facing site E. Showing the engine mounting 6105 with trapezoidal fixing bolts. Uncovered as part of strip and record Area 3, Trench B3 (behind) was backfilled for safety purposes.

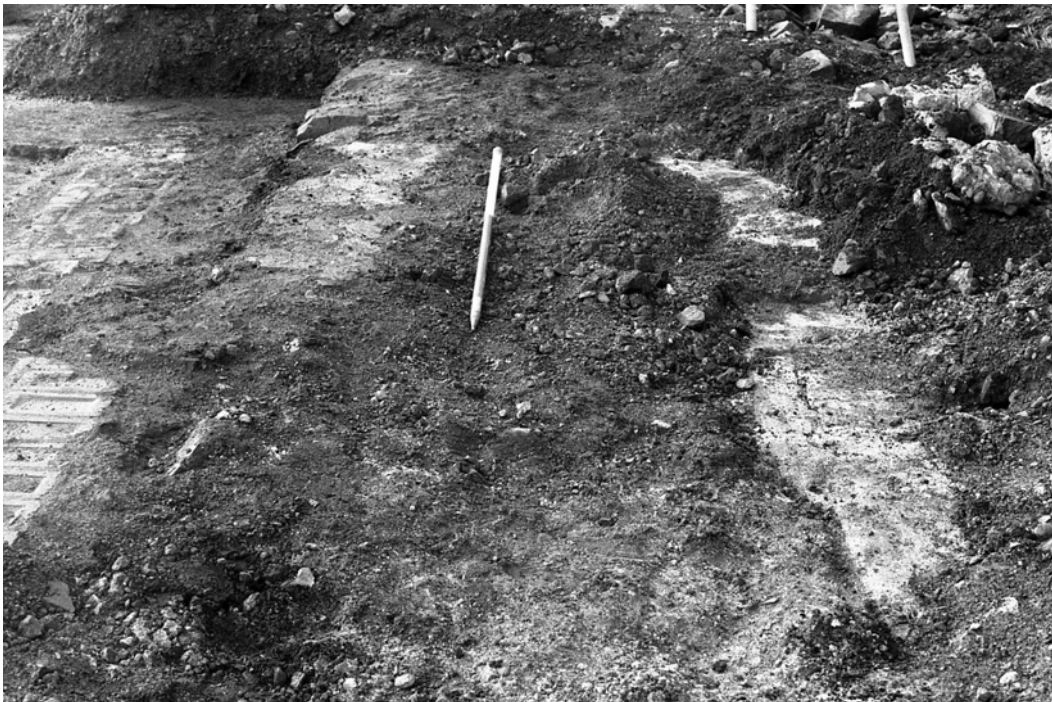
**Plate 8:** Facing site W. Showing the probable puddling furnace base 6179/6124/6179. Note the narrowing of the brick walling at the top of the photograph indicating the neck or exhaust end of the structure. Note also the slag lumps at the exhaust end of the structure.

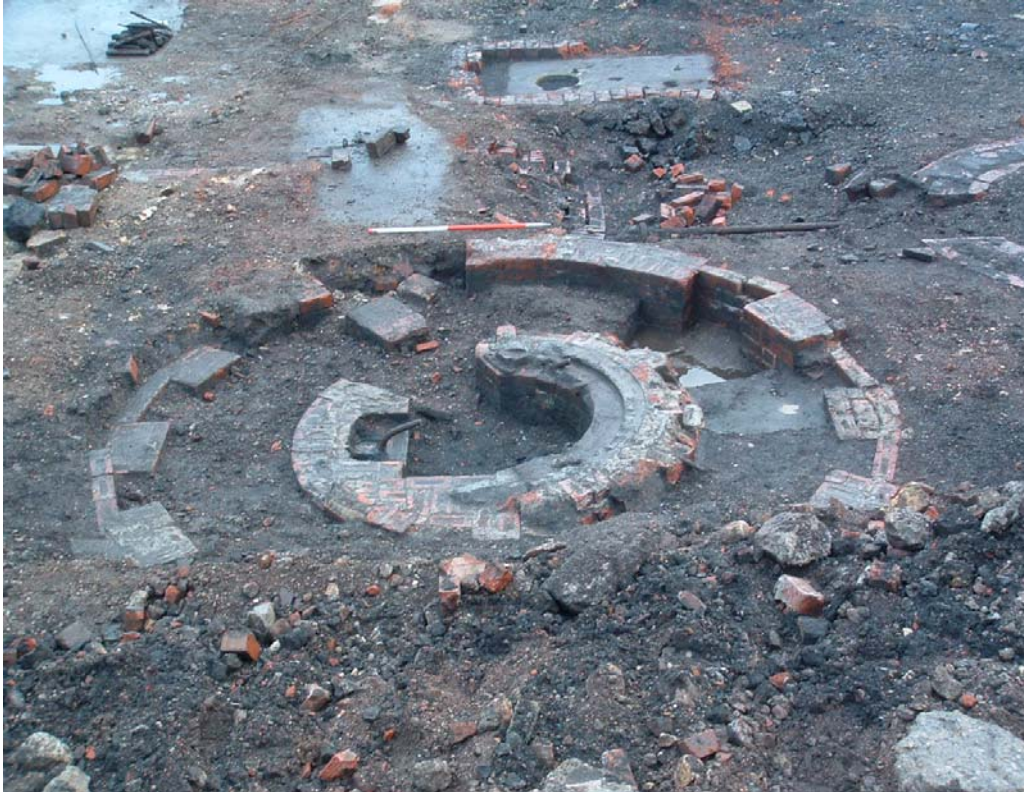
**Plate 9:** Facing site E. Showing the possible tyre blocking press to south of trench B1.

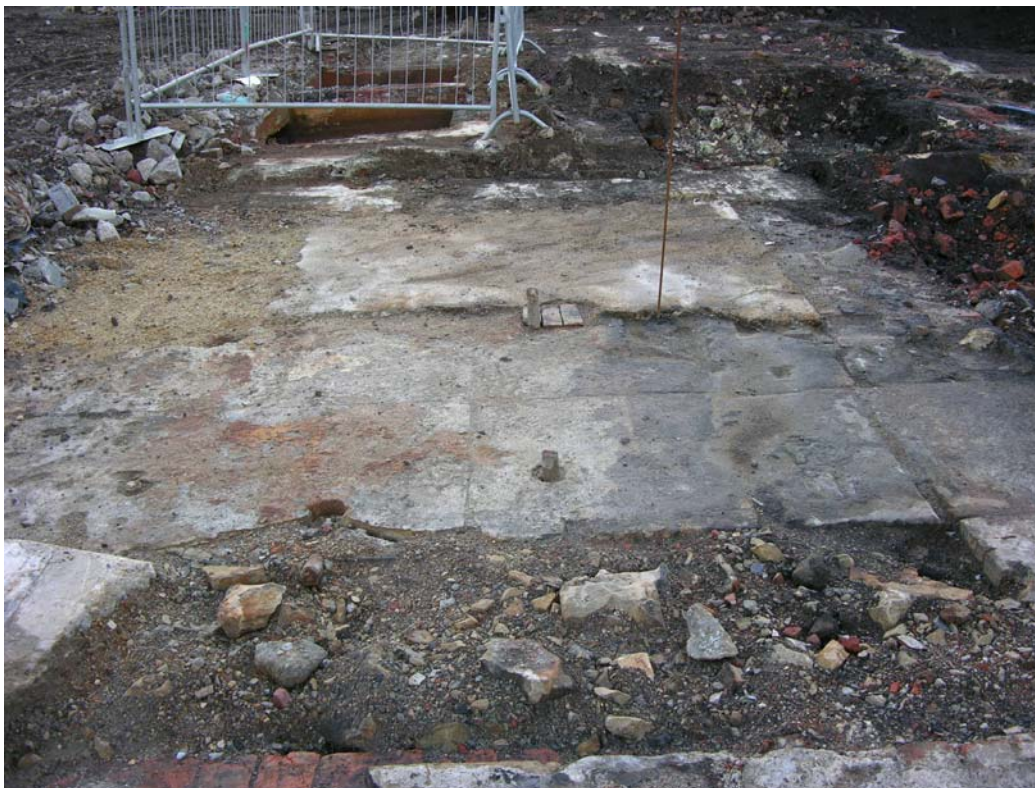
**Plate 10:** Facing site W. Showing the engine base and wheel pit (front) in Trench C. Note the four fixing bolts embedded in the sandstone blocks.

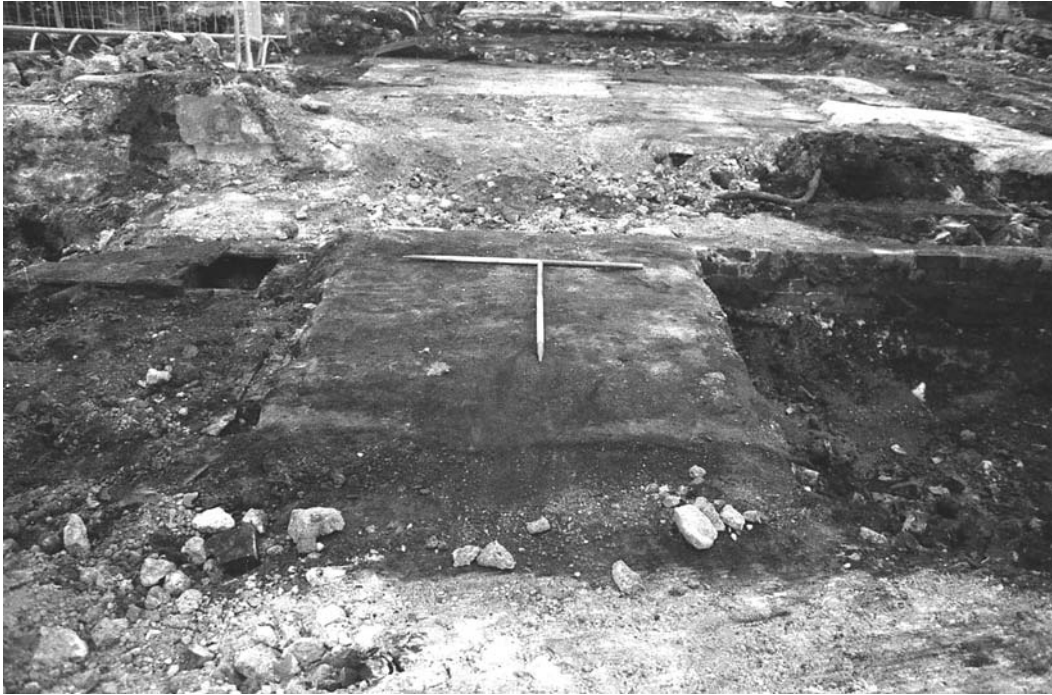
**Plate 11:** Facing site N. Showing the western support block 6023 of the hammer base uncovered in Strip and Record Area 1b.

south of the engine house in Trench C – **Plates 11 and 12**) and a continuation of massive engine mountings 6031, 6021 6020, 6035 and 6036 (**Plate 13**) which are likely to represent the foundations of a series of rolling stands and a rolling engine uncovered in Trench C (3006-3015) were also revealed. Other features of note were a gas regenerative furnace, sandstone machine bases 6015-6020 (**Plate 14**) and 6040-6043, two chimneys 6037 and 6070 (**Plate 15**) and a large a crane base (**Plate 16**) with a radial arc of 3.6m 6068 (see **Illustration 14**) These, and later features noted, such as a series of large concrete foundations 6062, 6063, 6073 and 6071 (A-D on **Plate 17**), will be worth exploring more fully, with reference to extant factory plans and the results of the standing building survey (Jessop and Douglas, forthcoming).

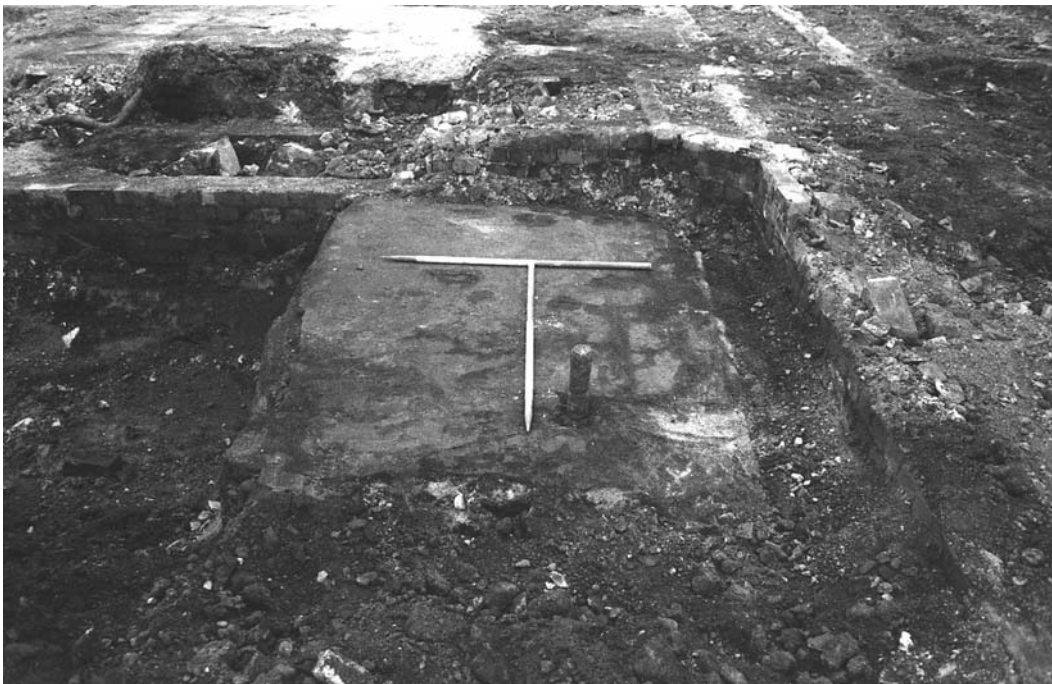
**Plate 12:** Facing site N. Showing the eastern support block 6024 of the hammer base uncovered in Strip and Record Area 1b.

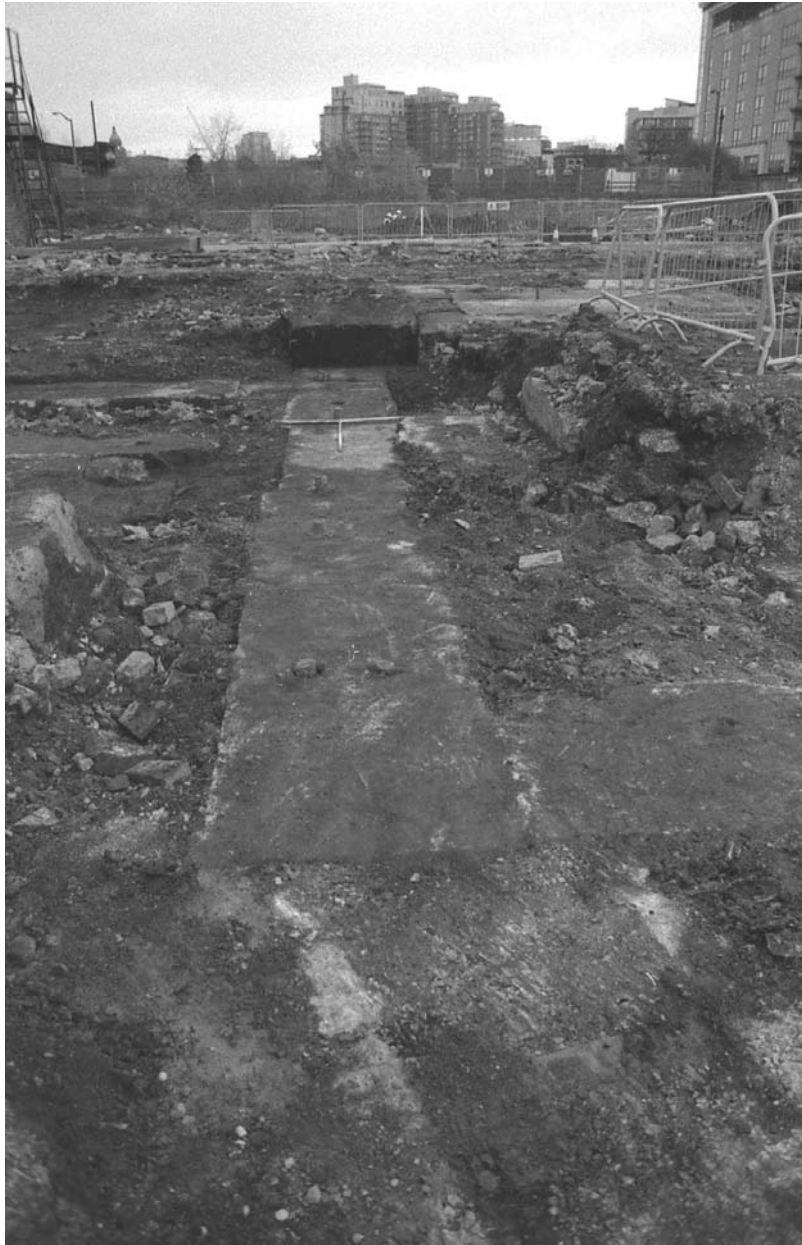
**Plate 13:** Facing site E. Showing part of the possible rolling mill stand 6020/6035 looking towards Trench C. This structure was uncovered in Strip and Record Area 1b and was linked to the bases uncovered in Trench C.

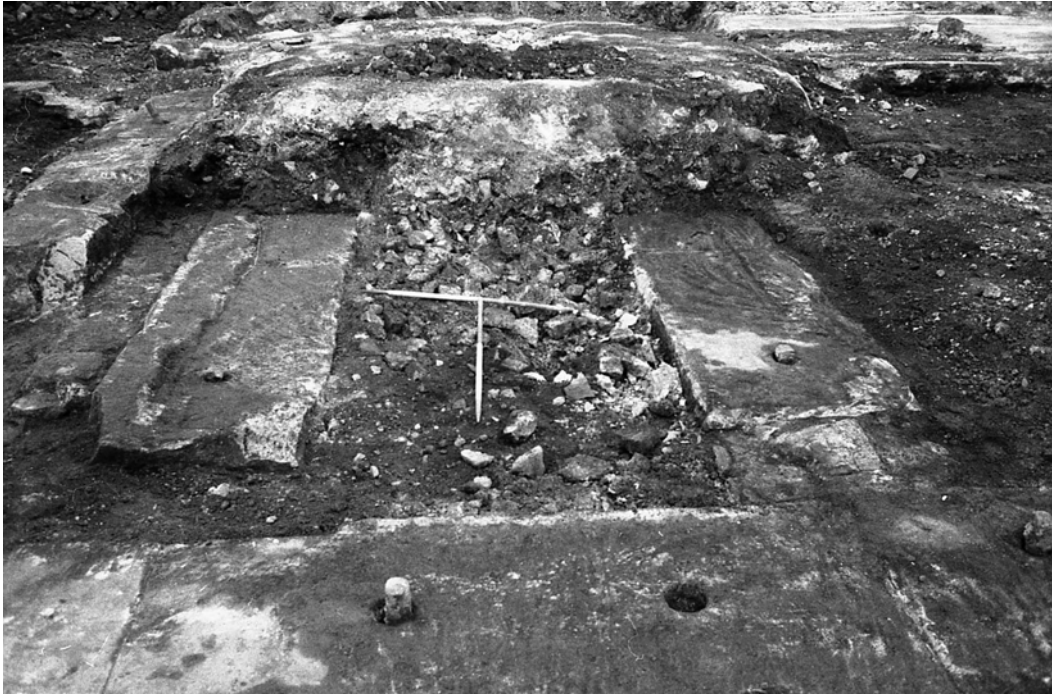
**Plate 14:** Facing site N. Showing bases 6018/6019 recovered in Strip and Record Area 1b.

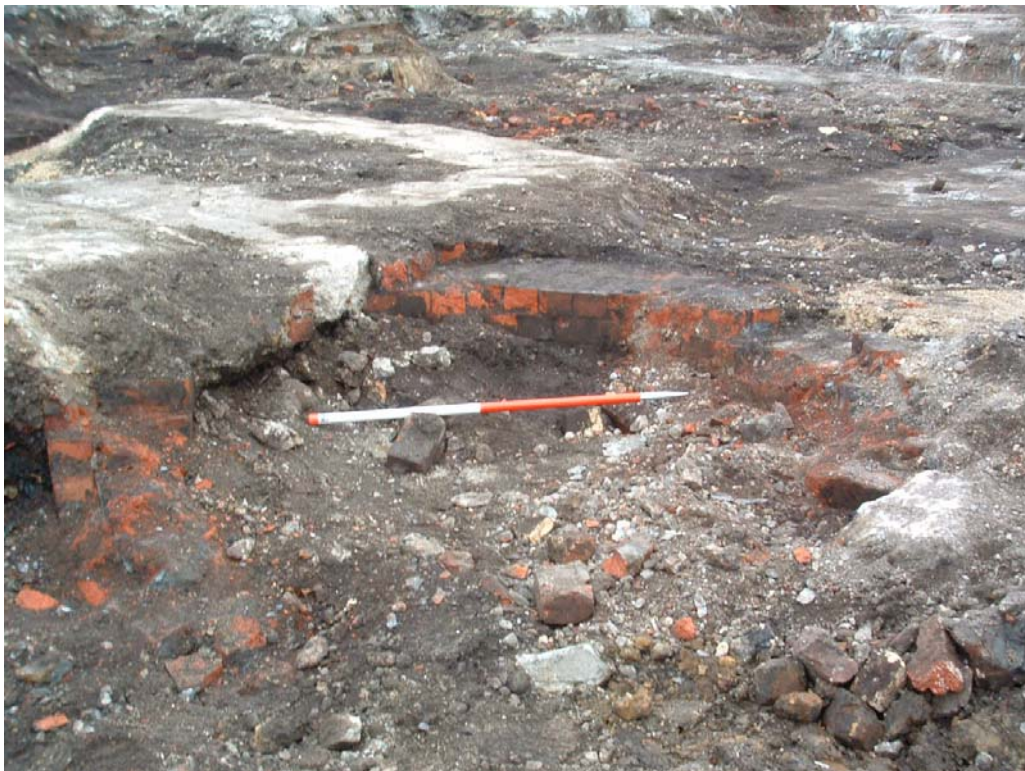
**Plate 15:** Facing site NW. Showing the chimney base 6070 uncovered during the Strip and Record Area 1b

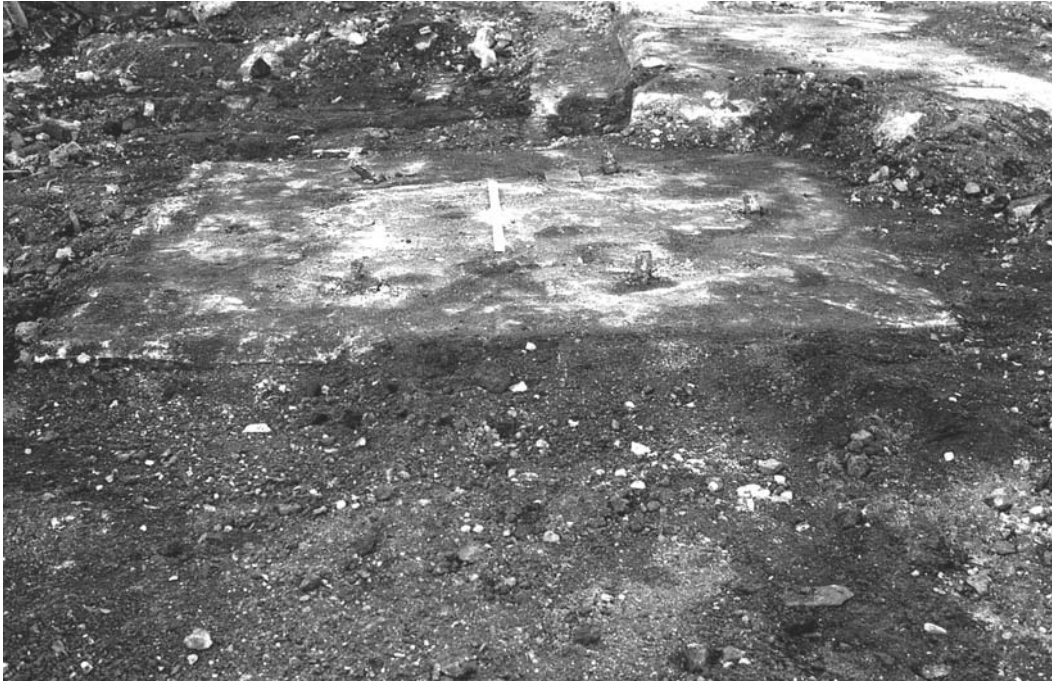
**Plate 16:** Facing site E. Showing crane base 6068 which was uncovered on the Strip and Record Area 2b. Note the circular fixing bolts and the grooved indentation on the right side of the sandstone blocks.

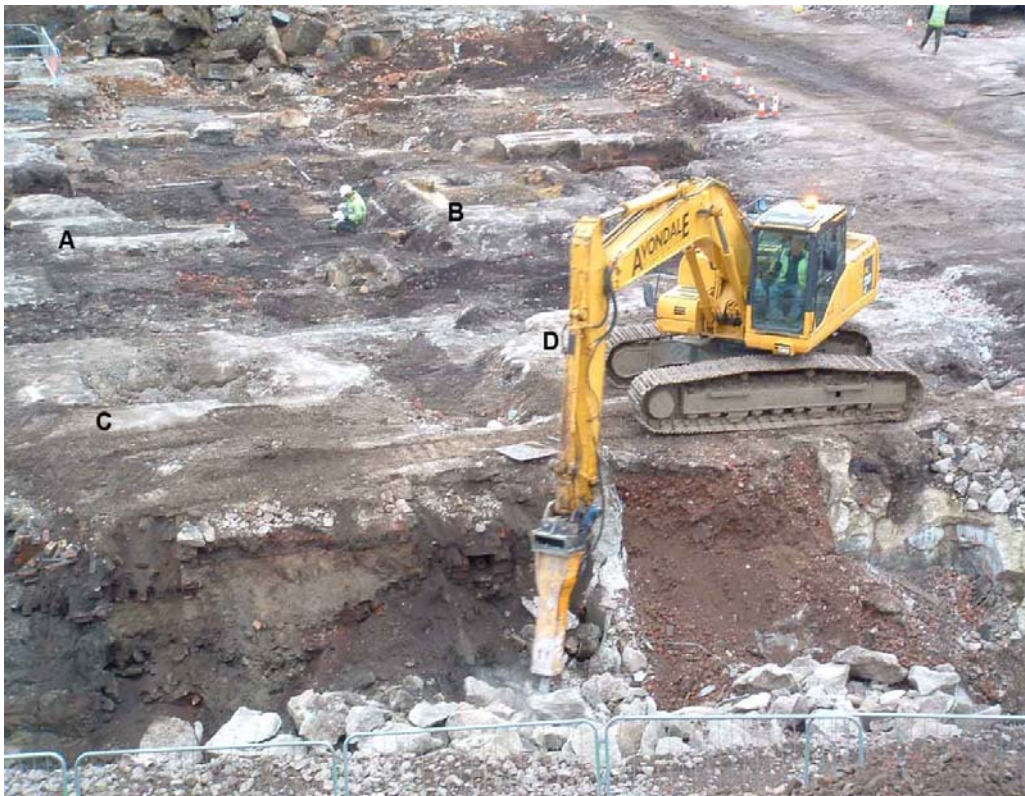
**Plate 17:** Facing site SSW. Showing the large modern tanks (A – D) possibly associated with the Doncasters factory on strip & record Area 2. Note that the features were being recorded whilst ground reduction was taking place.

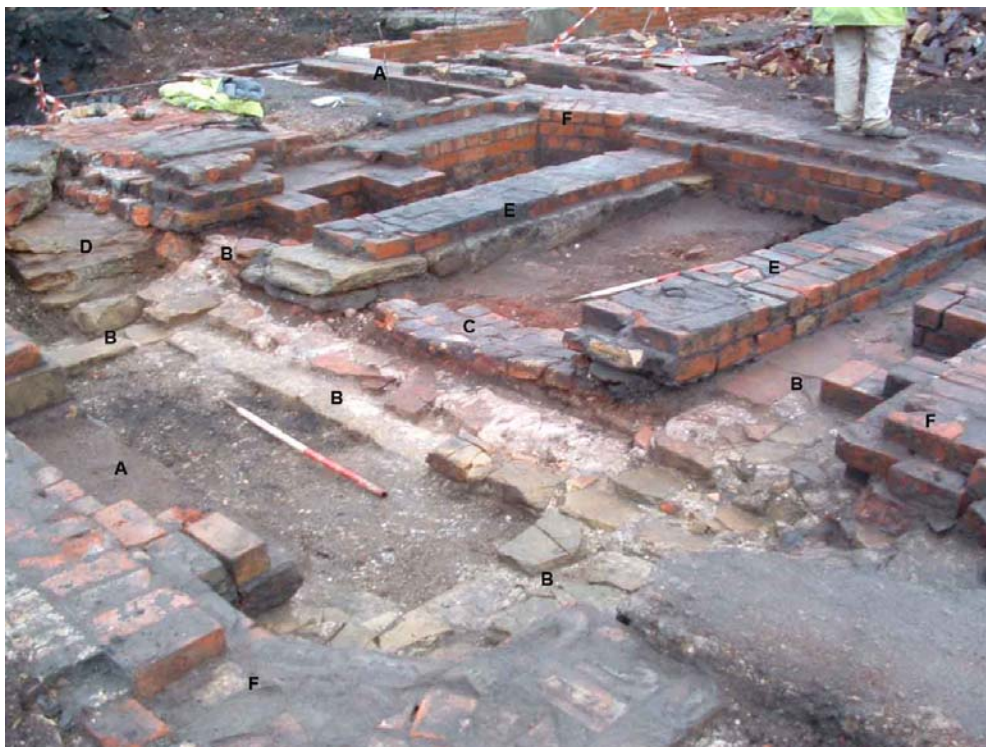
**Plate 18:** Facing site SE. Showing the cross struts (B) between the large stone walls (A) forming a possible early boiler base. The heavy heat damage is noticeable as pink discolouration and was also evident on the brick furnace floor (C). Note also the north western corner of Chimney III (D) and the phase 3 boiler base (F) with the boiler support cross struts (E).

The earliest features on Site were four substantial sandstone wall foundations, numbered 1 to 4, with red handmade brick upper walling bonded by a white lime mortar with charcoal inclusions (**Illustration 16** and **Plate 18**) (NB: walls 1 and 2 had been truncated at their western extents). The wall foundations 3 and 4 measured some 9.5m long x 0.5m wide x 1.9m in depth and essentially formed two parallel foundations with a gap between them of 3.5 metres. These walls coincide with the known positions of the north wall of the south range of puddling sheds and the south wall of the north range of puddling sheds.

Between walls 3 and 4, just to the west of chimney III, walls 3 and 4 were also connected by two transverse sandstone foundations, which were connected in turn by a pair of longitudinal sandstone foundations (**Illustration 16 and Plate 18**). The voids between the foundations were backfilled as part of the first phase made ground. The backfill was then overlaid by a flat brick floor 4373. The upper surfaces of the sandstone foundations, around the brick floor and the floor itself, showed considerable heat damage and discolouring suggesting that whatever structure was located here may have housed some form of furnace or a heat-exchanger that may have been connected above ground to the chimney to its east. No evidence of a similar furnace was evident between walls 1 and 2, although the western portion of these walls had been heavily truncated later by a massive concrete ramp and wall structure 4021-4023 and 4105-4116 (see Phase 4 below) just to the west of chimney I.

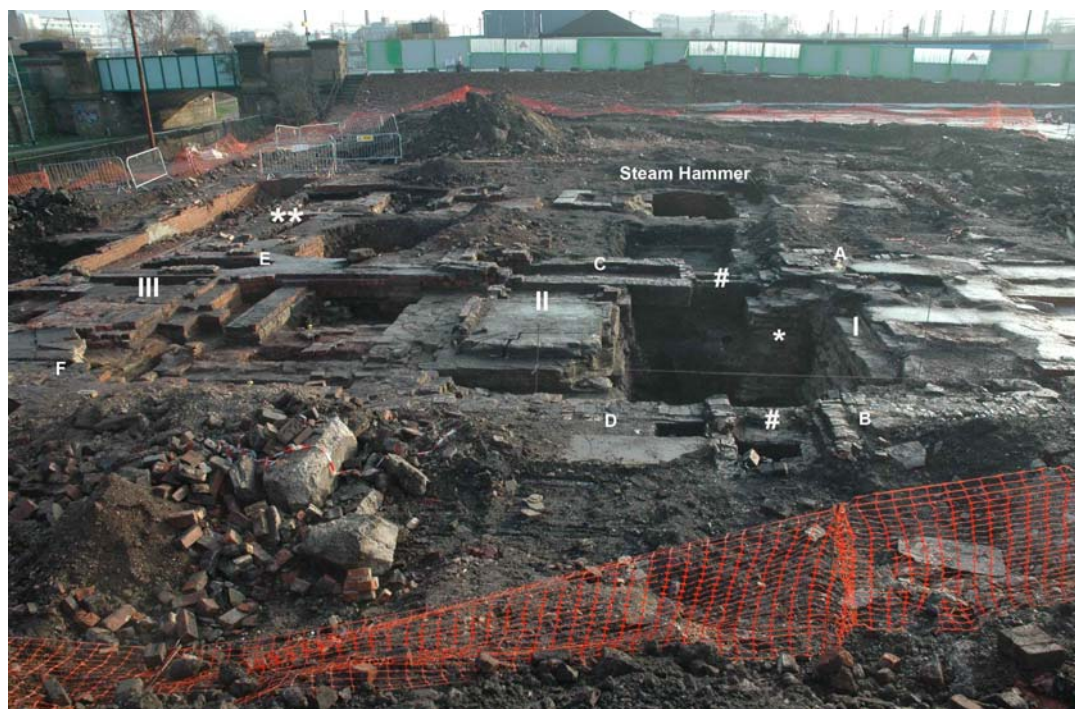
**Plate 19:** Facing site S, showing the location of the phase 3 puddling bases (A-F) either side of chimneys I-III. Note the locations of 1<sup>st</sup> phase wall 1 (\*), the 2<sup>nd</sup> phase gas regenerative furnaces (\*\*), the puddle drains (#) and the steam hammer base.

Linking the pairs of the walls were the foundations of two large chimney stacks (**I and III – Illustration 16 and Plate 19**), each consisting of a large stepped foundations of sandstone (I: 4419 between walls 1 and 2; III: 4067=4068 between walls 3 and 4). These measured around 3.5m square at the base and both went to a depth of c. 1.7 metres below ground level (**Plate 20**). On the top of each chimney foundation were rectangular brick chimney floors (I: 4150; III: 4072, 4073, 4074). Exhaust entry into the chimney must have been above ground level as no evidence for entry flues was noted.

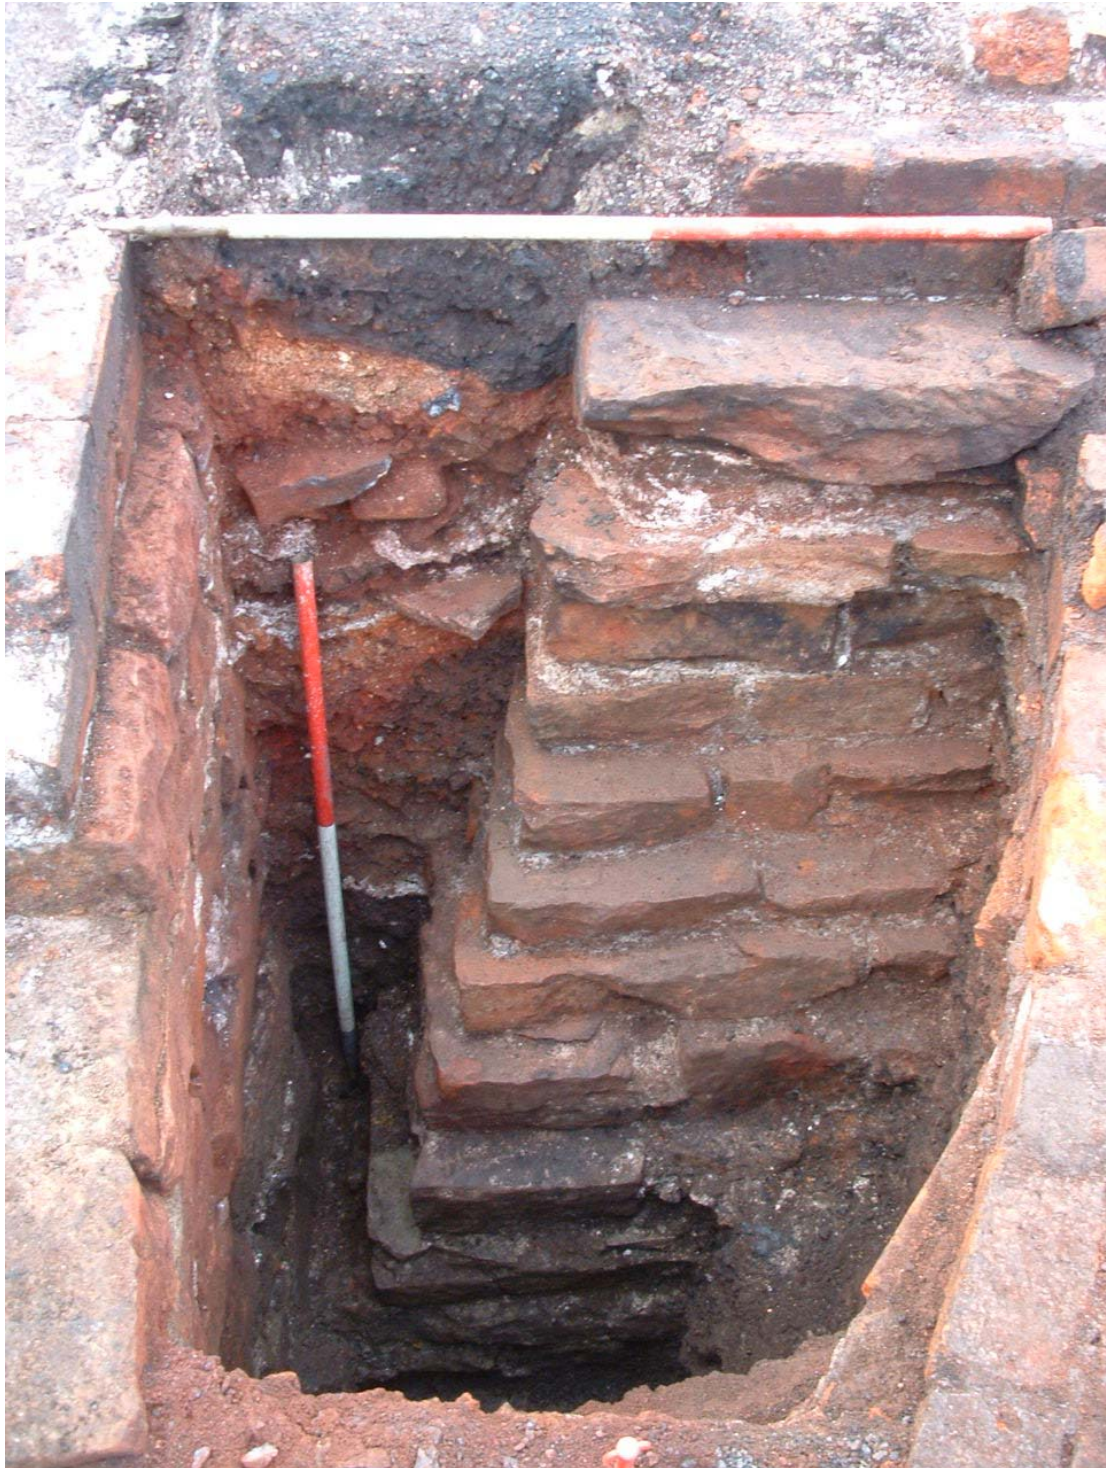
**Plate 20:** Facing site W. Showing the south eastern corner of the pyramidal sandstone foundations of Chimney III. Note the sandstone foundations at the eastern end of the first phase wall 4 (4191) to the left of the photograph. Note also the heat affected nature of the construction backfill between the two structures which indicates their contemporaneity.

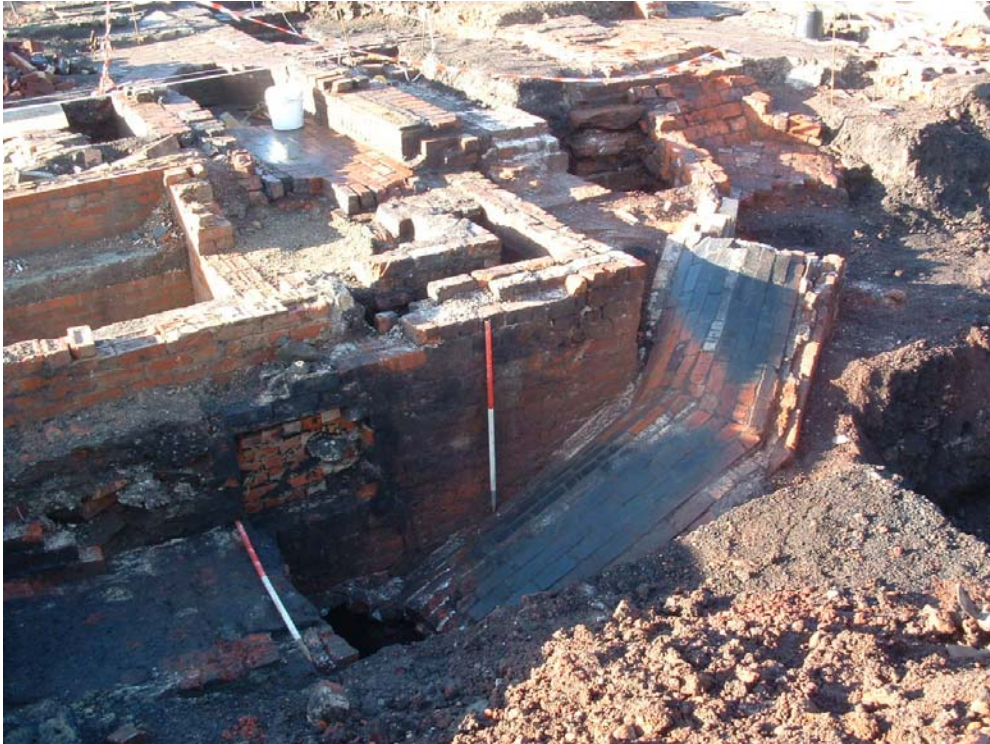
**Plate 21:** Facing site WNW. Showing culvert south extending from chimney III (top right) to the coal cellar and doorway to possible flue cellar (bottom left). Note modern building 4241 (left centre) and the Alpha regenerative furnace above this.

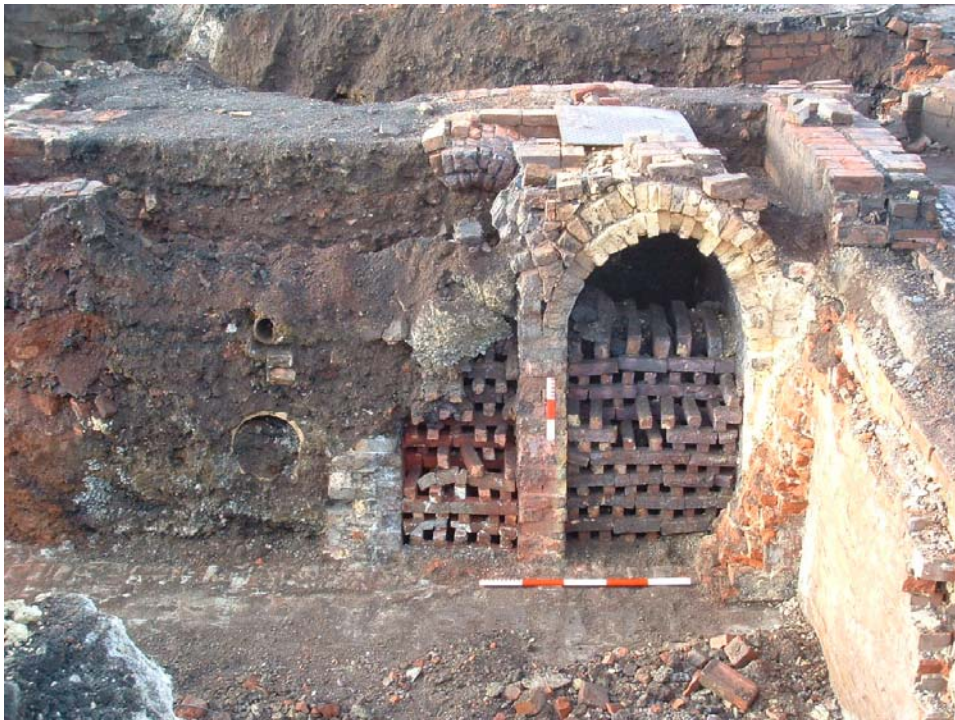
**Plate 22:** Facing site W. Showing a profile through the Alpha gas regenerative furnace. Note the brick arch extending to the right of the photograph suggesting further chambers to the north. Note also the difference in the widths of the hot air chamber to the left and the cold air chamber to the right.

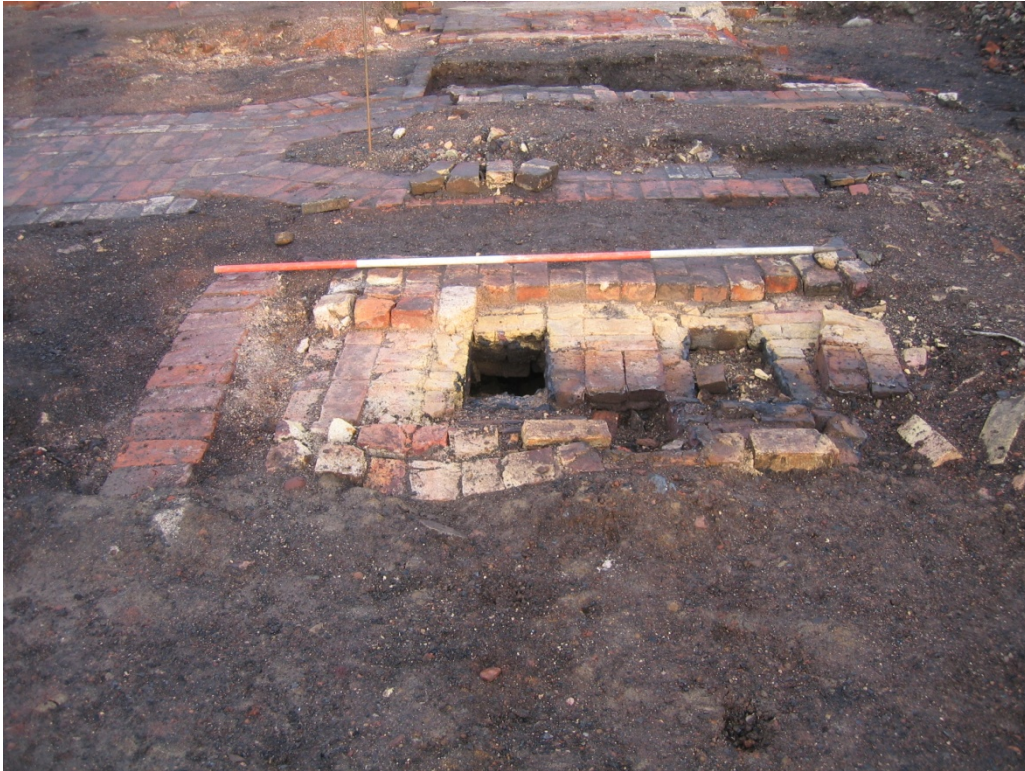
**Plate 23:** Facing site N. Showing the flues in the upper part of gas regenerator Alpha prior to excavation. These flues linked the hot and cold air chambers beneath (see plate 15 above) allowing hot air to circulate around the structure.

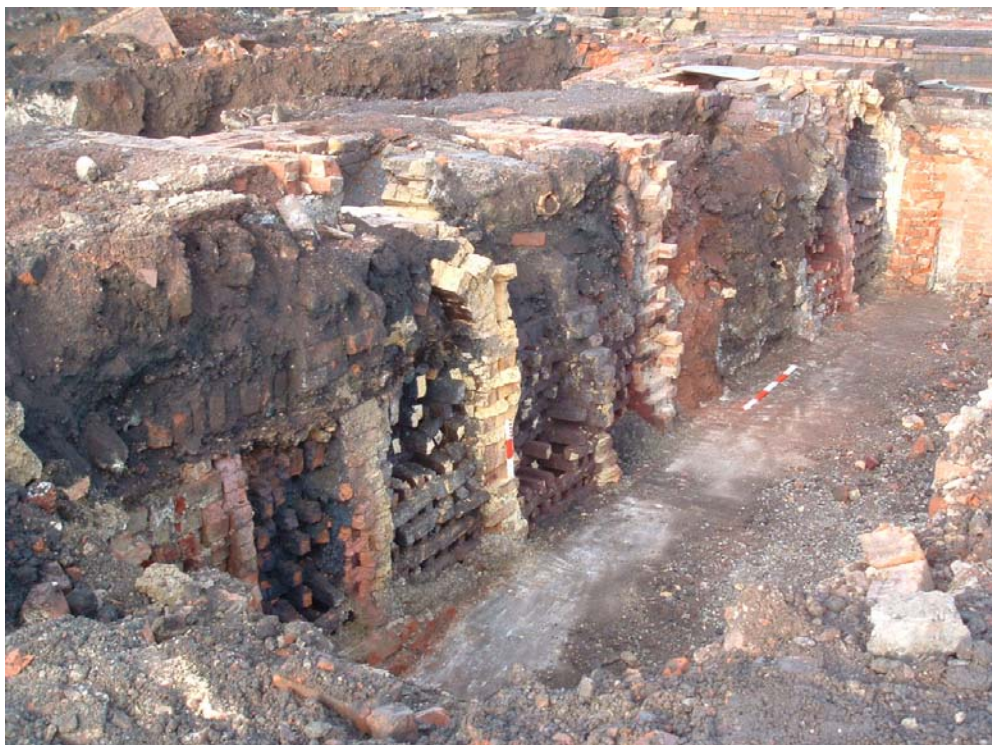
**Plate 24:** Facing site NW. Showing gas regenerative furnace Beta with gas regenerative furnace Alpha to the top right of the picture. Note the large pipe truncation between these two furnaces in line with the floor scale.

Some 2m to the south of the Alpha group was another similar group (**Beta – Plate 24**), which consisted of four regenerative chambers 6045, 6047, 6049, 6051 and 6053. Its two gas and two air chambers were identical to the single examples noted in the Alpha group. All had chequerboard brick interiors 6046, 6048, 6050 and 6052, arched roofs 4124, 4133 and 4267 and inlet / outlet flues 4134 and 4145 rising from the crowns of the arches to surface. Whilst it is uncertain whether there was a cellar at the east end, there clearly was an in-filled, formerly arched-roofed cellar 4126, 4384 and 4375 associated with these chambers abutting their western ends. This cellar contained bricked-up access arches (**Plate 25**), as noted in the regenerative furnace noted in Trench B3.
