# The former Monk Bridge Iron Works, Leeds, West Yorkshire

## Archaeological Assessment Report

**Report 971b.2(4) © ARCUS 2008**

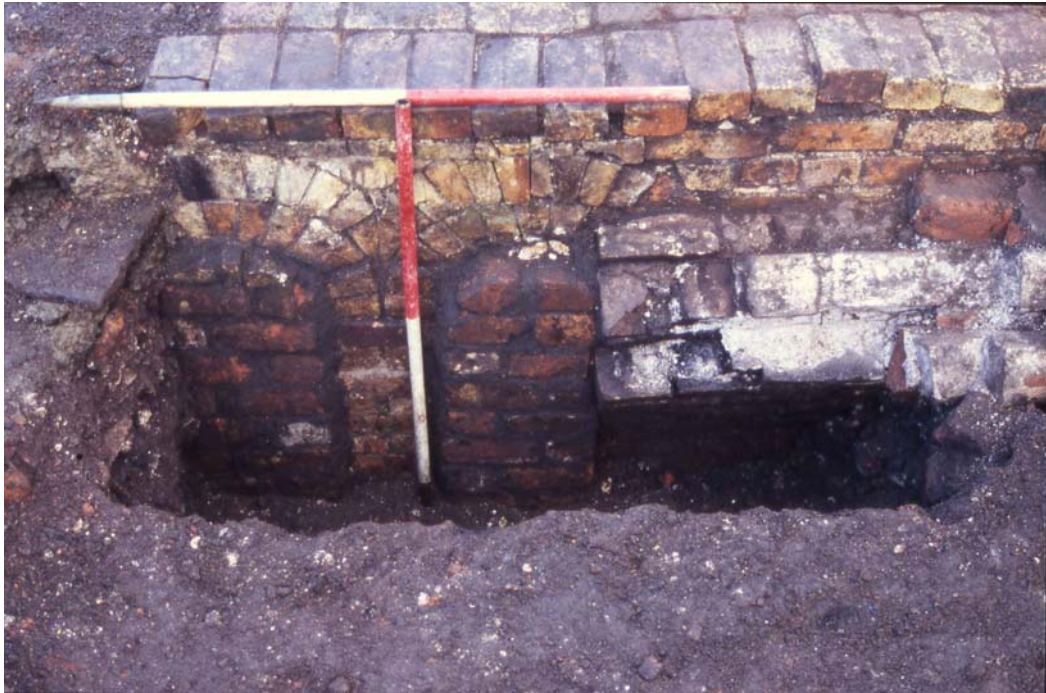
**Plate 25:** Facing site E. Showing the brick blocked access arches from the cellar located at the west of the Beta regenerative furnace.

Some 2m to the south of the Alpha group was another similar group (**Beta – Plate 24**), which consisted of four regenerative chambers 6045, 6047, 6049, 6051 and 6053. Its two gas and two air chambers were identical to the single examples noted in the Alpha group. All had chequerboard brick interiors 6046, 6048, 6050 and 6052, arched roofs 4124, 4133 and 4267 and inlet / outlet flues 4134 and 4145 rising from the crowns of the arches to surface. Whilst it is uncertain whether there was a cellar at the east end, there clearly was an in-filled, formerly arched-roofed cellar 4126, 4384 and 4375 associated with these chambers abutting their western ends. This cellar contained bricked-up access arches (**Plate 25**), as noted in the regenerative furnace noted in Trench B3.

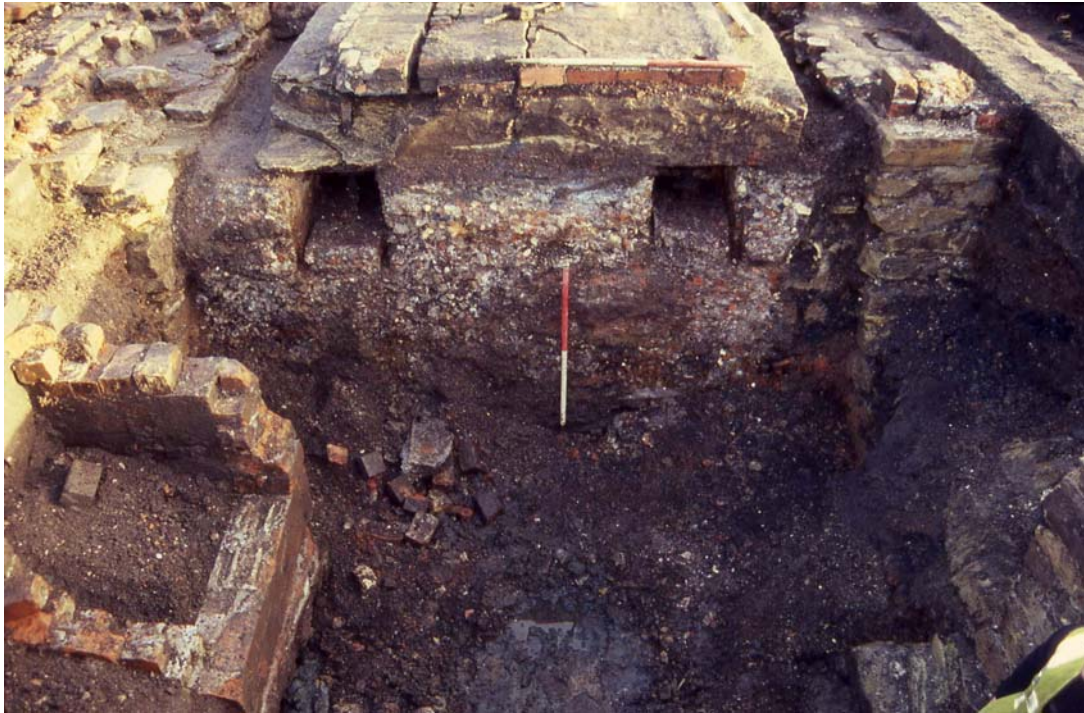
**Plate 27:** Facing site E. Showing the concrete and sandstone of the excavated base of Chimney II. Note the square brick surface on top of the foundations. Note also wall foundations 3 and 4 (to the left and right of respectively) and the manhole relating to the puddling furnace drainage(?) (bottom left).

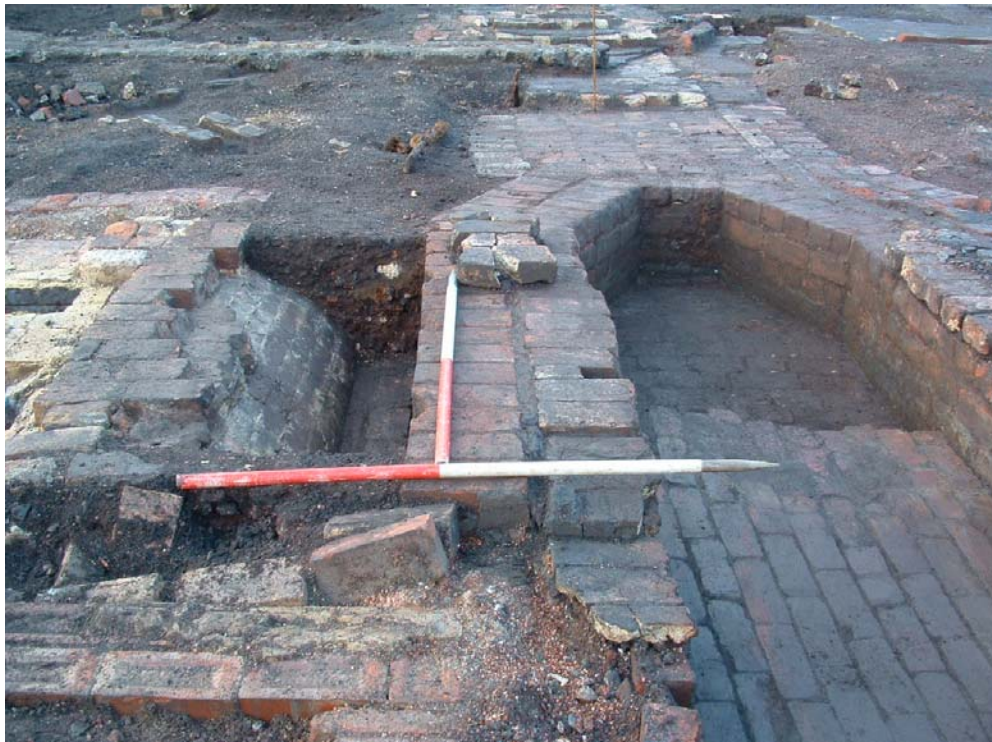
**Plate 28:** Facing site W. Showing the brick wall and stepped flooring of the fully excavated puddling furnace base (F) (right of picture). Note the top of the arch of one of the cold air chambers of the **Alpha** gas regenerative furnace (left of picture) which is truncated by the insertion of this puddling furnace base.

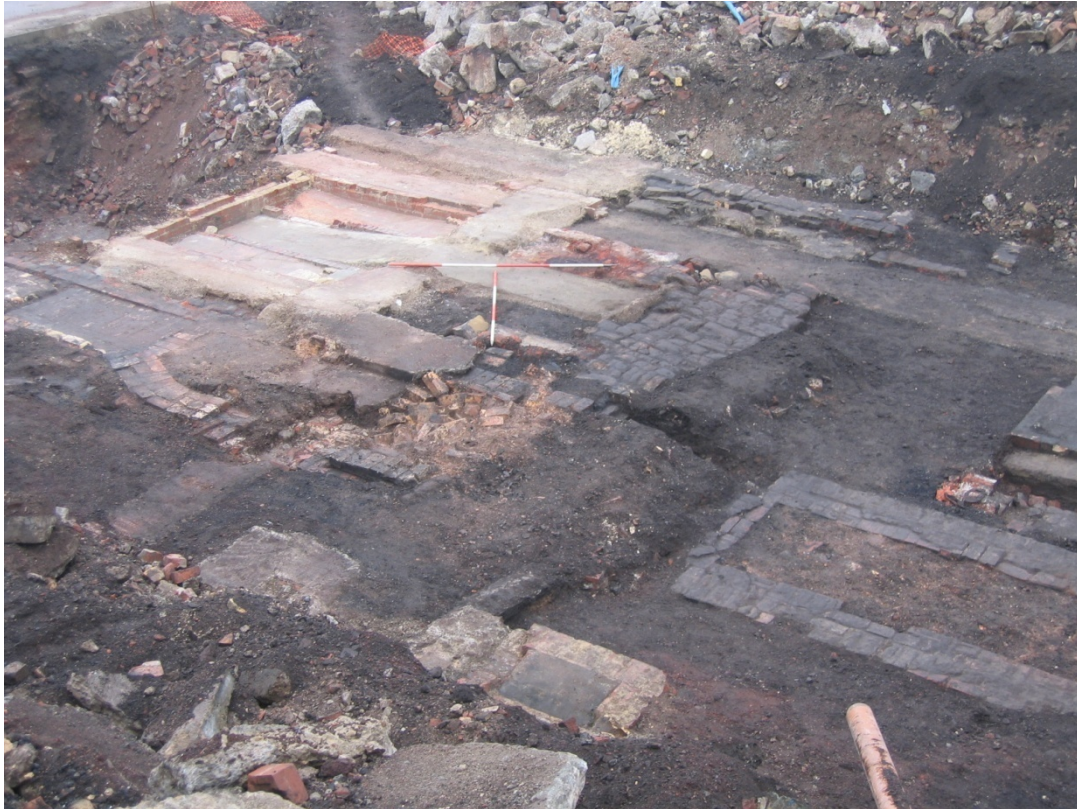
**Plate 29:** Facing site NNW. Showing the modern complex of features at the western edge of Trench D. This structure is probably connected to the later 1950s – 1970s Doncasters building identified by RPS as building H.

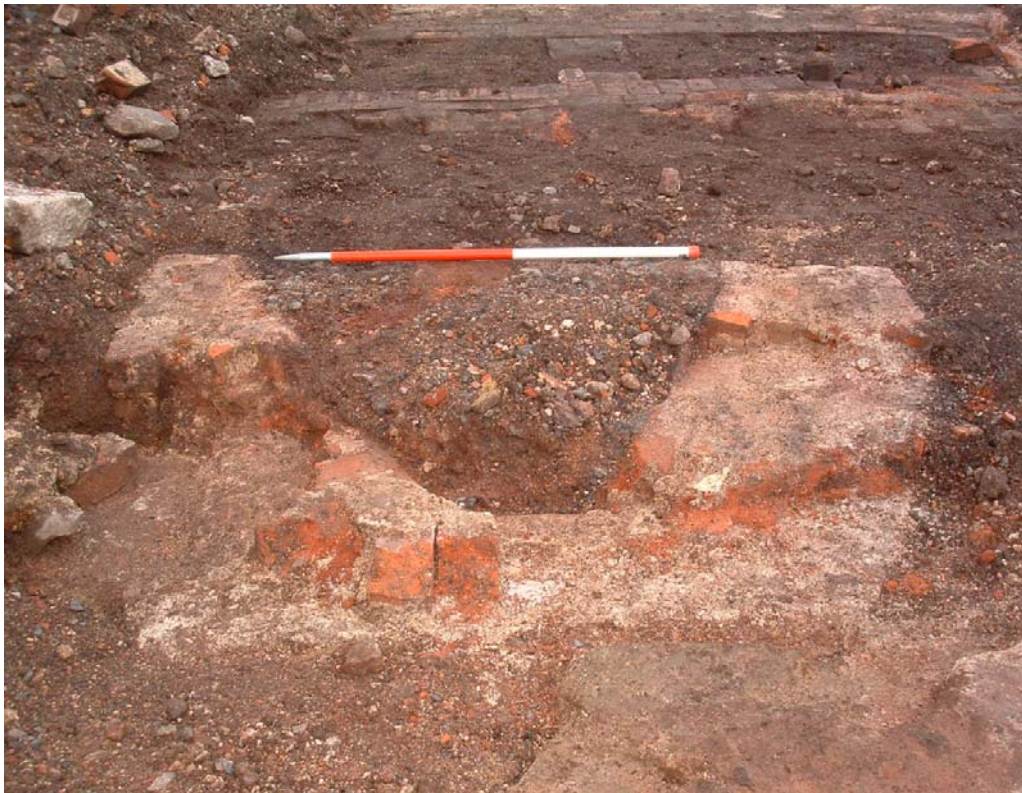
**Plate 30:** Facing site W. Showing one of the earliest puddling furnace bases 6161 within Strip and Record Area 2a. Note the later puddling furnace base 6159 at the top of the picture.

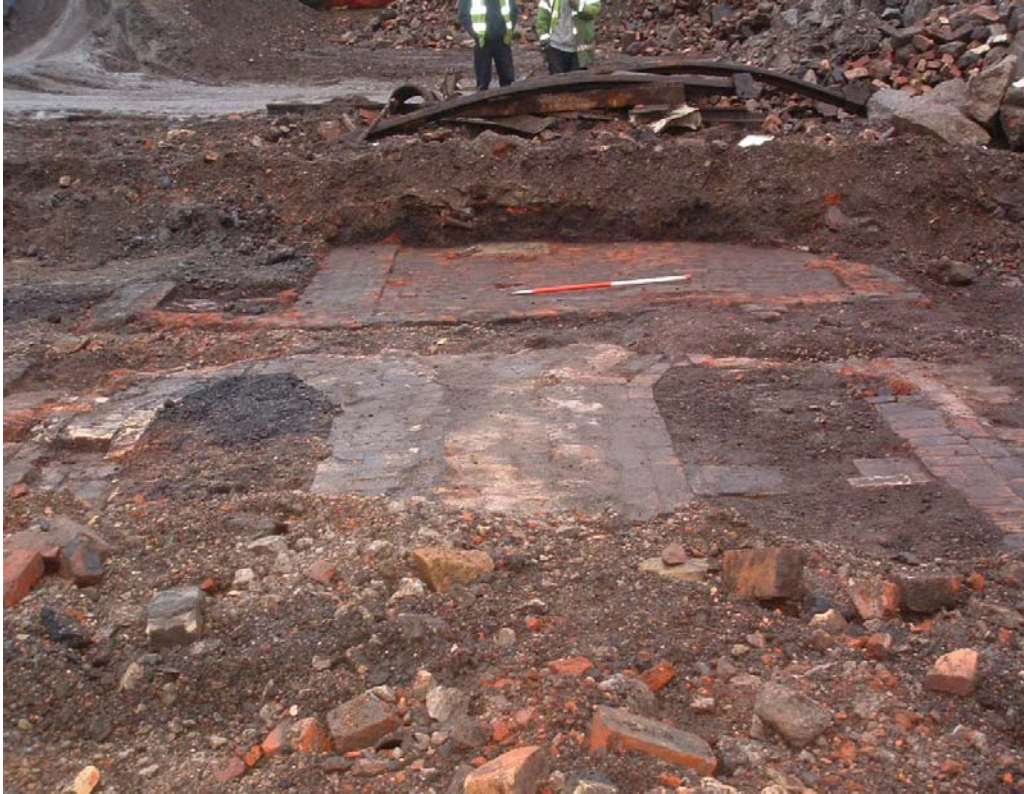
**Plate 31:** Facing site N. Showing the eastern pair of puddling furnace bases [6158 and 6159] uncovered in 'strip and record' Area 2a. Note the brick covered [6160] to the top of the picture (with 1m scale).

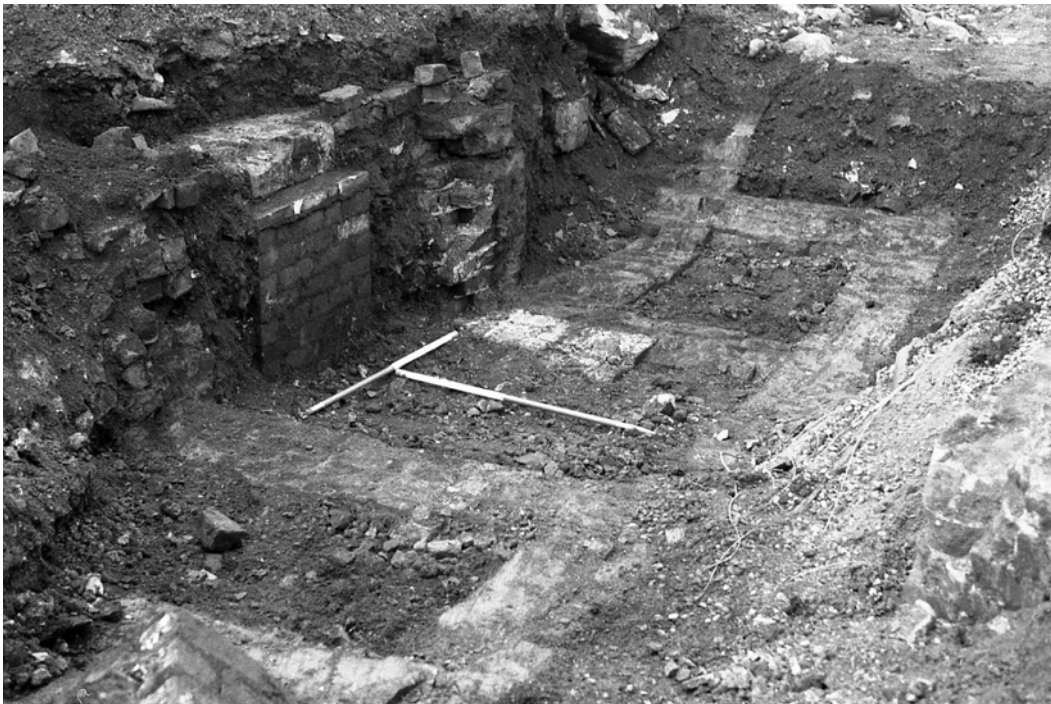
**Plate 32:** Facing site NE. Showing the structure 6160 uncovered during the Strip and Record Area 2a. This structure is depicted as early as 1888 and may have associations with the iron puddling process.

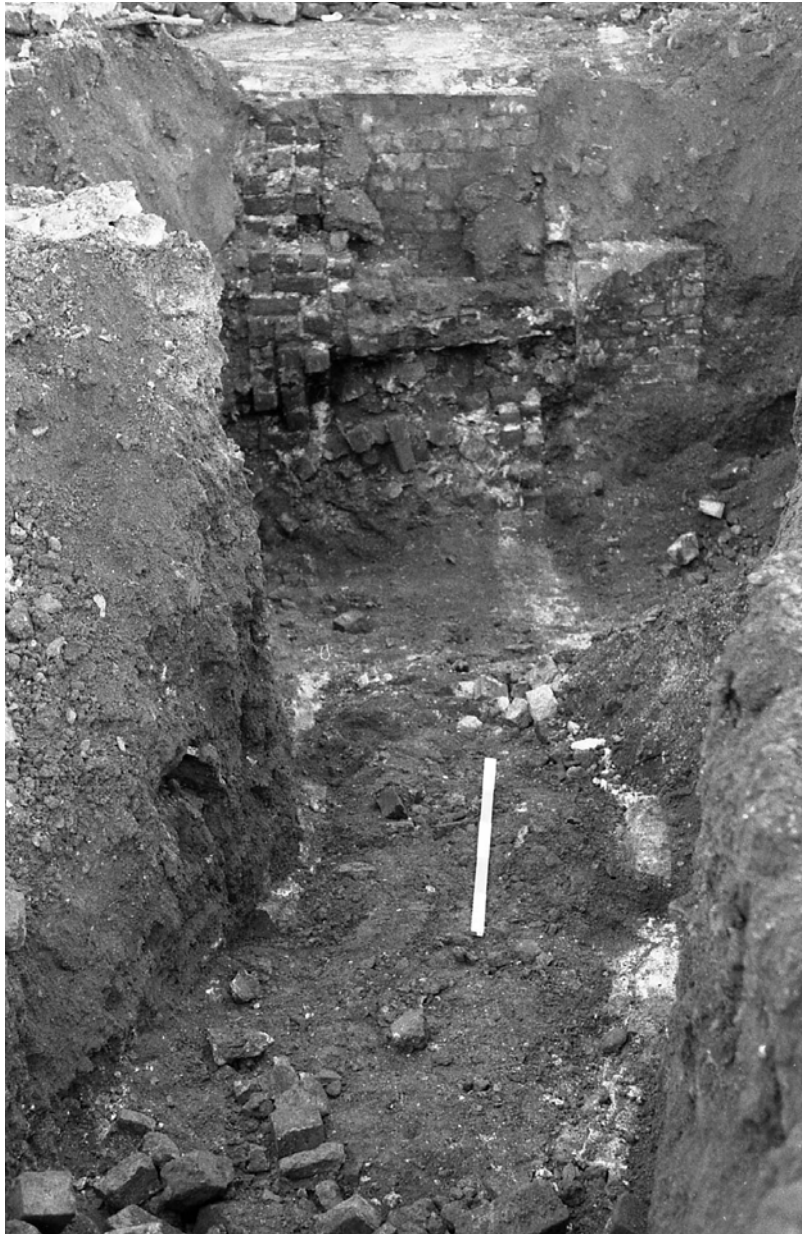
**Plate 33:** Facing site S. Showing the partially excavated curving flue 6058 and squared brick chimney 6059 (top of picture) which were uncovered during the early watching brief. It is possible that these structures may be linked to the earliest puddling phase of operation under Stephen Witham.
