## Project Report 1234.1 (1)

# St John's Church, Chapeltown, Sheffield

## Archaeological Watching Brief

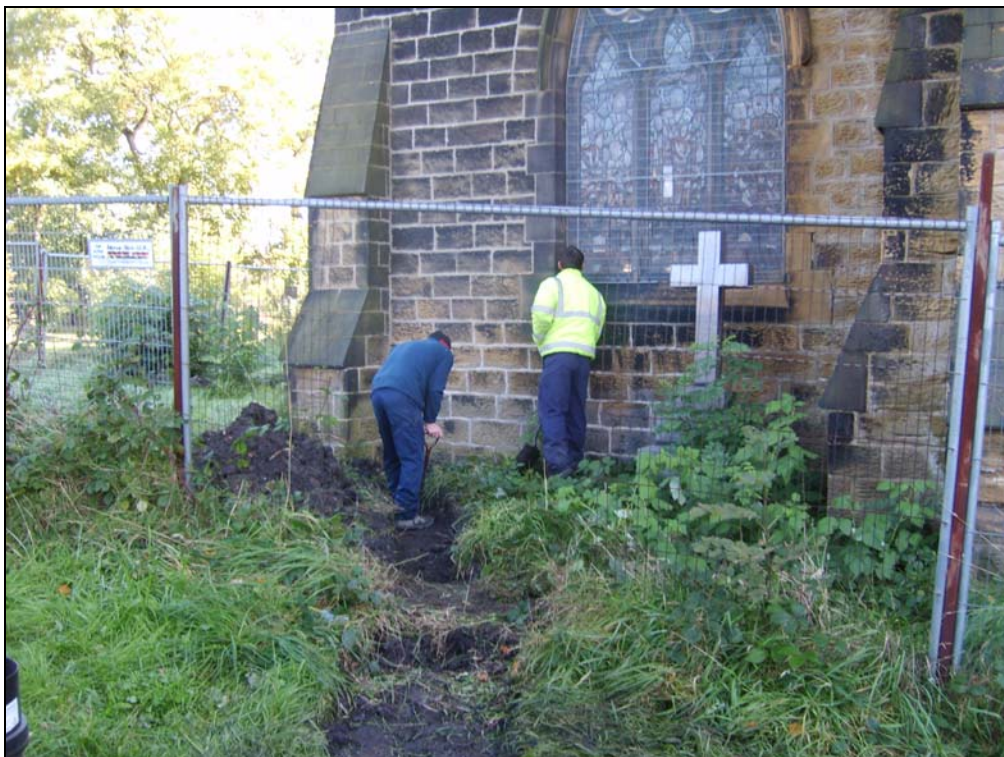
Plate 1 – Hand excavation of pipe trench, northeast facing.

The northern 15m of the route of the drainage pipe was excavated by hand, due to the close proximity of the church building and standing grave markers (**Plates 1 and 2**). The remainder of the trench was excavated with a mini-digger, and ran due south to

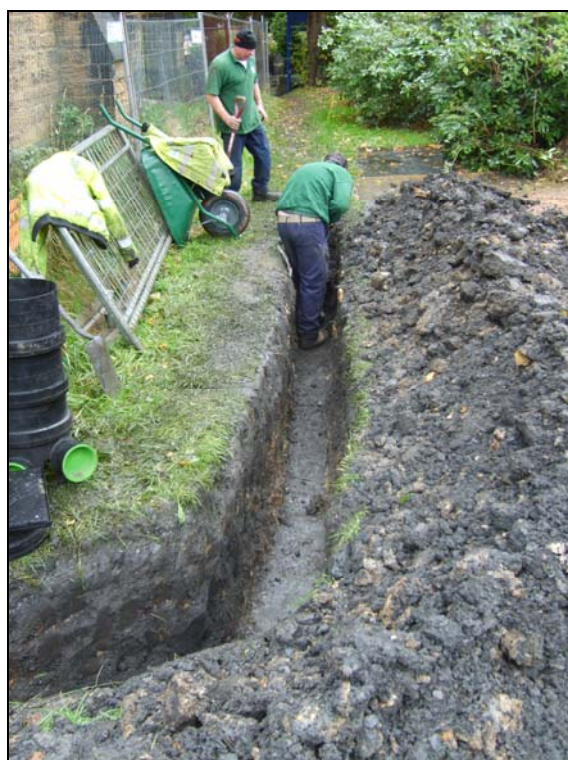
Plate 2 – Continued hand excavation of pipe trench, south facing.

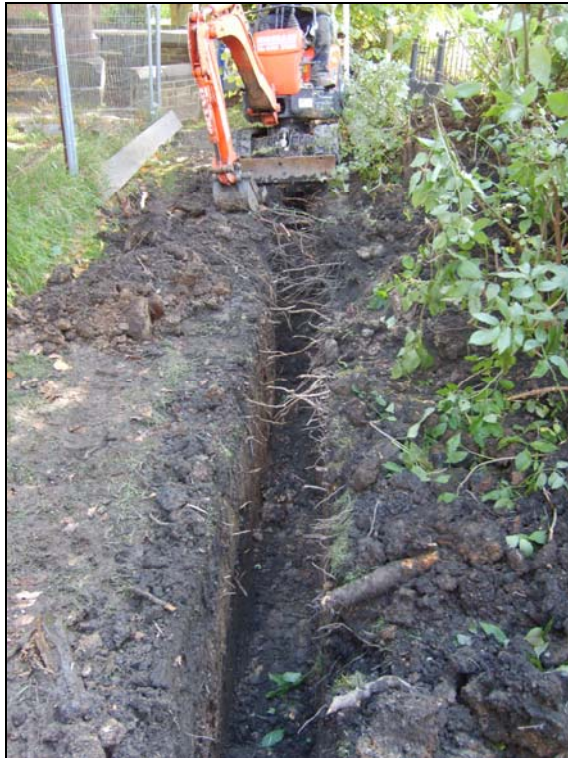
Plate 3 – Mechanical excavation of remainder of trench, south facing.

the existing services at the southwest corner of the graveyard (**Illustration 2**). All excavations were closely observed by the monitoring archaeologist. Working shots were taken throughout the course of the excavations.
