Assessment Report 943c.2

Assessment Report of Phase 1 and 2 Archaeological Evaluations, Rotherham Westgate Demonstrator Project (Sites 3 and 5), Rotherham, South Yorkshire

July 2006

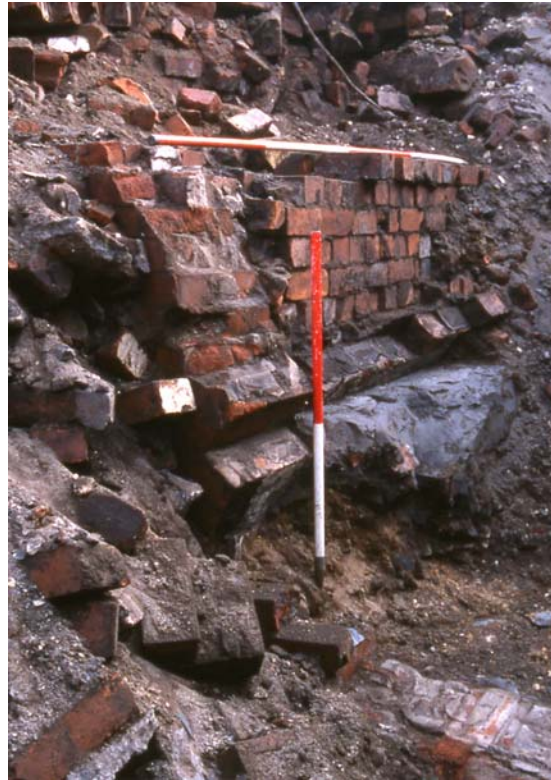
Plate 1: Brick vaulting in Walls (105) and (106), Trench 1 looking south east.

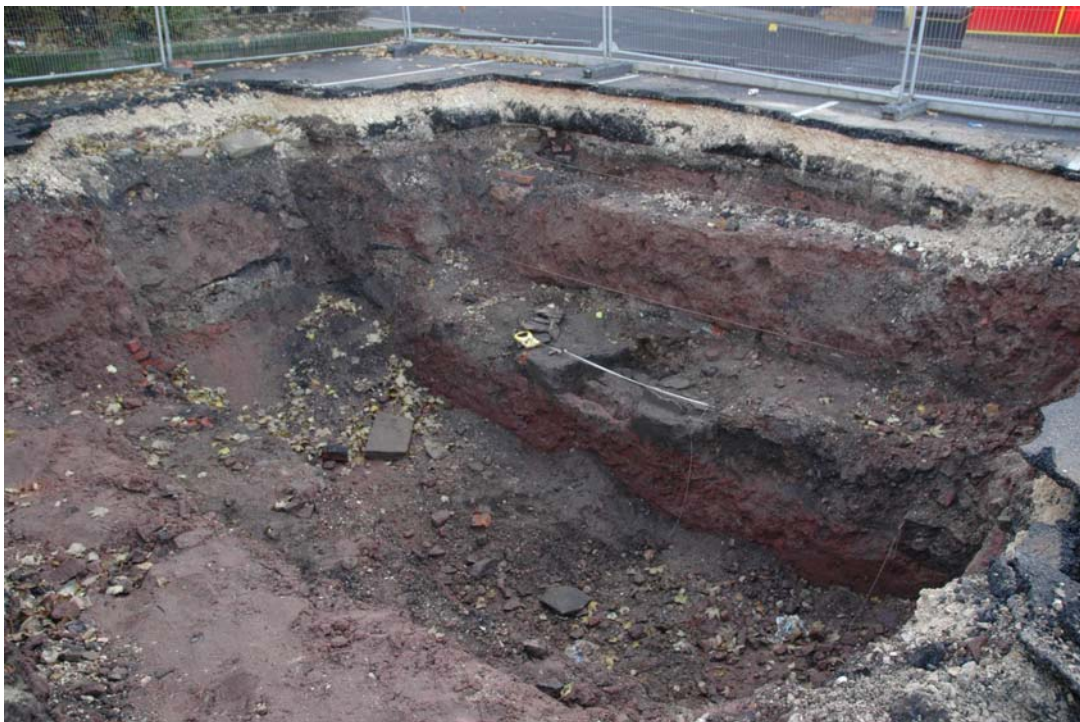
Plate 2: North facing section of sondage within Trench 2 showing possible rutting (222)

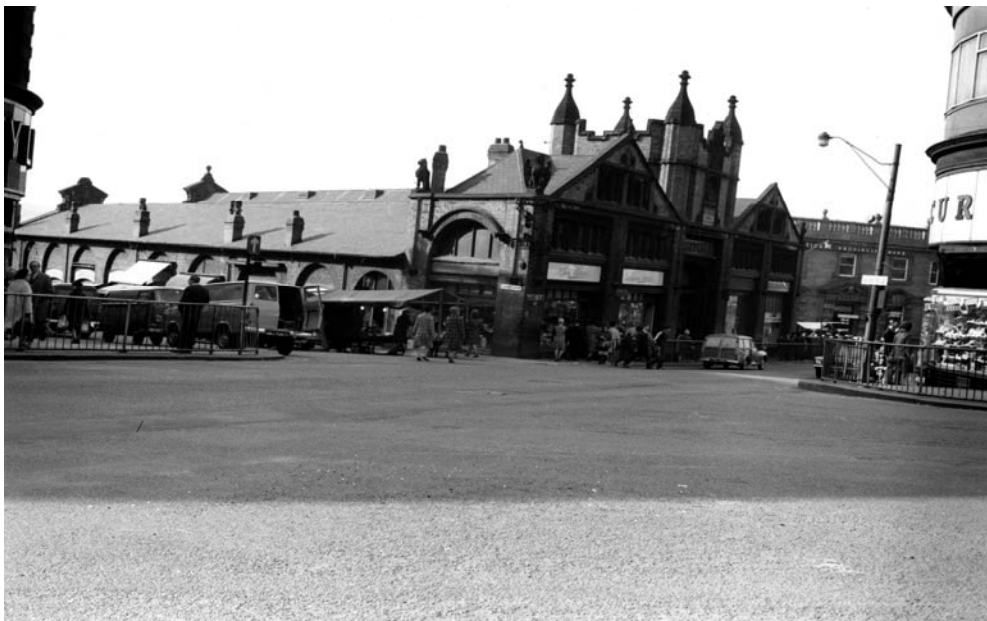
Plate 4: Photograph, facing northwest, showing the southern and eastern wall of the 1888 Market Hall. Note the arches set within the southern wall. (Courtesy of Rotherham Archives)

A corresponding wall (229) situated 4m to the west of wall (206) was of similar build, orientated on the same north to south alignment and truncated the same level (204). This is heavily suggestive that the walls were contemporary to each other, probably from the same structure. Surface (203) also abutted the wall to the east. The backfill (208) of the wall construction cut (207) was clearly overlain by the flagstones (219) and subsequent concreted surface (203), which appeared to have replaced the flagstones. The two walls (206) and (229) may have formed the base or lower brick foundation of arches visible in photographic evidence of the external southern wall of the 1888 Market Hall (**Plate 4**).

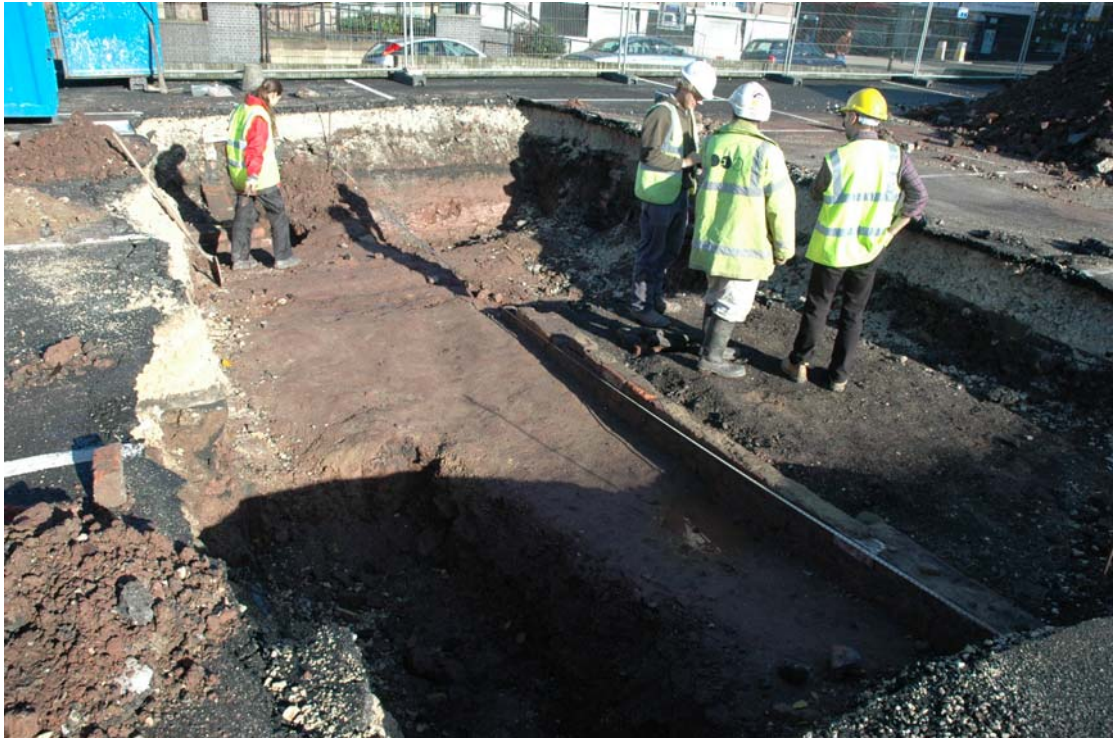
Plate 5: Ephemeral wall (312), looking northeast before removal.

Both the east and west faces of wall (403) were re-faced with industrially pressed and frogged bricks (404). The frogging is of the same style as those found in wall (312) in Trench 3 (**Plate 5**). Wall (404) was partially keyed in with the bricks of (403) and bonded with a mortar of dark brownish grey. It is likely that this wall represents a re-finishing of the wall it encloses, probably as part of a new building phase, associated with the second, 1888, Market Hall's western wall. Abutting the eastern side of wall (404) was a partially revealed stone flag (405) (**Illustration 10**), which directly underlay the hardcore (402). It is probable that these represent the internal stone flagged floor to the 1888 Market Hall as seen in Trenches 3 and 5 (as contexts (305) and (1005) respectively). To the west of wall (404), a 0.08m thick layer of blackish brown sandy grit (416) formed a bedding layer for flagstones (407). These flags were set at a lower level than (405) and sloped down gradually to the west, towards the River Don. It is likely that these flags are set externally to the building associated with walls (403) and (404). The flagstones were re-surfaced with a thin 0.01m layer of modern tarmac (406).

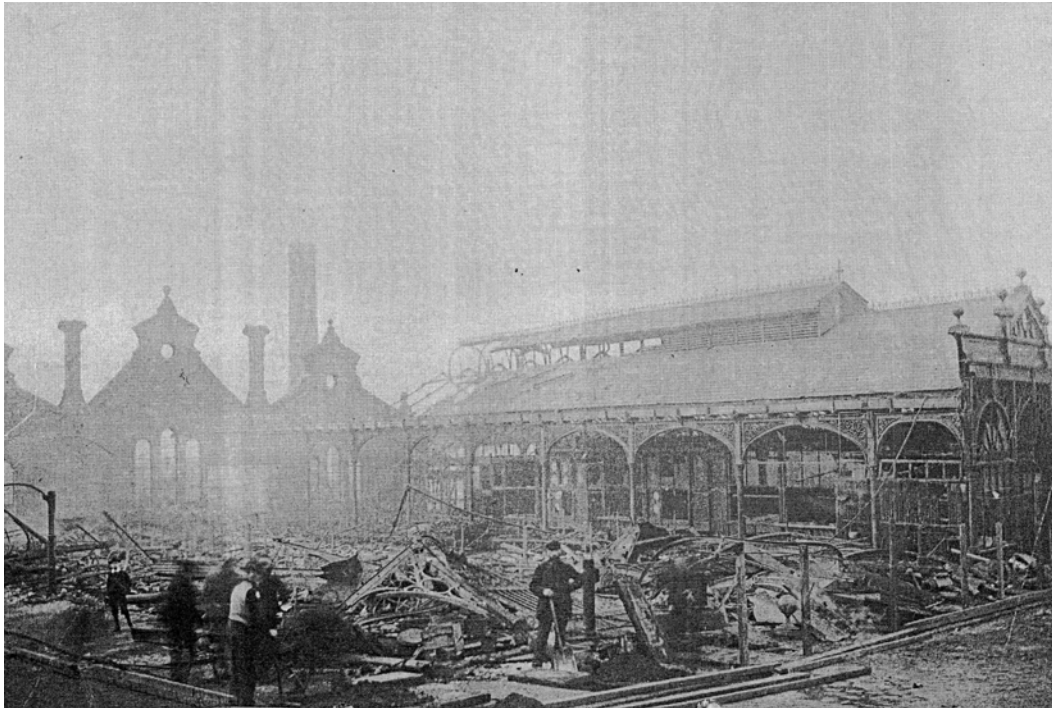
Plate 6: The first Market Hall after the fire of 1888. Note the surviving columns, possibly placed on the first phase brick pillars and the intact western façade (rear left). (Courtesy Rotherham Archives)

to that of (334). These layers probably represent the levelling of the area after the first market hall burnt down (**See Plate 6**) prior to the construction of the second market hall in 1888.

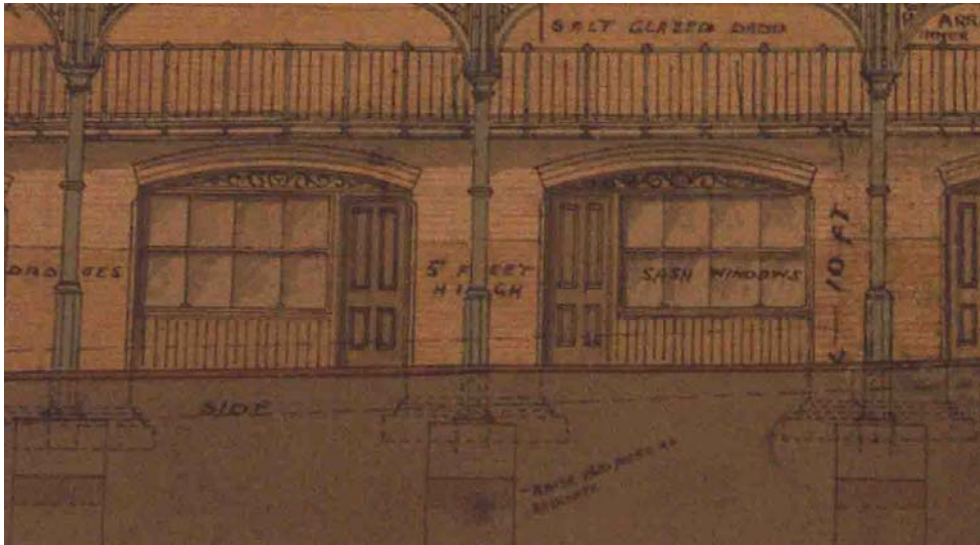
Plate 7: Showing original architects drawing of the second 1888 Market Hall design with instruction to “raise *old* peers as requested” relating to the brick pillars (my emphasis). Note also the blocks supporting cast iron roof support columns.
(Courtesy of Rotherham Archives)

columns. Pictorial evidence from the original architects design (**Plate 7**) supports the suggestion that the existing brick pillar bases were re-used as foundations for brick and sandstone block extensions forming the foundations for column bases.

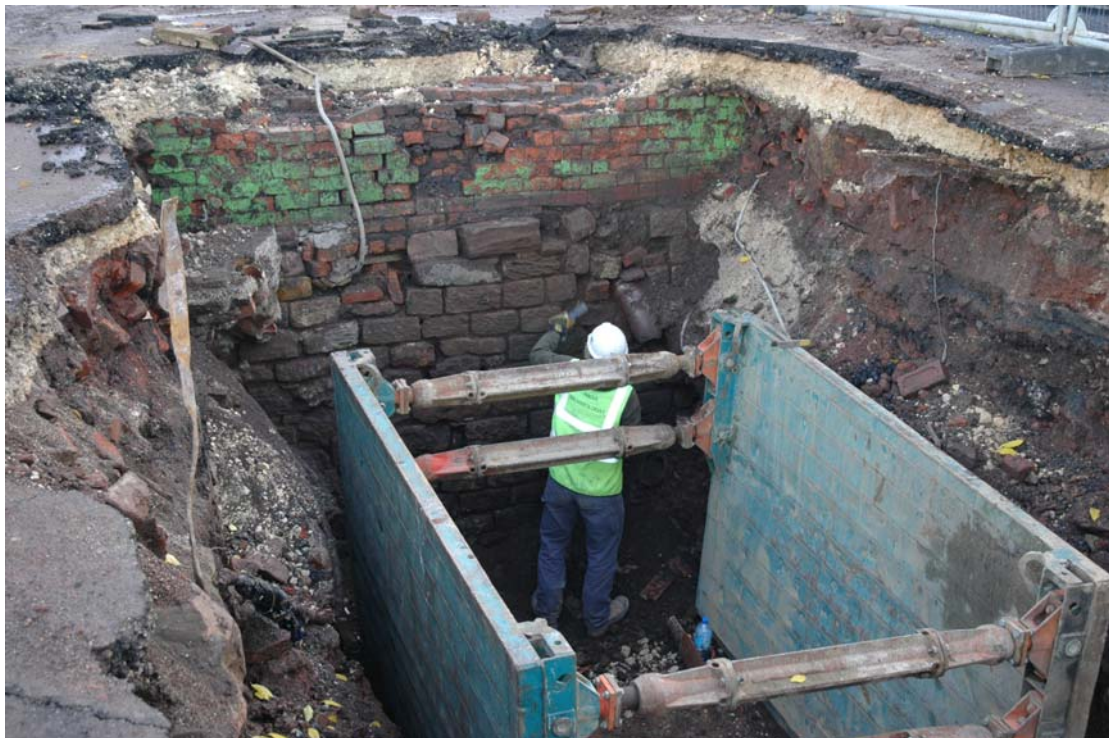
Plate 8: West facing section of Trench 4 showing stone wall (409) with walls (403 & 404) directly overlying

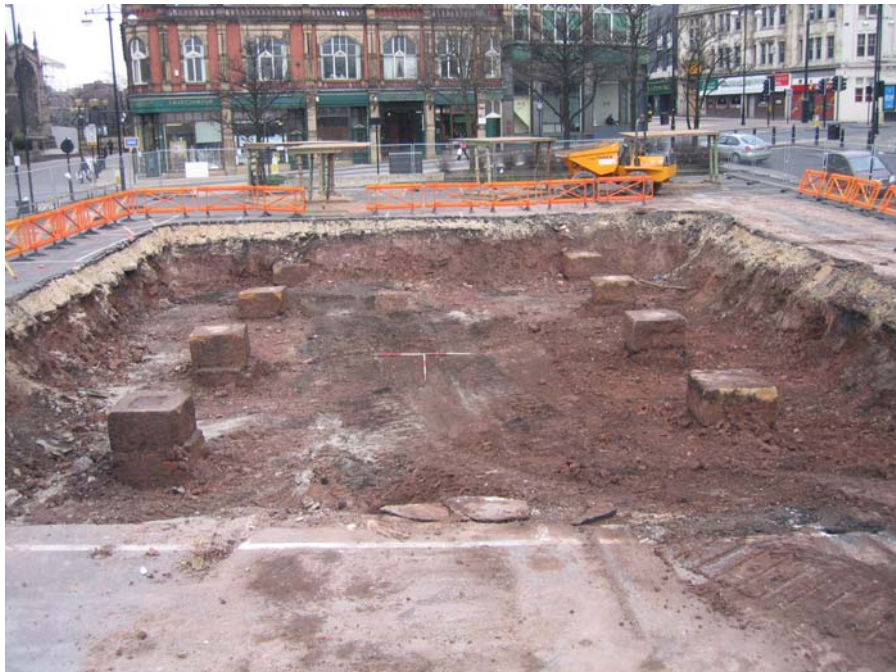
Plate 10: General view of the two rows of upper brick pillar extensions and sandstone blocks relating to the 1888 Market Hall, probably situated on top of the brick pillars of the 1879 Market Hall.

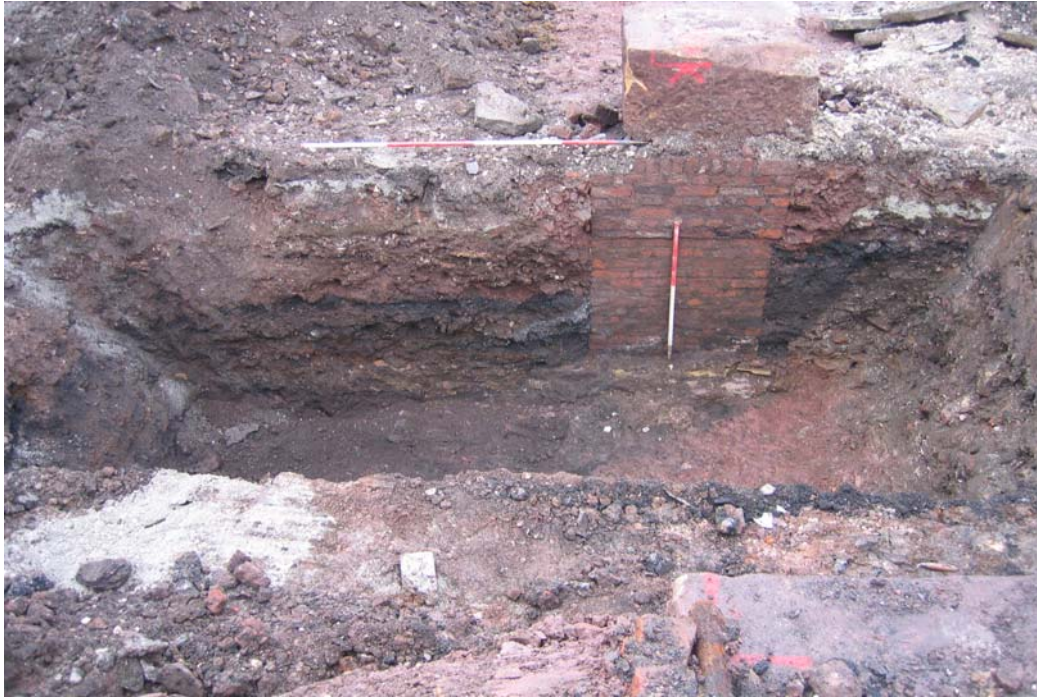
Plate 11: View looking west showing pillar (1060) with extension (1017) and sandstone block (1025) above. Note the deposits butting against the pillar to the left of the picture and the cut (1065) to the right.

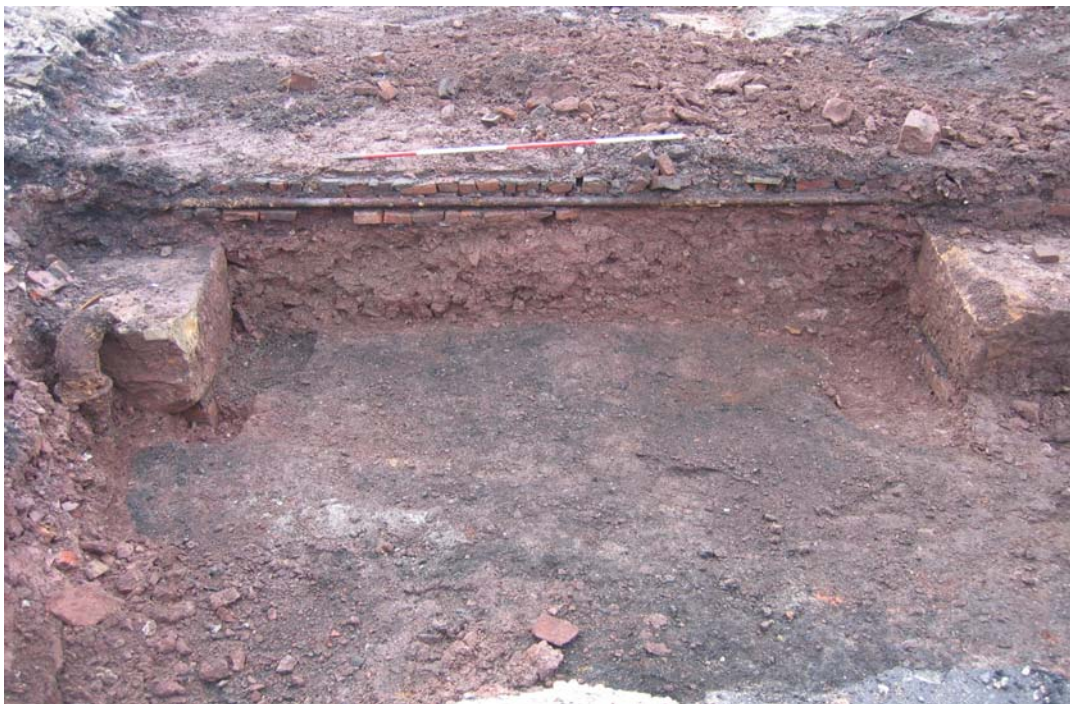
Plate 12: View looking south, showing (left – right) the top of brick extensions (1014) and (1017) below sandstone blocks (1024) & (1025). Note the cuts (1015) and (1018/1063) through the black possible fire debris (1022) and the thick overlying pink re-deposited sandstone layer (1007).

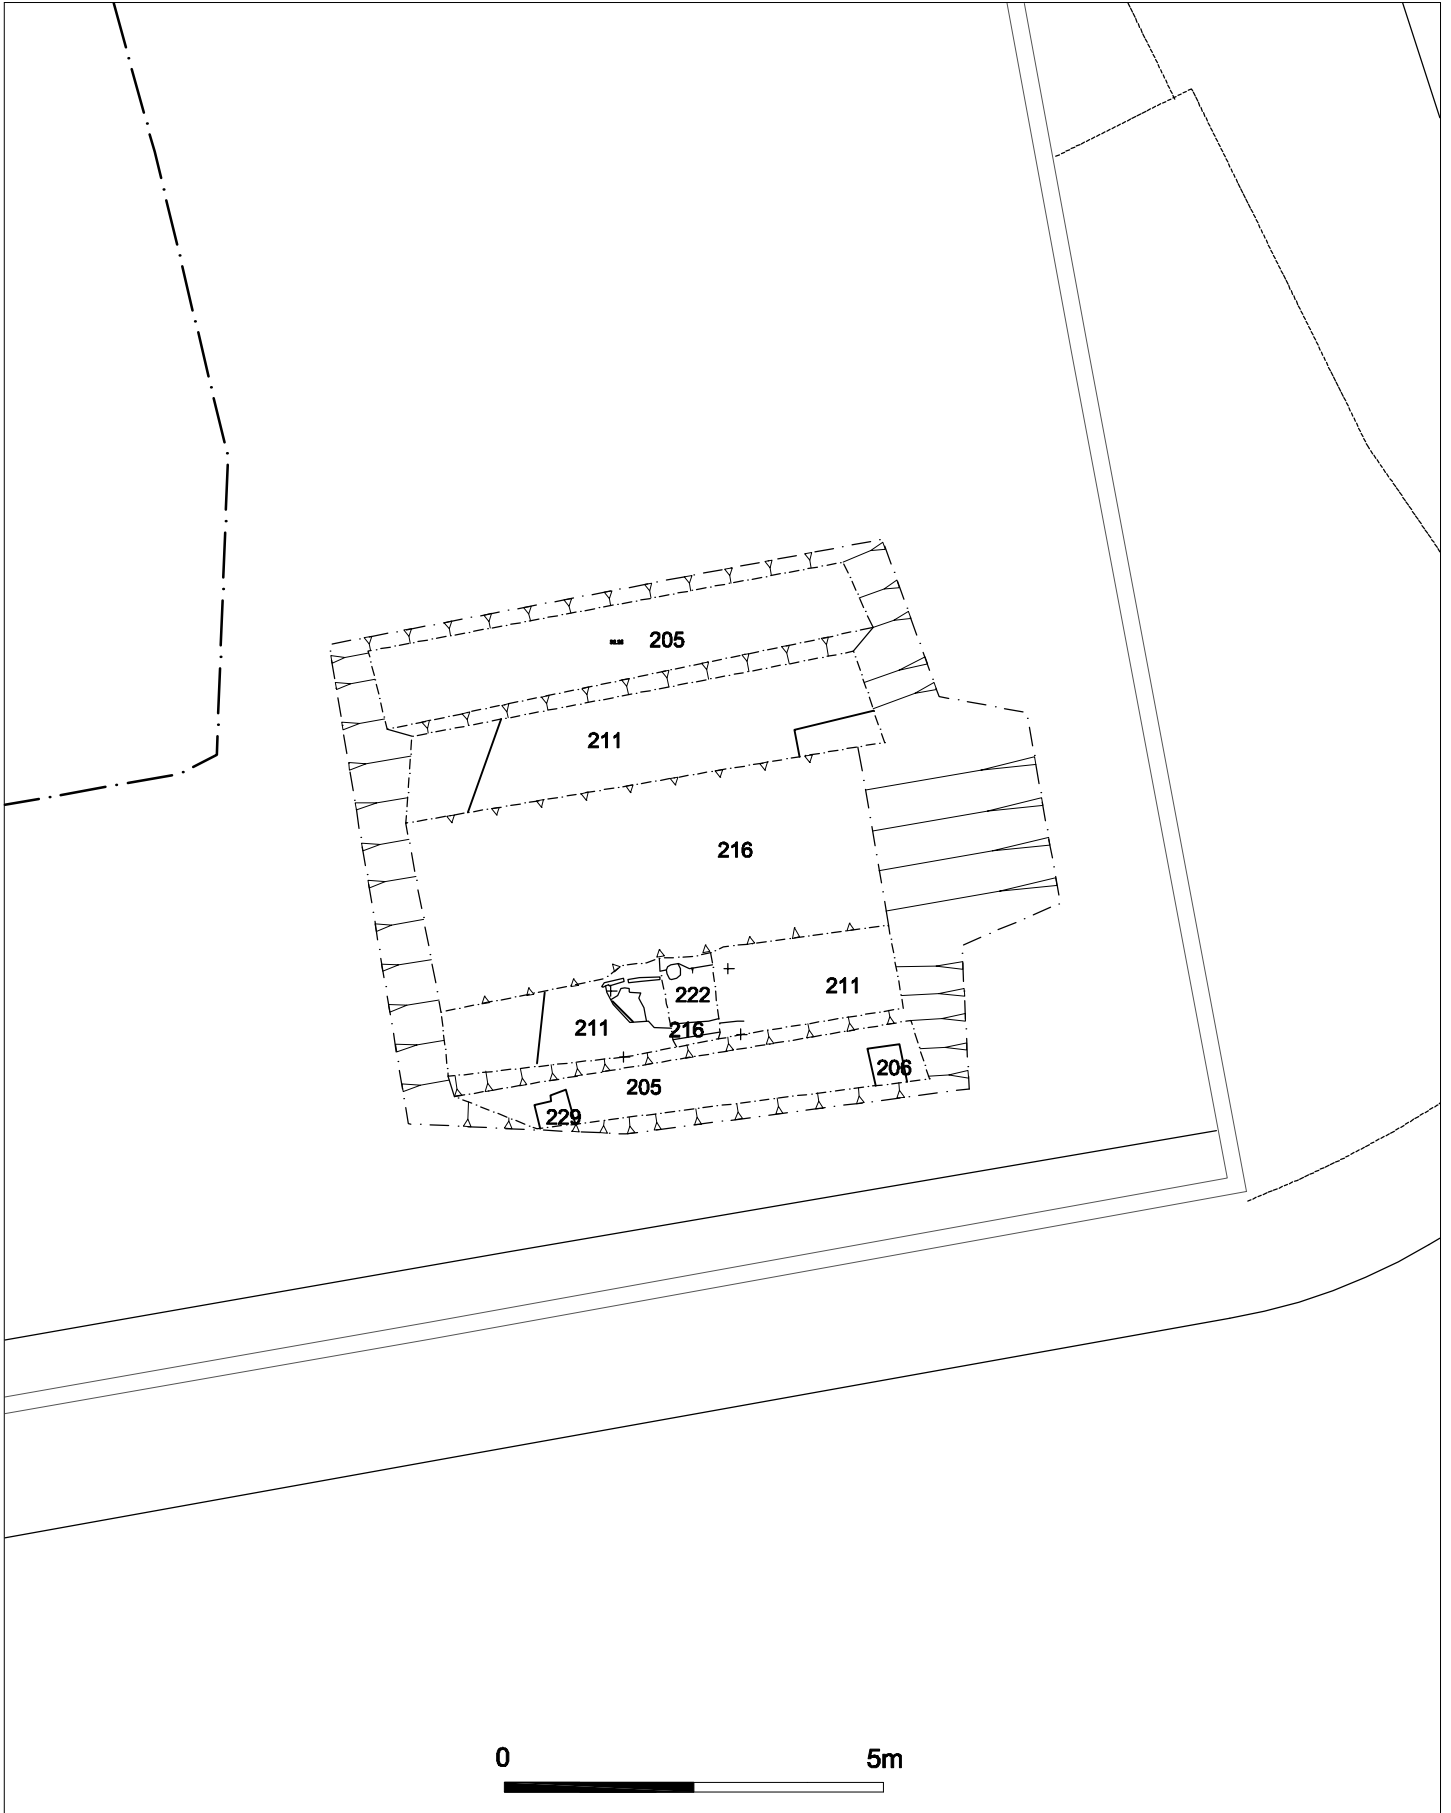
<p>ARCUS Research School of Archaeology Westcourt, 2 Mappin St Sheffield S1 4DT</p> <p style="text-align: center;">N ↑</p>	<p>Project</p> <p style="text-align: center;">Westgate, Rotherham</p>	<p>NGR</p> <p style="text-align: center;">SK 4278 9280</p>	<p>Date</p> <p style="text-align: center;">November 2005</p>
	<p>Title</p> <p style="text-align: center;">General Plan of Trench 2</p>	<p>Scale</p> <p style="text-align: center;">1:100</p>	<p>Drawn</p> <p style="text-align: center;">K.Speight</p>
		<p>Project No.</p> <p style="text-align: center;">943b</p>	<p>Illustration. No.</p> <p style="text-align: center;">4</p>

Trench 2 was 10m long and 6m wide. A maximum depth of 3m from the car park surface was achieved in the centre of the trench and the trench was stepped up by one metre for every metre of depth at the sides. The trench was located in the south east corner of the site (**Illustrations 3 and 4; Plate2**) in an area showing two inns and the Corn Exchange and Buttery on the 1854 OS map.

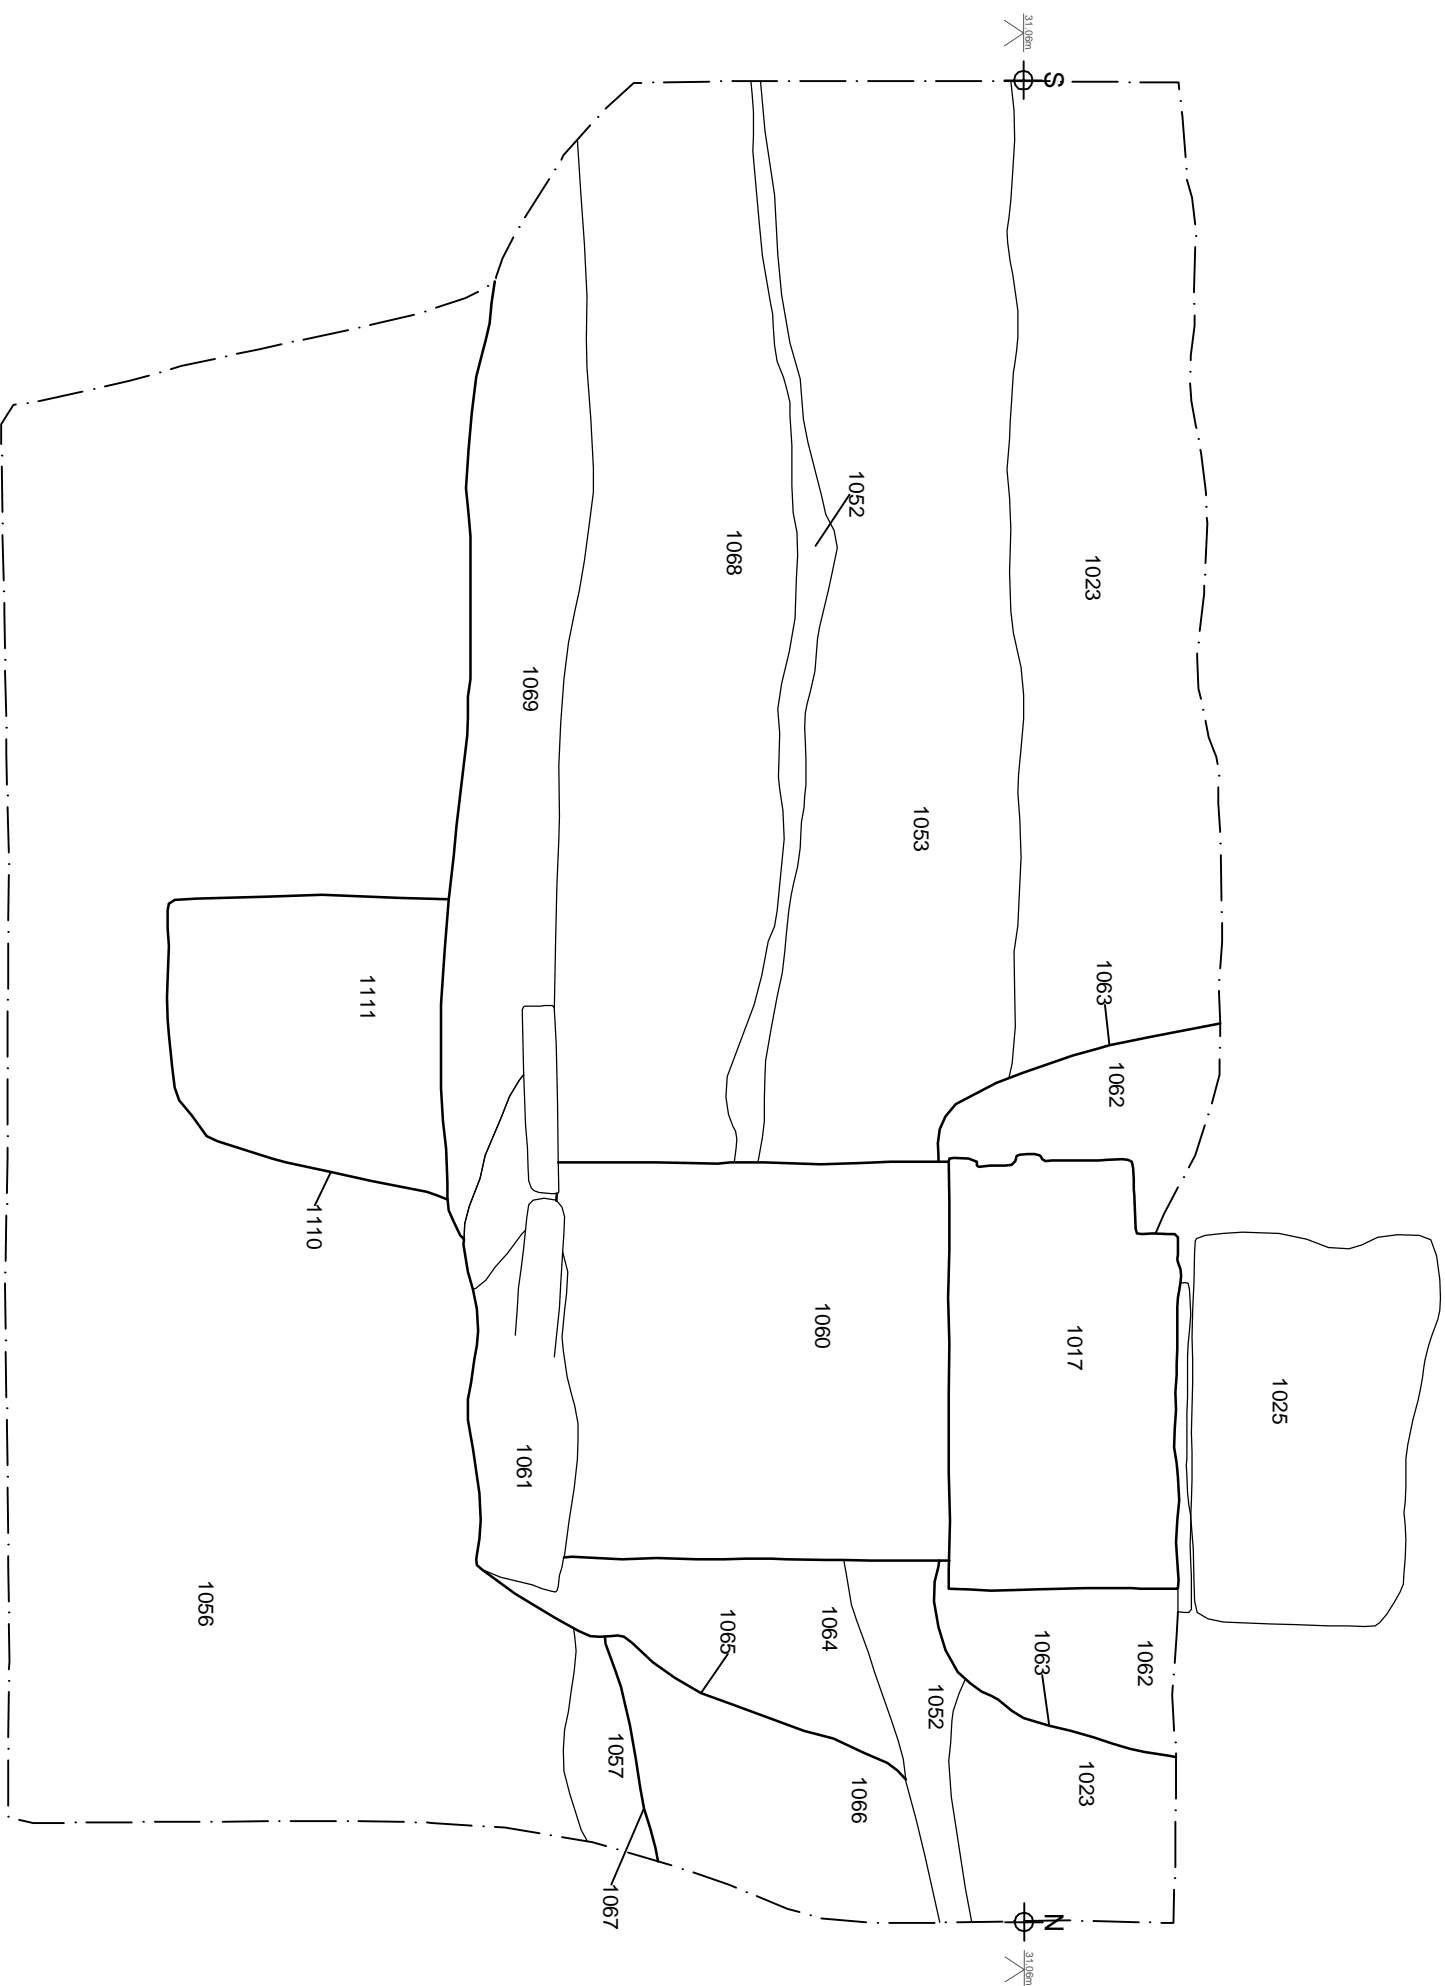
<p>Project: Westgate Demonstrator Project, Rotherham</p>		Scale	1:20	Date	04.06
<p>Title: Trench 5 - East facing section, showing brick pillar [1060, 1017 & 1025]</p>		NGR	SK 4278 9280	Drawn	T. Sparrow
<p>ARCUS Research School of Archaeology University of Sheffield Wendy House 2 Manor St Sheffield S1 4DT Tel: 0114 228108 Fax: 0114 2287198</p>		Project No.	943c	Illustration No.	14

Located to the south of brick pillar (1060) was a linear cut (1110) measuring at least 2m long x 0.7m wide x 0.74m deep (**Illustration 14**). Aligned roughly east to west, the cut had steep concave sides and a flattish base. The fill (1111) was a dark grey sandy silt. It is possible that the feature represents some form of silted drainage channel. The feature lies beneath the foundations of the brick pillar (1060) and appeared to be on the same alignment as the rows of pillars (**See Plate 10**). The top of the feature, however, was clearly truncated by cut (1065), suggesting the feature has already silted up. Cut (1110) is likely to be associated with the pre-Market structures, possibly the Corn Exchange and Buttery. No artefacts were recovered from the deposit.

On the base of cut (1045/1065) two brick pillars (1060) and (1108) were constructed upon foundations consisting of flattish sandstone slabs (1061) varying considerably in dimensions but with an average thickness of 0.1m, (**Illustrations 14 and 16 and Plate 11**). Pillar (1060) measured around 1.03m wide x 1.26m high, and consisted of thirteen

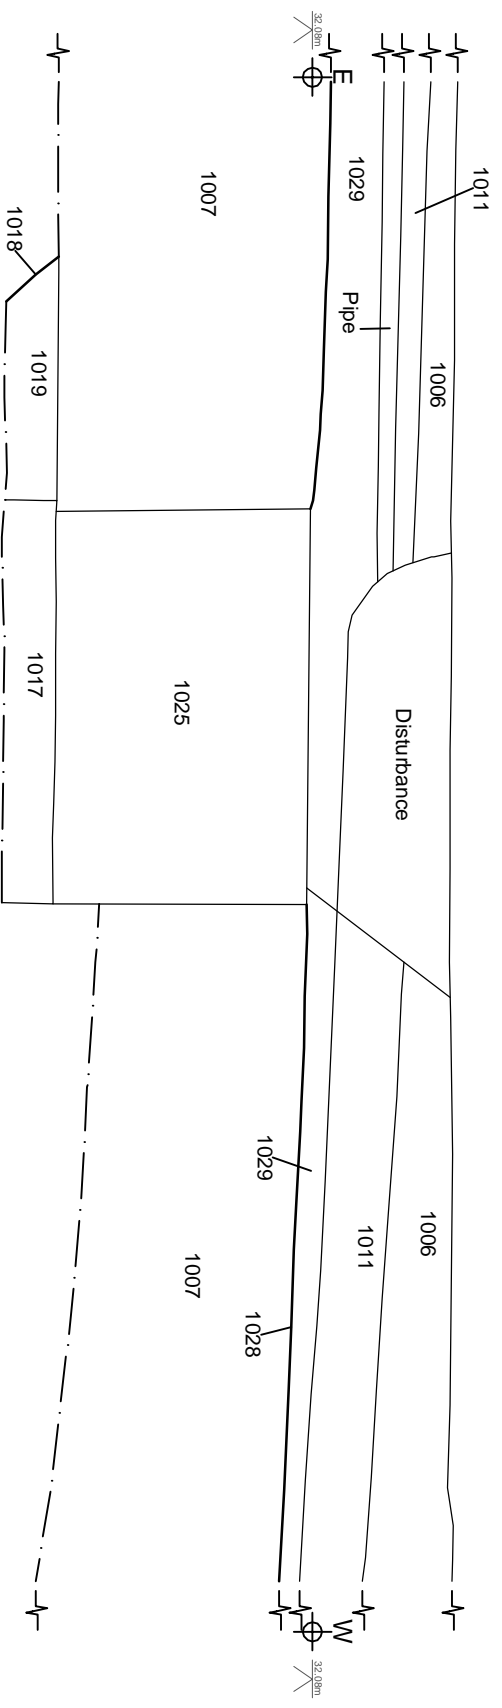
<p>Project: Westgate Demonstrator Project, Rotherham</p>		Scale	Date
<p>Title: North facing section showing made ground (1007) and 1888 Market Hall drainage [1011]</p>		1:20	04.08
<p>ARCUS <small>ARCUS Engineering Unit 10, The Warehouse, 101-103, The Gateway, Sheffield, S11 5TJ</small> Tel: 0114 2229188 Fax: 0114 2777188</p>		NGR	Drawn
<p>Project No. 943c</p>		SK 4278 9290	T. Sparrow
		Illustration No.	17
