Rotherham Westgate Demonstrator Project (Sites 3 and 5), Rotherham, South Yorkshire

Archaeological Excavation

ARCUS report 943e.1(1)

March 2009

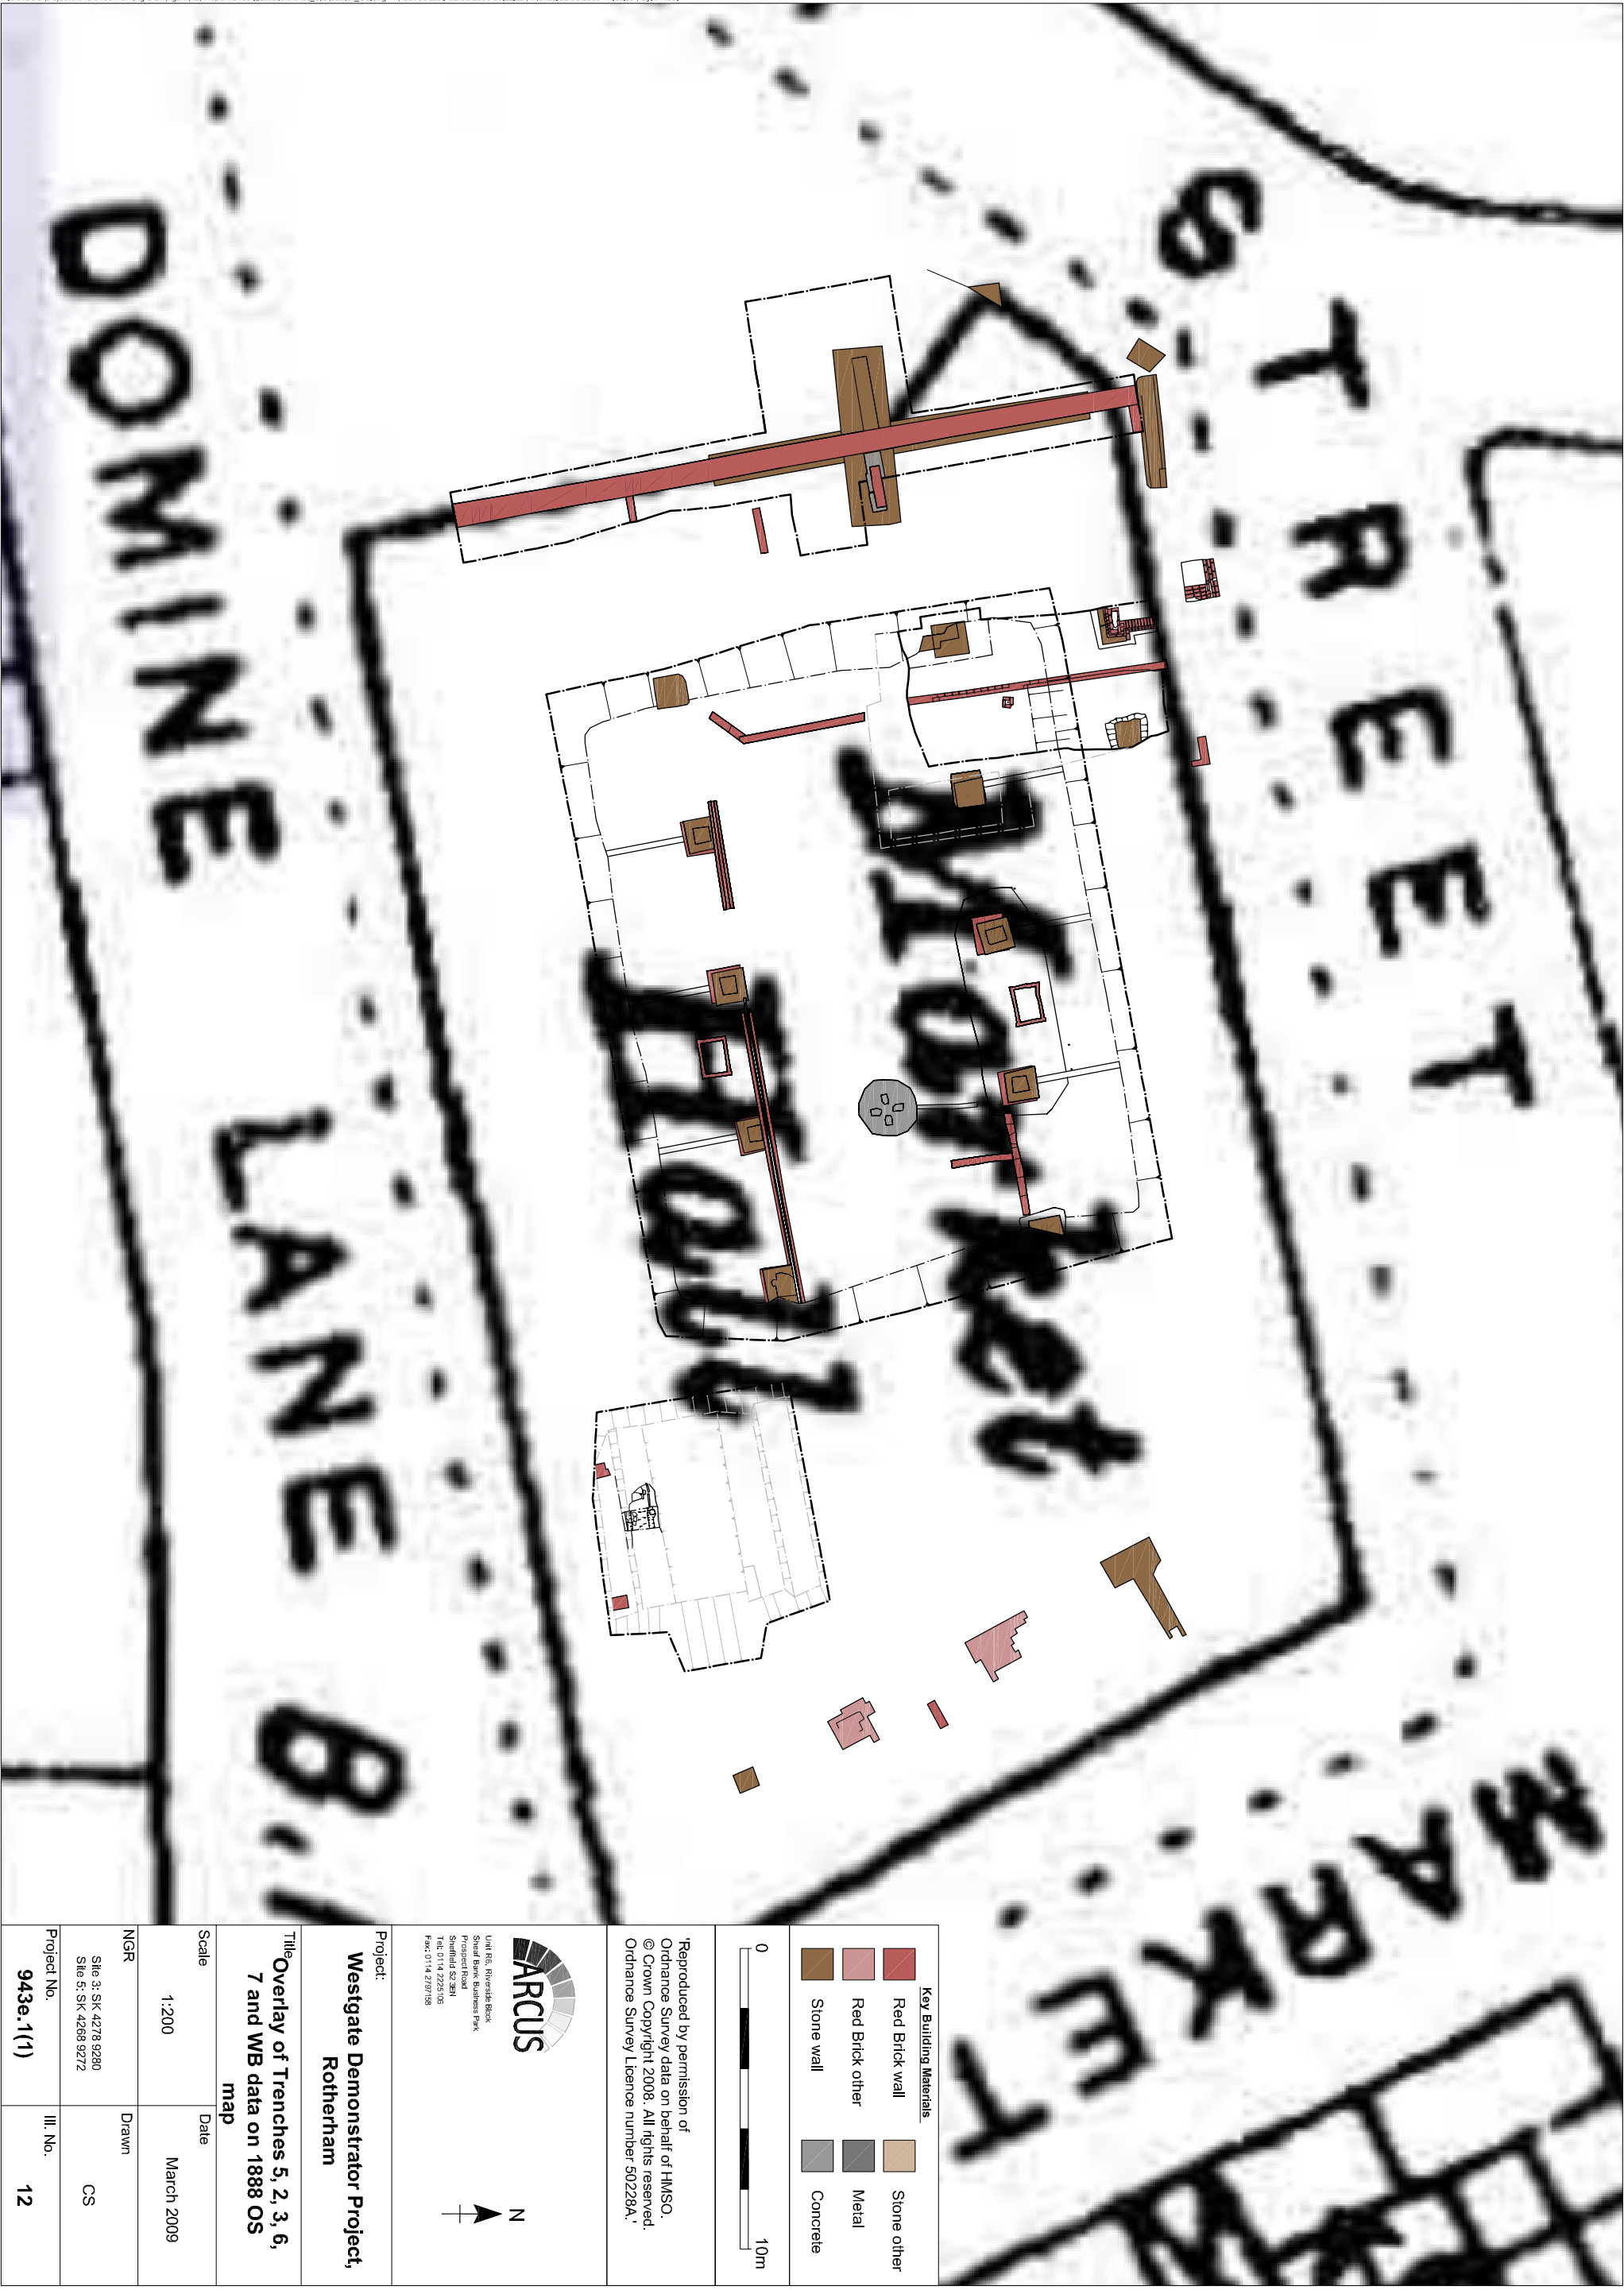
Project: Westgate Demonstrator Project, Rotherham	
Title: Overlay of Trenches 5, 2, 3, 6, 7 and WB data on 1888 OS map	
Scale	Date
1:200	March 2009
NGR	Drawn
Site 3: SK 4278 9280 Site 5: SK 4268 9272	CS
Project No.	Ill. No.
943e.1(1)	12

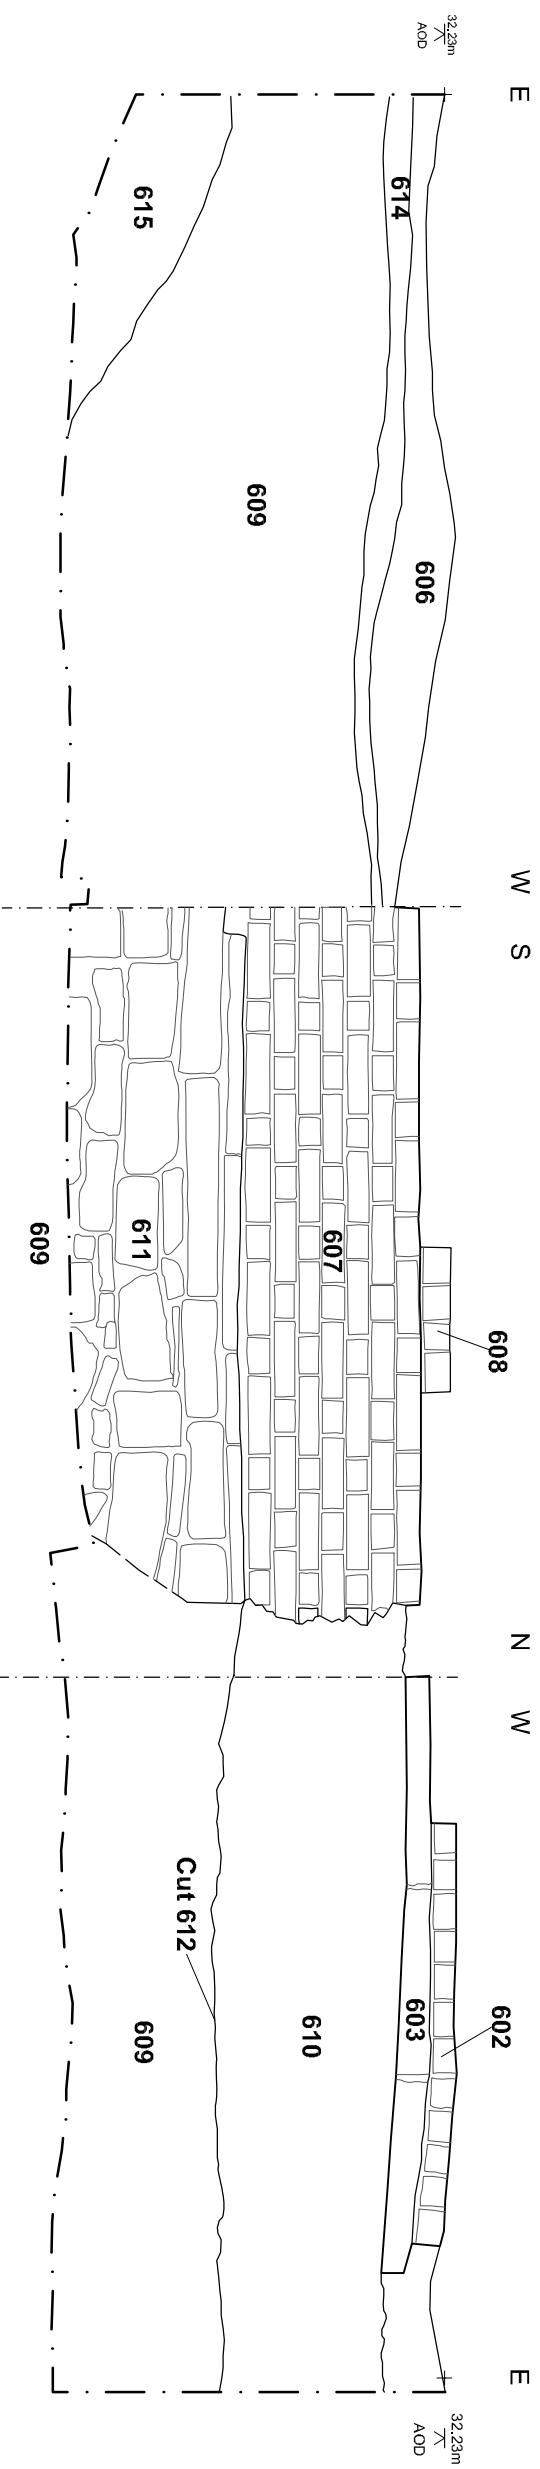
Scale	1:25	Date	March 2009
NGR	Site 3: SK 4278 9280 Site 5: SK 4268 9272	Drawn	CS
Project No.	943e.1(1)	Illustration No.	18

Title
**Trench 6. Section of sondage to
 the east of wall [607]**

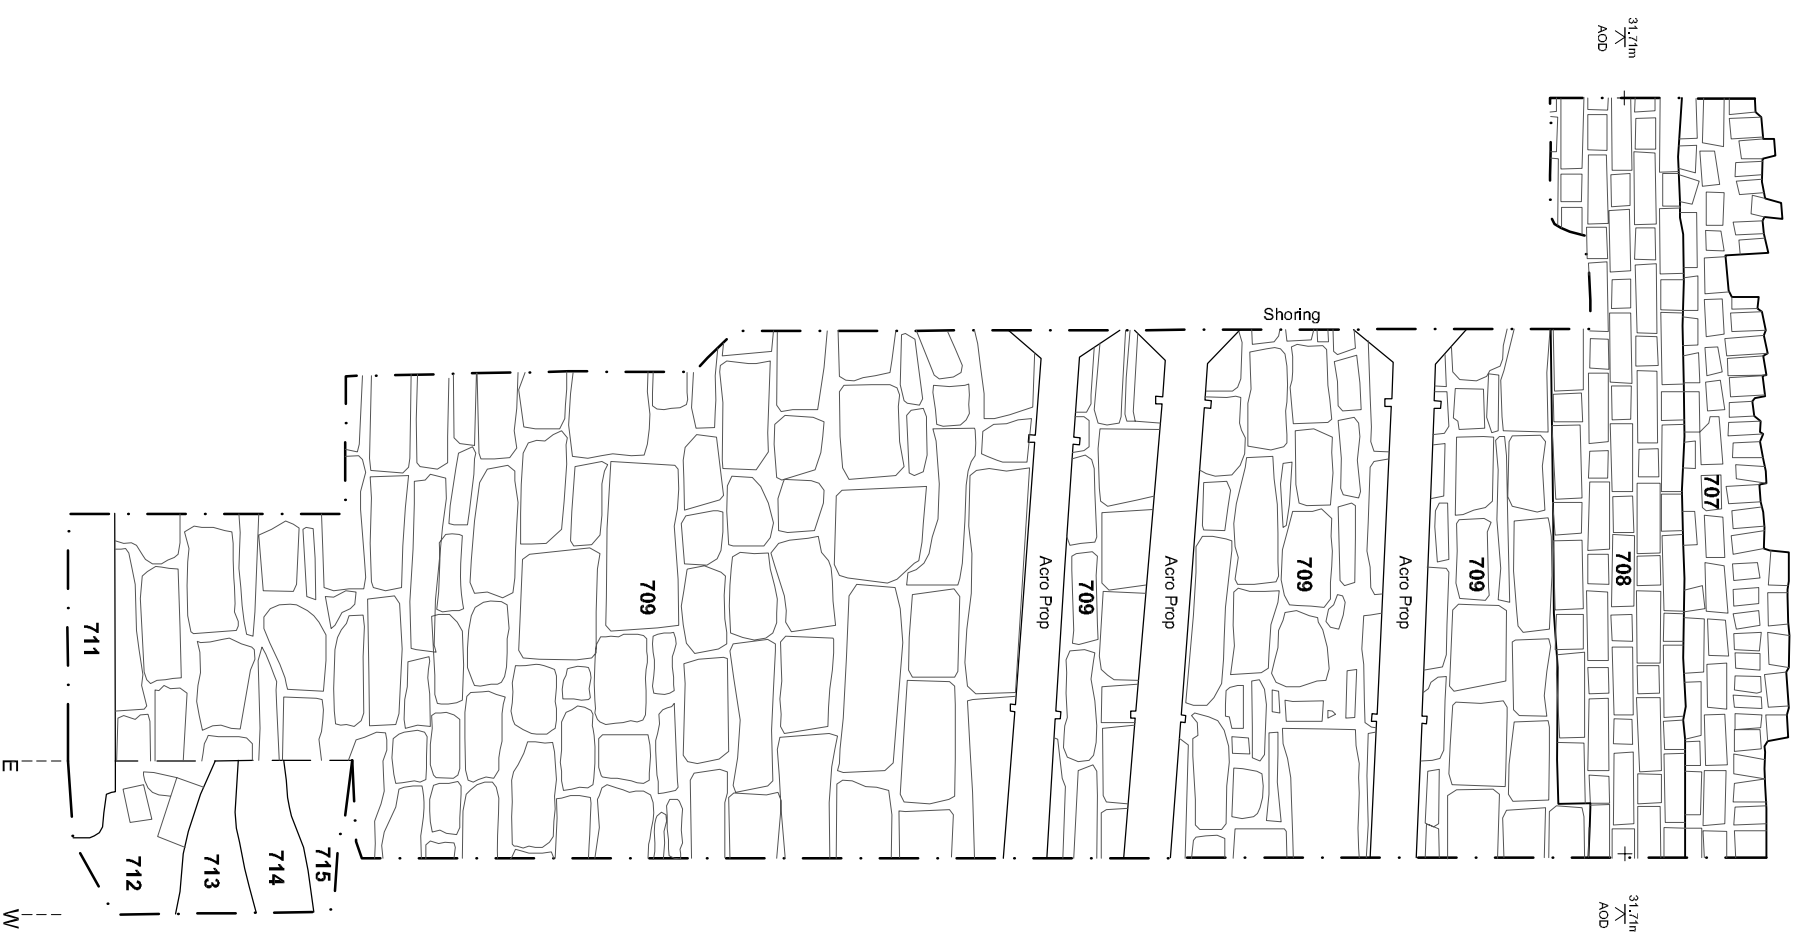
Project:		Scale		Date	
Westgate Demonstrator Project, Rotherham		1:25		March 2009	
Title		NGR		Drawn	
Trench 7. West facing section of wall [711], [709], [708] & [707]		Site 3: SK 4278 9280 Site 5: SK 4268 9272		CS	
Project No.		943e.1(1)		Illustration No.	
				19

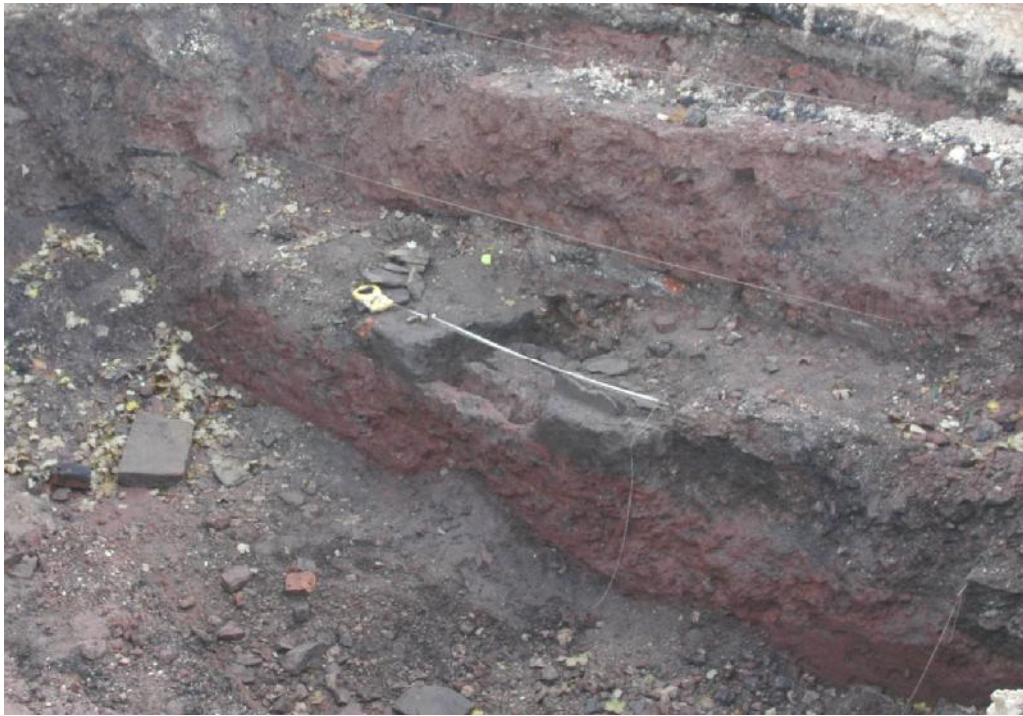
Plate 1: Facing SE. showing the sondage in the base of Trench 2 showing the gully [223]. Note also the upright slab of [221] to the right of the sondage.

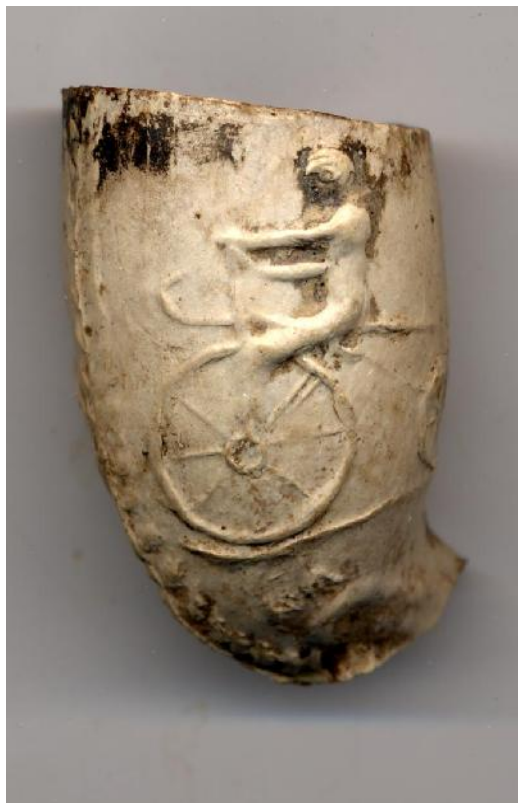
Plate 2: Showing the clay pipe bowl found in deposit [212]. The embossed image is that of a velocipede dating to 1863+.

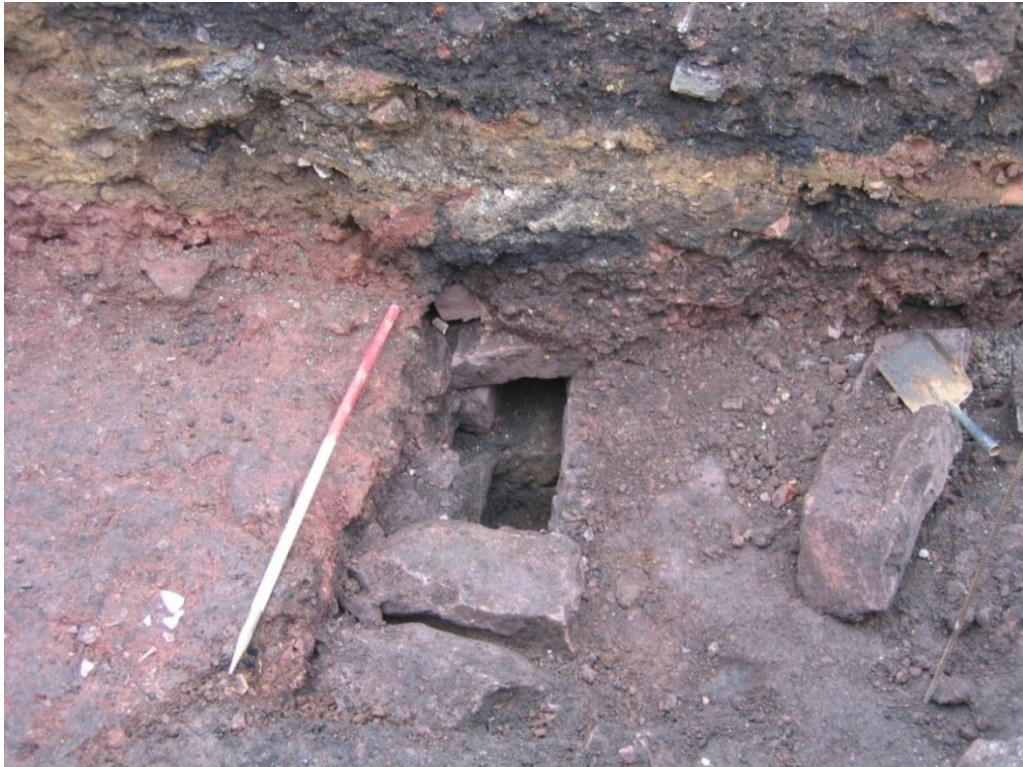
Plate 3: Facing E showing cut [1049] for stone lined drain [1050] uncovered in the L-shaped sondage in Trench 5.

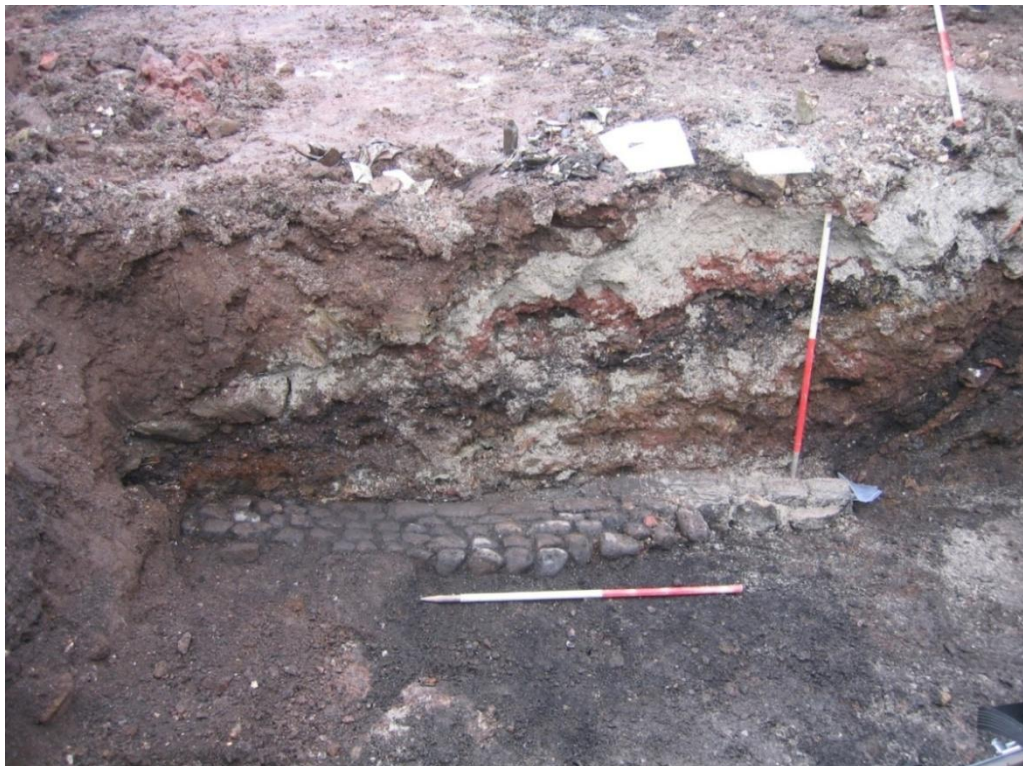
Plate 4: Facing W showing cobbled surface [1070] uncovered within the L-shaped sondage in Trench 5.

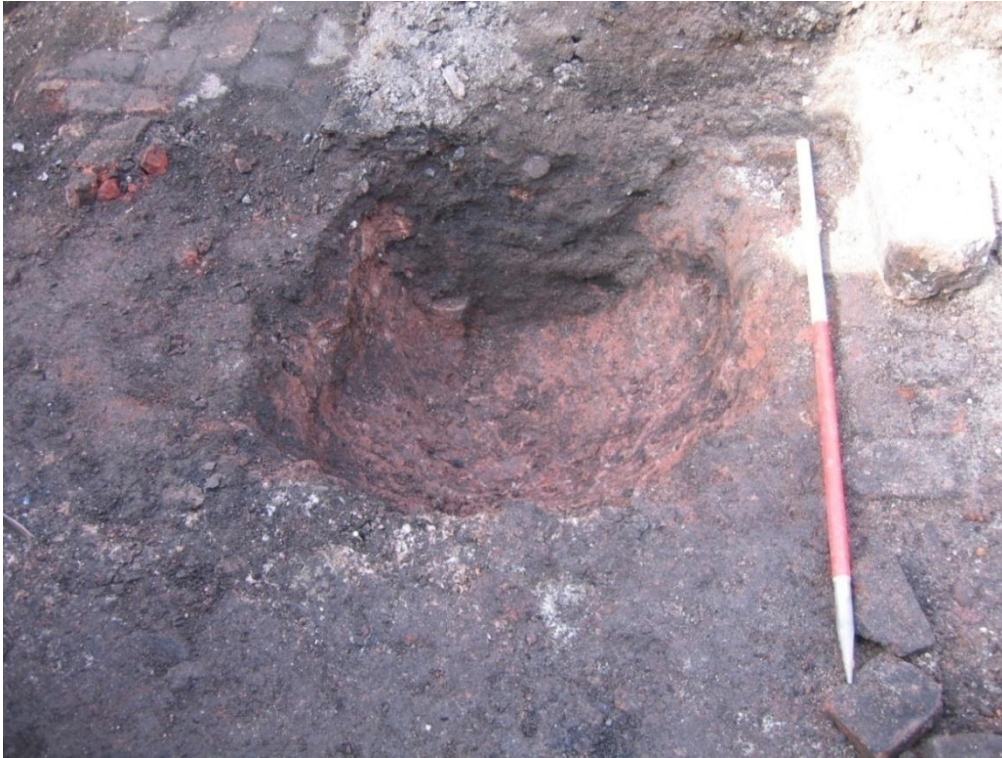
Plate 5: Facing N showing the brick surfaces [1086] (upper left) and [1084] (right) truncated by pit [1087].

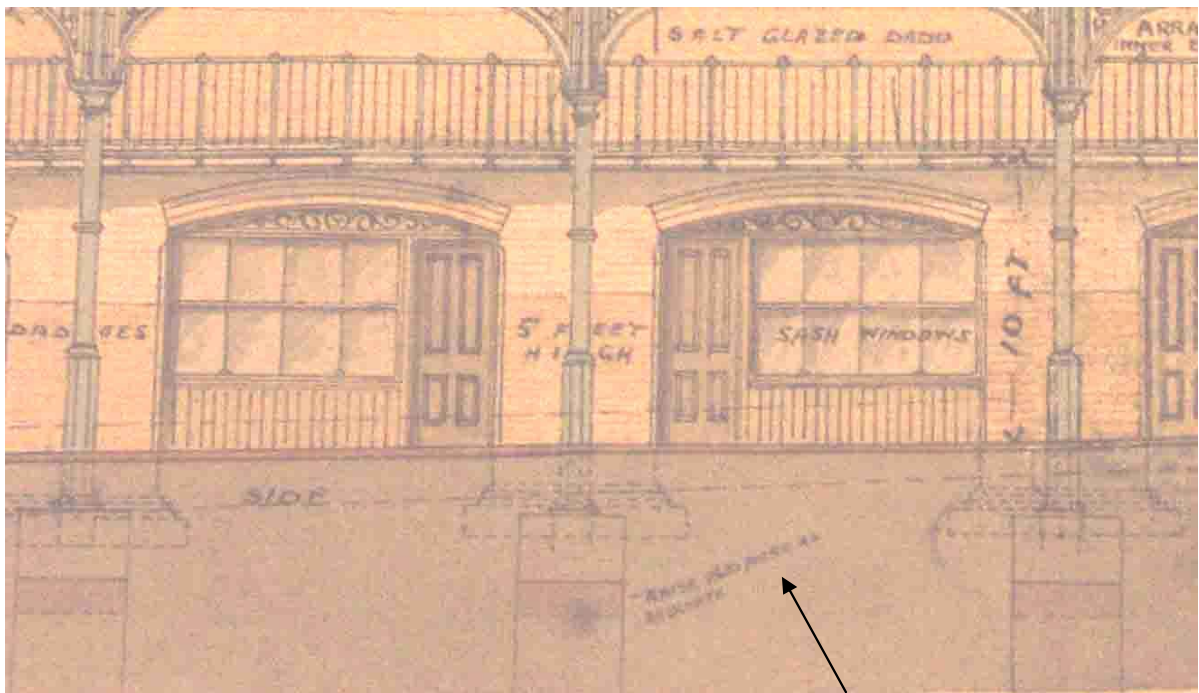
Plate 6: Showing one of the original architect's (Archibald Neill of Leeds) drawings relating to the market hall's rebuild after the fire of 1888. Note the text "raise old piers as requested" at the bottom of the picture.

Above this cut is a portion of the brick column which is probably related to the addition of raised piers noted on the original architects drawings (**Plate 6**).

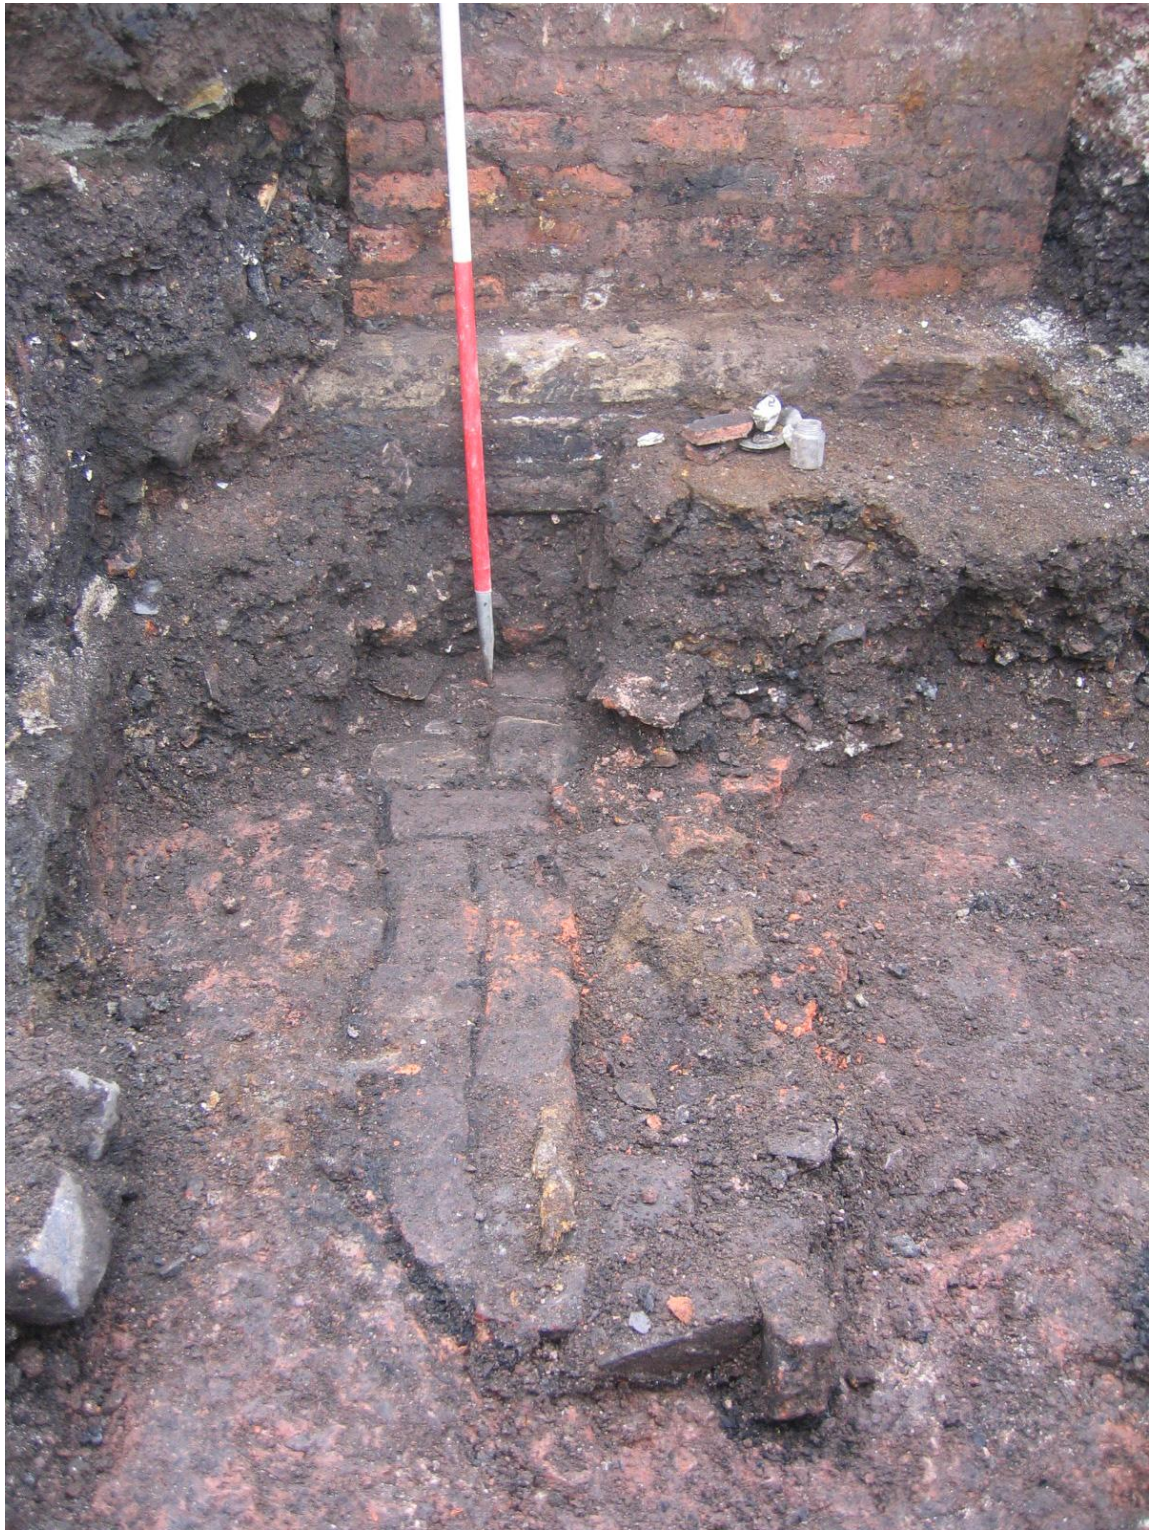
Plate 7: Facing S showing wall [1090] truncated by and underlying brick pillar [1108] associated with the first market hall built in 1879. Note also the truncation at the bottom of the picture due to drain [1092].

Also to the west of the cobbled surface [1070] was a 1.1m long remnant of possible walling [1090] within construction cut [1089], cutting into the natural. Wall [1090] consisted of one course of un-frogged, unevenly pressed bricks, two skins thick and orientated north-south. It has to be noted that the alignment of this wall was north-south whilst the alignment of the bricks in the floor surface to the north were oriented slightly NNE-SSW. The northern end of [1090] was truncated by a drain cut [1092] which effectively separated any relationship between this wall and the brick surfaces to the north (**Illustration 4**). Wall [1090] was also truncated at the southern end by a brick pillar [1108 – underlying 1034/5] and the surviving remnant ran underneath this pillar (**Illustration 11, Plate 7**). A deposit of demolition rubble [1091] lay to the west of wall [1090], overlying a layer of trample [1094]. Deposit [1094] may have been formed during the construction of the first market hall. This was in turn overlain by deposit [1095] containing pottery with a wide date range, from 1780 to the mid to late 19th century (**Appendix 10.4**). The foundation for brick pillar [1108] appeared to be within this deposit. It is possible that this deposit was laid as part of the first market hall construction, possibly to raise the foundation level of this pillar to the same levels as other pillars (i.e. [1060]). The 'best fit' location of wall [1090] is highly suggestive that this structure formed part of the eastern walling of building C (**Illustration 6**); however, some caution must be exercised due to the slight misalignment between the brick structures and the margin of error evident in the overlay of our data with the historic maps.

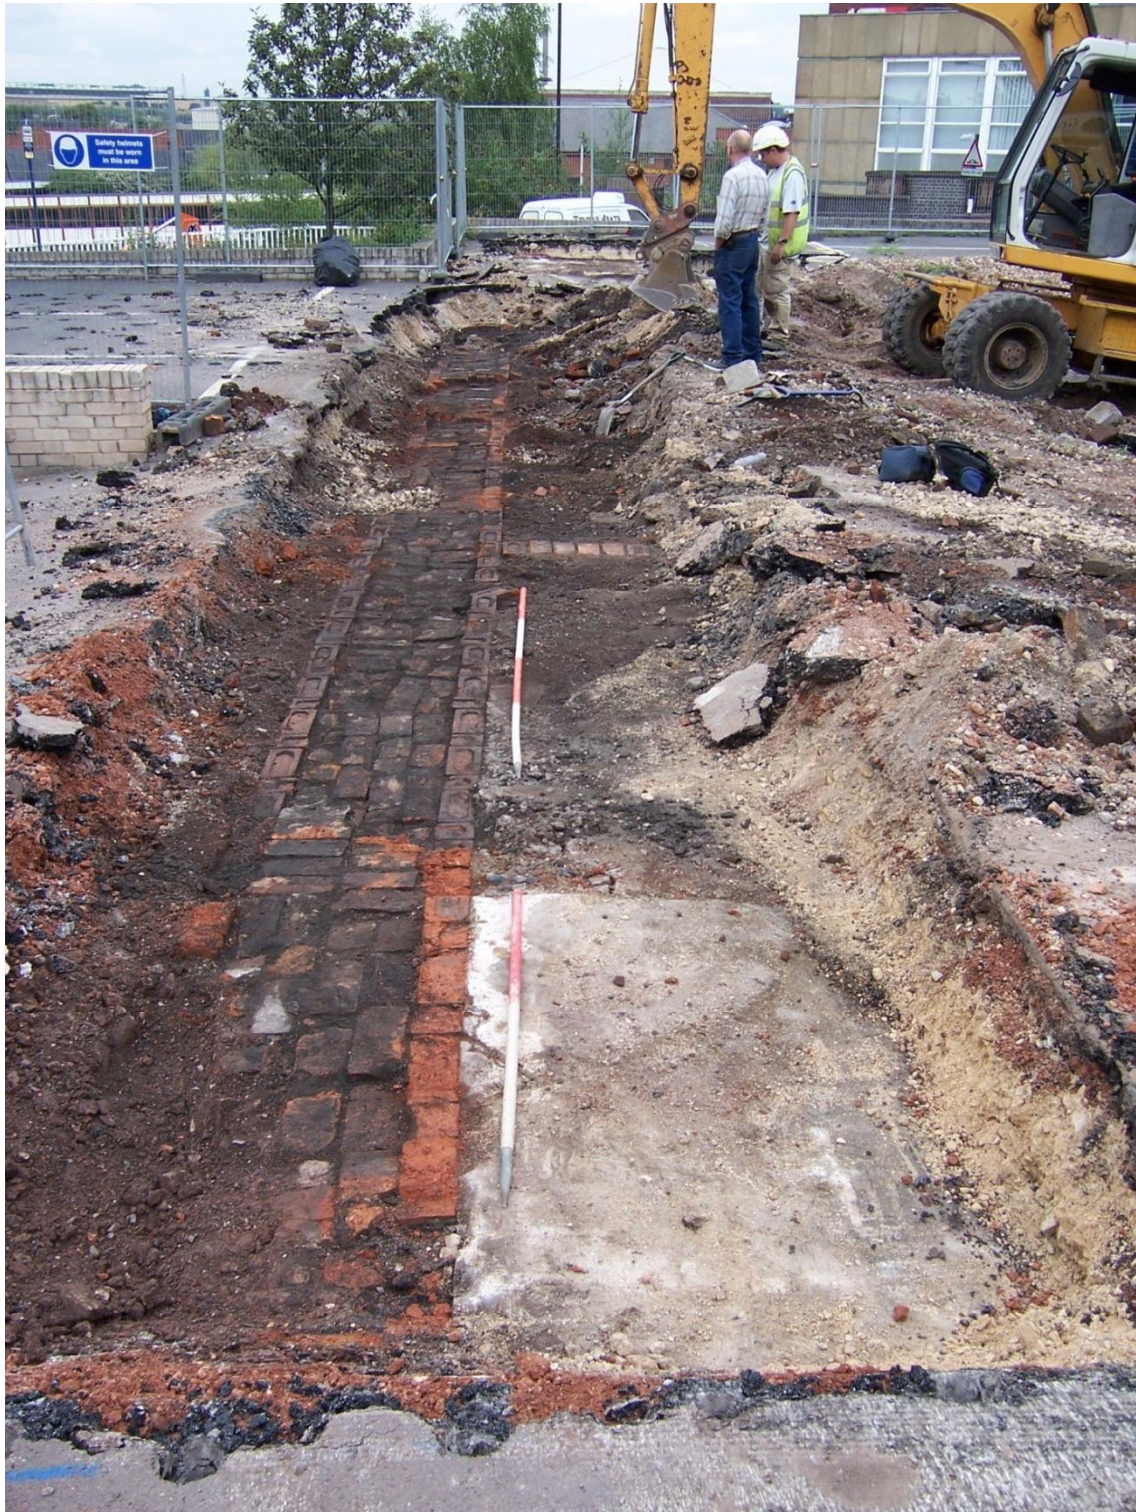
Plate 8: Facing N showing the western market hall brick walling that was built on the large sandstone revetment foundation. This photograph shows the archaeological strip to locate this wall prior to the excavation of Trenches 6 and 7.

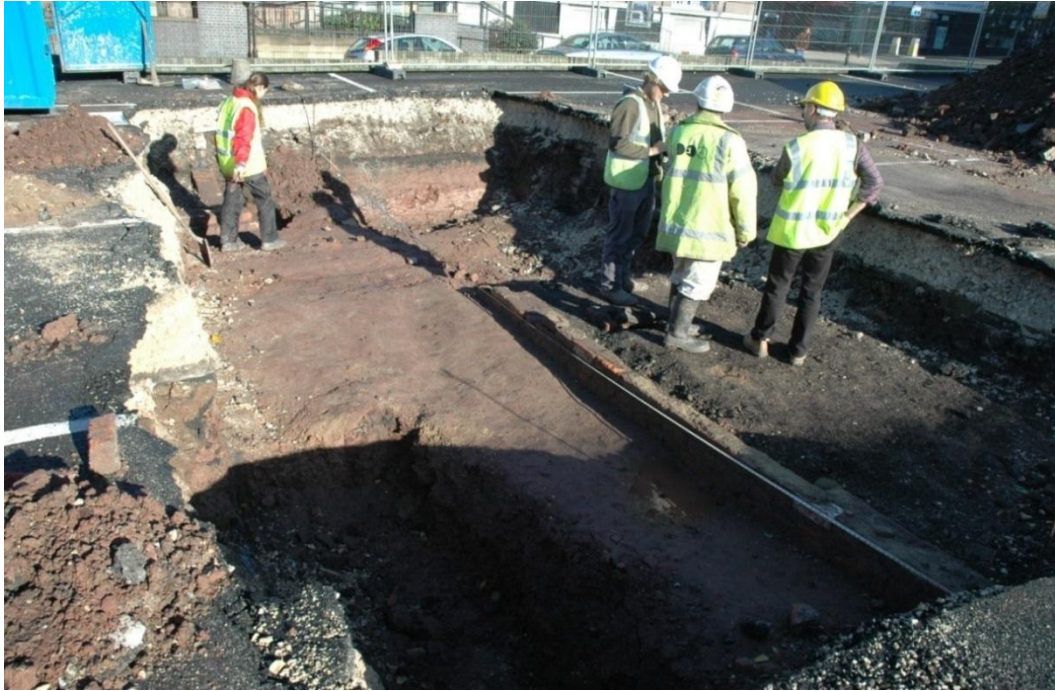
Plate 9: Facing NNE showing the internal market hall wall [312] in Trench 3.

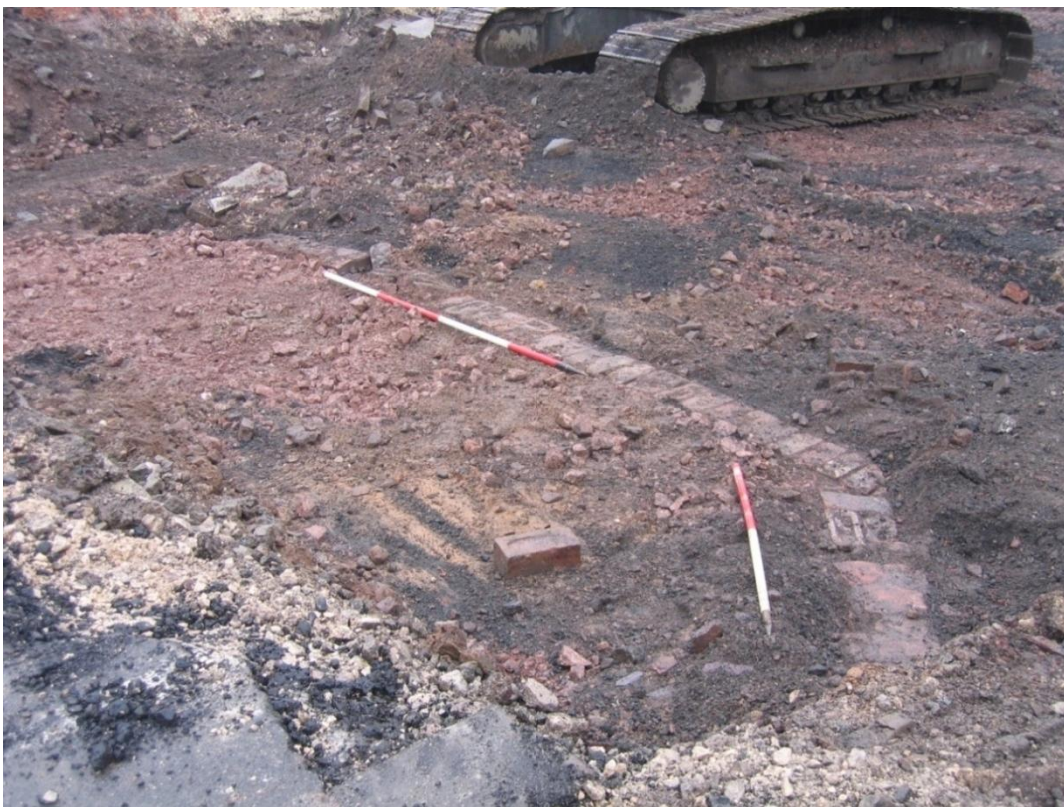
Plate 10: Facing NE showing wall [1013] in Trench 5. This walling was the probable continuation of wall [312] uncovered in Trench 3.

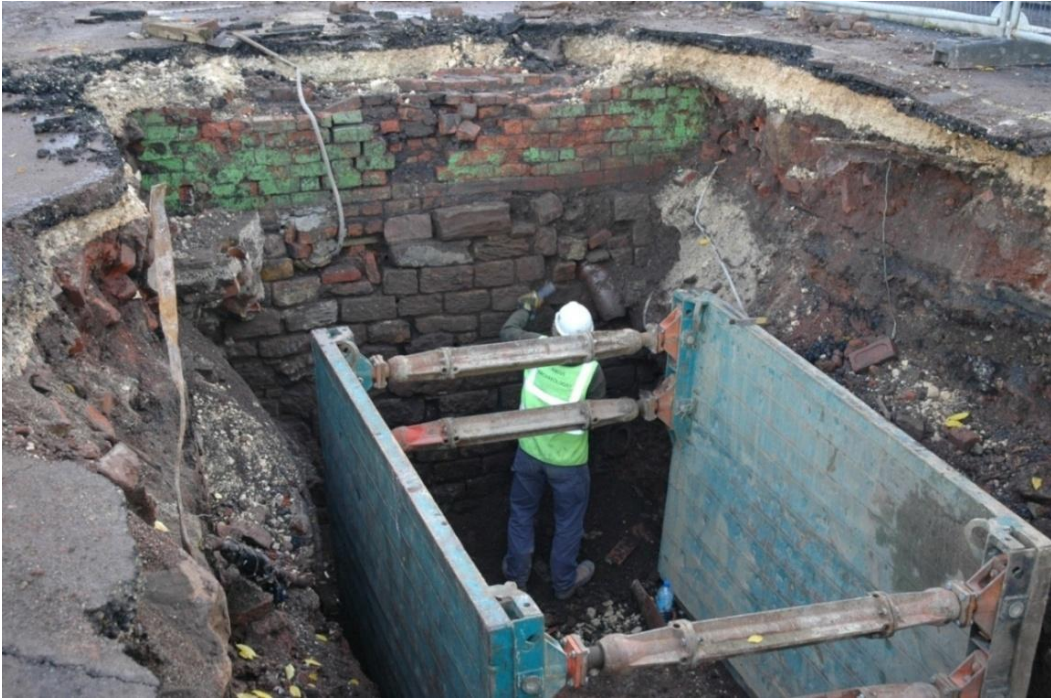
Plate 11: Facing ESE showing the western market hall walling as uncovered in Trench 4 [409].

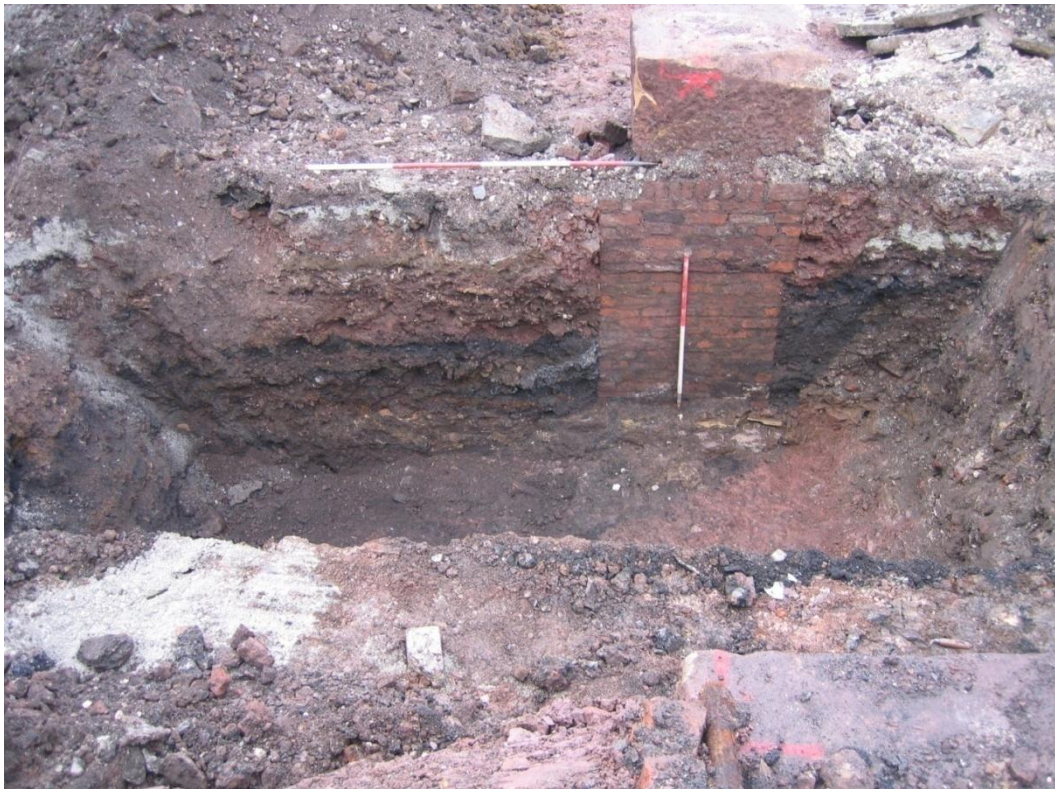
Plate 12: Facing W showing the first phase market hall pillar [1060] within cut [1065]. Note that above this are brick pillar [1017] and sandstone block [1025] which relate to the raised piers of the market's rebuild after the fire of 1888. Note also the deposits of made ground which abut the pillars.

At the base of cut [1045/1065], two brick pillars [1060] and [1108] were constructed upon foundations consisting of flattish sandstone slabs [1061] varying considerably in dimensions but with an average thickness of 0.1m (**Illustrations 9 and 11**). Pillar [1060] (**Plate 12**) measured around 1.03m wide by 1.26m high, and consisted of 13 courses in a predominantly stretcher bond with a cemented brownish grey sandy mortar containing shell inclusions. The bricks were hand made, unfrogged and measured on average 24cm by 10cm by 6cm. Pillar [1108] measured 1.08m wide by 0.80m high. It consisted of ten courses of brick with a form and bonding similar to that of [1060]. Both pillars were only partially exposed but appeared square in plan. The pillars may have formed the foundation bases or supports for the pillars of the first market hall. Pillar [1060] directly underlies sandstone block [1025] in plan. Pillar [1108] directly underlies sandstone block [1034] in plan.

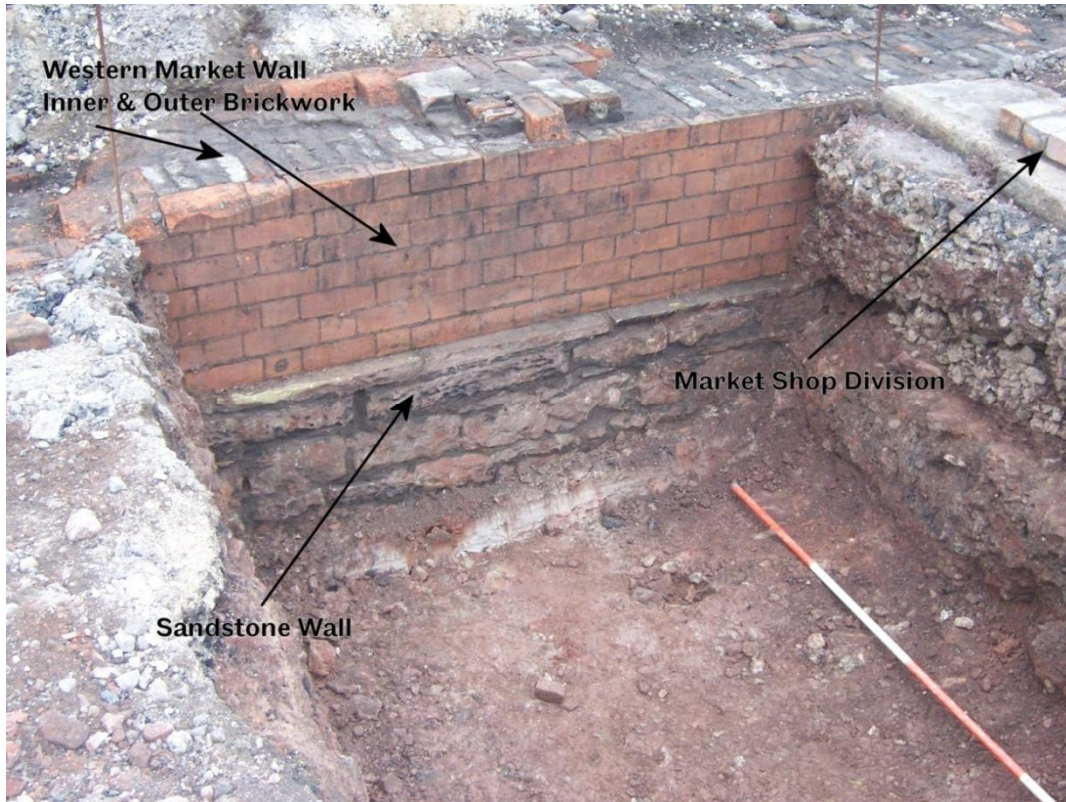
Plate 13: Facing WNW showing several features within the Trench 6 section.

As Trenches 4 and 7 revealed, the original brick walling over the sandstone wall at the west of the site was subsequently re-faced with more modern, shallow-frogged bricks. In Trench 6, the east face of wall [608] was intermittently bonded to a skin of red, industrially pressed brick [607]. The bricks measured 23.7cm x 11.5cm x 8cm and had shallow rectangular frogging with bevelled corners. Eight courses were evident, bonded in the Flemish style by a dark grey mortar (**Illustration 18** and **Plate 13**).

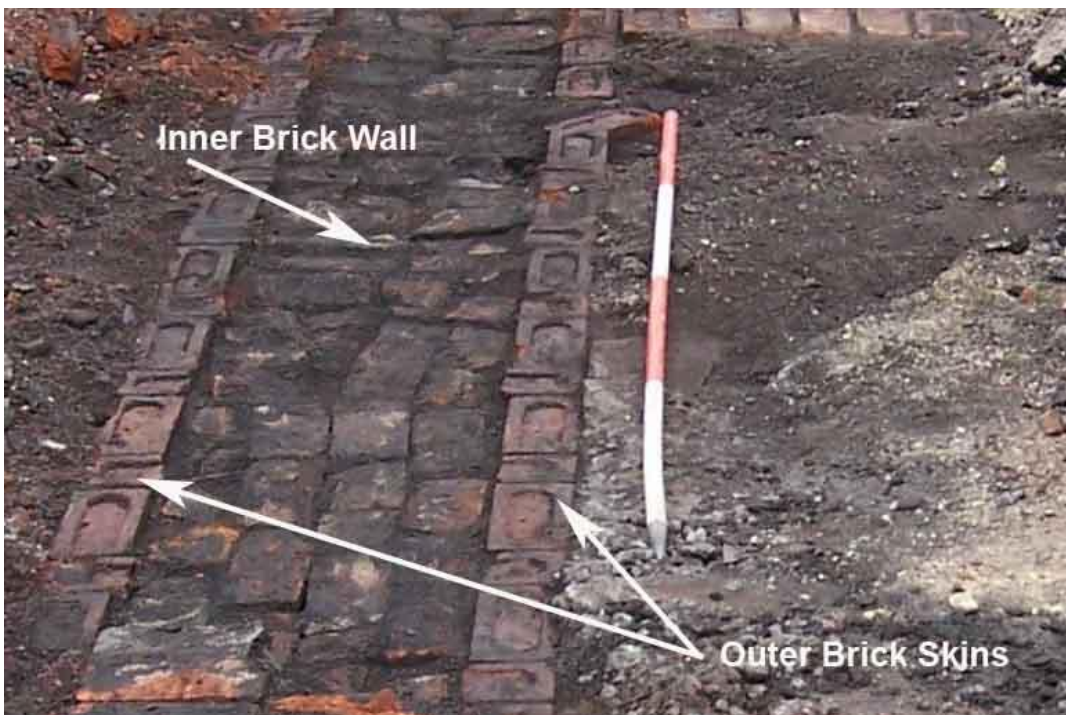
Plate 14: Facing N showing a close up of the inner and outer brickwork of the market hall's western wall.

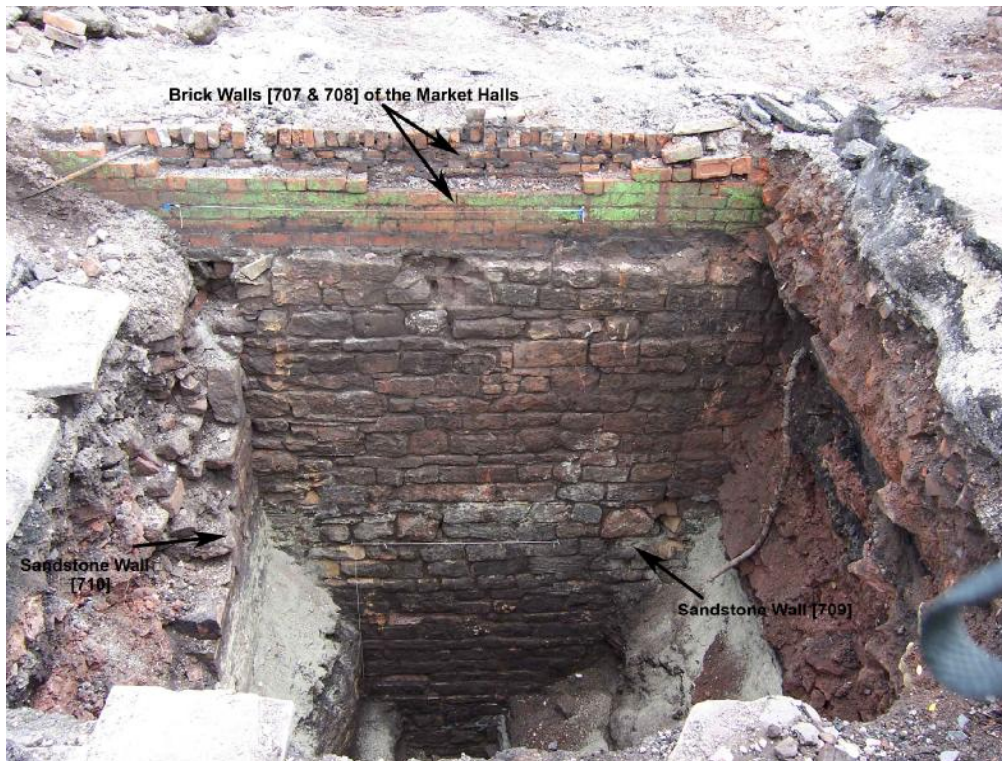
Plate 15: Facing E showing the western market hall wall [707, 708 and 709] with buttress [710] uncovered within Trench 7.

wall [709]'s western face at its eastern end (**Illustrations 17 and 20, Plate 15**). Wall [710] measured 3.0m long by 0.5m wide by 3.0m long and was constructed from similar dressed sandstone blocks to those seen in wall [709]. Again, these were laid in uneven courses, though in this structure the constituents were bonded by a thickly-laid greyish-brown-coloured mortar which was soft to the touch. Following the watching brief it was quite clear that the wall directly overlaid a substantially wider east-west aligned sandstone wall [1236], which it may have utilized as a foundation (see the watching brief results below). The wall may have had an inclined slope at the western extent. Wall [710] had been truncated at the top. This truncation possibly occurred as a result of the construction works associated with the reconstruction of the market hall after the fire of 1888. The deposits that abutted walls [709 and 710] often appeared to be tipped, indicating a rapid process of in-filling. The date range of the artefacts recovered from these made-ground deposits, mainly pottery and clay pipe, is fairly narrow. The analysis (**Appendices 10.4 and 10.5**) indicates a date of the mid to late 19th century for the deposition of these deposits, which is consistent with the construction of the first market hall in 1879. It is likely that wall [710/1236] formed a supporting buttress to the large north-south revetment/foundation wall at the west of the site.
