Rotherham Westgate Demonstrator Project (Sites 3 and 5), Rotherham, South Yorkshire

Archaeological Excavation

ARCUS report 943e.1(1)

March 2009

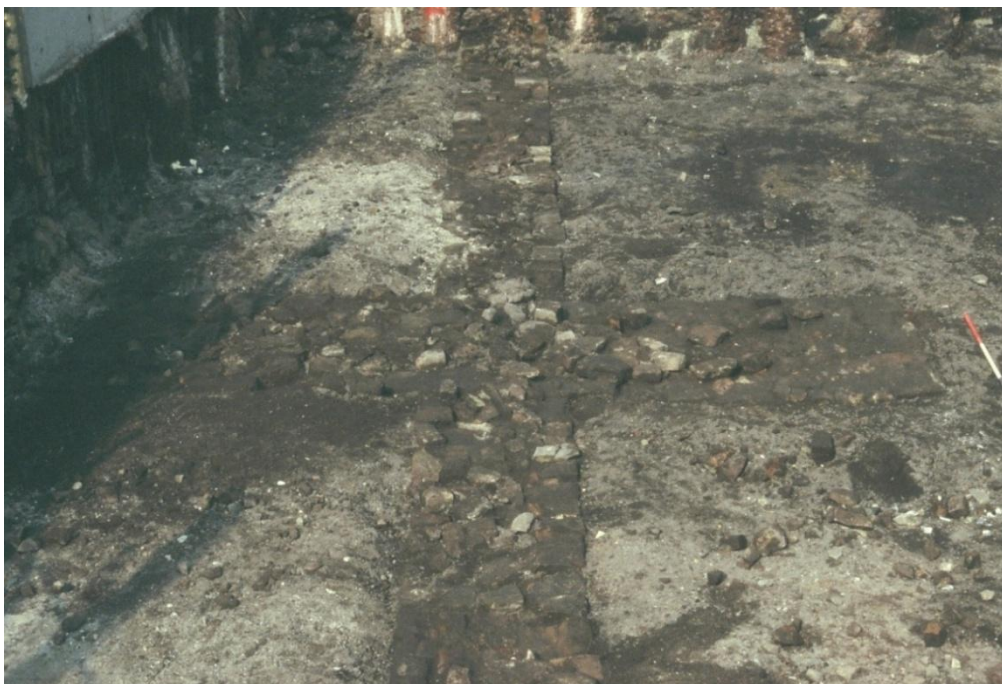
Plate 16: Facing N showing the east-west buttress foundation [1236] which lay beneath wall [710] in Trench 7. Note walls [1231] to the north and [1235] to the south which form the base of the market hall's western wall. These structures were recovered on the watching brief during ground remediation and piling.

The data from the watching brief was overlaid with the data from the previous excavations and a very good fit in the data was achieved (**Illustration 21**). The watching brief also revealed an east-west aligned sandstone structure [1236] underlying the major north-west wall (**Plate 16**). The structure measured 6.2m long by 1.55m wide and was faced with dressed blocks externally with a core of sandstone rubble within. The wall was built on an offset foundation of sandstone which extended 0.1m beyond the upper portion of the wall. The wall extended beyond the western limits of the site, where it was truncated by the modern piling. The eastern limit of the walling was faced by dressed blocks, suggesting that this was the wall's terminus. The function of this structure was unclear, but it was clearly substantial. The structure was unlikely to form part of the walling of a building as there was no evidence of a return wall at its eastern extent. It is now understood that the structure probably formed the lower offset part of a buttress below wall [710] uncovered in Trench 7, and that the wall may have a role in the terracing, revetting or landscaping of the area prior to the building of the market hall in 1879. It is important to note that the deposits to the east of the terminus of wall [1236] were a mixture of black industrial clinker and grey ash that extended well beyond the terminus of the wall (**Plate 16**). No cut was visible through these deposits and we know from Trenches 6 and 7 that the deposits related to the first market hall built in 1879. This suggests that both of the walls were constructed within a pre-existing void. From their location with regard to the 1774 and 1854 historic maps (see **D** on **Illustrations 5** and **6**), it is suggested that this area housed the tenements associated with the Rotherham Old Pottery and the later Iron Foundry as well as a block of buildings immediately to the east.

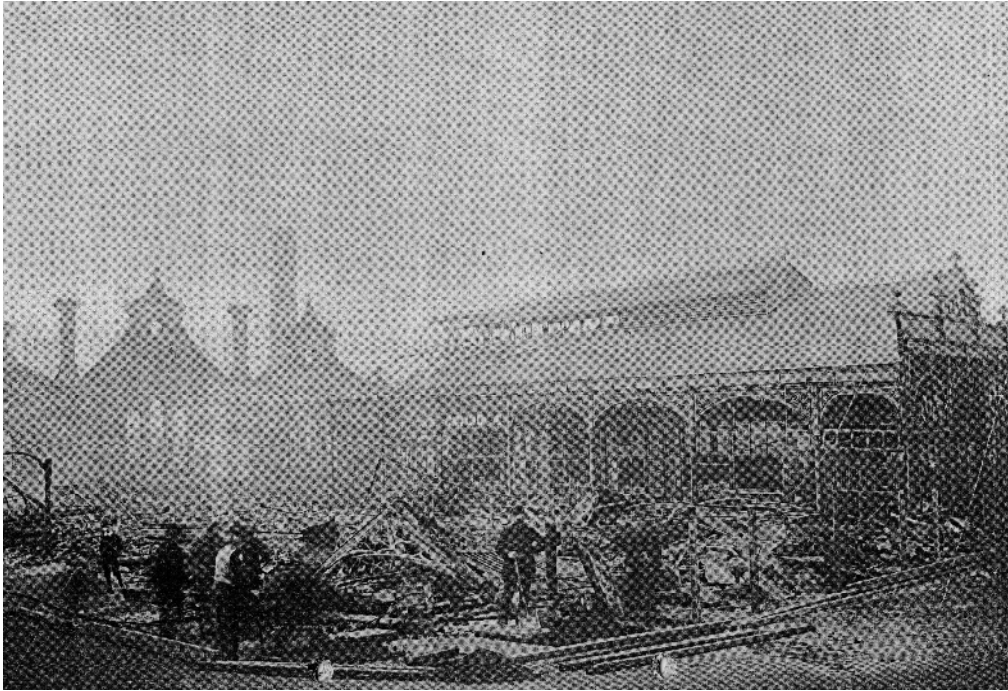
Plate 17: Historic archive photograph, facing NW, showing the destruction after the fire of 1888. Note that the triple gable ended western market hall wall (centre left) and the northern wall are still standing.

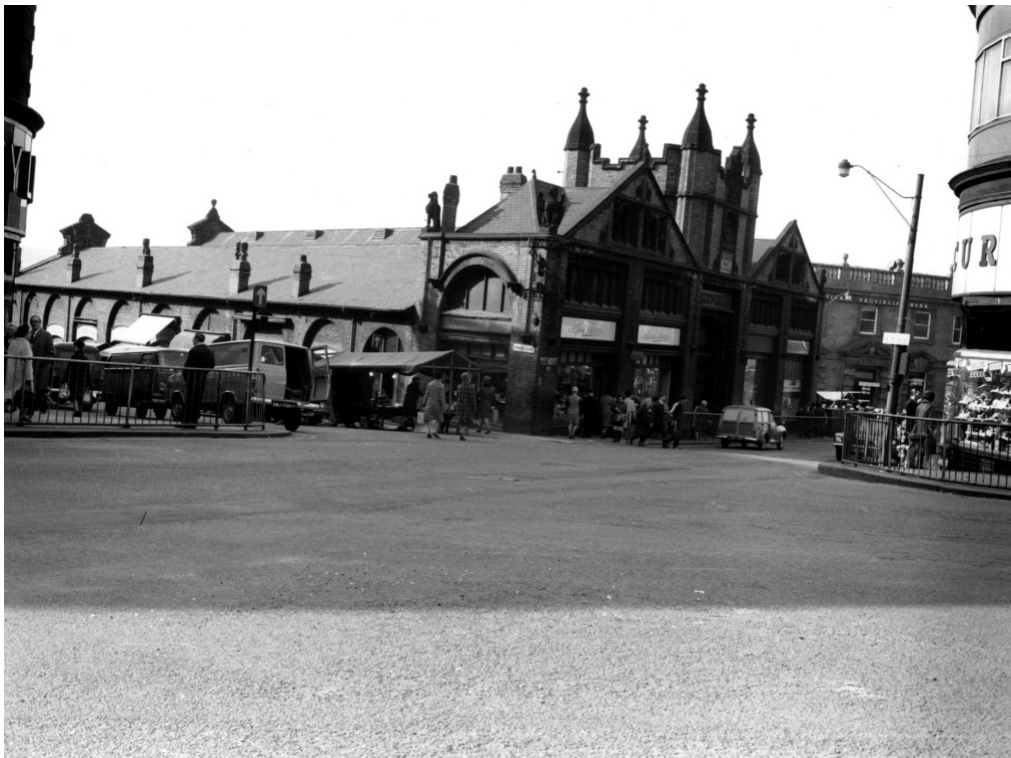
Plate 18: Historic archive photograph, facing NW, showing the rebuilt market (RALSS, photo no. 02977). Note the arched (shop?) bays in the southern market wall which may relate to structures [206] and [229] uncovered in Trench 2. Note also the four turreted tower of the market's eastern entrance.

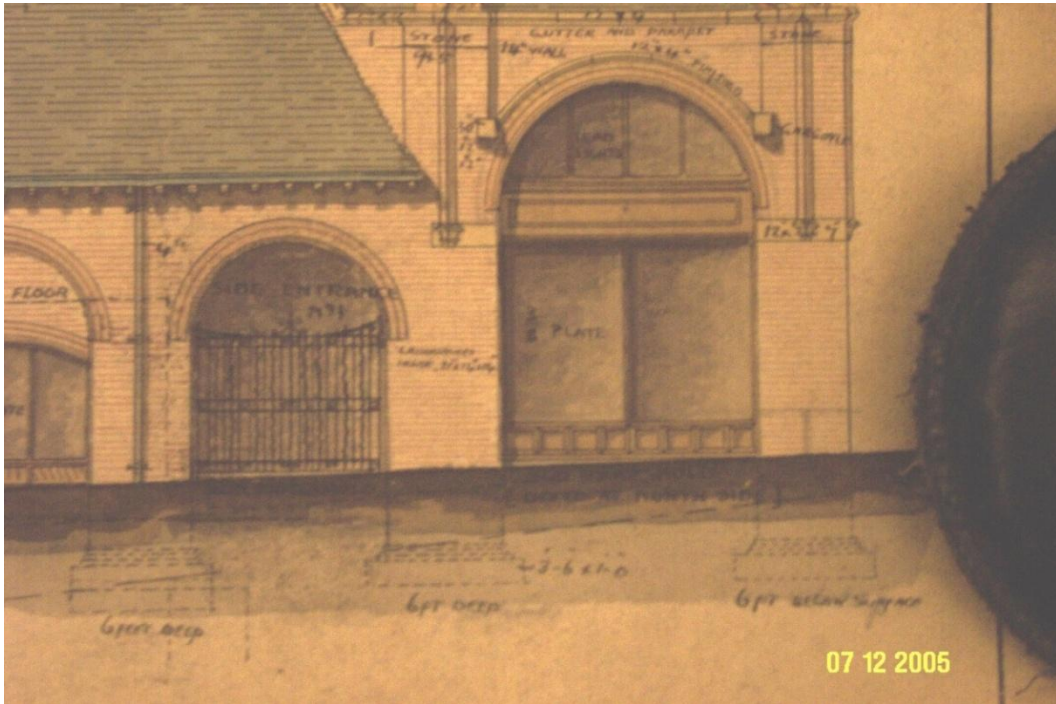
Plate 19: Showing the architect's drawing of the market's south-western corner depicting the southern side entrance and one of the probable shop units to the left of this.

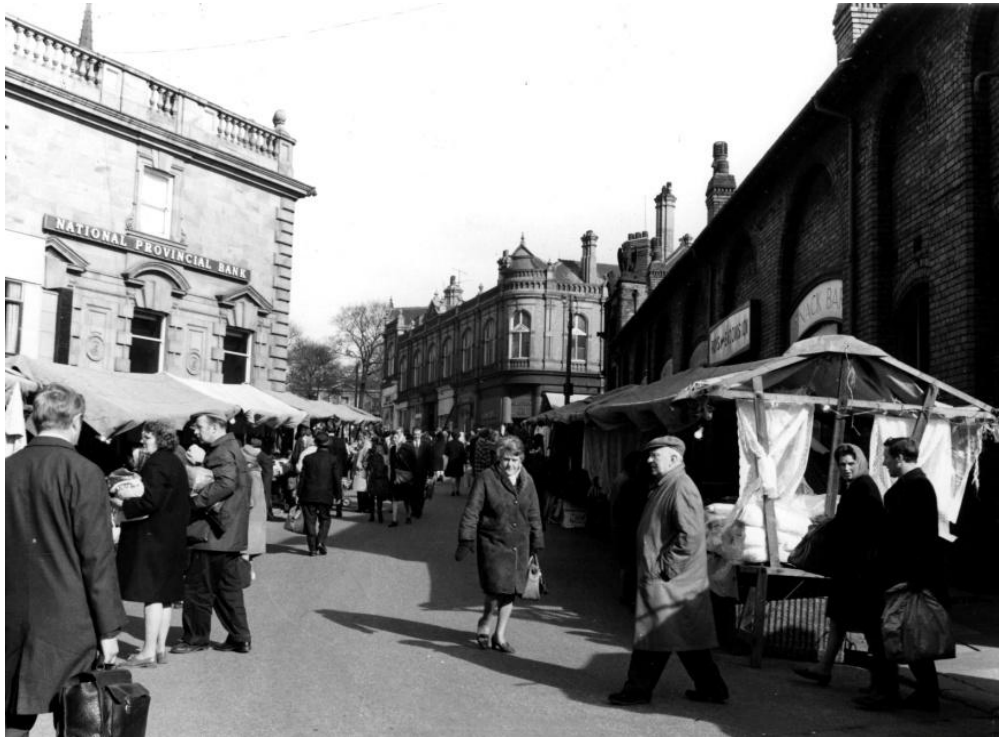
Plate 21: Historic archive photograph, facing ESE, showing the northern market wall (right) (RALSS, photo no. 02988). Note the brick arches that may have been supported on substantial brick pillars.

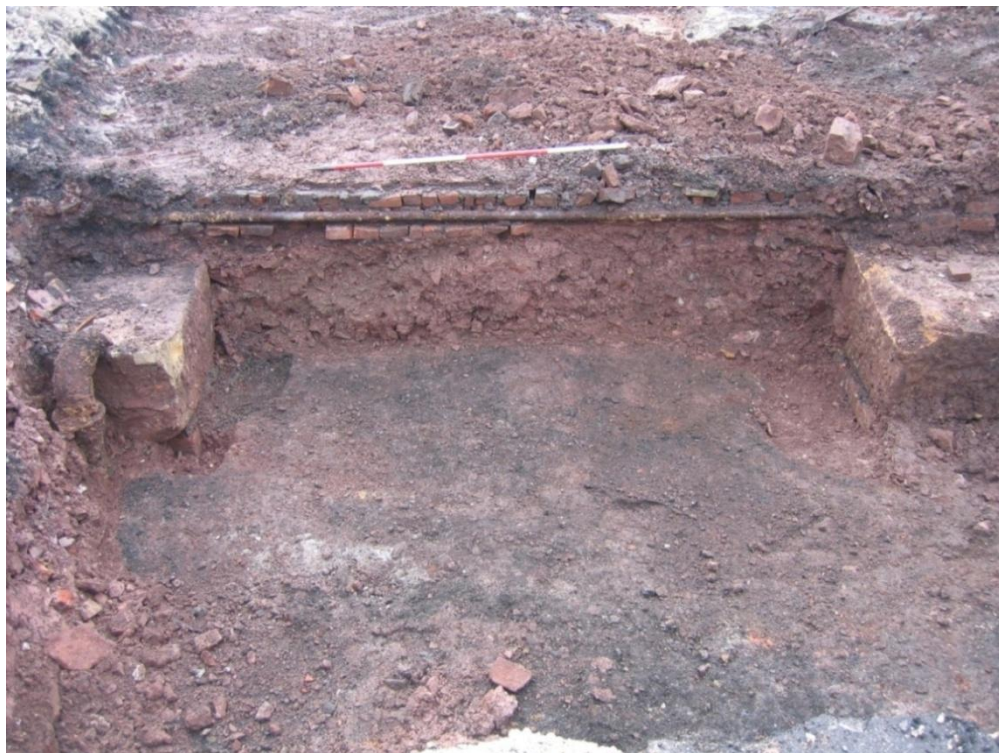
Plate 22: Facing S showing cuts [1015] and [1018/1063] through the blackened burning deposit of [1022]. Note the second market hall sandstone blocks [1024] and [1025] within these cuts and the made ground deposit abutting these. Note also the drainage channel [1011] at the top of the section.

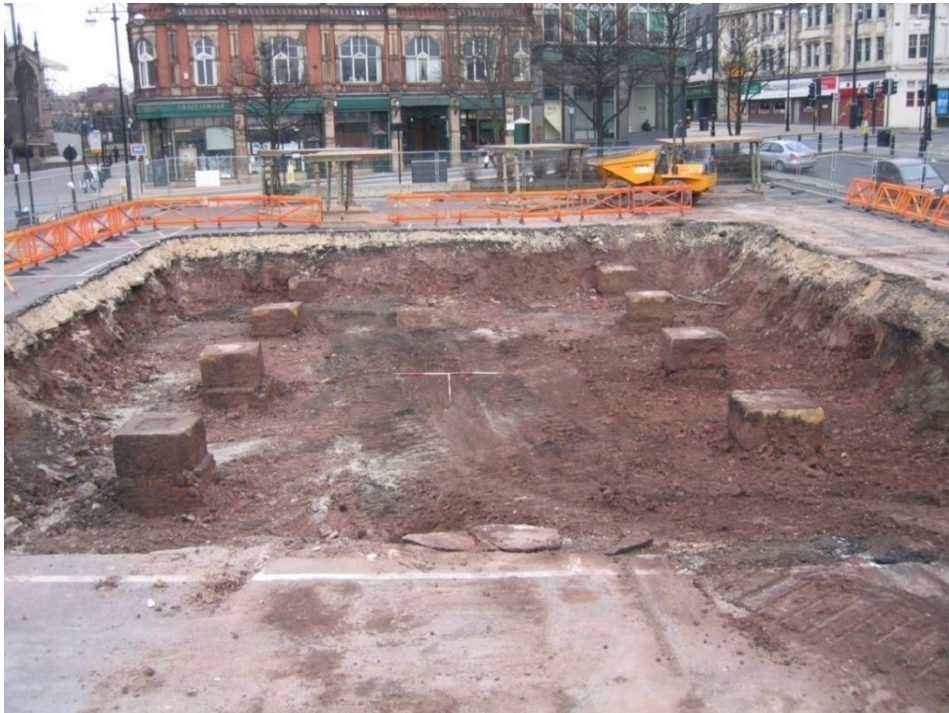
Plate 23: Facing E showing Trench 5 prior to the excavation of the L-shaped sondage. Note the sandstone blocks which would have probably supported the cast roof support columns. Note also the 'Imperial Buildings', built in 1907 to replace 'The Shambles' (top).

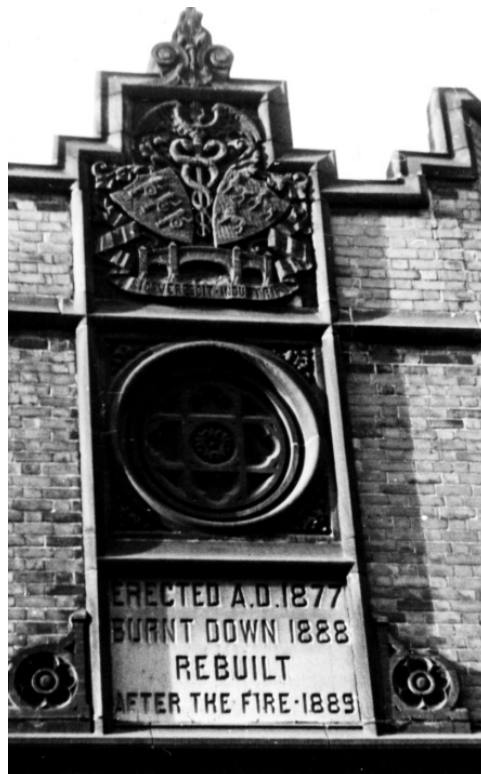
Plate 24: Historic archive photograph showing the date plaque in the tower of the 2nd market hall (RALSS, photo no. 03006). Work was begun after the fire in 1888 and completed by 1889.

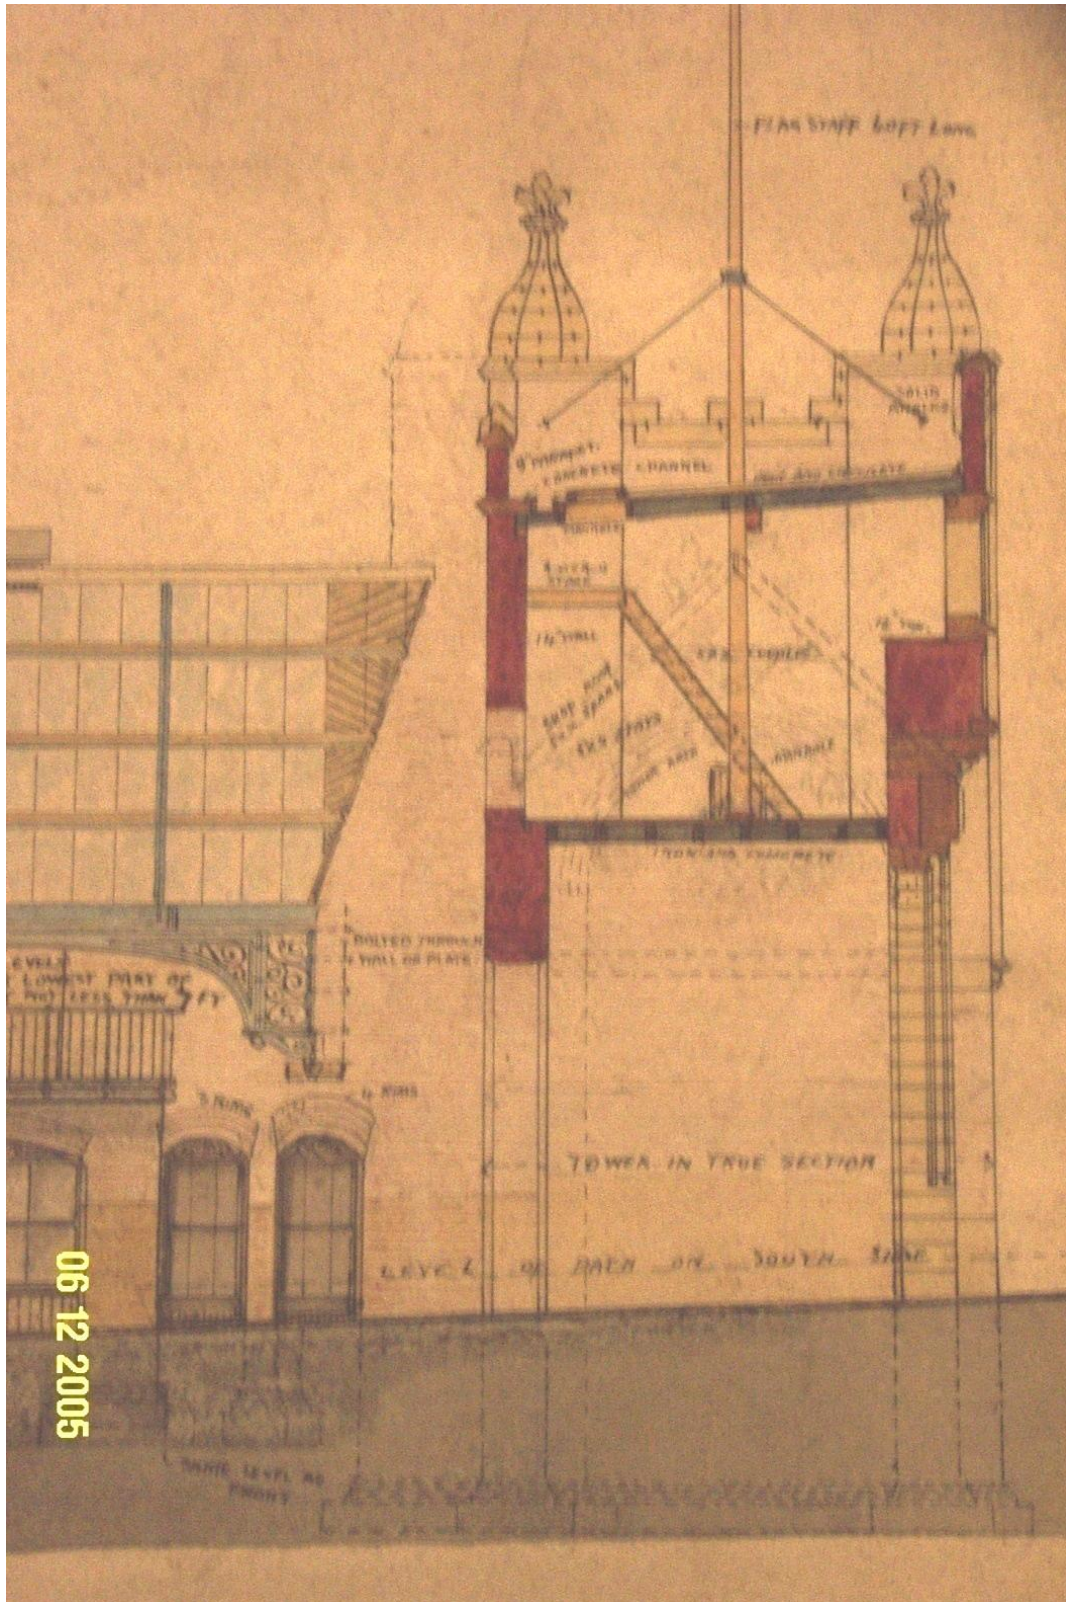
Plate 25: Original architects south facing elevation of the tower to be constructed in the eastern market wall. Note that the tower was to be constructed on piers similar to those found throughout the site. Structures [1221] and [1222] recovered during the watching brief may have related to the interior supports.

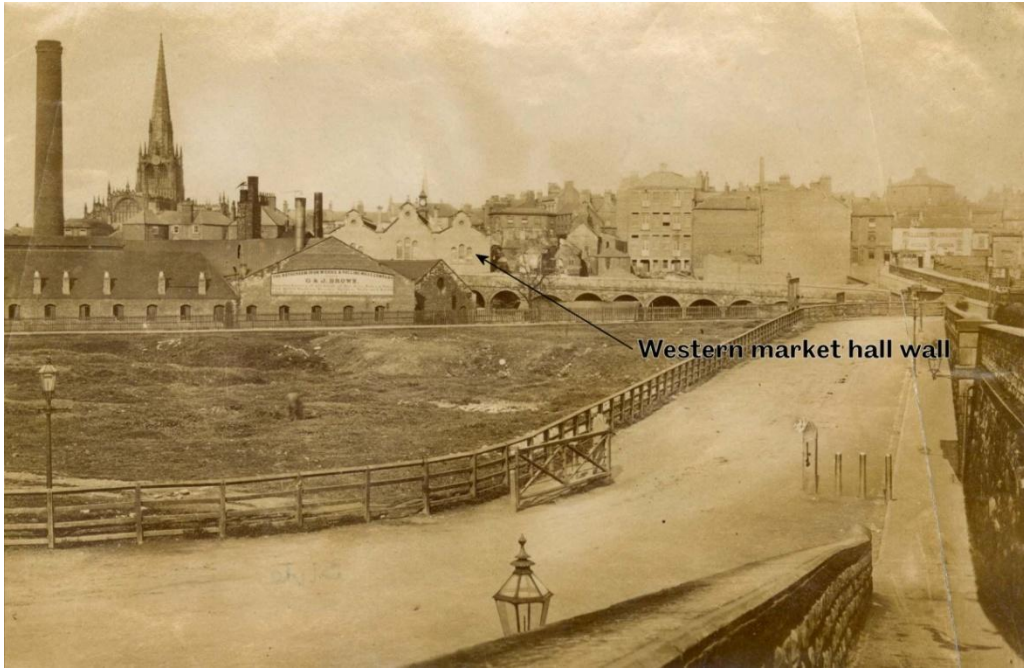
Plate 26: Historic archive etching, facing E, showing the first market hall (RALSS, photo no. 01324). Note that there is no large square turreted tower visible behind the western market hall walling.

market, which depicted a towered entrance way, as well as pillared supports in the eastern wall (**Plate 25**). The first market of 1879 does not appear to have had a tower at the eastern entrance (**Plate 26**).

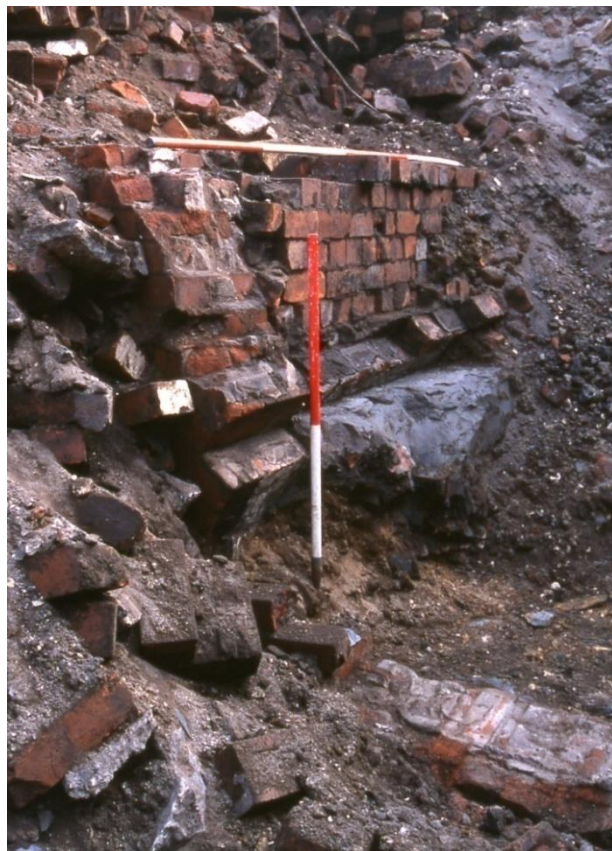
Plate 27: Facing SSE showing the vaulting and walling probably associated with the late 19th-century public baths

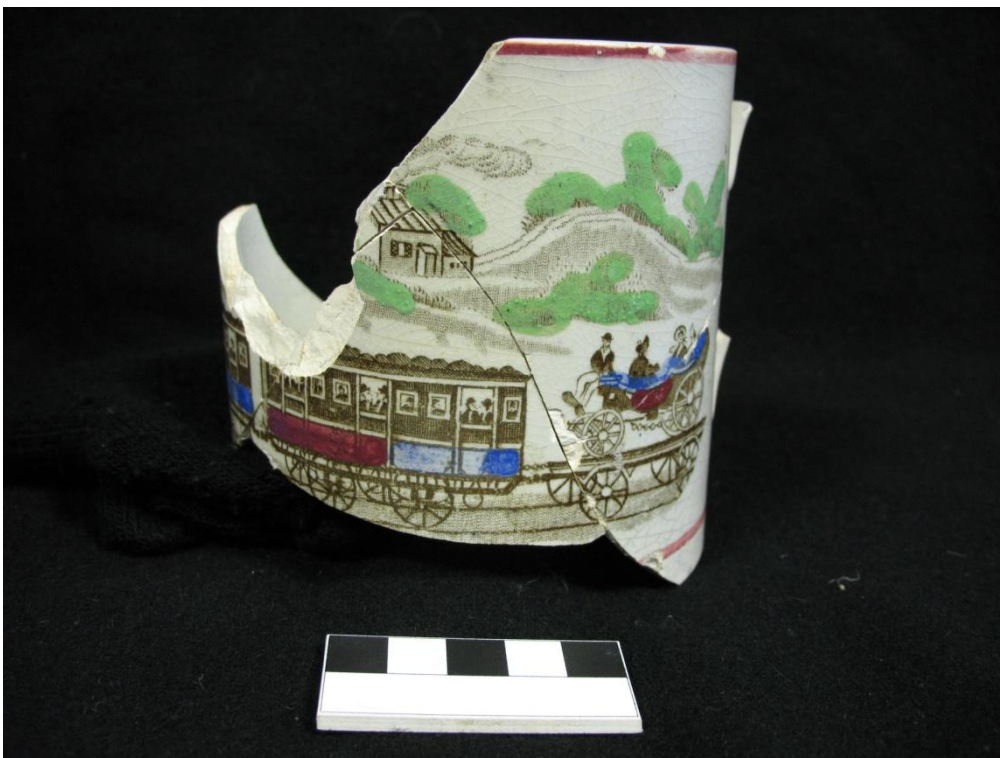
Plates 28/29: Showing the mug depicting the early steam engine named 'Deakin' pulling carriages uncovered from context [1095] in Trench 5.

The second piece from this context is a mug bearing a design featuring an early steam engine named 'Deakin' pulling a number of carriages (Plates 28 and 29). It is believed that this is a commemorative mug but to date it has proved impossible to identify either the engine or the event commemorated. Two individuals named Deakin have been traced with links to the railway industry, but in each case the character of the engine and carriages shown on the mug appear to predate the working lives of the individuals concerned.
