100 Penistone Road, Sheffield, South Yorkshire

Archaeological Desk-Based Assessment

ARCUS report 1278.1(3) April 2009

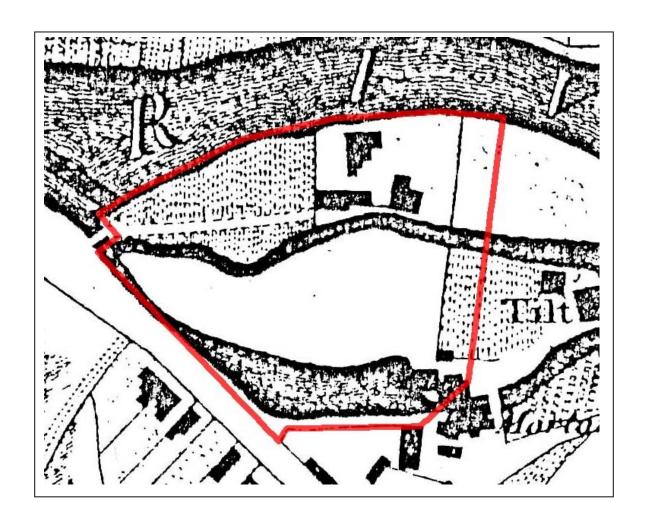
Project:	Scale:	Date:
	Penistone Road, Sheffield	-	April 2009
		NGR:	Drawn:
ARCUS	Title:	SK 345 388	M. Stenton
Unit 6, Riverside Block Sheaf Bank Business Park Prospect Road	1808 Fairbank map	Project No:	Illustration No:
Sheffield S2 3EN Tel: 0114 2225106 Fax: 0114 2224346		1278	3

William Fairbank III produced a map of Sheffield in 1808 (**Illustration 3**). This showed the whole of the Morton Wheels site and the locations of features such as the wheels, dam, goits, bridge and outbuildings that had been roughly sketched the previous year were depicted with greater clarity on the 1808 map. Several features were shown for the first time on this map, including areas of land under cultivation on the north-east side of the dam and in the westernmost plot to the north of the goit. The footbridge at the south-west corner of the site was shown leading to a path or track that ran east through the cultivated area to the plot containing the three large, detached buildings.

The 1808 map marked a 'tilt' at the Lower Morton Wheel to the north-east of the proposed development area, suggesting that the goit was powering a forge that had been constructed in that location. It is not clear if an 1810 record of a 'new tilt' at the site referred to this feature or if a further tilt had been constructed elsewhere within the site by that date.

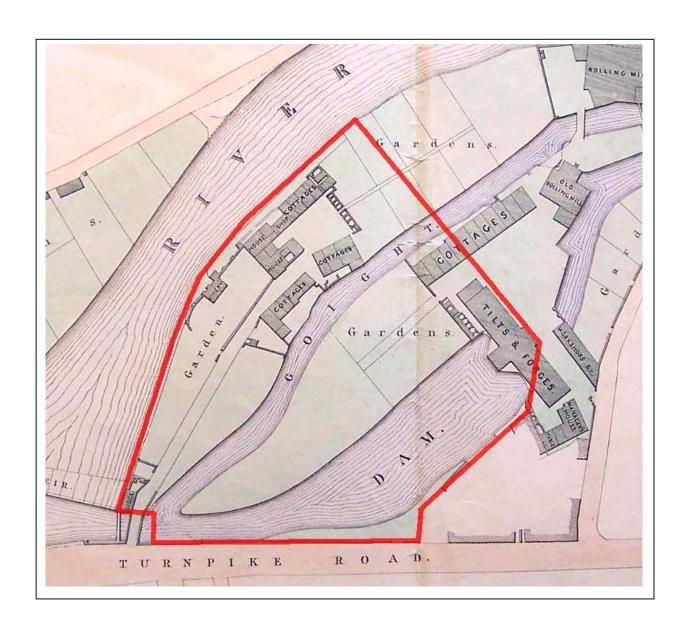
Butchers, a long-established Sheffield steel company, conducted a substantial redevelopment of the site. These changes were shown on William Flockton's 1845 plan (**Illustration 4**). Flocktons were a firm of Sheffield architects and are likely to have designed the new buildings within the site. The 1845 plan suggested that the Morton Wheels had been demolished and replaced by the new Philadelphia Works. The latter were shown as a sub-rectangular building marked 'tilts and forges', which occupied the southern parts of the former Morton Wheels site but which ran further to the north-west and south-east.

Further features depicted on the 1845 plan included three pairs of back-to-back houses and five terraced cottages on the north side of the goit; a row of twelve

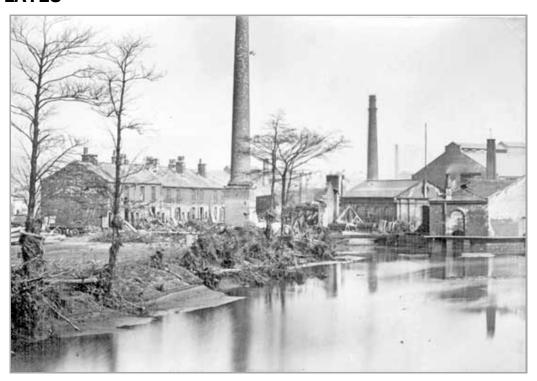
Plate 1 – Looking north-east towards mill dam, cottages, works chimney and part of Philadelphia Steel Works, following 1864 Sheffield Flood (Picture Sheffield y00945).

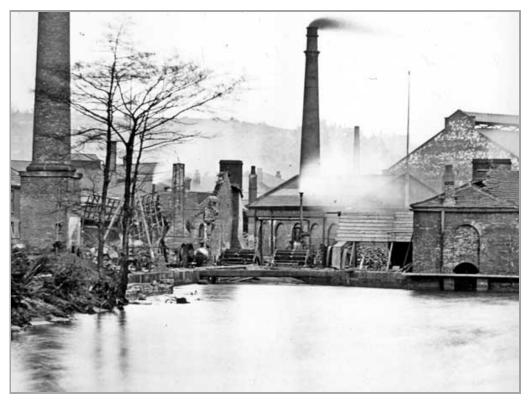
Plate 2 – North-east corner of dam following 1864 flood, showing sluice leading to two water wheels at centre. Remains of gable wall to left of wheels suggests wheelhouse destroyed during flood. North Wheel of post-medieval Morton Wheels located formerly in area of small building at right (Picture Sheffield w00450).

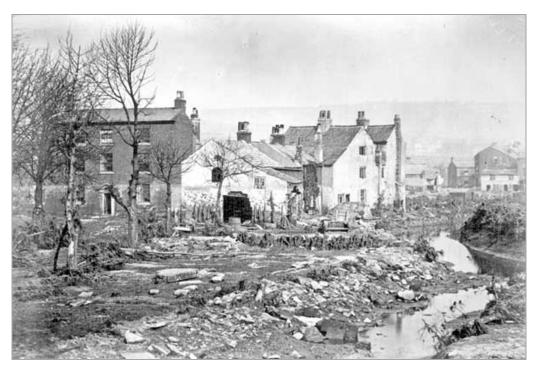
Plate 3 – Domestic housing to north of goit (shown bottom right), following 1864 Sheffield Flood. Large house at left named 'The Grove' on 1854 OS map (Picture Sheffield y00943).

The large house known as The Grove, the goit and the cottages on the north side of the latter were also photographed (**Plate 3**). The Grove was shown to be a substantial, three-storey building, while the cottages to the south were two- and three-storey properties with cat-slide roofs.

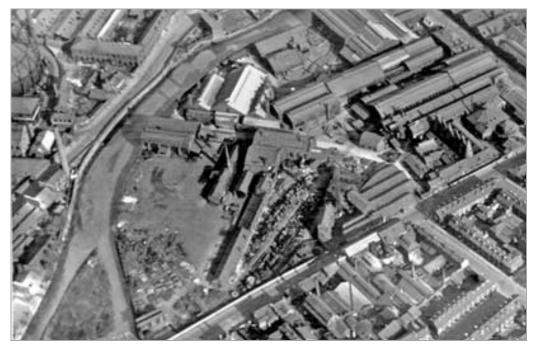
Plate 4 – Mid-20th-century aerial photograph of site during final phase of Philadelphia Works. River Don at left, with former dam site in area of rubble at centre-right (Picture Sheffield s12360).

Subsequent mid-20th-century aerial photographs showed the modern development of the site, with various buildings replacing the 19th-century industrial units to the north of the Penistone Road frontage (Picture Sheffield s22114). Several of these structures were themselves replaced during the later 20th century, although the 1981 Ordnance Survey map (**Illustration 8**) suggested that the majority of the site's standing buildings had been constructed by that date.

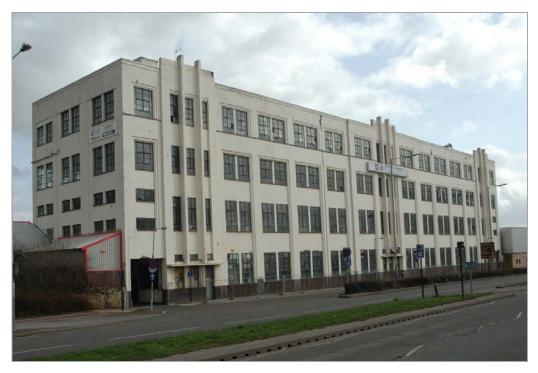
Plate 5 – Osborn Mushet Tools, street frontage structure probably built during the 1940s, on site of Morton Wheels dam. Looking north-east from Penistone Road.

The site is bounded by Penistone Road to the south-west, the River Don to the north and several large industrial works to the east and south-east. Six buildings, ranging in date, are set around a central yard and a rear yard. The principal building within the site is the former Osborn Mushet Tool works (**Plate 5**). This four-storey-plus-basement block fronts onto Penistone Road and appears to have been constructed between the mid-1930s and mid-1940s.

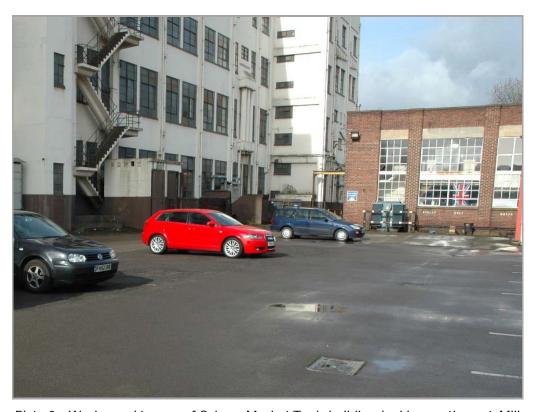
Plate 6 – Works yard to rear of Osborn Mushet Tools building, looking south-west. Mill dam located formerly in area occupied by Osborn building and yard, with goit running north-east through site of single-storey building at centre-right.

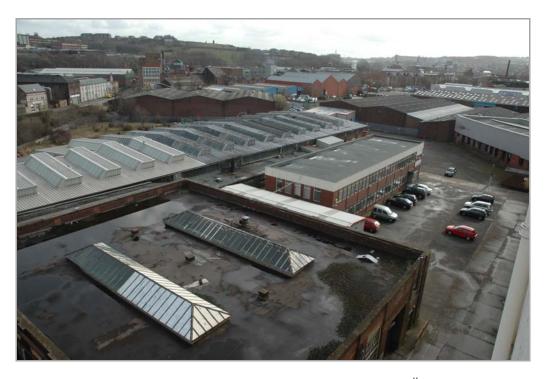
Plate 7 - Looking north-east from roof of Osborn Mushet Tools. 16th-century Morton Wheels and 19th-century Philadelphia Works stood in area at centre-right, with mill dam in yard at lower right. Buildings at left occupy site of goit.

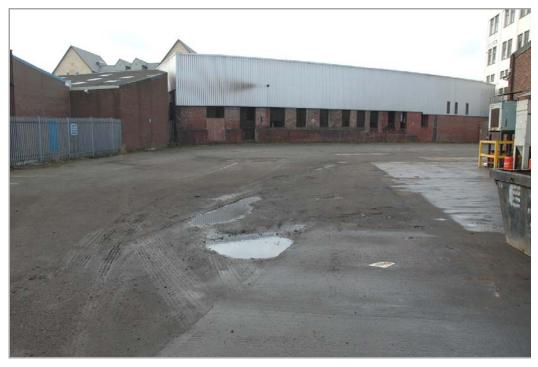
Plate 8 - Yard at east of site. Mill dam wall and tail goit located formerly in area towards centre of shot. Morton Wheels located formerly in upper part of yard, with Philadelphia Works situated in foreground.

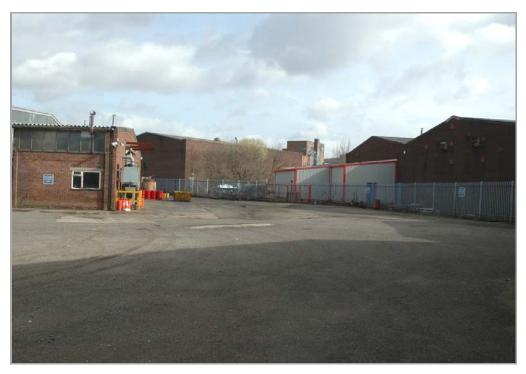
Plate 9 - Yard at east of site. Dam located from left to centre of yard, with sites of Morton Wheels and Philadelphia Works at right of yard. Site of large chimney in Plates 1 and 2 located within footprint of building at centre-left.

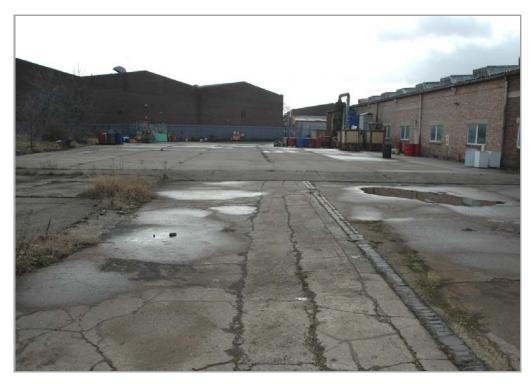
Plate 10 – Works yard at north of site. Goit crossed this area on 1759 plan, while the white buildings shown in Plate 3 occupied the foreground from the late 18th century.

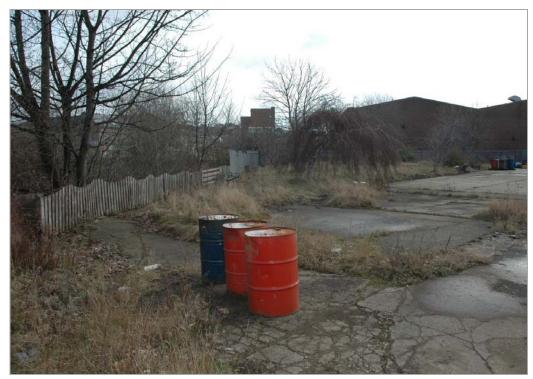
Plate 11 – Area of scrub at north of site. Cottages and gardens shown in this area in 1845.

10), which are typically surfaced in tarmac or concrete. A triangular area of scrub and trees is present at the north of the site (**Plates 11** and **12**). No obvious evidence of pre-20th-century standing structures or potential sub-surface archaeological deposits were observed during the site visit.

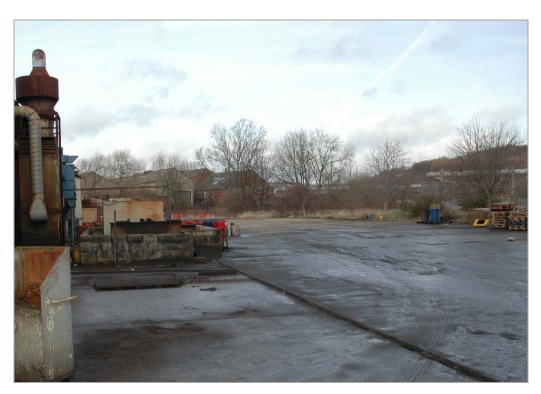
Plate 12 – North of site, looking west towards site of Garden House, shop and cottages shown on 1845 map. Goit and cottages occupied area at lower and centre-right of shot.
