## Wing, Leicestershire

### Archaeological Watching Brief

ARCUS report 1282.2(1)

PROJECT DETAILS		
OASIS identifier	Arcus2_60705	
Project title	Water Main Renewal, Wing, Rutland	
Short description of the project	An archaeological watching brief monitoring the excavation of geotechnical trial pits on an existing water mains was required as the pipeline crossed fields containing medieval ridge and furrow earthworks close to the historic settlement core of Wing. In addition a probable prehistoric site lies near the northwest end of the pipeline route. The scope of works consisted of the excavation of 7 trial pits along a water main pipeline to the north of Wing to determine it's condition using non-destructive testing. The trial pits were designed to excavate down to the pipe and approximately 0.5m below. Trial Pits 1 and 3 were located on the verge of a road whilst 2, 4, 5 and 6 were excavated within open fields currently under pasture and 7 within a roadway. All of the excavated trial pits were located within the original construction cut of the water main except for pits 5 and 6, which were relocated due to the fragile nature of the pipe in the original location. No archaeologic

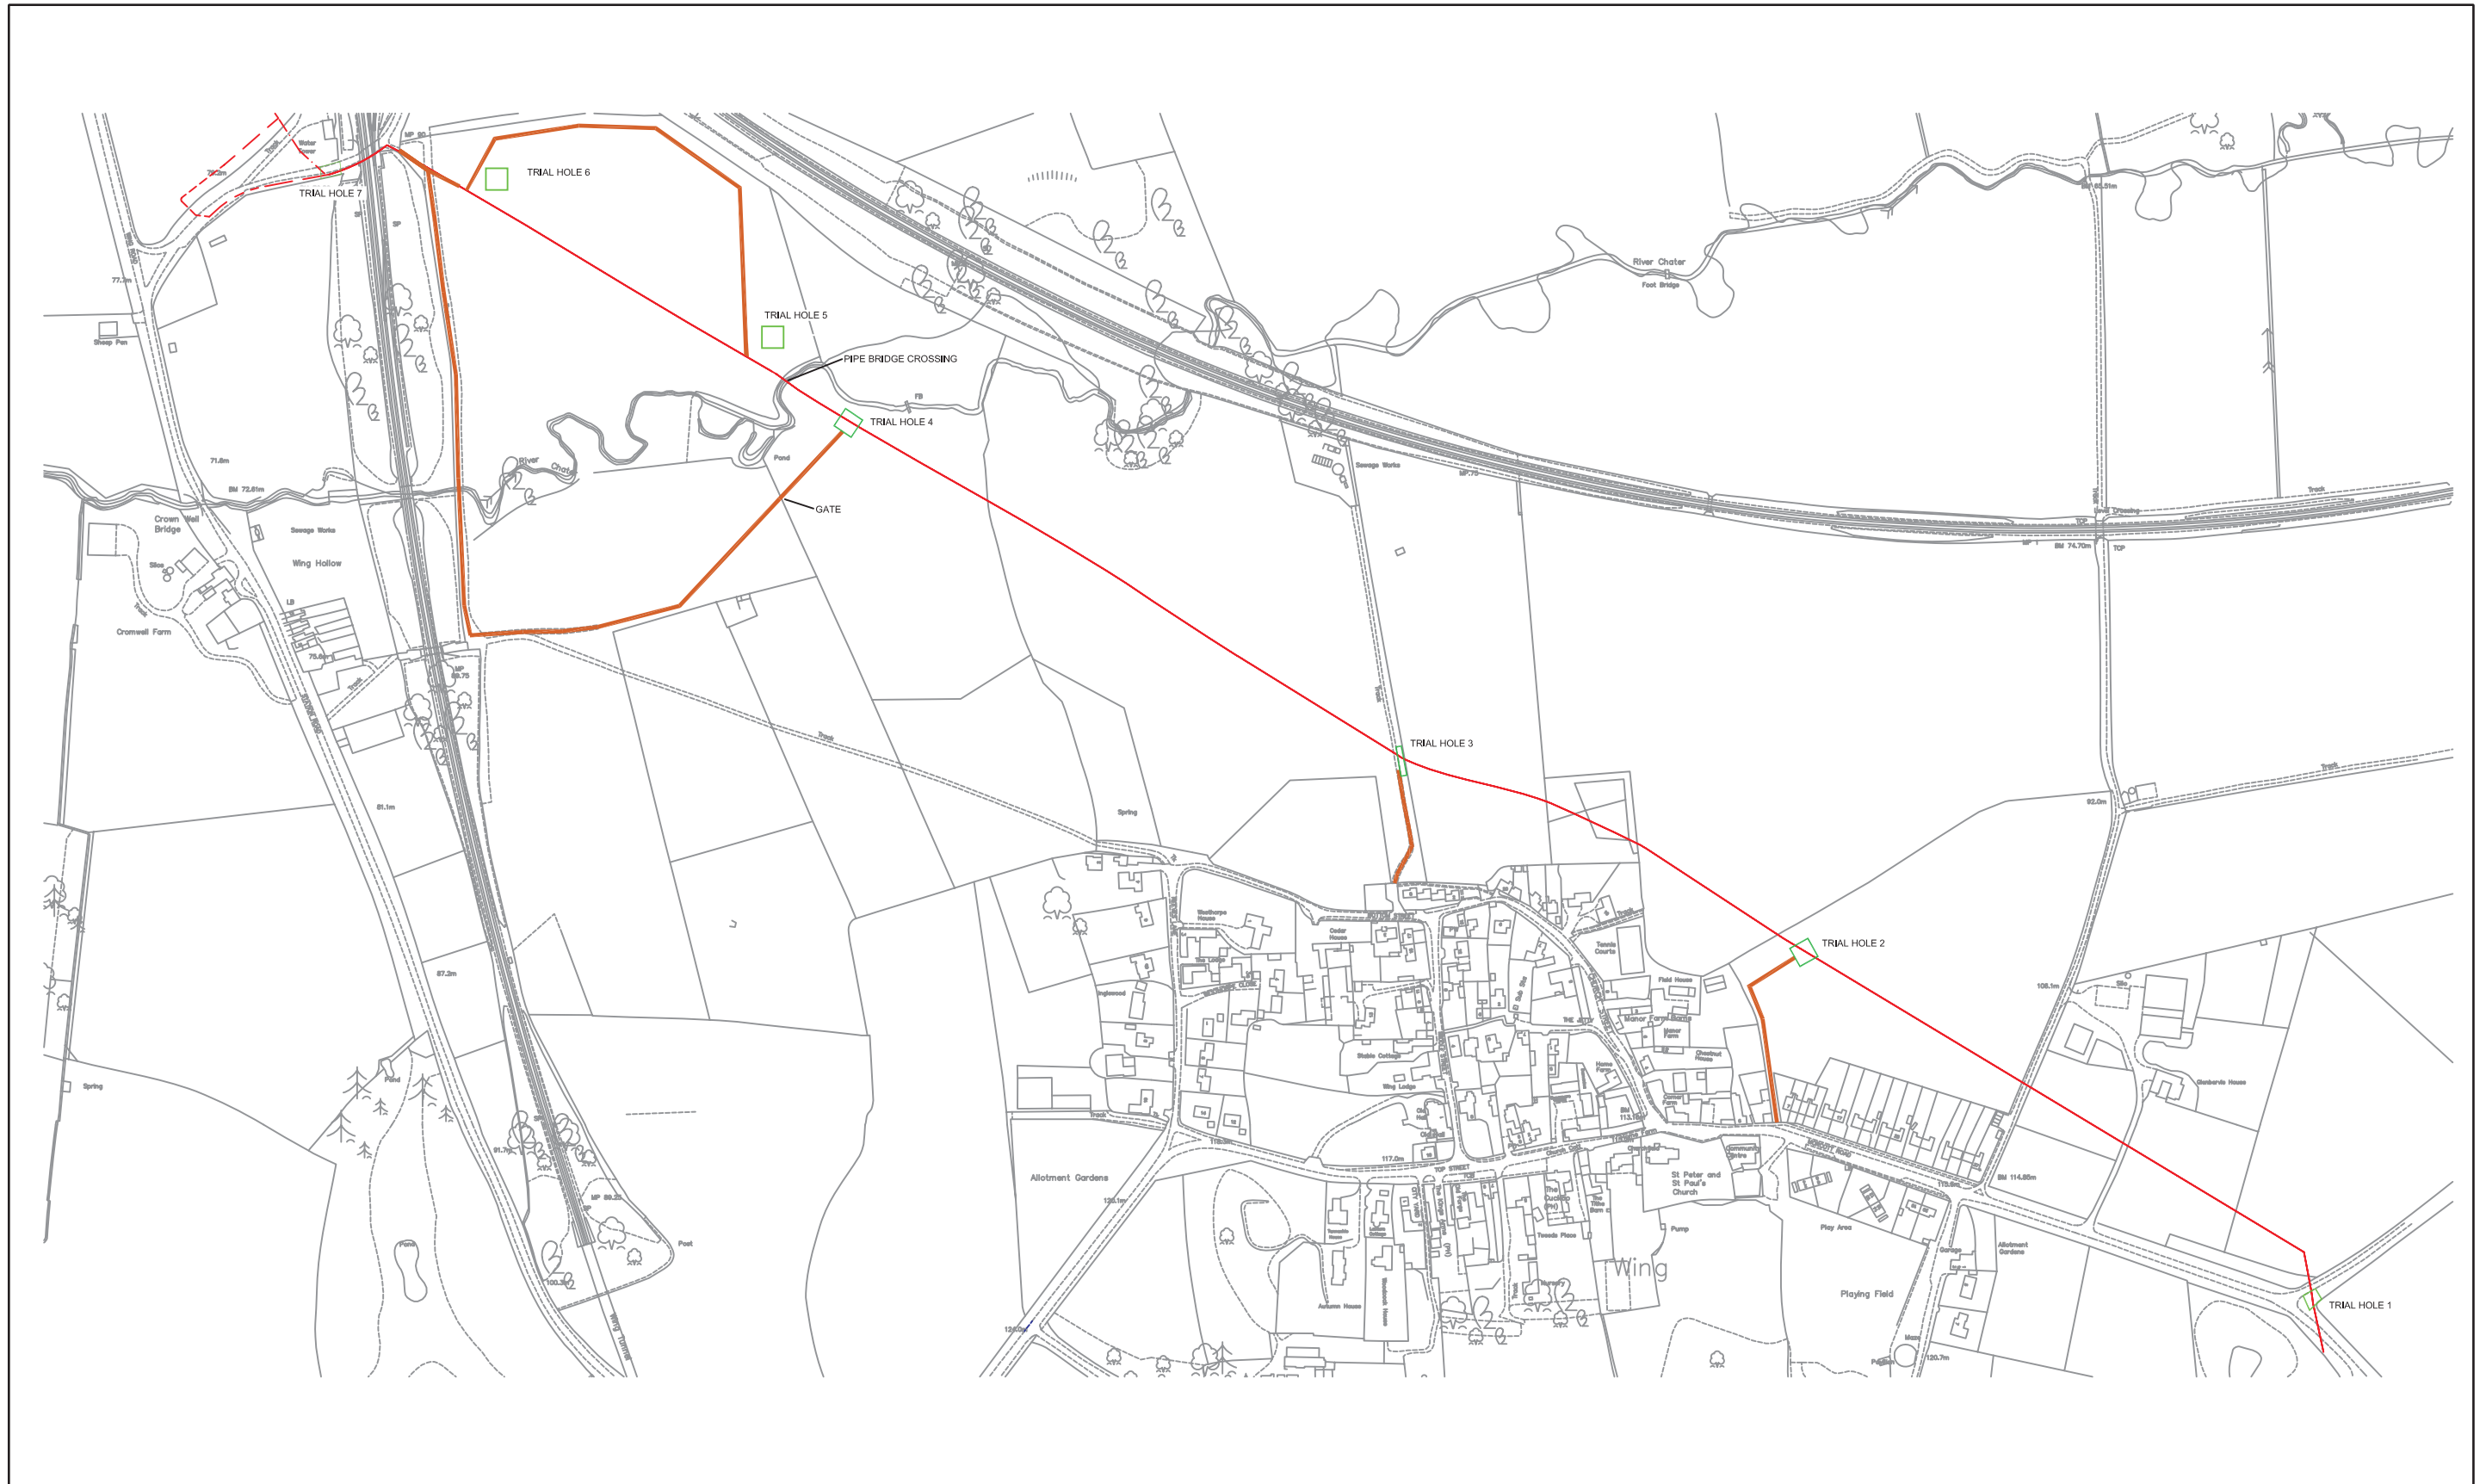
Project:	Wing, Leicestershire Watermain Renewal		Scale	As Shown	Date	June 2009
	Title	Trial Pits location		NGR	SK 882 039 to SK 898 028	Drawn
				Project No.	1282	Illustration No.

- 1 Site location map
- 2 Site plan showing pipeline route and location of Trial Pits 1 – 7

Taking the location of the site in the vicinity of prehistoric and medieval archaeology into account, the areas crossed by a pipeline route were considered likely to have some archaeological potential (**Illustration 2**). The specific aims of the archaeological watching brief were as follows:

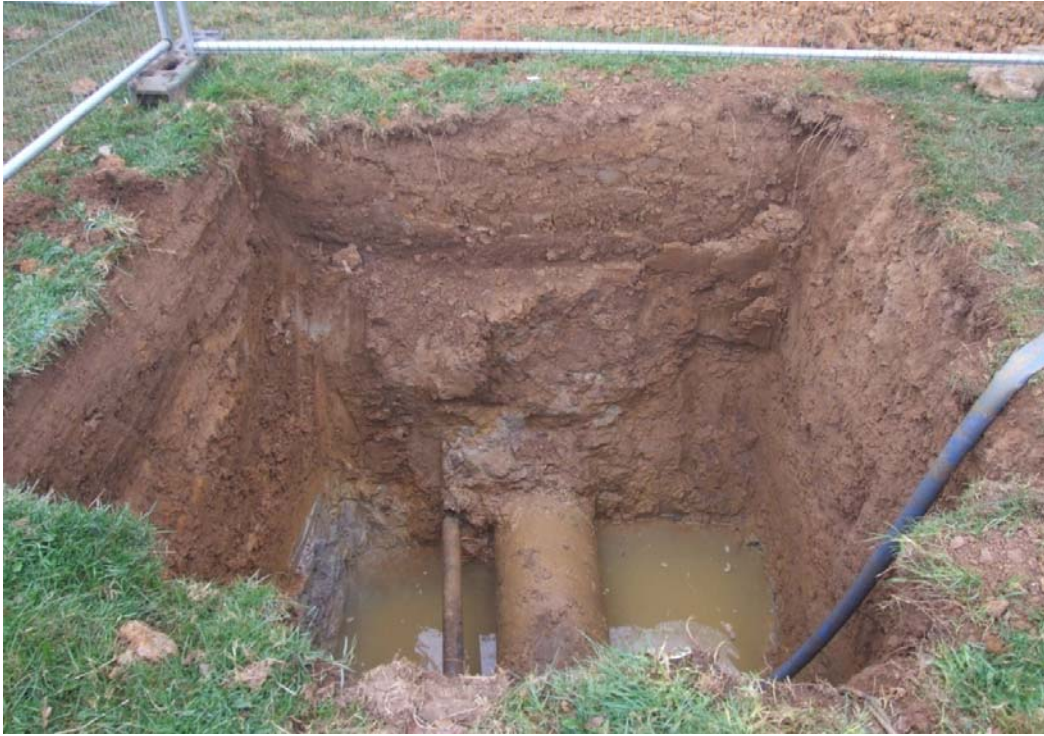
Plate 1 – Trial Pit 2 – looking north

(2.5m x 2.5m x 2.5m)

(200) Turf to 0.05m depth

(201) Orange-brown sandy clay topsoil to 0.2m depth

(202) Reddish-brown sandy clay subsoil to 0.3m depth

(203) Mixed clay backfill of cut [208] to 1.7m depth

(204) Yellow clay substrate to 2.1m depth

(205) Blue clay substrate to 2.5m depth

[206] Water main at 1.7m depth

[207] Plastic pipe running along west side of [207]

[208] Linear straight sided cut measuring 1.50m width cutting (202), (204) and (205) containing (203), [207] and [206] to the base of excavation at 2.5m depth

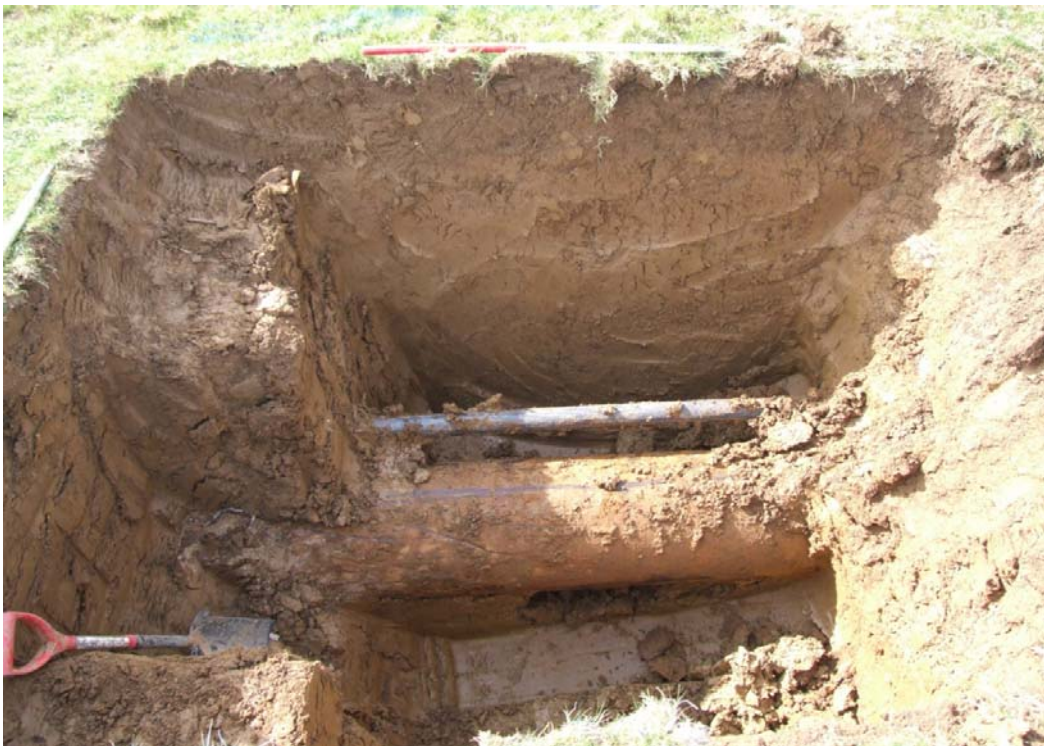
Plate 2 – Trial pit 4 – looking south

(2.5m x 2.5m x 1.9m)

(400) Turf and mid-brown silty clay loam topsoil to 0.15m depth

(401) Mid orange-brown silty clay loam subsoil to 0.40m depth

(402) Yellow clay substrate to 1.9m depth

[403] Ductile pipe running along south side of [404]

[404] Water main at 1.05m depth

[405] Linear straight sided cut 1.5m width cutting (401) and (402) containing [403], (404) and (406) to base of excavation at 1.9m depth

(406) Mixed yellow and blue clay, backfill of [405]
