Archaeological Evaluation
of land at
MARSH HOUSE,
NO.11 MARSH STREET, BRISTOL.
for
Lace Market Properties

Report No. 1466/2005
BUAD No. 4221

Archaeological Evaluation
of land at
MARSH HOUSE,
NO.11 MARSH STREET, BRISTOL.

Centred on
N.G.R. ST 58688 72804

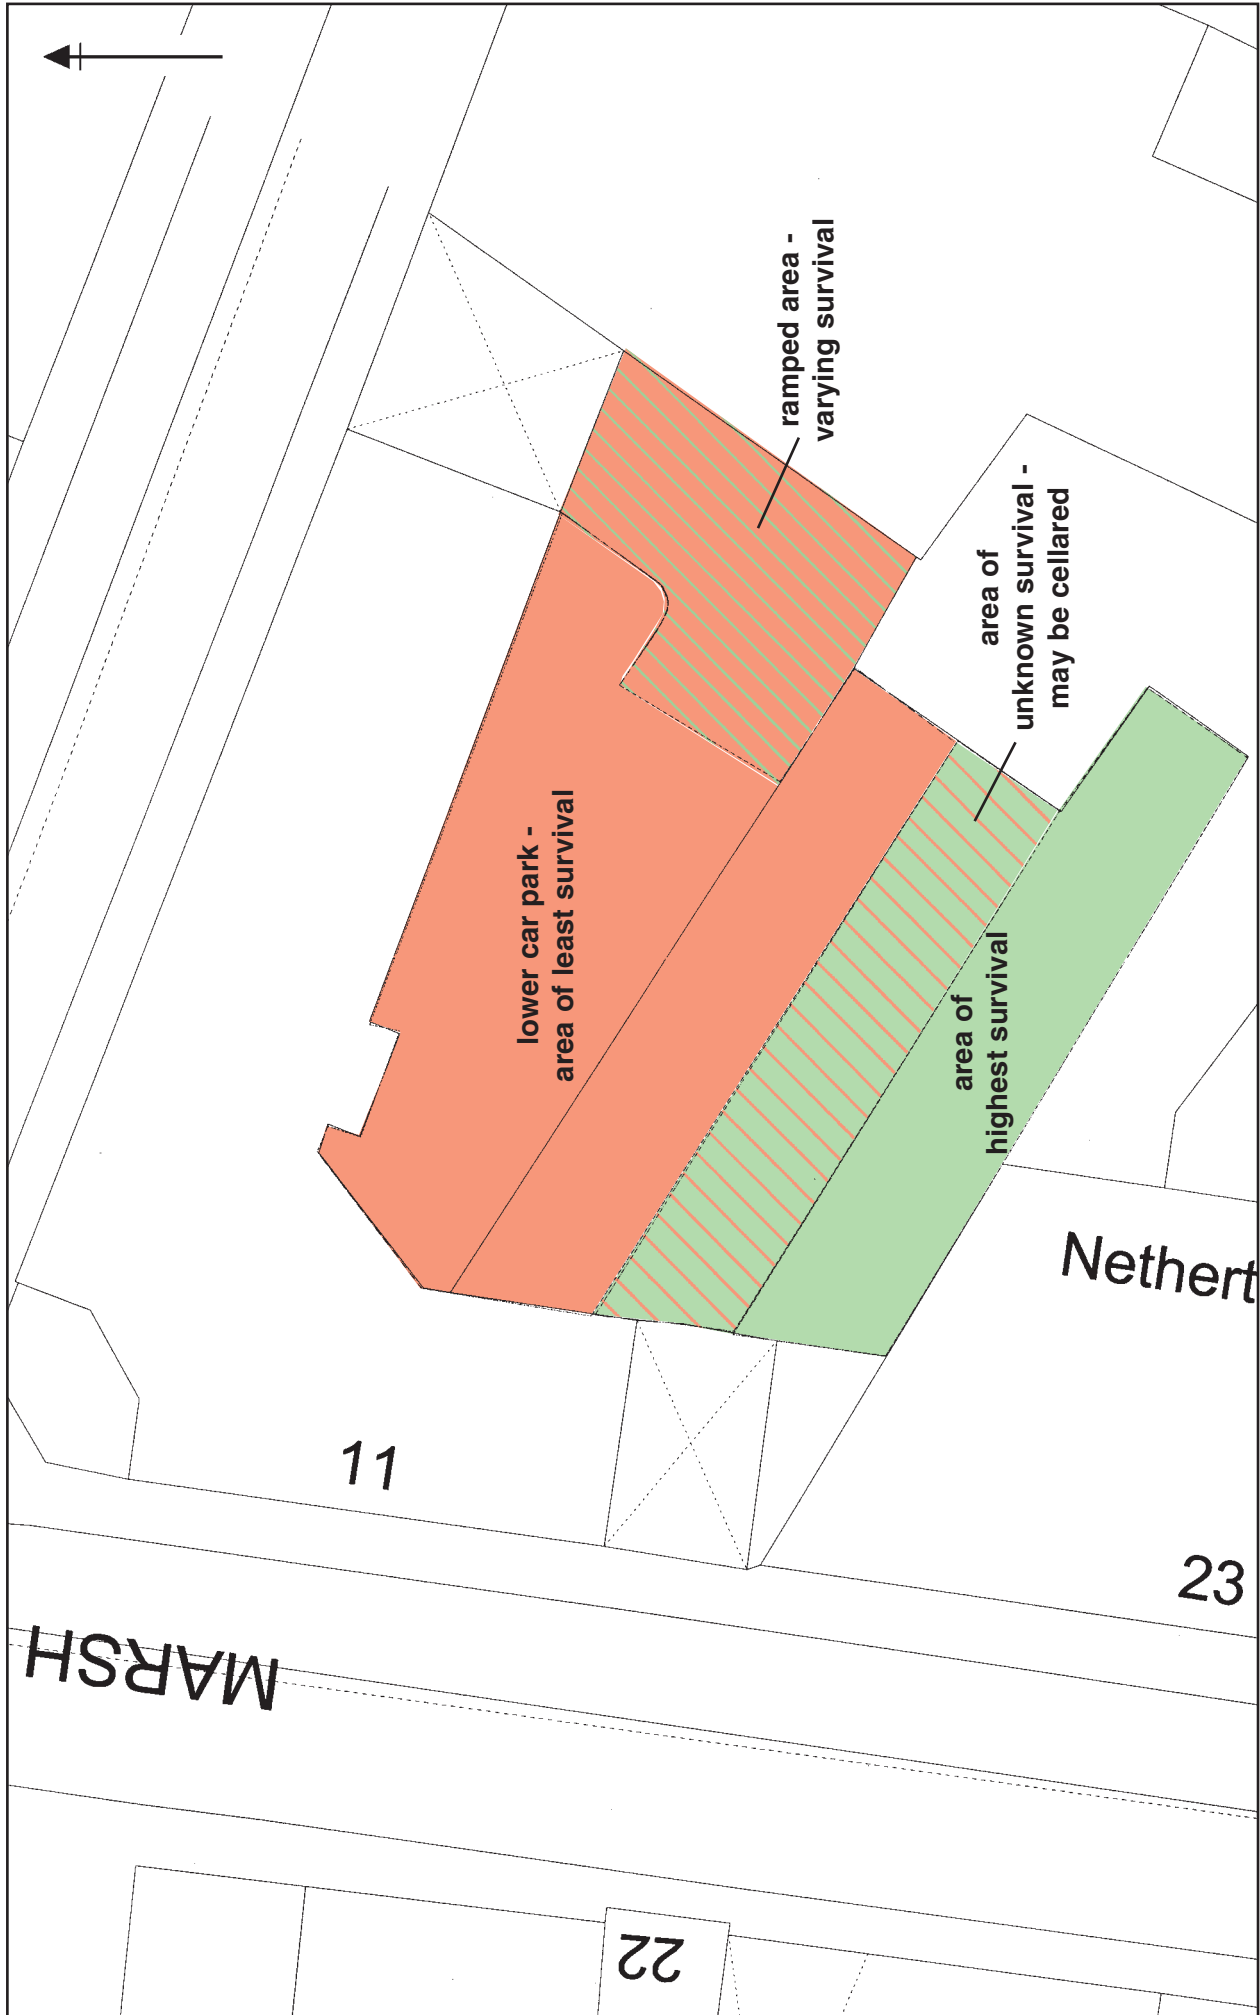
Fig.16 Plan of site, showing varying degrees of survival of archaeological remains

- 5.2.1 The evaluation has shown that archaeological deposits survive in good condition to the rear of Marsh House. The level of survival varies (**Fig.16**) but can be summarised as follows.

- 5.2.2 The highest level of preservation is to be found at the south of the area, around trench 2. Here, levelling deposits for the early 20th-century structures overlie earlier masonry, and it is most likely that earlier deposits survive beneath those observed in the trench. The trench was excavated to 7.61m aOD, which compared with the alluvial layers at 6.4m aOD indicates the survival of approximately 1.2m of archaeological deposits and features below the level reached in the trench.

- 5.2.3 North of trench 2 lies an area of unknown condition. It is possible that this area is cellared, in which case there will be only partial survival of archaeological features and deposits. This is not proved, however, and it should be assumed that there is the same level of preservation as in the area to the south until shown otherwise.

- 5.2.4 The lower car park is the area of least archaeological survival. The alluvial deposits were encountered at 6.4m aOD, between 0.5m and 0.6m lower than at Broad Quay (P Insole *pers. comm.*), indicating truncation well below the upper surface of the alluvium. It can be expected that only the bases of the deepest features would survive here.

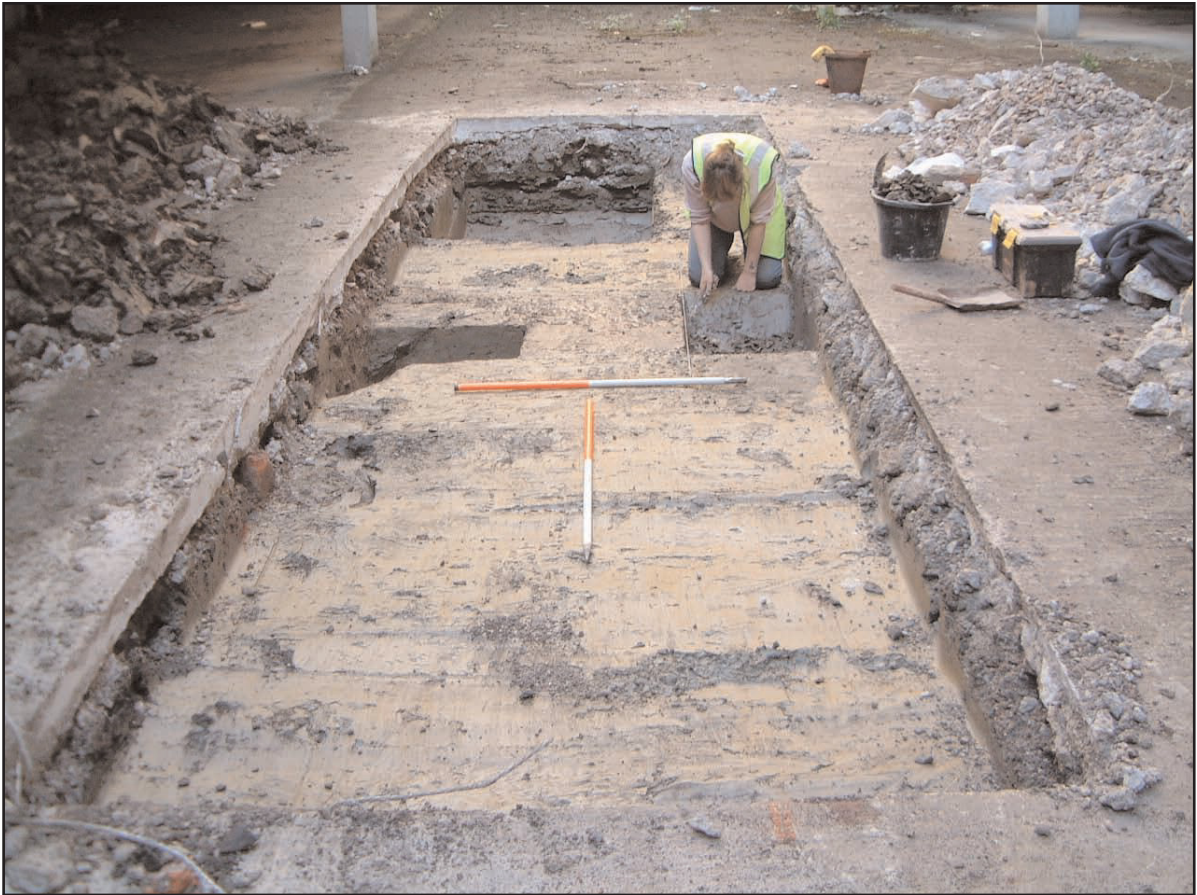
Plate 1 Trench 1, during excavation, looking west

- 4.1.1 Trench 1 was located in the lower car park, accessed from Telephone Avenue. A depth of up to 0.18m of reinforced concrete was removed, under which was a layer of rubble up to 0.3m thick acting as bedding for the concrete. This directly overlay archaeological features and deposits, and alluvial clays that were present at a height of 6.4m aOD.

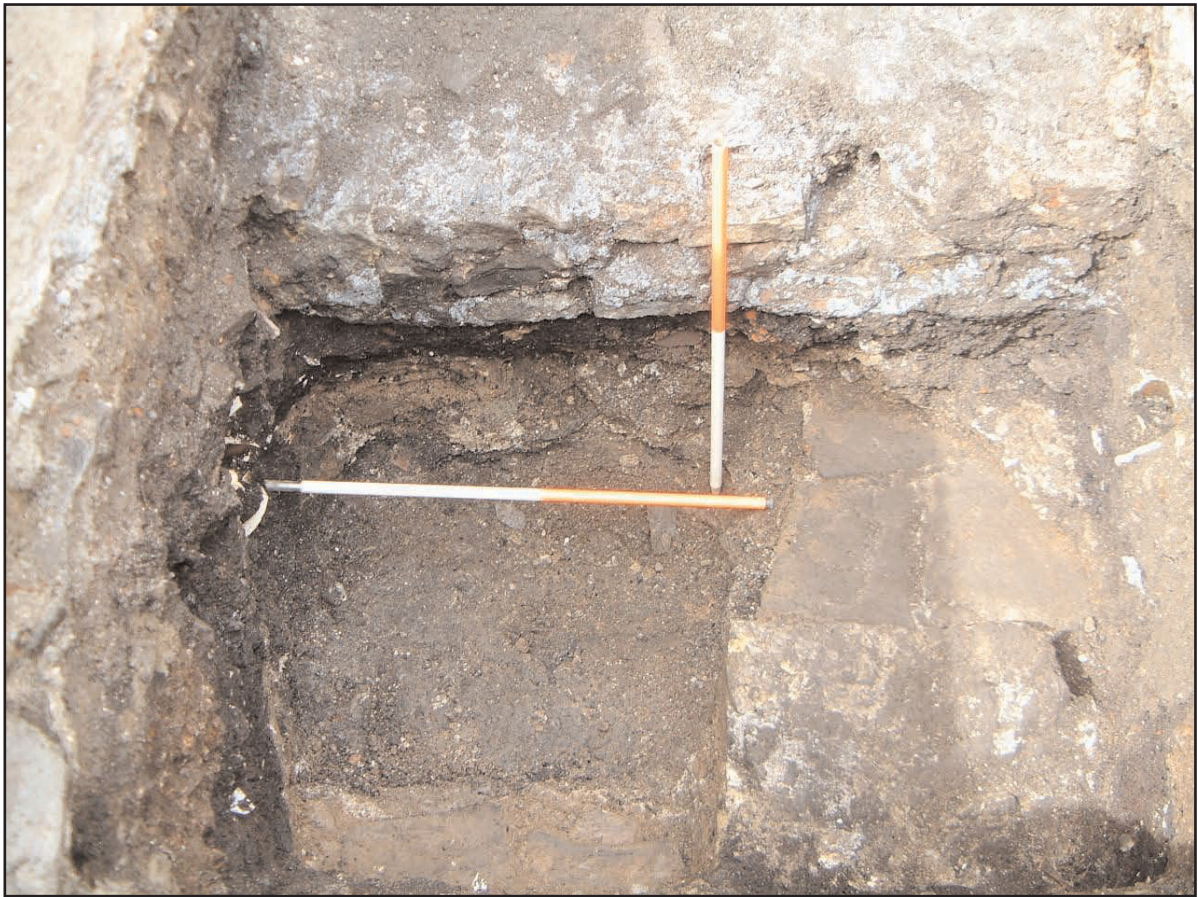
Plate 5 Wall 209 (bottom right) and floors 210 (bottom left) and 213 (middle right), looking west

- 4.2.3 Wall 209 lay at 7.99m aOD, and formed a corner with an area of flagstone floor (213) to its west and possibly another (210) to its south (**Pl.5**). 209 was constructed of a mixture of stone types, with limestone predominating, bonded with a yellowish sand and lime mortar. Like 210, 213 was of Pennant Sandstone slabs, but was better constructed.

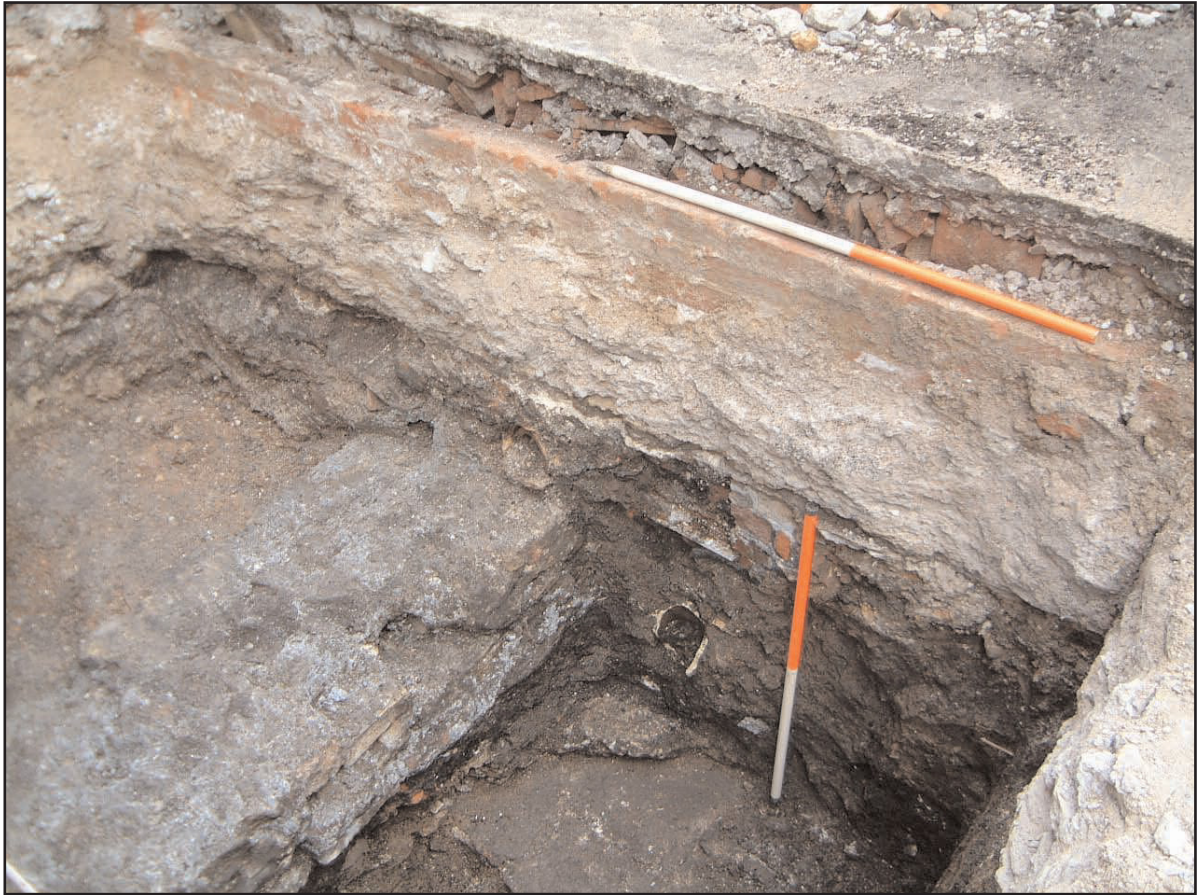
Plate 7 Trench 2: south-facing section, looking north-west

- 4.2.6 A narrow brick wall was seen running along the northern edge of the trench. This was part of the car park construction and coincided with the edge of one of the concrete slabs. The fill to the north of this wall could be seen in the trench section (**Pl.7**) and consisted of loose brick rubble; this was markedly different from the tightly packed concrete and brick seen south of the wall. This suggests a difference in the underlying deposits and features, and it is possible that the area north of this wall is cellared.
