Archaeological Watching Brief

HAYESFIELD LOWER SCHOOL, BROUGHAM HAYES, BATH, B&NES.

Report No. 2615/2012 OASIS ID: bristola1-118868

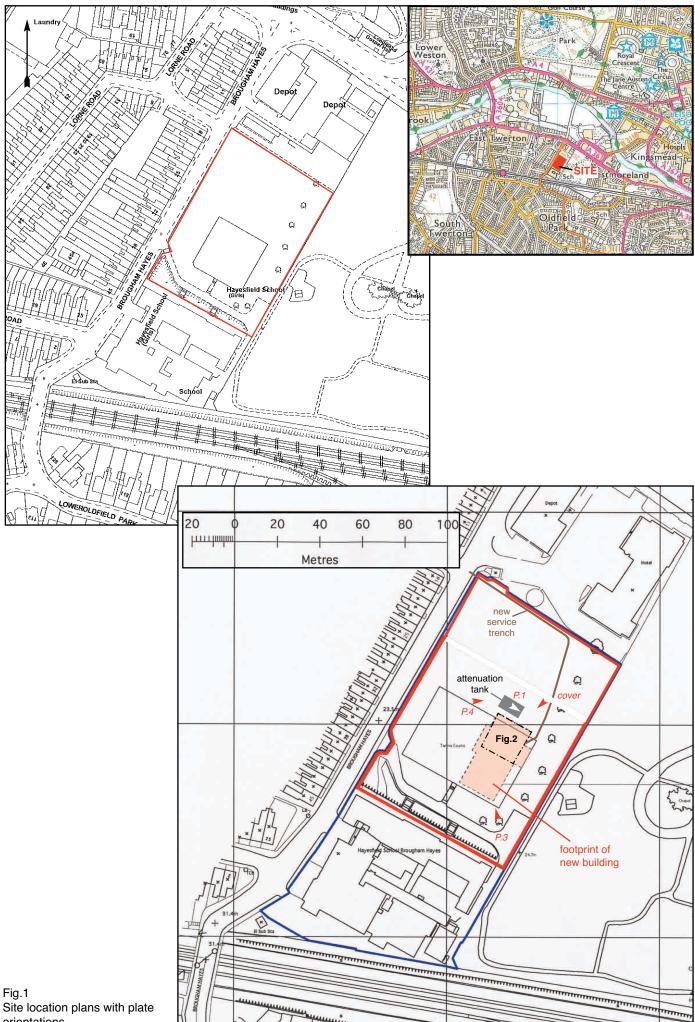
Figures	
Figure 1	Site location plans with plate orientations
Figure 2	Plan of features in tennis court area
Plates	
Cover	Hayesfield Lower School with STEM centre site in the foreground, viewed from the north-east
Plate 1	Representative section of natural deposits
Plate 2	Typical section of 1940s hutment foundations
Plate 3	Ground reduction in the tennis court area, viewed from the south
Plate 4	Excavating the attenuation tank, viewed from the south-west

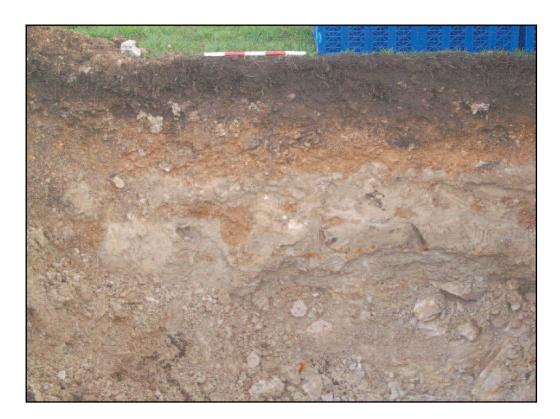
Plate 1 Representative section of natural deposits

5.2 The natural geology of the site (**Plate 1**) comprises interbedded Lower Jurassic clay and mudstone of the Charmouth mudstone formation (112), which was overlain by Middle Pleistocene river terrace deposits of sand and gravel (116) up to 0.35m thick. In the southern half of the site layer 116 was overlain by silty clay colluvium (111). This layer was up to 0.35m thick and contained clay tobacco pipe fragments near the interface with the overlying modern topsoil (109). Layer 111 was cut by Second World War construction trenches [117], [119], [123] and [126].

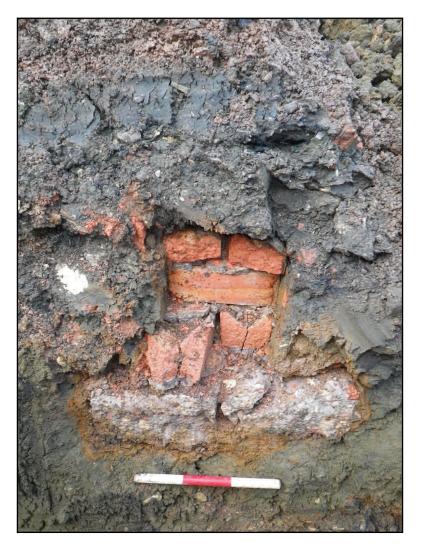
Plate 2 Typical section of 1940s hutment foundations

- The remains of footings of a group of wartime hutments (104), (107), (120), (124), (127) and (143-4) were uncovered in the tennis court area (**Plate 2; Fig. 2**), all of which were constructed of concrete with brick walls 0.225m in width bonded with a hard black Portland cement mortar. The bricks were all frogged, machine-made, and stamped with the makers mark 'MARSTON BESTPRESS'. The bricks are a product of the Marston Valley Brick Company, which operated between 1929 and 1971 (O'Connor 2002).

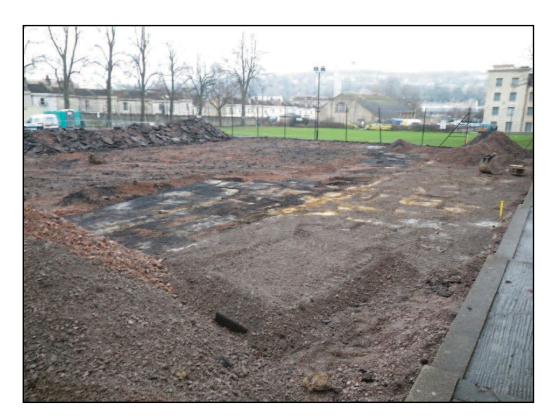
Plate 3 Ground reduction in the tennis court area, viewed from the south
