Archaeological Recording
of
**GARDEN WALLING AT THE FORMER HEAD'S HOUSE,
SILVERHILL SCHOOL, SWAN LANE, WINTERBOURNE,
SOUTH GLOUCESTERSHIRE.**
for
Mr R. Tanton

Report No. 2650/2012
SGSMR No. 20066

Archaeological Recording
of
**GARDEN WALLING AT THE FORMER HEAD'S HOUSE,
SILVERHILL SCHOOL, SWAN LANE, WINTERBOURNE,
SOUTH GLOUCESTERSHIRE.**

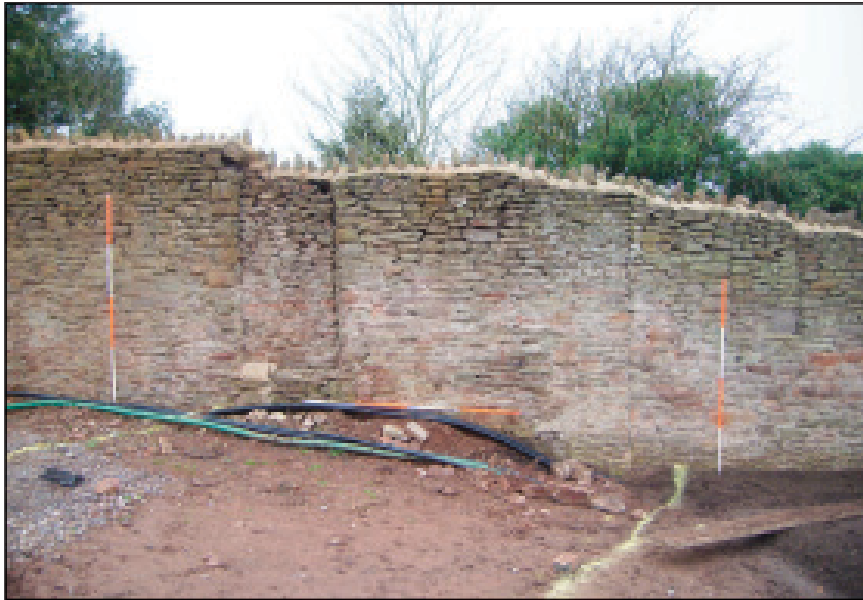
- 4.2 The main wall is constructed of locally quarried, un-worked Pennant Sandstone, forming a roughly coursed rubble wall. The area under investigation for the purposes of this report formed a 7 metre length of the wall at its north-western extent, with the 4m length proposed for demolition located within this recorded extent. The recorded segment extended beyond that proposed for demolition to allow full recording of the southern side of a blocked arched opening (opening A) and a second blocked arched opening (opening B) to the northern end of the elevation, which, although it is outside of the proposed area of demolition is close enough to have been included in the survey (**Plates 1 & 2**).

Plate 1
General overview of the
recorded segment of
wall, interior face, looking
west

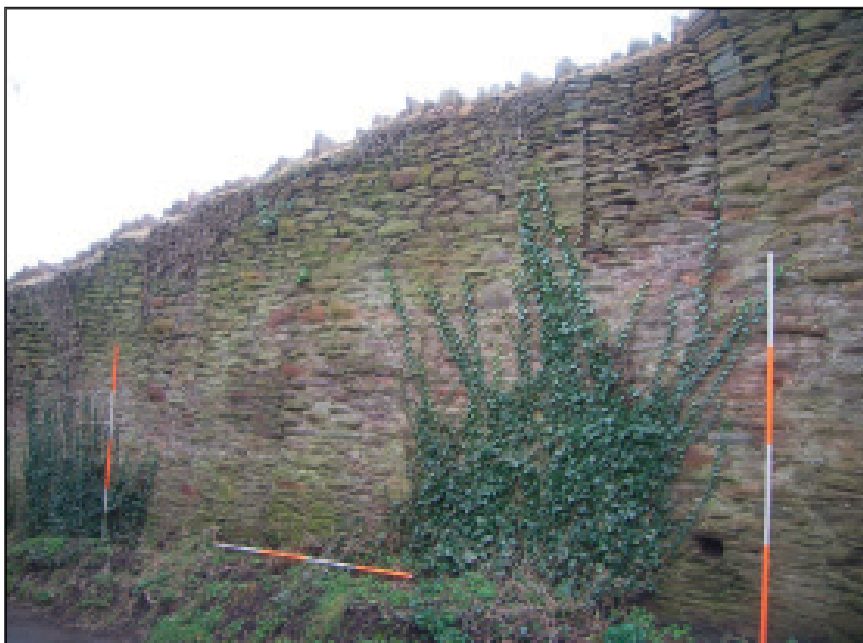
Plate 2
General overview of the
recorded segment of wall,
exterior face, looking
north-east

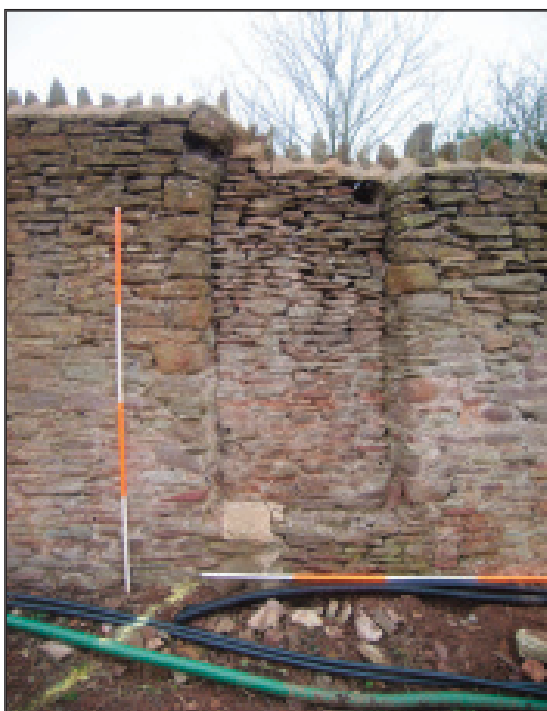
- 4.3 The internal elevation (south-east facing) provided perhaps the clearest view of the architectural features within the wall, although the existing ground level was higher on that side than the external Green Lane elevation. The damage inflicted on the wall from the ivy roots recently removed was evident, with a considerable loss of mortar bonding in the areas of heaviest growth. It was evident from the missing upper portions of the arched openings that the wall had also been lowered at some point in its life, possibly quite late based on the cement mortar used to bond the top of the wall (**Plate 3**).

- 4.4 At the southern end of the area under investigation a large blocked-off arched opening (opening A) with chamfered sides was evident, clearly visible in the internal elevation (**Plate 3**) where the blocking was off-set approximately 0.30m into the window and not flush with the wall face. The base of the window has been badly cemented over in the near past and this had mostly crumbled away at the time of recording, revealing eroded sandstone slabs but no obvious sill. Although missing due to the wall being lowered in height, the inward curve recorded in the last remaining three or four stones at the top of the wall suggests the opening was originally arched. Possibly the most interesting detail of this opening was its construction, for while on the internal face of the wall it was built to a depth of 1.90m from the remains of the top of the wall (the top of the arch now missing), on the external elevation it appeared to be only 1.20m deep (**Plate 4**). These differences in depth appear to be deliberate and not a later alteration as in both cases the rough coursing around and below the opening appears undisturbed and not a later re-build. The only explanation for the differences in height would be if the opening had been meant to have a deep 'alcove' below the window opening on the internal wall face, possibly for observation or simply sitting in.

Plate 3
Southern blocked-in Opening
A, interior face, looking west

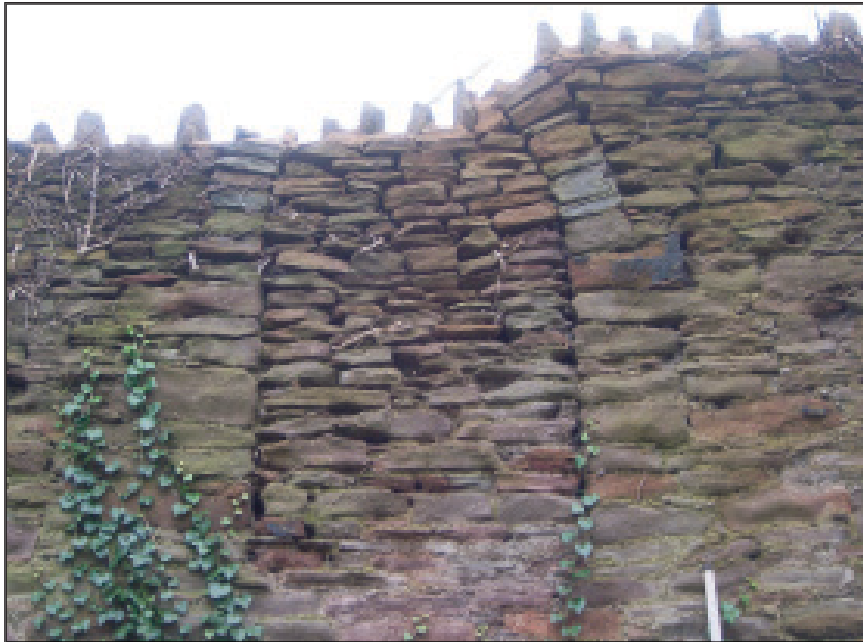
Plate 4
Southern blocked-in
Opening A, exterior face,
facing east

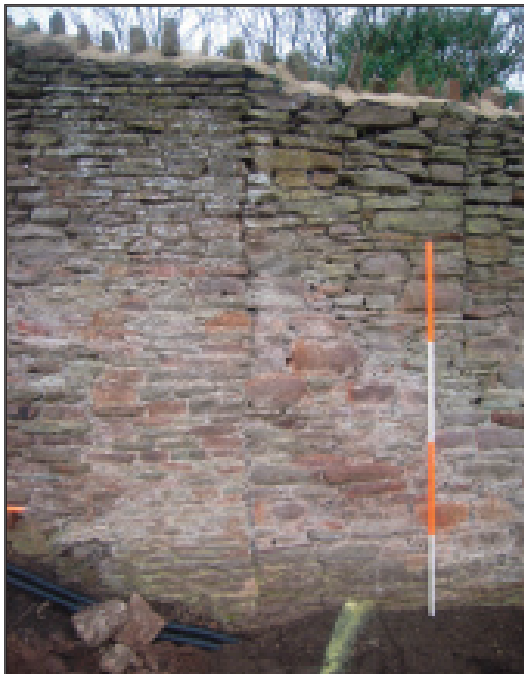
- 4.5 The central area of wall in the recorded segment showed evidence of later repair work. When first observed it was thought that a vertical break in the wall, visible in the internal elevation and running the complete height of the wall (**Plate 5**), indicated a possible re-build or different phasing of wall construction. In fact with the wall cleared of ivy on both sides, it was clear that while very evident on the internal elevation, the break did not appear on the external north-west facing elevation (**Fig. 4**). This, and the fact that while the main 'break' is obvious on the internal elevation, no corresponding southern edge was seen, to indicate a full re-build, which suggests that re-facing had been carried out at some point in the life of the wall. There were differences in the rough coursing of the sandstone slabs to the south of the main break but these were only partial and suggested the repair was fitted into the existing wall face. To the north, the main break with its vertical edge suggested that at least the inner face must have stopped at that point when originally built. There may have been something constructed into

this internal elevation of the wall, an outbuilding perhaps, which on its removal had left the gap that needed to be re-faced. This has to remain conjectural however as no definite southern side of any such structure could be seen in the rest of the wall. The line of the 'break' as seen on the internal elevation formed the northern extent of the segment due to be demolished.

Plate 5
Central area of the wall
segment showing vertical
'break', interior face,
looking west

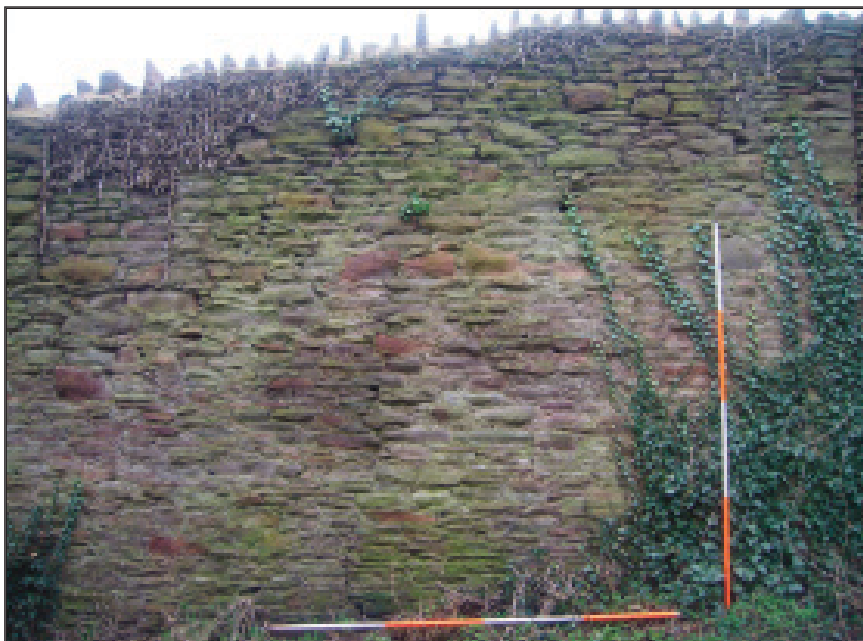
Plate 6
Central area of the wall
segment, exterior face,
looking east

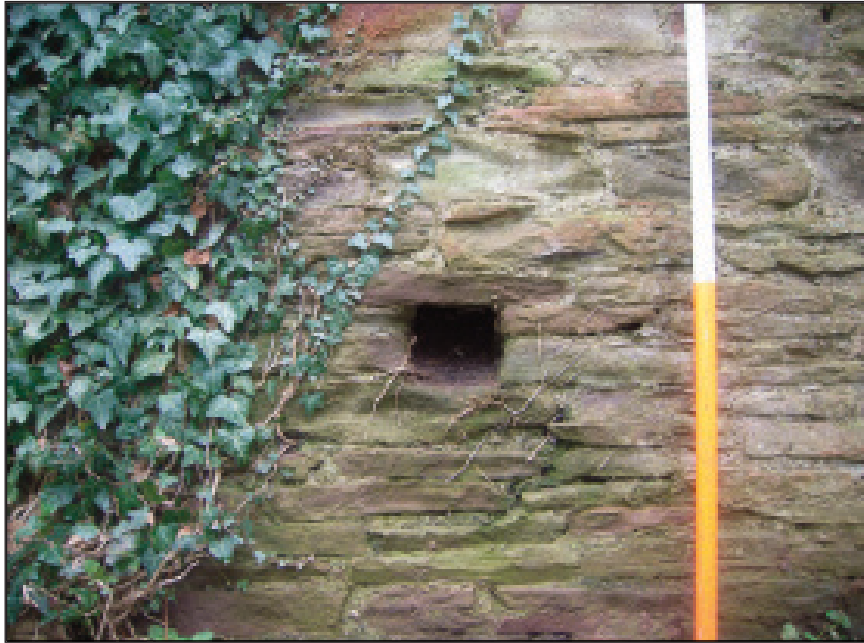
- 4.6 A small stepped area of wall at the very base of the internal elevation was also recorded just to the south of the main 'break' line, with disturbance evident between it and the 'break'. However as only a very small section of this was uncovered above the existing ground surface it is not possible to explain its function. It does not appear to have been a stepped footing as there was no indication of it continuing to the north, or to the south in places where the ground level dipped enough to have exposed it, had it been there. This 'step' protruded approximately 0.20m from the face of the wall. On the external wall elevation a drainage hole was evident in the wall below opening A (**Plate 7**).

Plate 7
Drainage hole on exterior
wall face, looking east

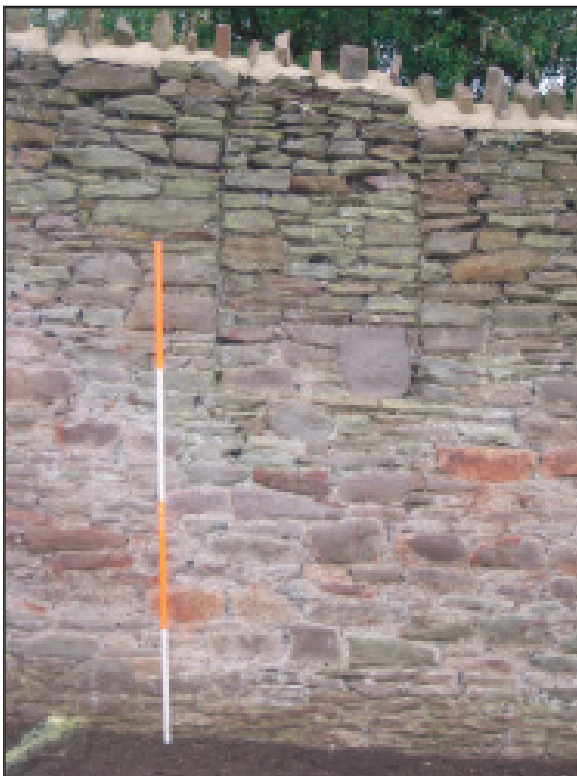
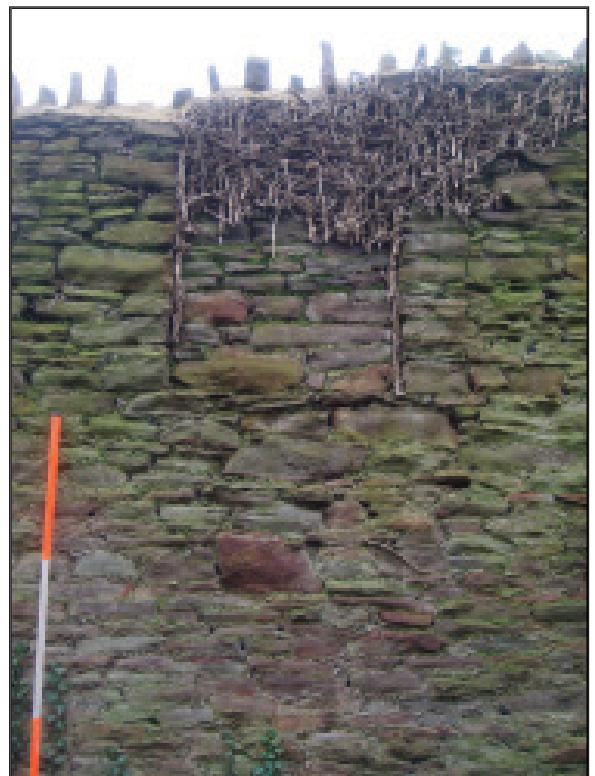
- 4.7 At the northern extent of the recorded segment and just outside of the 4m length to be demolished was a second opening (opening B), un-chamfered and 1.20m deep from the disturbed top of the wall (**Plates 8 & 9**). This opening had been completely blocked-in flush with the wall on both sides, unlike opening A. It also displayed a slight inward curve at the top suggesting it had originally been arched before the height of the wall was reduced. This was a simpler design than opening A, and though if looked at from the Green Lane side of the wall (external) it would have appeared nearly identical to opening A, it lacked both the depth and the chamfering on the internal elevation.

Plate 8 Northern blocked-in Opening B, interior wall face,
looking west

Plate 9 Northern blocked-in Opening B, exterior wall face,
looking east

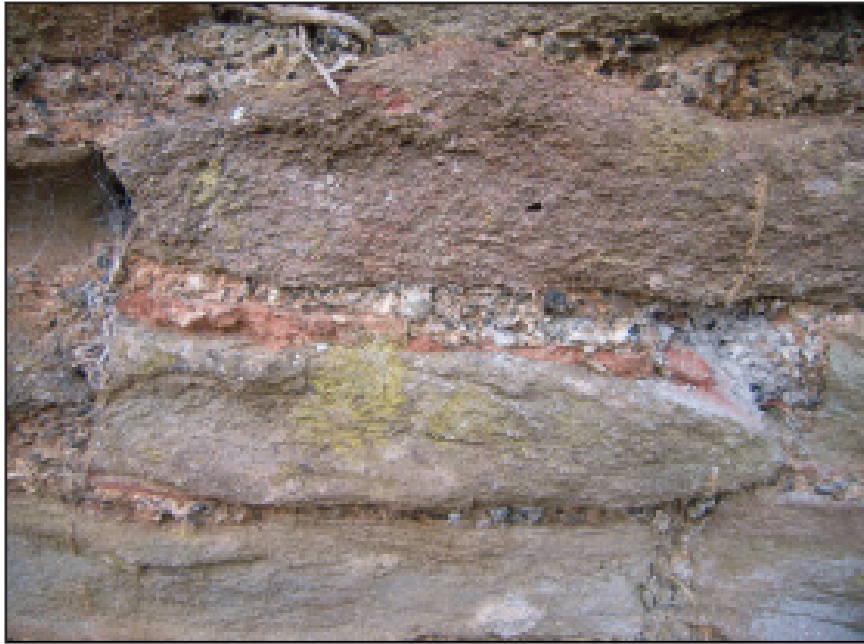
- 4.8 The mortar used along the length of the recorded segment, on both sides of the wall, was a pale grey-ash mortar containing abundant fragments of coal and small lumps of lime. It also had iron pins embedded into it at scattered intervals. On first inspection no differences could be seen in the mortar at any point in the wall, raising the question of whether this could be the original mortar, though its' make-up would suggest a late 18th or early 19th-century date, far later than the supposed date for the boundary wall. On closer inspection however, small areas of pinkish-red sandy mortar with very small fragments of lime could be seen still adhering to the surface of occasional stones (**Plate 10**). It was un-clear whether this was original mortar or whether the stones had been re-used from elsewhere until a closer look was made at a small segment of the wall further around the boundary, where the face had partially collapsed and the core had been exposed. This small area indicated that the pinkish-red mortar had originally been used in the construction of the wall, but that the whole circuit had been scraped and re-pointed using the grey-ash mortar later in its history, possibly when the openings were blocked in. The use of the pinkish-red mortar would suggest an earlier date than 19th century, making it more likely that the wall could be contemporary with the building of Winterbourne House.

Plate 10
Mortar details on interior wall, showing 'scraped out' pinkish mortar and later ashy mortar re-pointing

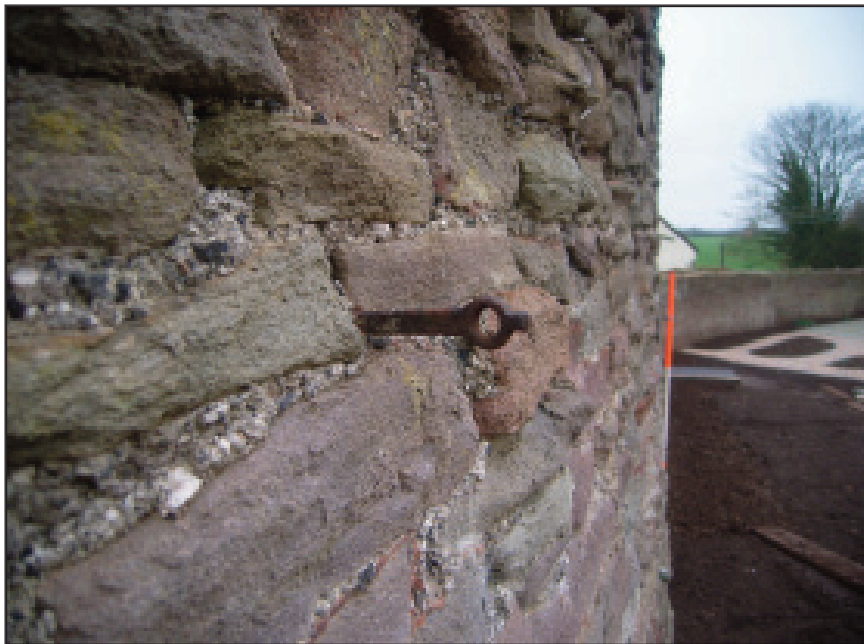
Plate 11
Example of iron trellis pin set into ashy mortar, looking north
