Bristol and Region
Archaeological
Services

Archaeological Watching Brief
**LAND AT BARNES HILL, CALIFORNIA,
BIRMINGHAM.**

Report No. 2641/2013
EBM No. 633
OASIS: bristola1-123624

Archaeological Watching Brief
of land at
**BARNES HILL,
CALIFORNIA, BIRMINGHAM.**

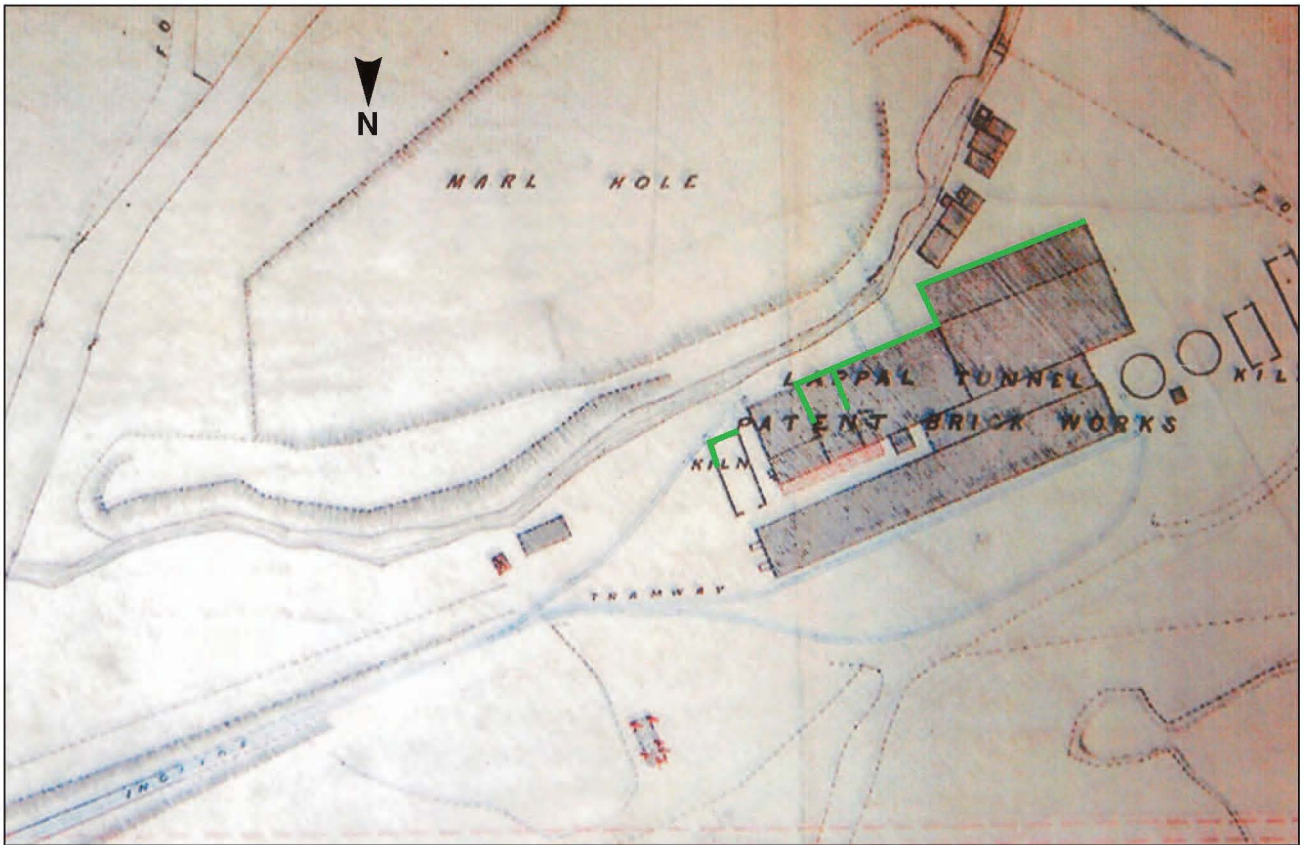
Fig.4 1881 plan of the 'Lappal Patent Brick Works' (green lines indicate walls uncovered during the watching brief)

- 5.4 Four rooms of the main southern block of the brickworks and parts of a brick kiln were uncovered during the excavation of the Stonehouse Brook diversion trench; both structures are depicted on an 1881 plan, and are likely to have been built in the late 1870s.

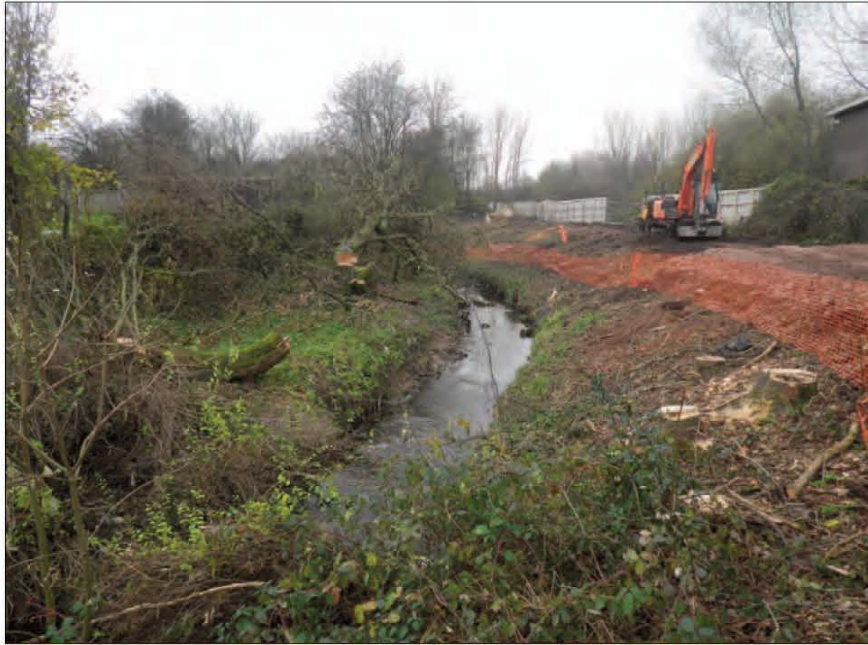
Plate 1
The Stonehouse Brook
during initial clearance
work, looking south-west

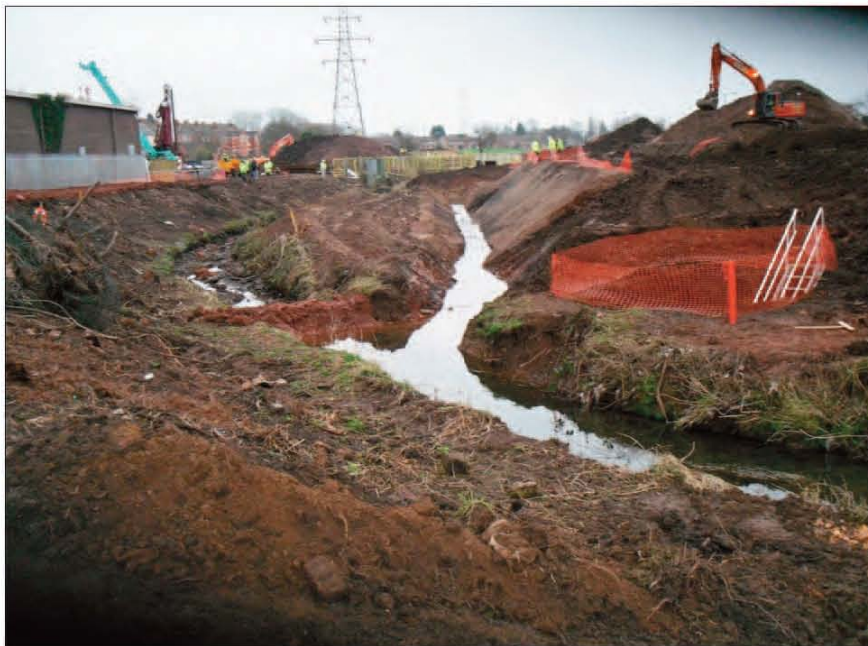
Plate 2
Temporary diversion of
the Stonehouse Brook,
looking north-east

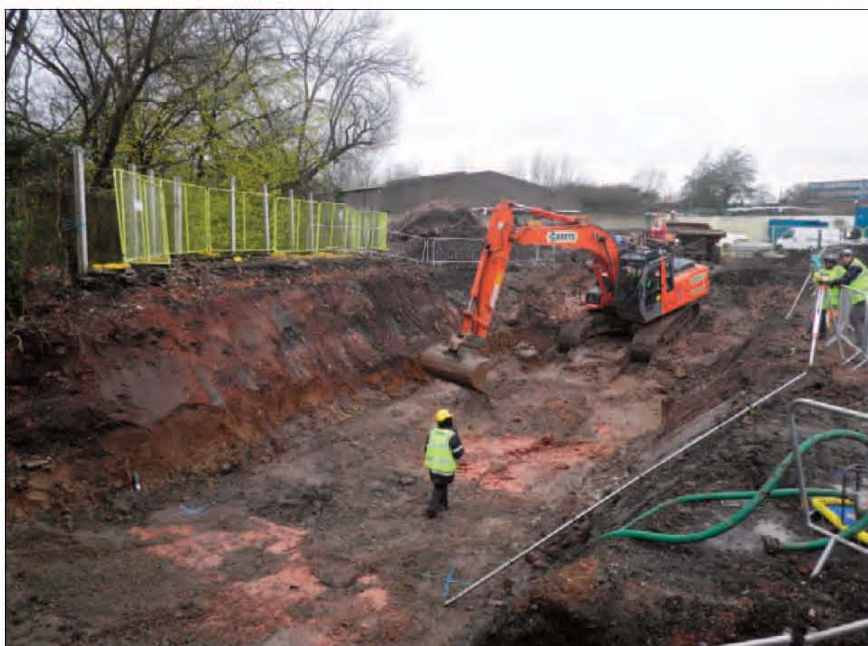
Plate 3
Permanant diversion of
the Stonehouse Brook,
looking south-west

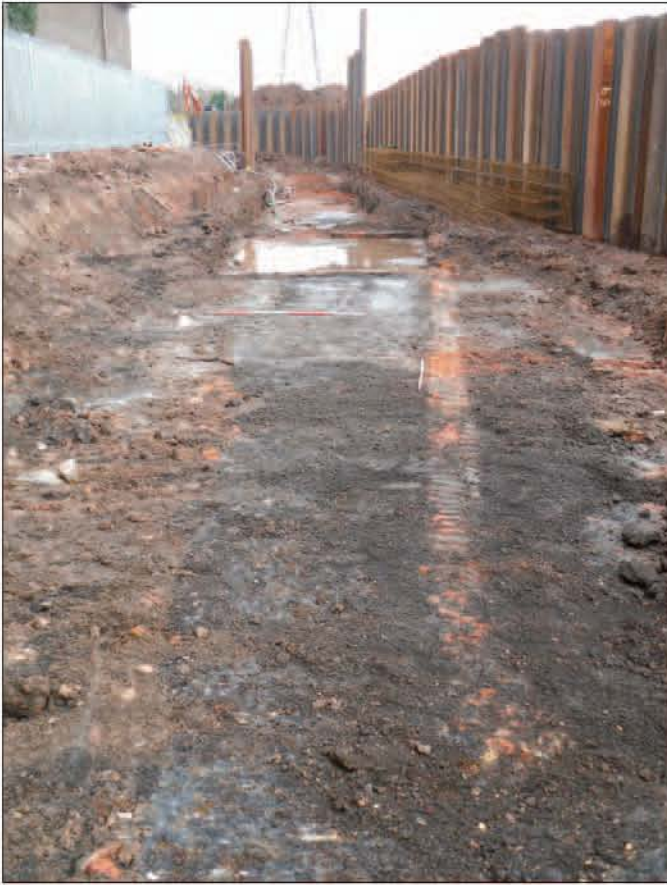
- 5.5 The walls of the brickworks (704–5 & 718; **Plates 4 & 5**) were constructed with frogged, machine-made bricks, embossed with the name 'J. GARLICK UPPER SALTLEY'. The walls were for the most part 1 to 1 ½ bricks thick and bonded with a pink lime mortar. The westernmost room had a blue engineering-brick floor (719), the middle room had a concrete floor (703), and the easternmost rooms had orange brick floors (706-7). A raised cambered strip in the easternmost room (707) may indicate the position of a corridor. It was not possible to determine the easternmost extent of the building due to constant flooding of the trench.

Plate 4 Brickworks structures 703-6, looking north-east

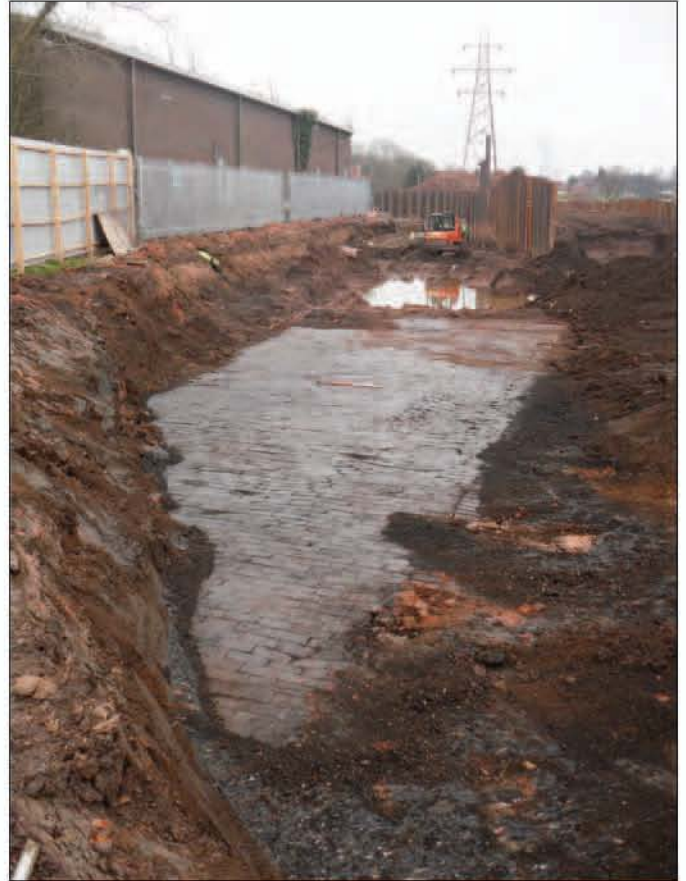
Plate 5 Brickworks structures 718-9, looking north-east

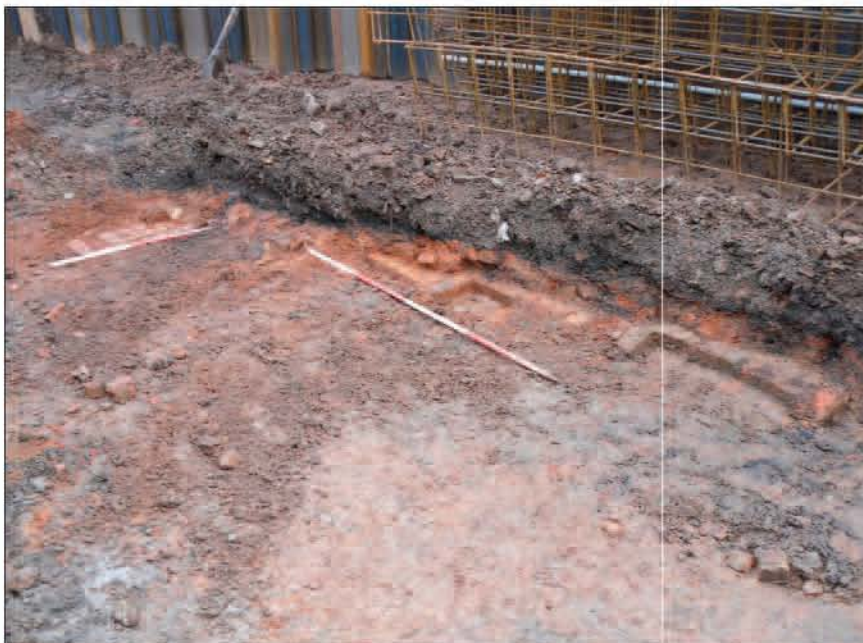
- 5.6 Fragmentary remains of a brick Scotch kiln (708–10; **Plate 6**) were uncovered immediately to the west of the brickworks building. The kiln was constructed with bricks embossed with the name 'JOHN HALL & CO STOURBRIDGE'. Historic plans show that the kiln was originally approximately 5m wide and 12m long.

Plate 6
Kiln structures 708-10,
looking east

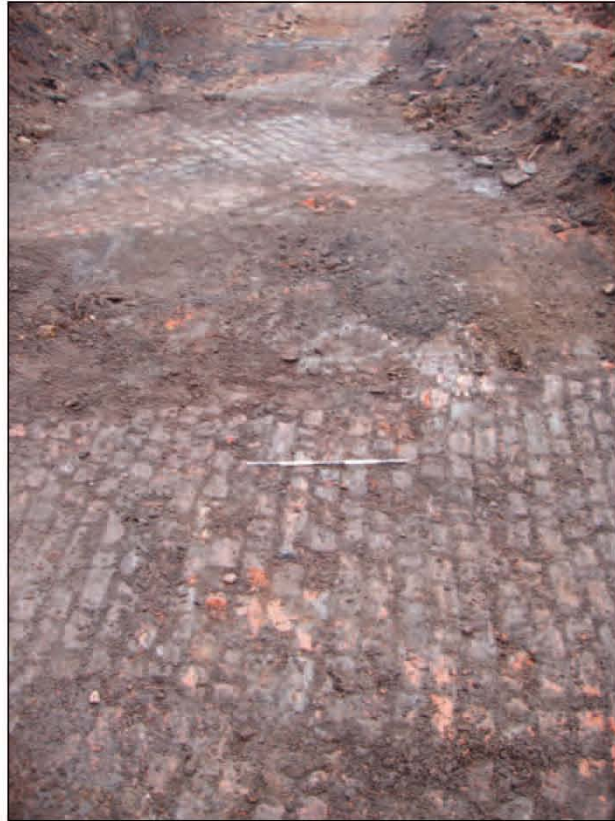
- 5.7 External yard surfaces were uncovered to the south and east of the brickworks. The surfaces to the east were constructed with bricks laid up to three courses thick (711–12; **Plate 7**), whilst the surface to the south comprises an extensive area of compacted clinker and slag (302).

Plate 7
Brickyard surfaces 711-12,
looking north

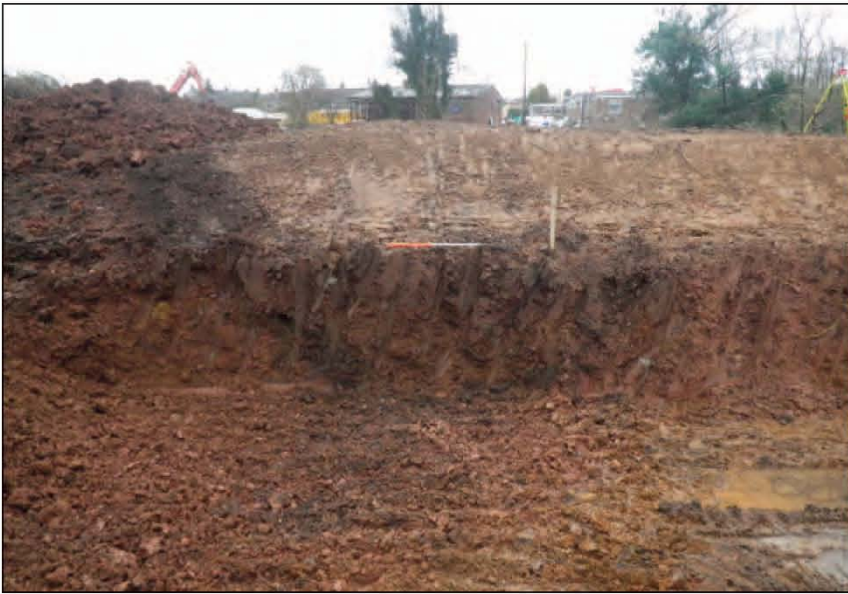
- 5.9 Remains associated with the tramway system used to transport clay around the site include a 4.8m wide and 1.6m deep cutting (204; **Plate 8**) uncovered towards the south-western end of

Plate 8 Tramway cutting 204, looking east

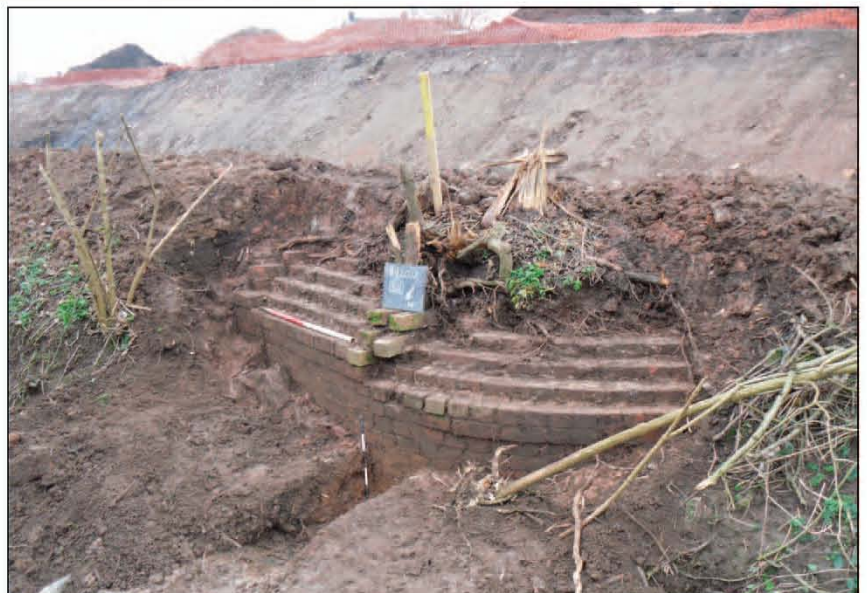
the site, a 14.5m wide and 2.7m deep cutting towards the eastern end of the site (112/115), and a 3.1m wide bridge abutment (900; **Plate 9**) that was exposed on the south bank of the Stonehouse Brook. Structure 900 can be identified as part of one of two tramway bridges that are first shown on the 1885 Ordnance Survey plan. The bridge appears to have remained in use until the brickworks closed. Cutting 204 is first depicted on the 1916 Ordnance Survey plan, which suggests that it was dug in the early 1900s.

Plate 9
Tramway bridge abutment 900,
looking south-east

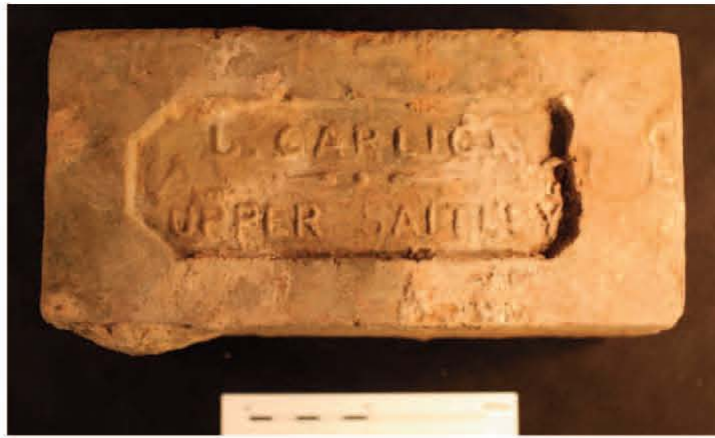
- 6.2 The walls of the brickworks were built with machine-made frogged bricks (**Plate 10**) that measured 228 x 105 x 75mm and were marked with name 'J. GARLICK UPPER SALTLEY' (the 'J' was back-to-front). The brick can be identified as a product of John Garlick (b. 1837), founder of the Lapal Tunnel Brick Company. The fact that these bricks are machine-made indicates that he had modern brick-presses installed at his Upper Saltley premises prior to c 1876.

Plate 10
Brick marked J. GARLICK
UPPER SALTLEY,
recovered from wall 718

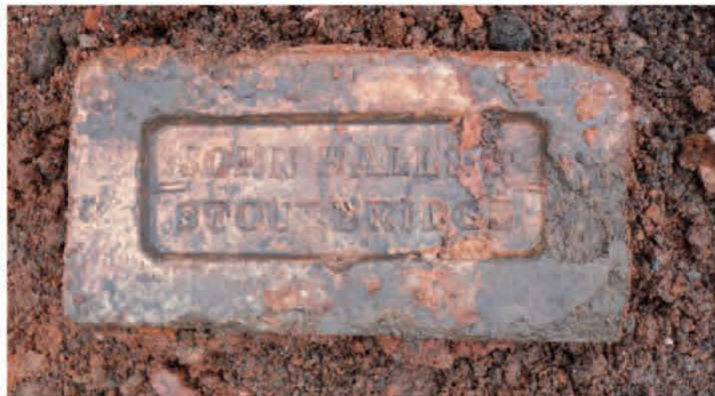
- 6.3 The firebricks used in the construction of a Scotch kiln (contexts 708–10) measured 235 x 102 x 80mm, were frogged and marked with the name 'JOHN HALL & CO STOURBRIDGE' (**Plate 11**). John Hall & Co. was a coal and fireclay mining, and firebrick making company that had works in Amblecote, near Stourbridge and at Brierly Hill, approximately 15km to the east of Barnes Hill. The company has existed since at least the early 1870s and remains in business today.

Plate 11
Brick marked JOHN HALL
& CO. STOURBRIDGE
recovered from kiln
structure 709

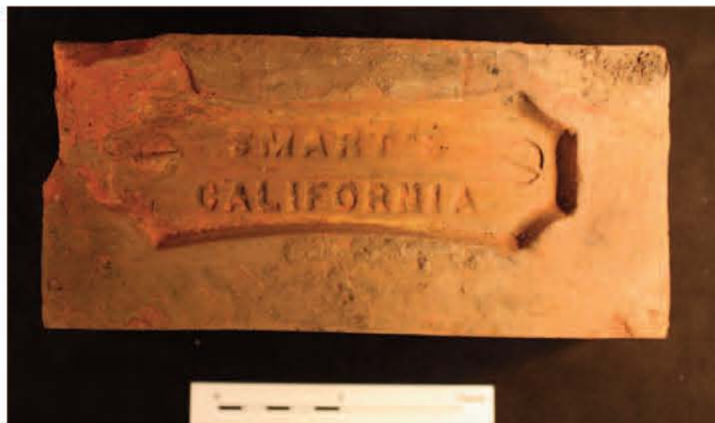
- 6.4 The bricks used in the construction of manhole 721 measured 224 x 102 x 82mm, were machine-made, frogged and marked 'SMARTS CALIFORNIA' (**Plate 12**), which suggest that this structure was probably built when the brickworks was re-opened as part of Smart's in the early 1900s. Smart's brickworks closed in the 1950s (Shill 2010).

Plate 12
Brick marked SMARTS
CALIFORNIA, recovered
from structure 721

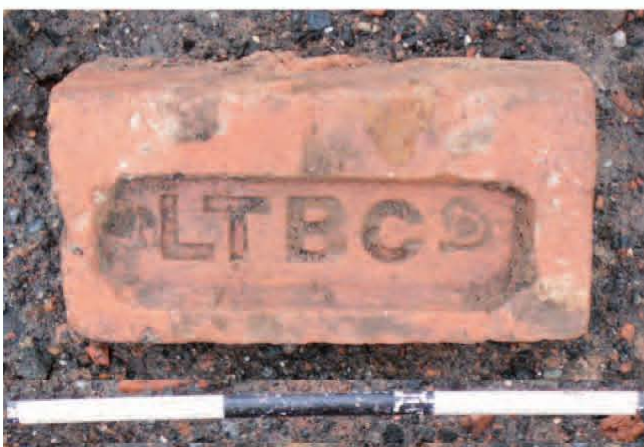
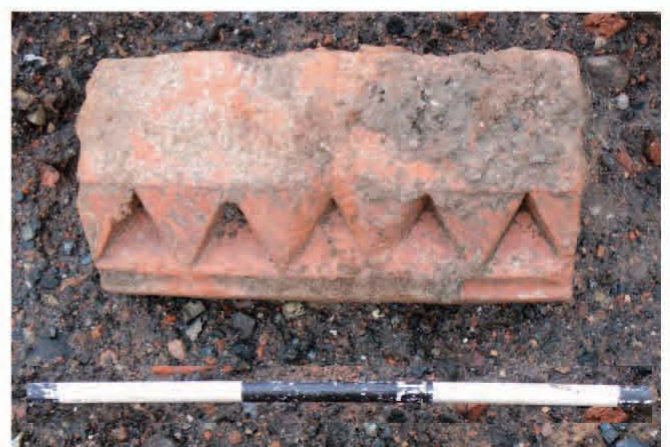
- 6.5 Two bricks produced by the Lapal Tunnel Brick Company were recovered, one as an unstratified find, the other from layer 203. The bricks were both machine made, frogged and stamped with the letters 'LTBC^o'. One brick was plain and measured 210 x 110 x 72mm, the other was a decorative brick (**Plates 13 & 14**) that measured 230 x 75mm. Both bricks were probably produced between 1876 and 1884.

Plate 13 Brick marked LTBCo recovered as an unstratified find

Plate 14 Decorated face of LTBCo brick
