Archaeological Watching Brief NOS 76-88 HORFIELD ROAD, KINGSDOWN, BRISTOL.

Report No. 2867/2014 BHER No. 25369

Archaeological Watching Brief

NOS 76-88 HORFIELD ROAD, KINGSDOWN, BRISTOL.

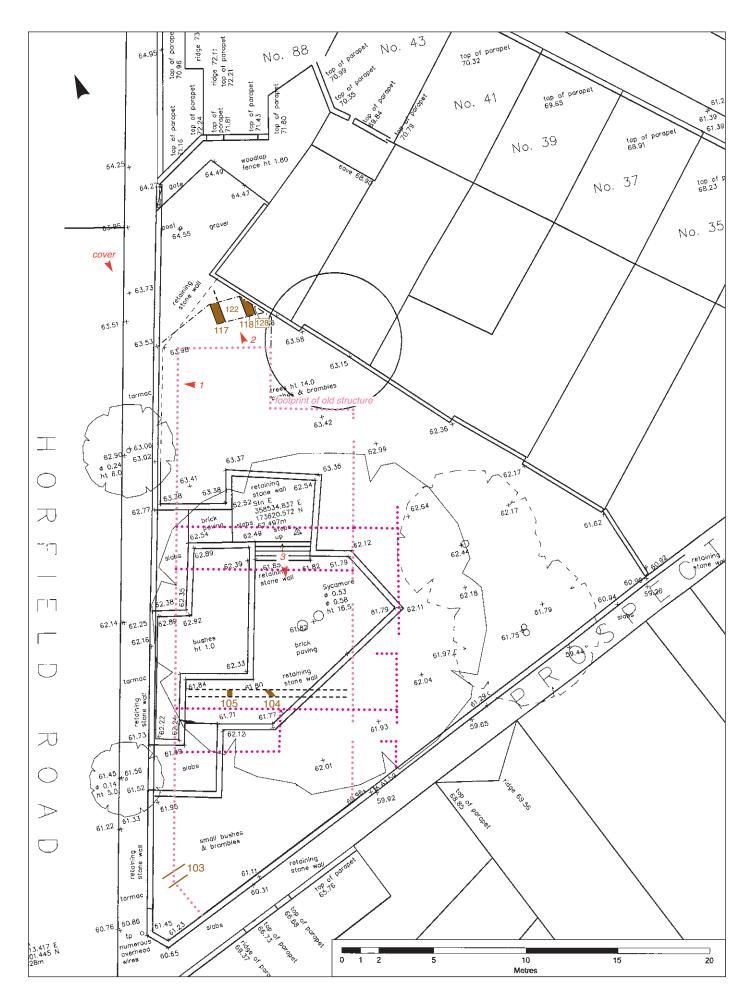
Fig.2 Site plan, scale approx. 1: 200 @ A3, showing key features and plate directions

- 5.1 Full context descriptions are provided in the context summary (**Appendix 2**). Major features are shown on the site plan (**Fig.2**).
- 5.2 Ground reduction on the south-west end of site exposed a brick-built Pennant flagstone capped drain (106) and pennant rubble stone walls (108/124, 110 &111) (**Plate 1**) bonded with white lime mortar. All were contemporary and either external or internal walls related to the demolished buildings shown in the 1820s maps of the area.

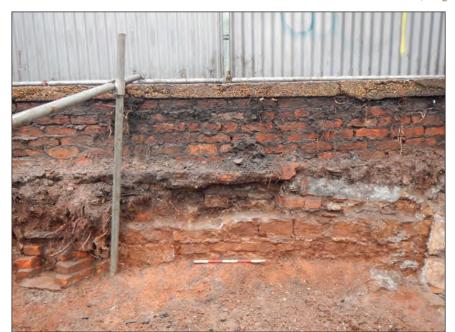
Plate 1 Wall section showing 116,124, 125, 130 & 134 looking north-west

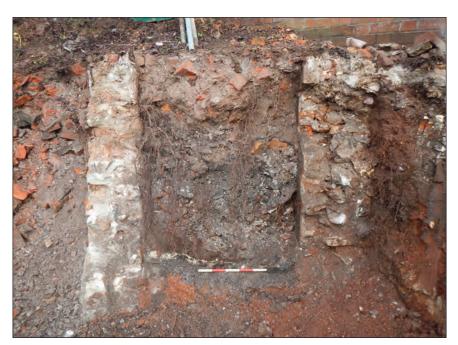
- 5.3 Ground reduction at the northern end of the site revealed the rear wall of a cellar (117) and the remnants of a cesspit (118) (**Plate 2**) built against it. Two copper pennies, one a Georg III cartwheel penny, the other unidentifiable, were recovered from the demolition rubble fill (123) of the cellar. This fill appears to be the same as context (109), a layer of demolition rubble, up to 1.50m thick, sealing the remnant 18th-20th century structures across the entire site (**Plate 3**), with a small area in the southern corner of the site having a concrete layer (102) above this.

Plate 2 Cess pit & cellar wall looking north

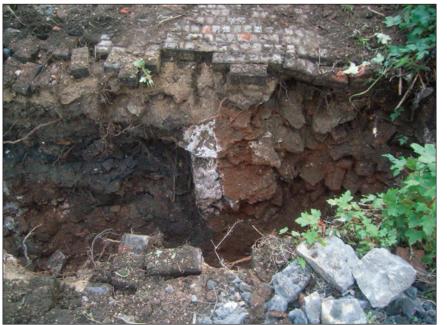
Plate 3 Section through made ground and walls, looking south
