Archaeological Watching Brief
**ST ANDREW'S PRIMARY SCHOOL,
NORTHAMPTON STREET, BATH,
SOMERSET.**

Report No. 2763/2013
BATRM No. 2013.20
OASIS: bristola1-155200

Archaeological Watching Brief
at
**ST ANDREW'S PRIMARY SCHOOL,
NORTHAMPTON STREET, BATH,
SOMERSET.**

Centred on NGR ST 74537 65595

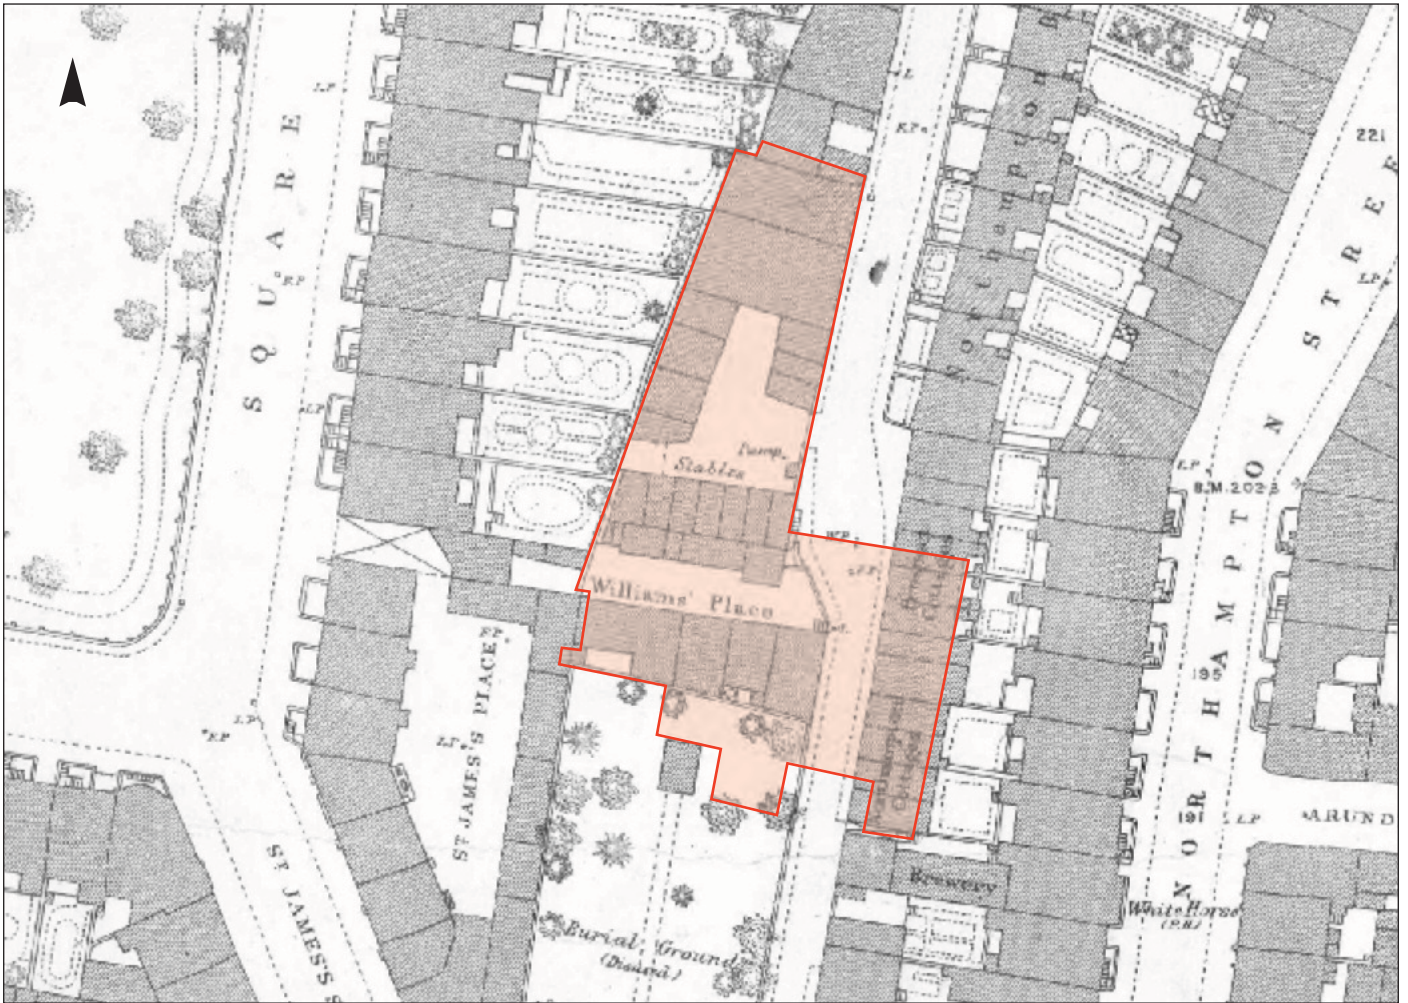
Fig.3 Extract from 1st Edition OS (1:500) map of 1885

- 3.9 By the time of the large-scale 1:500 OS survey (**Fig. 3**) of the city in the mid-1880s, the burial ground was disused, but there remained what was probably a mortuary chapel near its northern end. Bounding the northern end of the cemetery was the short terrace of four buildings known as Williams' Place, with smaller shed-like structures on the opposite side of the yard. Immediately to the north again was an east-west terrace of stables, mainly behind No. 33 St James's Square, with a yard (with pump) and further buildings reaching as far as the far end of the back of No.30. Beyond this again were larger structures, possibly housing, at the rear of Nos. 28 & 29 in the Square and fronting onto the lane outside of Northampton Buildings. The city of Bath became a county borough in 1889.

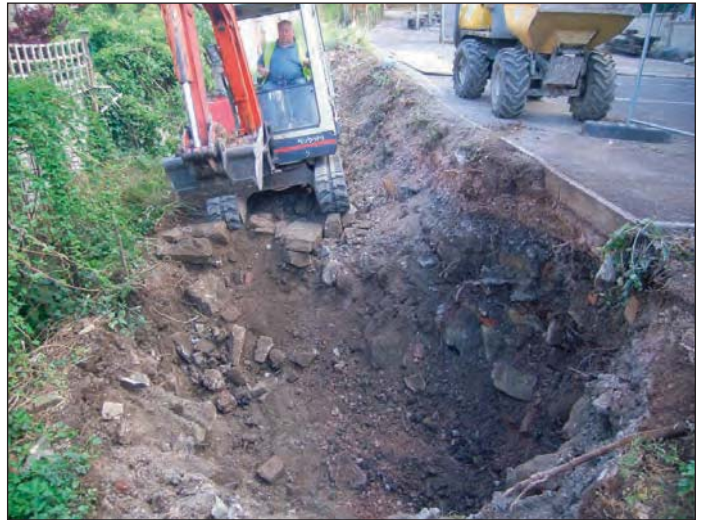
Plate 7
Looking west at structural remains belonging to one of the former terraced houses of Williams' Place. Left of the Pennant flagstone surface (103) is the remains of the north exterior wall of one of the houses (wall 104), while to the right is the buried garden soil 102

- 5.3 Starting several metres north of the north-west corner of the church/school buildings a strip of ground adjoining the western boundary wall, measuring some 3m wide, was reduced (**Plate 6**) by up to 2m. Observed at the base of the reduced area, after a rapid clean-up, was a narrow length of a demolished wall (104) abutted by a flagstone surface (103) (**Plates 7 & 8**). The wall (104), which measured some 0.4m wide, was constructed from variable sized rectangular blocks of dressed Bath-stone each measuring between 0.22 long by 0.17m wide by 0.15m thick and 0.30m long by 0.23m wide by 0.15m thick, and from bricks measuring 0.24m long by 0.10m wide by 0.05m thick. The masonry was bonded utilising a (much degraded) brownish yellow charcoal flecked mortar. The wall would have formed the north-facing front elevation of Williams' Buildings from its construction c1794 until the terrace was demolished in the mid-1960s. The wall-face (104) was in line with the extant north wall of the neighbouring No. 6 St James's Place, as shown on the 1st Edition OS (**Fig. 3**).

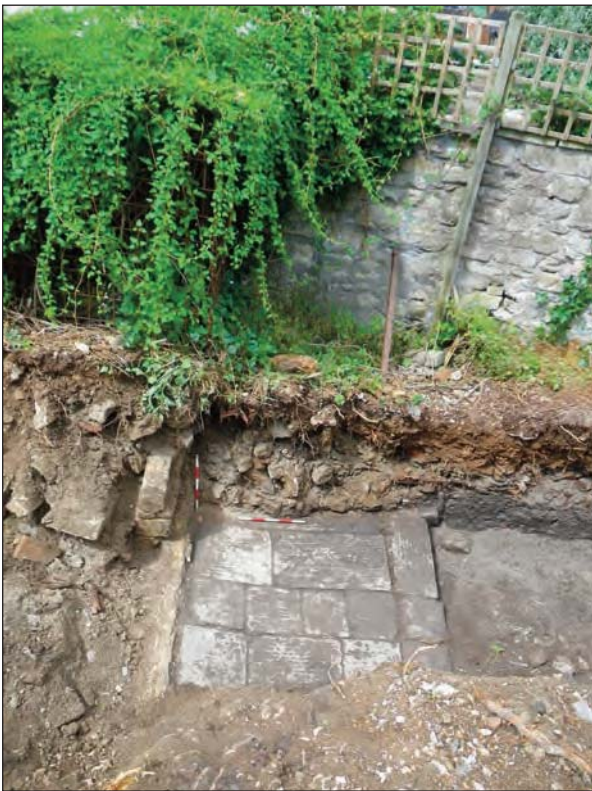
Plate 8
Flagstone surface 103 and the north-face of wall 104, looking south

- 5.4 Abutting the latter wall (104) was a flagstone surface (103) composed of slabs of Pennant Sandstone, which ranged in size from 0.32m long by 0.3m wide to 0.82m long by 0.48m wide. They also varied in thickness from 0.04m to 0.07m. The surface, which lay at a height of 61.2m aOD, seems likely to have formed a path providing access to the terraced houses of Williams' Place. There were indications, such as the presence of an upright stone slab in the east-facing section, of a former line of edging stones along the northern edge of the surface. Immediately north of, and probably contemporary with the latter surface, was a layer of dark brown/black buried topsoil (102). The area of ground may have been cultivated as allotments/gardens by the residents of Williams' Place. The deposit measured at least 0.4m thick and extended at least 3.5m towards the north side of the former lane.

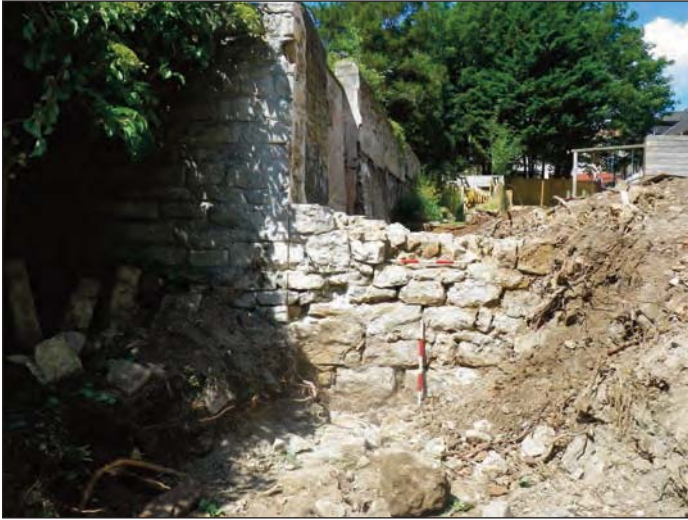
Plate 10
Wall foundation 108 and cobbled floor 109; part of a stall within former stable block, looking north-east

- 5.8 Abutting the north side of the latter partition wall (108) was part of a cobbled floor (**Plate 10**), the exposed portion of which measured 1.3m wide (east/west) by 0.7m wide (north/south). The roughly dressed Sandstone cobbles (109) were bonded with pale greyish pink charcoal and lime flecked mortar. This cobbled surface, recorded at a height of 62.4m aOD, is probably the floor of a stall within a former stable block that occupied part of the site until the mid-1960s.

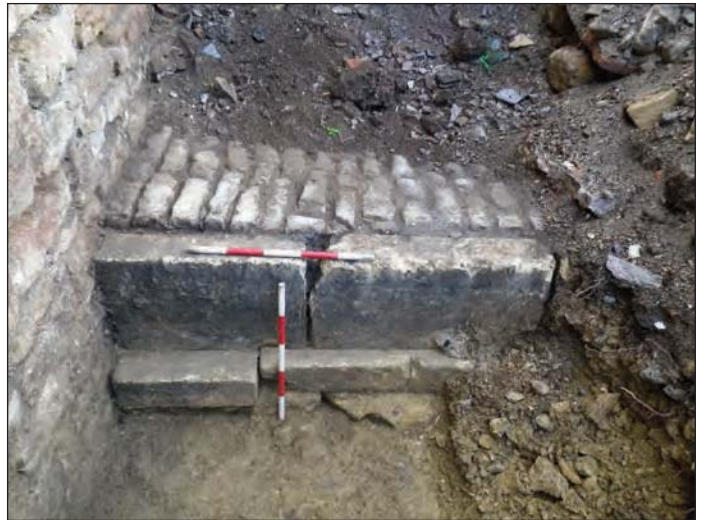
Plate 11
Looking north-west at wall foundation 108 and cobbled floor 109; vestiges of wall 108 can be seen bonded into the east-facing elevation of boundary wall 121

contemporary documentary evidence indicates were built in the 1790s. Traces of wall 108 were also present above ground level, integrated into the east-facing elevation of boundary wall 121 (**Plate 11**).

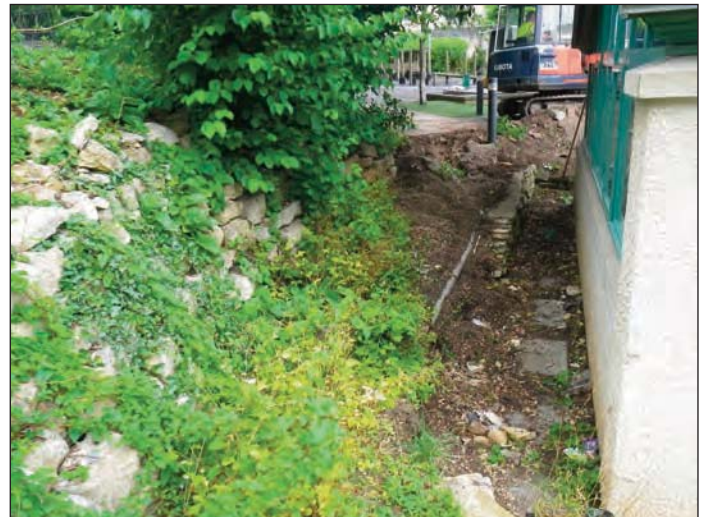
Plate 13
Excavation work in progress
north of wall 107; late Victorian
wall 113 can be seen at the
base of the trench, looking north

- 5.11 A week later, work resumed in the main trench next to the western boundary wall (**Plate 13**) adjoining the rear gardens of properties on St James's Square. Following the excavation of layers of overlying topsoil (100) and demolition rubble (101) the mechanical excavator soon exposed in-situ archaeology at a depth of about 1.4m below the surface of the nearby playground. The earliest structure recorded on this part of the site was the foundations of a 0.26m wide wall (115) (**Plate 14**) built from blocks of dressed Bath-stone and bonded with brownish yellow mortar indicative of probable late-18th century (c 1794) construction. It appears likely to be the south-facing exterior wall (contemporary with wall 108) of part of a range of stable buildings, it abutted part of the standing boundary wall (121), which being slightly earlier may be contemporary with the building of properties on St James's Square in the early 1790s.

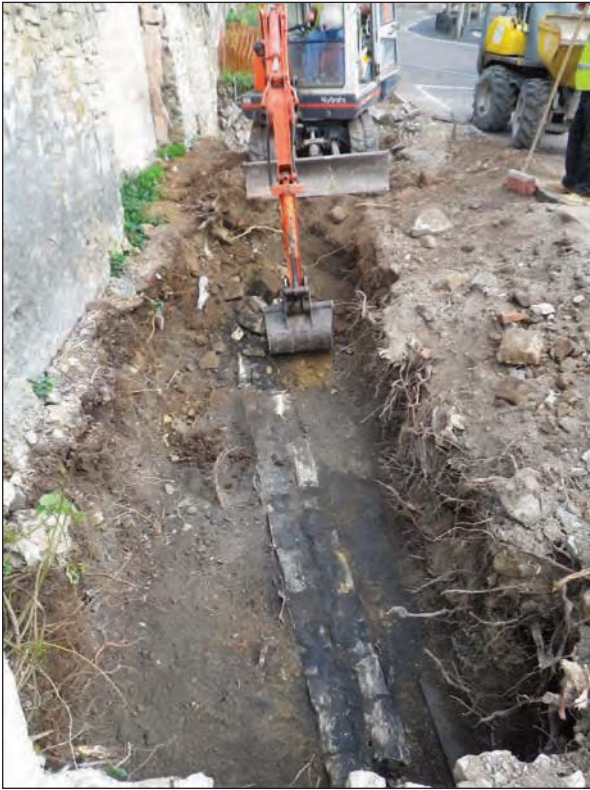
Plate 14
Looking south at the foundation
of wall 115, brick floor 116 and
Victorian drain pipe 119

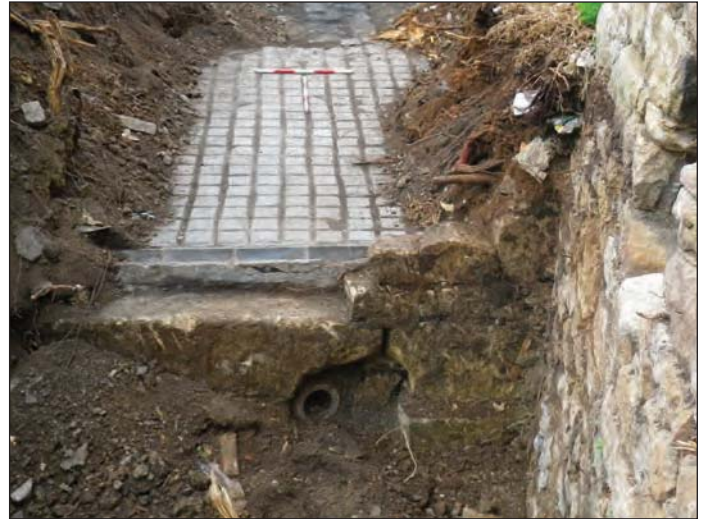
Plate 15
Wall foundation 115 and
brick floor (incorporating
a gutter) 116, looking
west

- 5.12 Abutting the south side of wall 115 was a late 19th/early-20th century brick surface composed of small greyish blue-coloured bricks (**Plate 15**) and including a concave-shaped surface rain-water gutter, indicating that it was the floor of an outside yard, which conforms with the cartographic evidence. The bricks were bedded on a layer of grey lime and charcoal flecked mortar (117). The exposed area of yard surface measured 1.4m wide (east/west) by 2.8m wide (north/south) and lay at a height of 62.2m aOD.

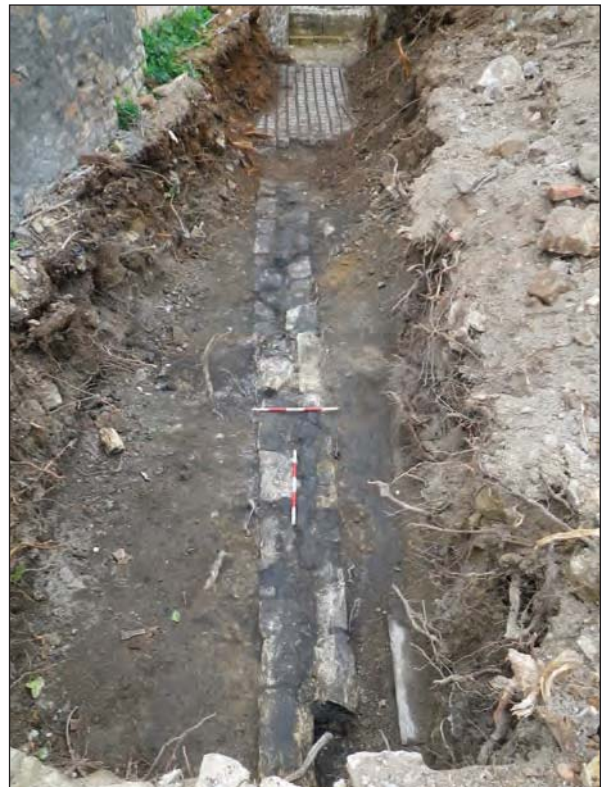
Plate 16
Looking north along wall
foundation 113 towards
stable yard 116 (bricks)

- 5.13 There was no sign of an east/west aligned north-facing exterior wall belonging to the range of stables south of the yard. However, a north/south aligned wall (113) (**Plate 16**), which was probably an internal dividing wall, abutted the north side of wall 107. The stone wall, faced with blocks of dressed Bath-stone, bonded with dark grey/black mortar and measuring some 0.4m wide, would appear to date from the late 19th century. Possibly contemporary with the latter wall was a late 19th-century ceramic drain (119), which had been inserted through the lower courses of wall 115 (**Plate 14**). It seems almost certain that the drain continues beneath yard surface 116.
