Archaeological Building Recording and Evaluation
**NEWLAND HOUSE,
NEWLAND, FOREST OF DEAN,
GLOUCESTERSHIRE.**

Report Nos 2897 & 2898/2013
Acc. No. SOYDH 2013/39
OASIS: bristola1-159411 & 159514

Archaeological Building Recording and Evaluation
at
**NEWLAND HOUSE,
NEWLAND, FOREST OF DEAN,
GLOUCESTERSHIRE.**

Centred on NGR SO 5522 0948

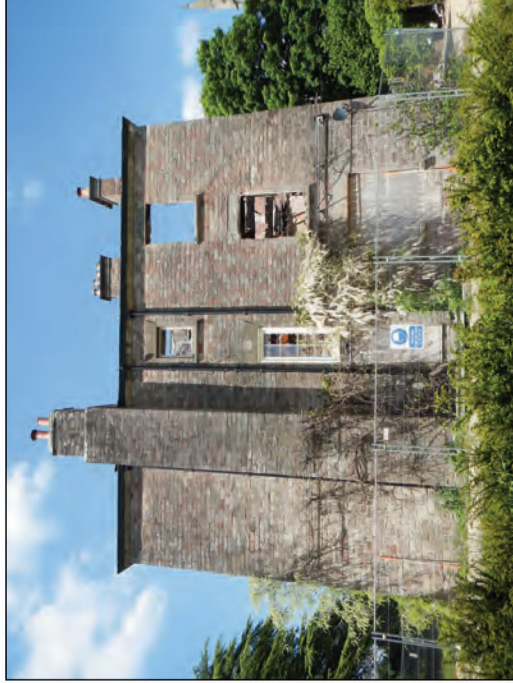
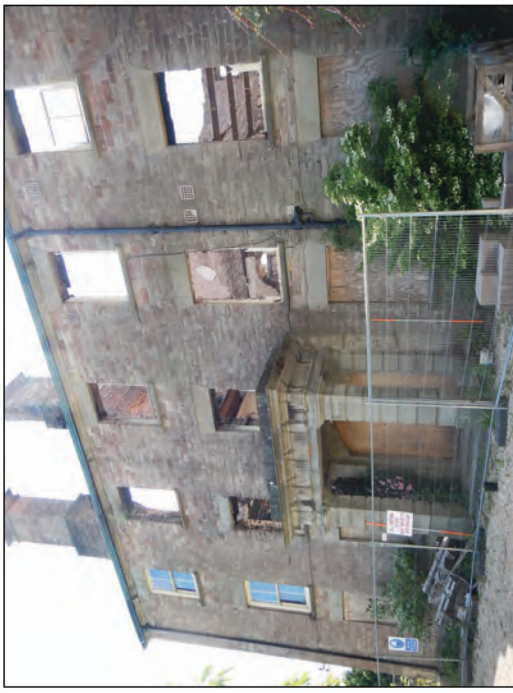
- 5.2 Details noted included the third storey added in the 19th century, the sandstone blocks used for this section appearing slightly more regular (**Plates 2 & 3**) and a blocked window on the north elevation (**Plate 8**). A light-well located on the south side of the building (**Plate 9**) also provided external access to the cellars. Many of the internal walls still retained a covering of plaster (**Plates 15 & 17**) obscuring the construction of the wall, whilst others were blackened with soot (**Plate 16**). A number of construction features were visible however, such as the iron beams formed of three sections bolted together which supported the second floor in the central bay section of the house, brickwork chimney breasts (**Plate 18**), and modern inserted doorways (**Plate 14**).

Plate 2 South elevation of Newland House, looking north

Plate 3 East elevation of Newland House, looking south-west

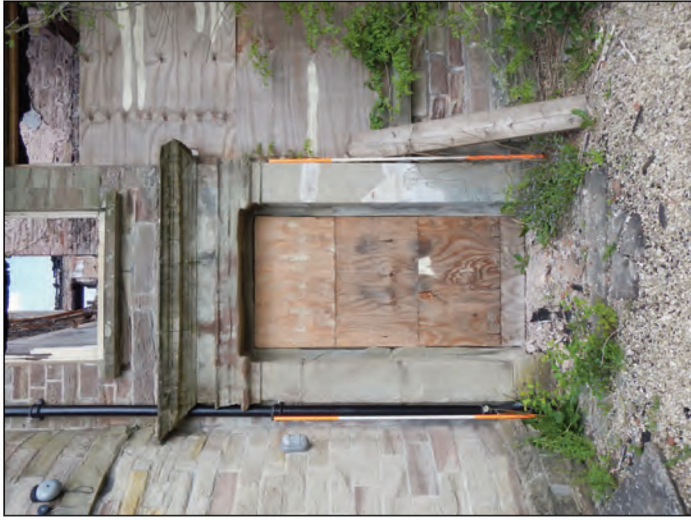
Plate 7
18th-century
inserted doorway
in west elevation,
looking east

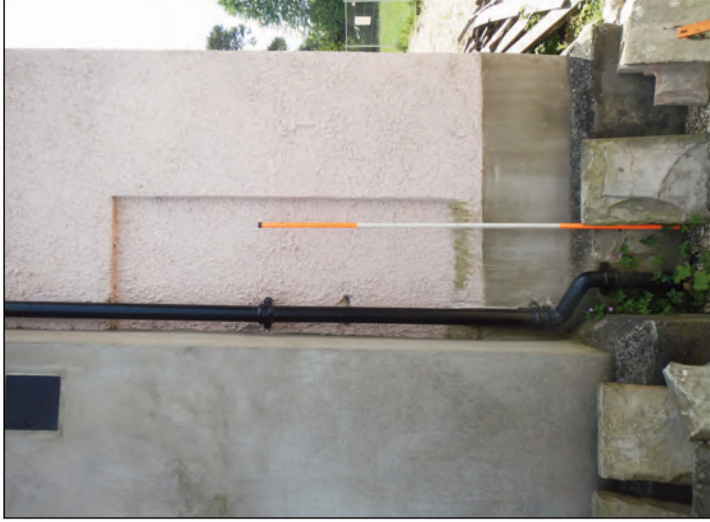
Plate 8
Blocked window opening
in north elevation,
looking south

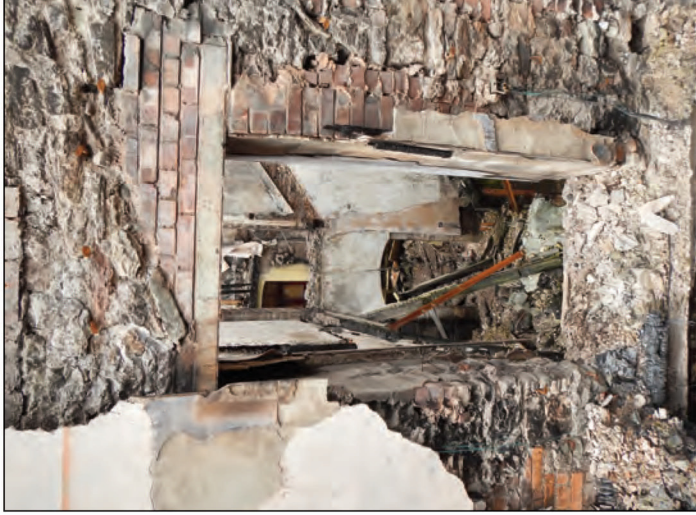
- 5.5 A series of more minor alterations believed to have occurred during the 20th century have been amalgamated into phase six. These include the blocking or opening up of doorways (**Plate 14**) and the use of a very friable, sandy yellow lime mortar in some areas (**Plate 25**). This was observed forming parts of the north-south internal dividing wall of the northern half of the building, and may represent an attempt at sympathetic repair by someone unfamiliar with the use of lime mortar.

Plate 14 Inserted 20th-century first floor doorway, looking north

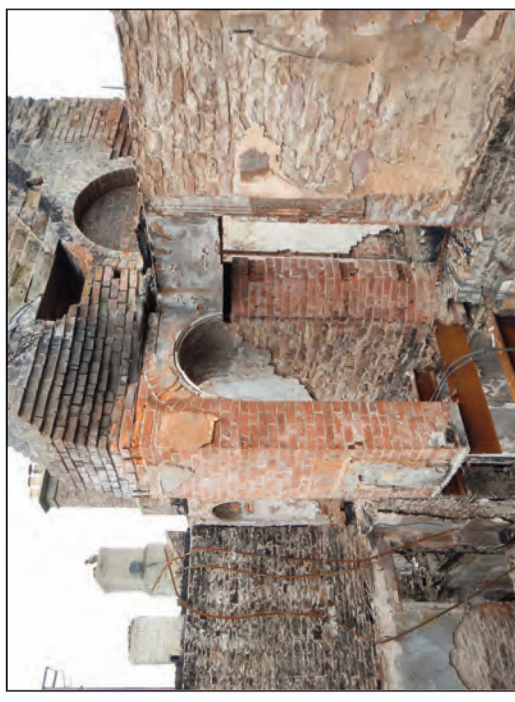
Plate 18 19th-century brick fireplace and arched doorway, looking north-east

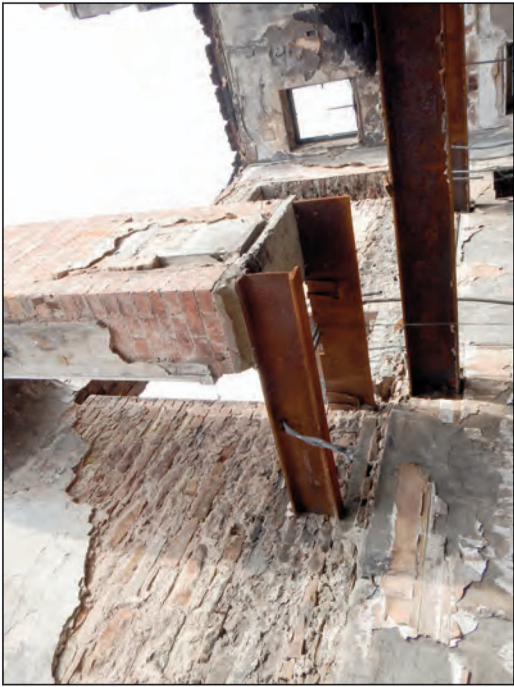
Plate 19 19th-century brick fireplace supported by one girder and one iron plate, looking south-east

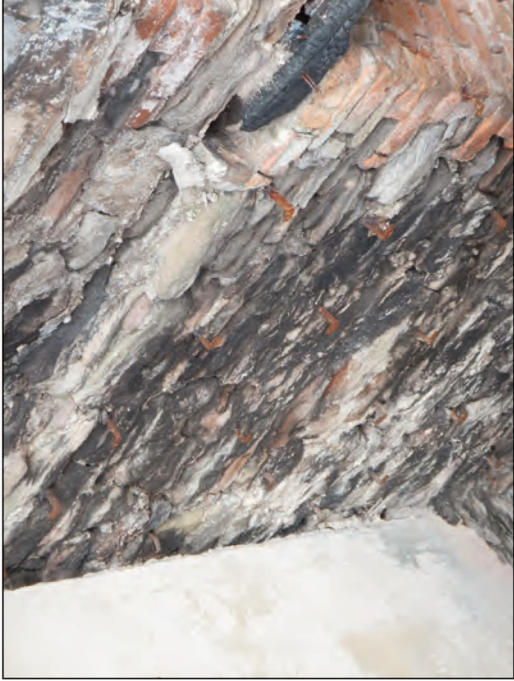
Plate 20 South wall, looking south-east, showing nails for keying plaster

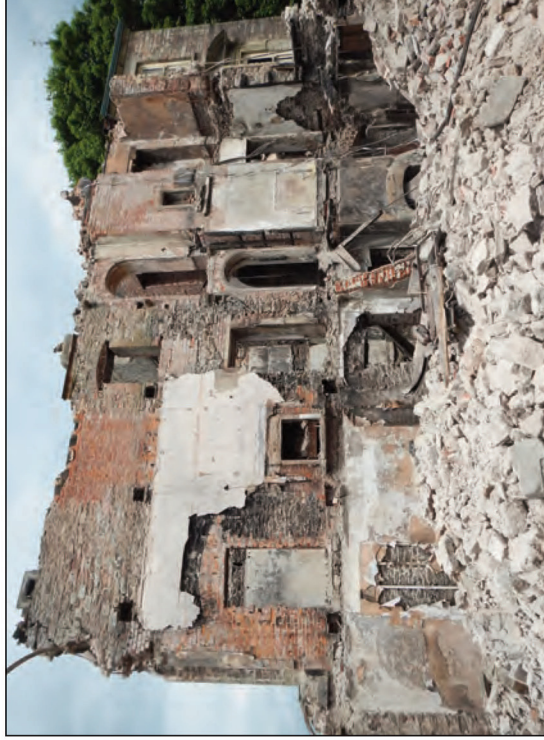
Plate 23 Original north wall, which became the central dividing wall following construction of the north wing, looking north-east

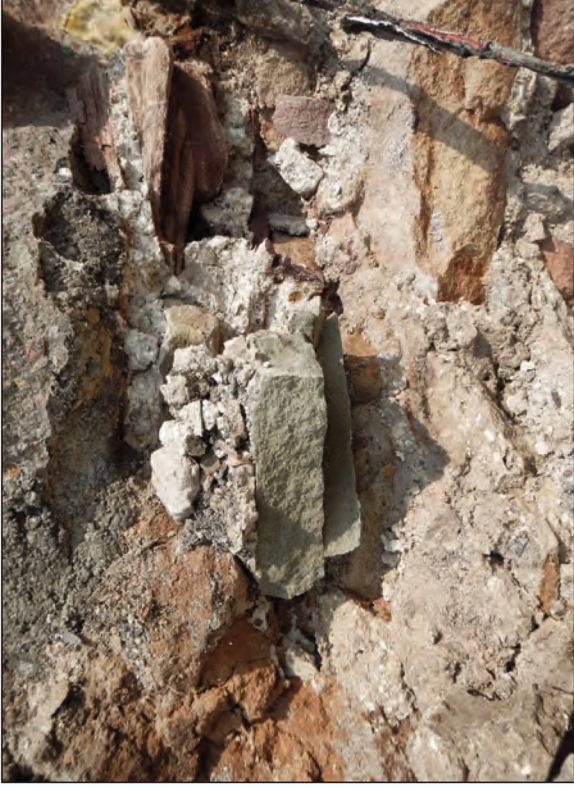
Plate 26 Buff lime mortar in north-south dividing wall of the north wing, looking north

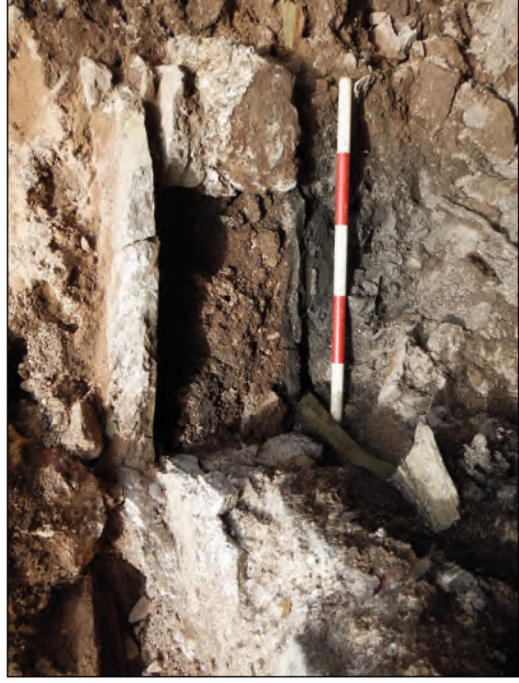
- 5.7 Trench 1 was the largest, measuring 16 x 1.6m, and running roughly east to west. Natural bedrock (106) was encountered at approximately 1m depth along the trench (e.g 121.93 & 121.61m OD) apart from at the east end where solid bedrock was not encountered until 2.8m deep (119.66m OD). Overlying this was a loose deposit of what appeared to be redeposited natural, clay and pieces of sandstone, with voids within it, suggesting it was backfill of the deep cut. The cut (122) was located 5.28 metres along the trench, with an abrupt break of slope at the top and sheer sides, its purpose is unknown however quarrying is a possibility. Along the north side of the trench and extending down to the bedrock within this cut was a roughly built rubble wall (**Plate 27**) bonded with a buff lime mortar similar to that used for phase 1 (late 17th/early 18th century) of the house. No foundation cut for this wall was visible which with the very rough appearance and excess mortar in places suggests this was the 'back' face of the wall built against the cut itself, and may be part of the cellars of the house hence its depth. Sitting above this wall was a stone-built drain (105) which ran north-east to south-west across the trench within cut (114), and was bonded with white lime mortar similar to that used in phase 2 (early 18th century) of the house. The backfill (121) of cut (114) contained the bases of two free-blown dark green wine bottles, dated to between 1770-1840 (Appendix 3), indicating the drain may be later than the mortar initially suggested. This drain was subsequently cut on the north-west side to allow a later ceramic drainpipe to feed into it (**Plate 28**) and the drain was re-capped at the same time, with the ceramic pipe and the cap-stones bonded with a hard pinkish grey mortar (**Plate 29**) similar to that used for phase 4 (mid-19th century) of the house.

Plate 29 Drain 105 and later capping 107 in Trench 1, looking north

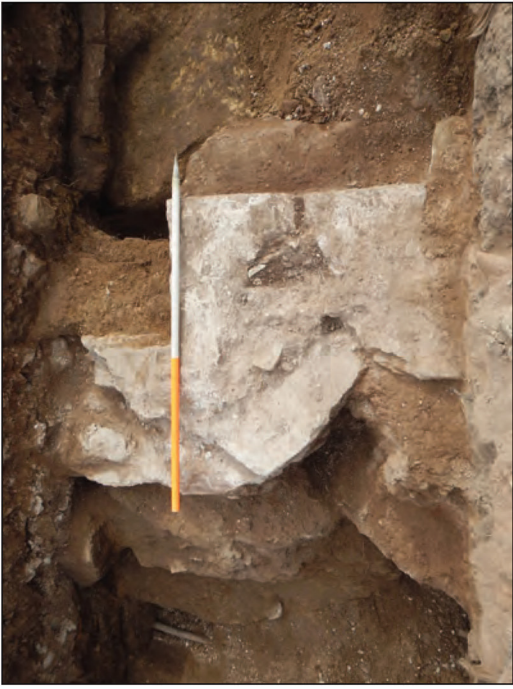
- 5.8 Across the middle of the trench, and running at right angles to it, was a substantial sandstone wall bonded with a pale lime mortar (**Plate 31**), which sat within a cut (125) made in the bedrock (106). To the east a lead water pipe (116) ran alongside the wall within cut (115) (**Plate 30**), while to the west was another cut (126) for a now robbed-out wall. The sketch of Newland House from 1772 (3.3) shows a small lean-to type of building located at the south-west corner of the house with a wall running alongside it to the stable block to the south; wall (124) may be the foundations of the lean-to structure and (126) the cut for the wall which ran to the stables. Above wall (124) and the water pipe (116) was a very mixed deposit (123) which was probably demolition rubble from the removal of the wall. Similarly deposit (132) which abutted wall (124) and overlay the backfill (127) of cut (126), contained fragments of post-medieval window glass, a strip of lead and a fragment of medieval roof tile, and may therefore also be associated with the demolition of these structures.

Plate 31 Sandstone wall 124 in Trench 1, looking south

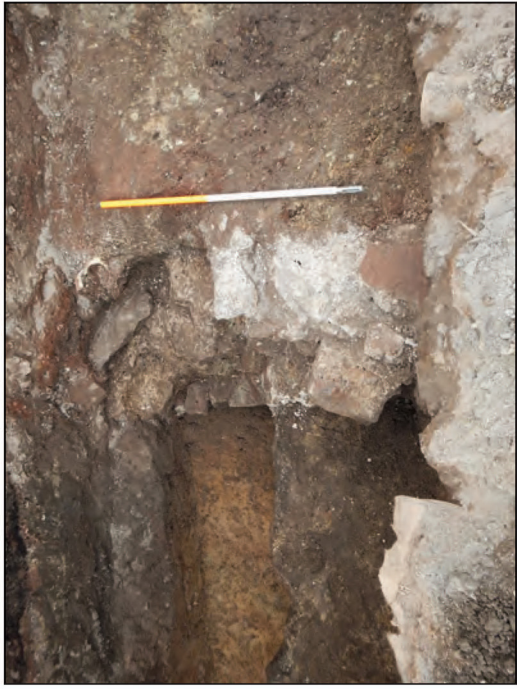
foundation cut for wall (212) which was composed of sandstone rubble bonded with a white lime mortar, and ran north-south across the trench (**Plate 37**). The 1881 OS plan shows a wall running from the north-west corner of the house to the boundary wall. To the east of this wall the foundations of the chimney stack (221) of the house were exposed with two ceramic drain pipes and their associated cuts sitting above the stone structures, with modern ground surfaces of gravel and paving (218) above this.

Plate 37 Sandstone wall 212 in Trench 2, looking north

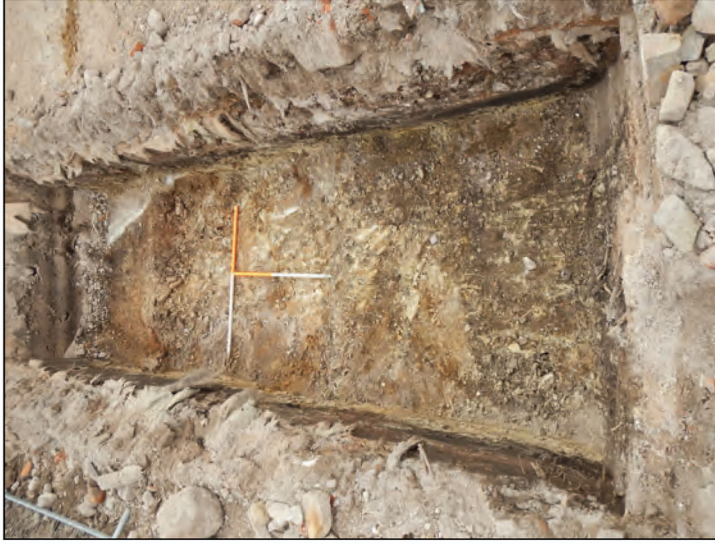
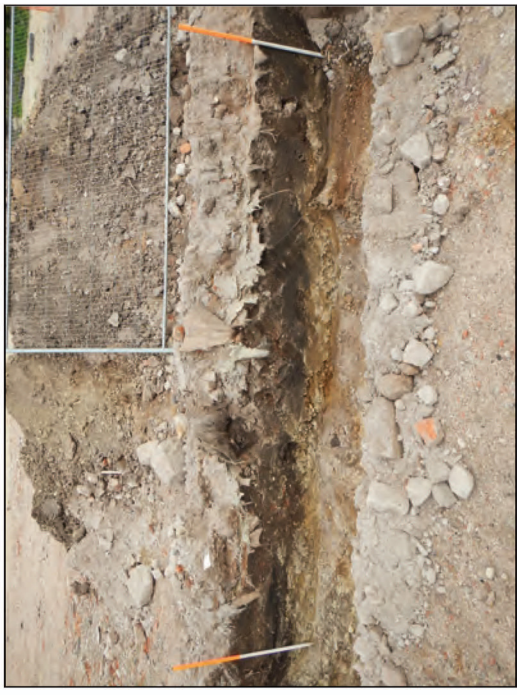
- 5.11 Trench 3 was the smallest of the trenches measuring 4 x 1.6m, and ran roughly north to south. Natural bedrock was encountered at a depth of approximately 1m (121.94m OD), with a clean brown sand overlying it in the southern half of the trench, similar to Trench 2. Above these was a dark brown buried soil 0.15m thick, containing lots of charcoal, probably the same deposit seen in Trench 2. A made ground layer, more mixed than in Trench 2 with individual dumps hard to identify, sat above this to a depth of 0.38m, with modern ground and recent demolition material overlying the made ground. No features other than a modern pipe trench in the south-west corner were identified (**Plates 38 & 39**).

Plate 38 Base of Trench 3, looking south

Plate 39 East section of Trench 3, looking east
