Archaeological Watching Brief
**WALLSCOURT PARK SITE, UWE FRENCHAY CAMPUS,
STOKE GIFFORD,
SOUTH GLOUCESTERSHIRE.**

Report No. 2962/2014
SGHER No. 20327
OASIS: bristola1-162546

Archaeological Watching Brief
at
**WALLSCOURT PARK SITE, UWE FRENCHAY CAMPUS,
STOKE GIFFORD,
SOUTH GLOUCESTERSHIRE**

Date Issued: 24 April 2014

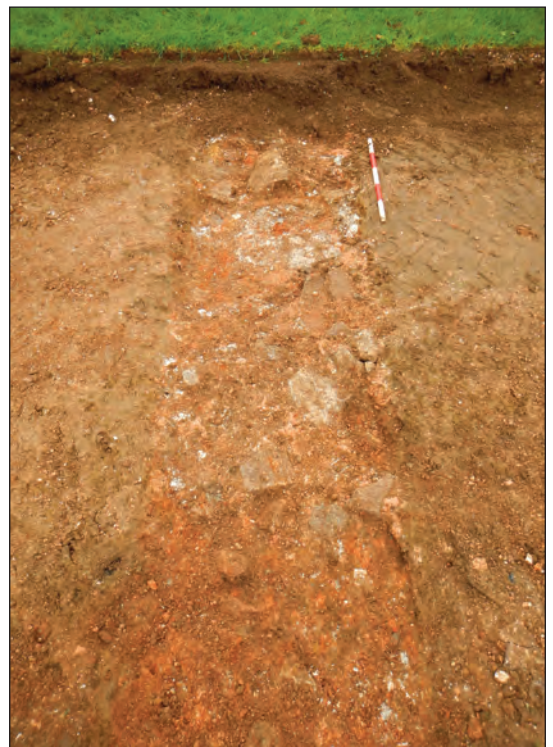
Plate 4
Wall 101, looking east

- 5.3 A shallow east-west aligned wall (101) was uncovered to the west of Wallscourt Farm (**Cover & Plate 4**). The wall was constructed with limestone rubble bonded with a soft pinkish red lime mortar, and measured 0.62m wide, 0.1m deep and extended for over 5m. Wall 101 was overlain by robber backfill 118, which comprised a mixture of limestone rubble, pinkish red and grey ashy lime mortar. This structure may have been a boundary wall or the rear wall of an open-sided agricultural outbuilding.

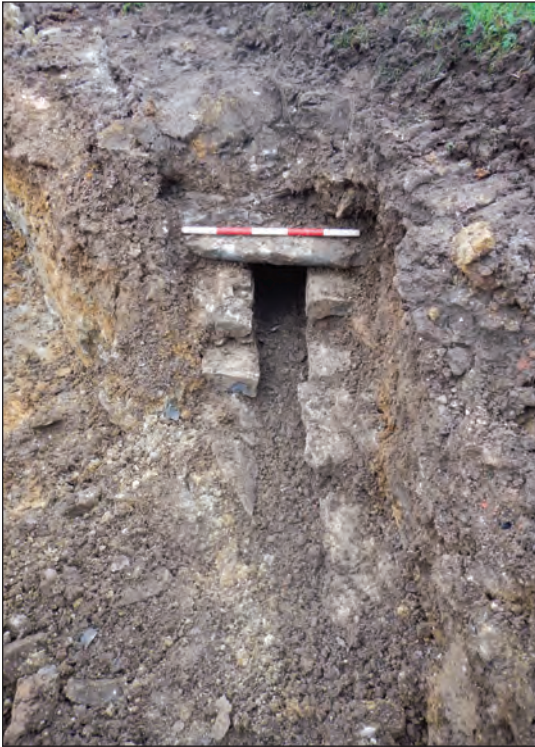
Plate 5
Drain 111, looking north-east

- 5.5 Layer 117 was cut by two stone-lined land drains (111 & 114; **Plates 5–6**), which formed part of an extensive drainage system (contexts 106-8, 111-16 & 119-20) that was uncovered to the north and west of Wallscourt Farm. The backfill (116) of drain 114 contained 19th-century pottery, animal bones and a copper alloy livery button dating from the period 1815-1823. The finds are indicative of domestic refuse.

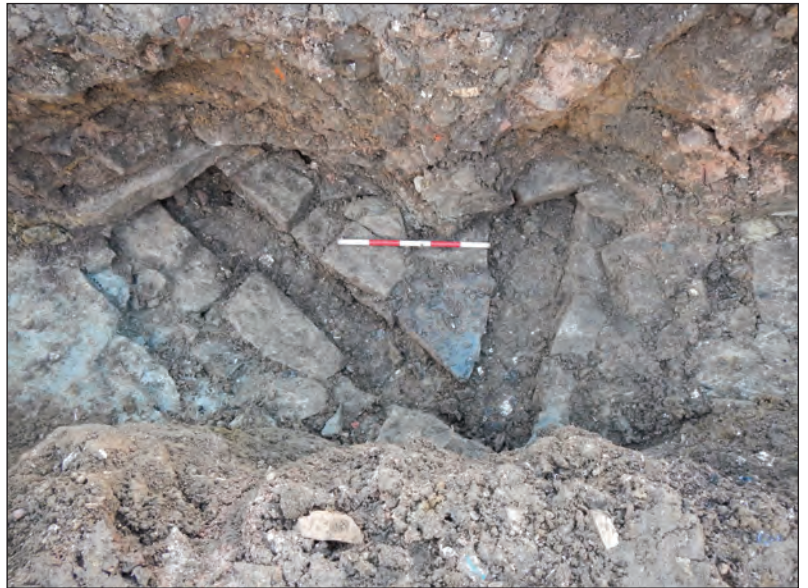
Plate 6
Drain 114, looking east

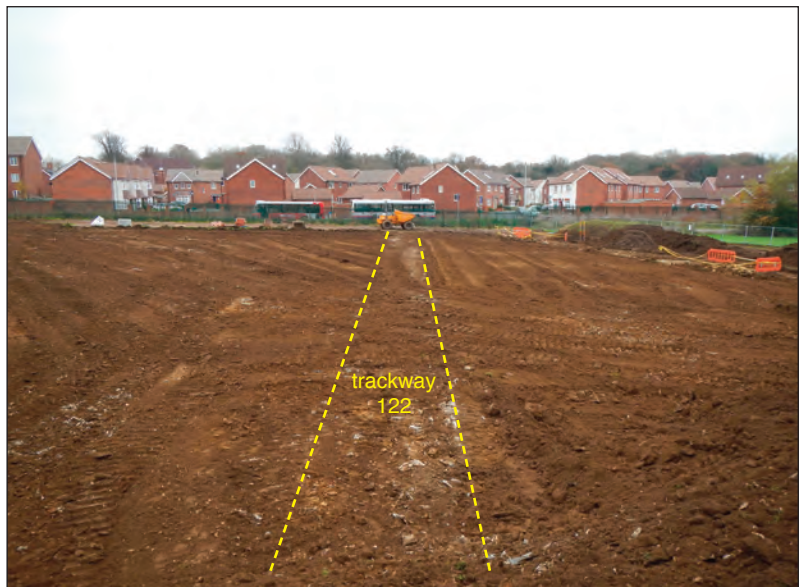
Plate 8
Trackway 122, looking south

- 5.6 An 80m length of well-made north-south aligned trackway (122; **Plates 7–8**) was uncovered in the field to the south of Wallscourt Farm. The trackway comprised a 0.2m deep, 3m wide cut, which was filled with locally quarried limestone rubble slabs, covered with smaller pieces of limestone rubble, topped with limestone gravel. The trackway is depicted on the 1st Edition Ordnance Survey plan of 1882 and is clearly visible as a parch mark in modern aerial photographs. The track is likely to have been constructed during farm improvements undertaken in the early 1850s.
