Archaeological Desk-based Assessment THE RECREATION GROUND, SPRING GARDENS ROAD, BATH.

Report No. 2978/2013 OASIS: bristola1-162996

Archaeological Desk-based Assessment

THE RECREATION GROUND, SPRING GARDENS ROAD, BATH.

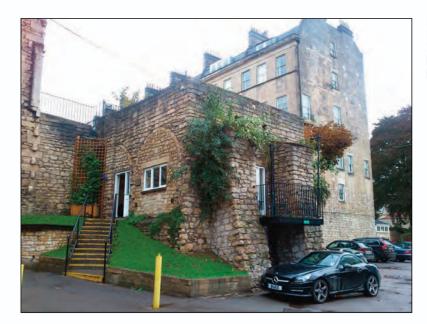
Plate 1 Bath Rugby Presidents Lounge, a converted limekiln Grade II listed, looking north

- 5.10 To the east of the clubhouse is the Presidents Lounge (Plate 1), a converted limekiln and the only listed building (Grade II) within the study area. As detailed above (see § 3.4) this would have provided the lime used in the construction of the late 18th century Bathwick suburb and would have been demolished if the development had continued to the south. Also noted here was the south-east end elevation of the south-west terrace of Johnstone Street, which unlike the rest of the terrace or the north-east terrace opposite, has the upper stories constructed in brick. The reason for this may be financial or due to timescale, and appear to be another remnant of the changes to the planned development. Located to the north-east are the other two listed buildings within the Recreation Ground, the late 19th century Cricket Pavilion (Plate 9) and entrance Kiosks (Plate 10), the latter of which provided access to the ground via William Street which descended quite steeply from Great Pulteney Street. Both of these are Grade II and are outside the study area but as survivors of the early history of the Recreation Ground the impact of any changes to its layout may be greater than on other listed buildings in the locality.

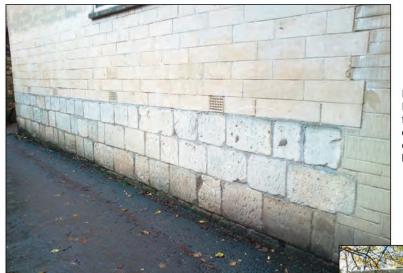
Plate 7 Reused limestone blocks forming the bottom courses of the south-west elevation of the clubhouse, looking north

- A rapid walkover of the study area was undertaken by Simon Roper (BaRAS Project Officer) on the 22nd of October. The study area includes the 20th century stands of the rugby ground (Plates 2, 4, 5 & 6), the pitch itself (Cover), tarmac areas around the north-west (Plate 2), south-east and south-west sides of the pitch and buildings located on the north-west side (Plate 3). These buildings include the 20th century clubhouse, the south-west and north-west elevation of which appears to have reused limestone blocks forming the lower courses (Fig. 1). These have the traces of keying for plaster on them suggesting they may have originally been the internal face of a wall. Examination of the historic maps (Fig. 6) indicates that these do not represent the remains of a pre-existing wall but are reused material.
