Archaeological Evaluation  
**LAND AT HIGH STREET  
HIGH LITTLETON  
SOMERSET.**

Archaeological Evaluation  
of  
**LAND AT HIGH STREET  
HIGH LITTLETON  
SOMERSET.**

Centred on NGR ST 6450 5838

Prepared for **Curo Group Ltd.**

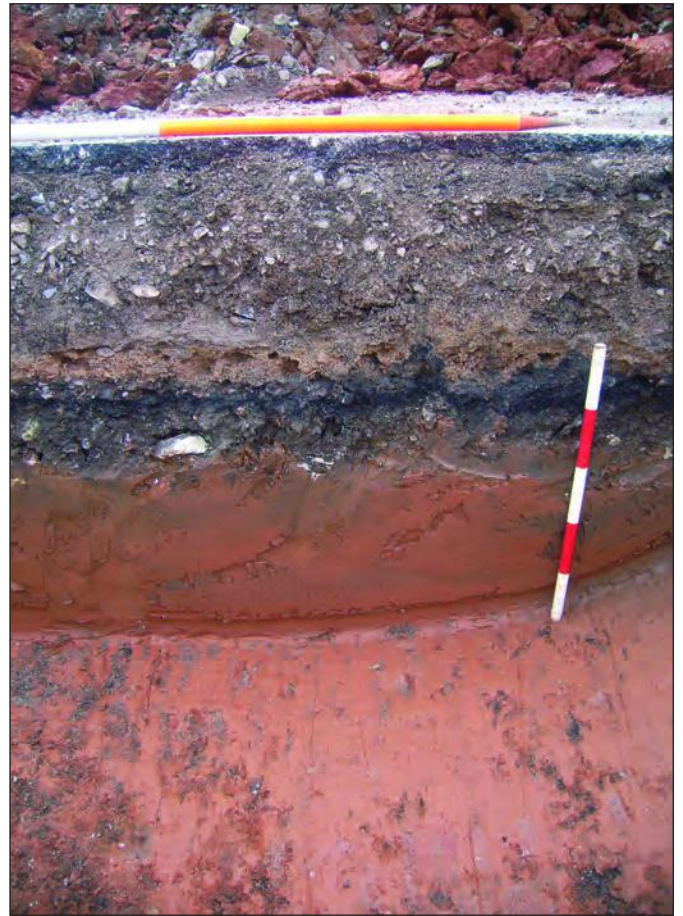
Plate 2  
Trench 1, south-west section  
at north-west end of trench  
(layers 101-107), from the  
north-east

- 5.3 The deposits encountered generally comprised a fairly uniform series throughout the trench, albeit with some variation.
- 5.4 The top of the natural geology, comprising a deposit of orange-brown clay (107), was encountered at approximately 0.50m below existing ground level and was excavated for a depth of 380 mm. This was overlain by a 90-mm thick deposit of grey-brown silty clay (106) which itself was overlain a 30mm-thick dark-coloured ash/clinker deposit (105), although these deposits were not visible in the eastern end of the trench (**Plate 2**). The layers possibly represent levelling associated with the construction of the modern surfacing.

- 5.5 The top four layers of the trench comprised sand blinding (103 & 104), scalplings (102) and tarmac surface (101), having a combined thickness of approximately 400 mm (**Plate 2**).

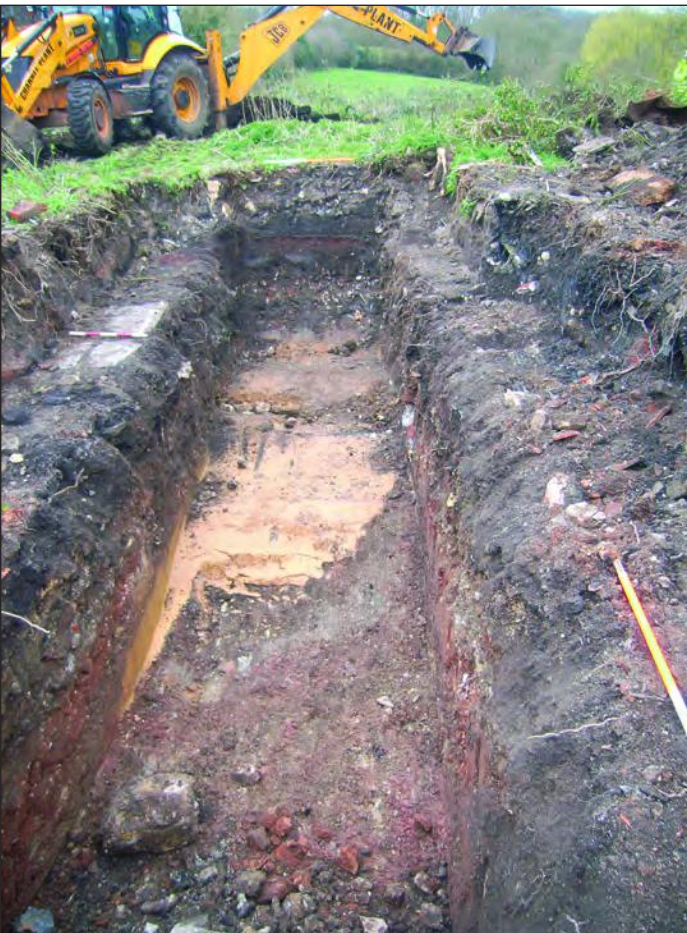
Plate 3  
Trench 2, including stone  
slabs under layer 200  
(left of photo), from the  
north-east

- 5.7 Trench 2 was situated in the central portion of the redevelopment site (**Plate 3**). The trench was aligned north-east to south-west and measured 10 m x 2 m wide. Due to site conditions it was not possible to enter the trench to undertake detailed recording.

- 5.10 A layer of stone paving slabs was observed between the surface material (200) and garden-soil layer (201) in the south-east section of the trench (**Plate 3**).

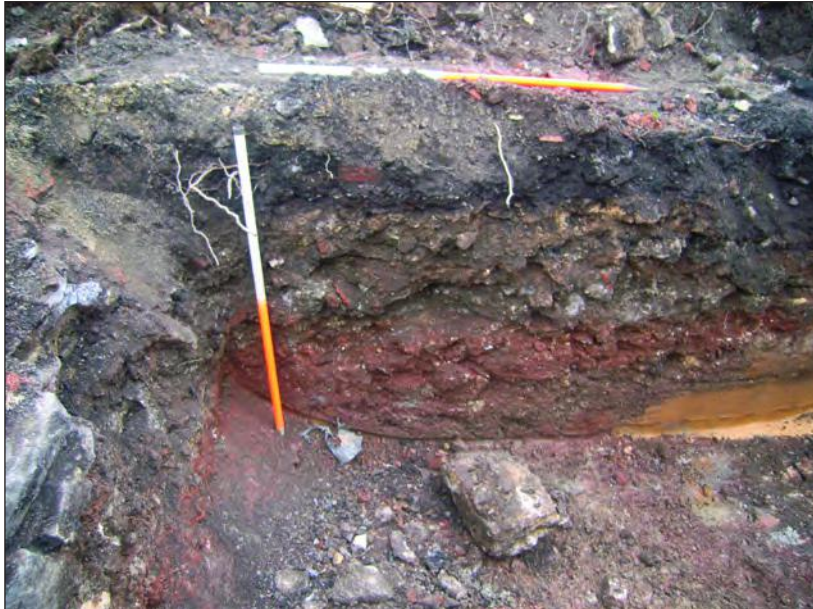
Plate 4 Trench 2, south-east section at north-east end of trench (layers 200-205), from the north-west

- 5.8 Generally, a yellow-brown clay (205), was overlain by a series of deposits (201-204), some of which appeared to comprise re-deposited garden soil, although one of the deposits (202) comprised a grey-coloured mortar. A surface layer (200), comprising a mixture of demolition rubble and other dumped material of modern date, directly overlay deposit 201 (**Plate 4**).

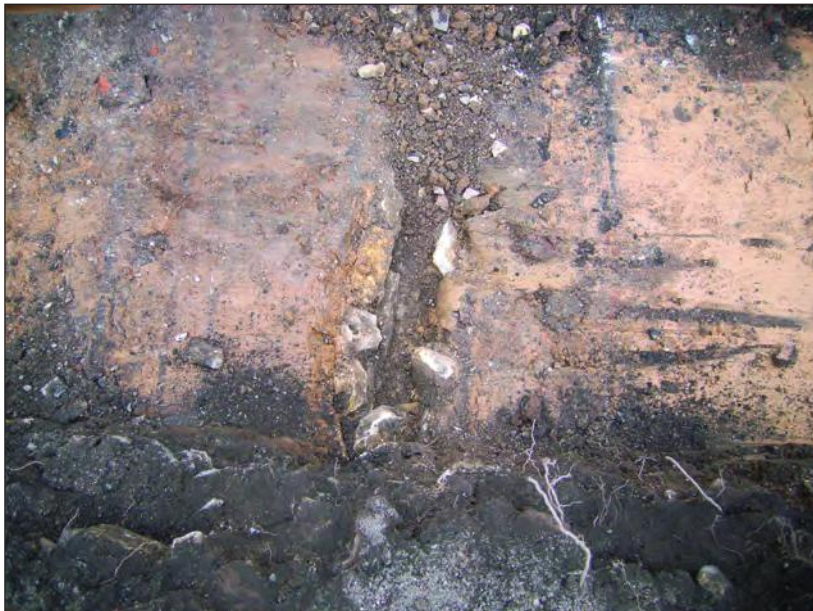
Plate 5 Trench 2, stone-lined drain (in layer 205) in central portion of trench, from the north-west

- 5.9 A stone-lined drain formed within layer 205 was observed crossing the trench in a roughly north-west/south-east direction appearing to continue beyond the sides of the trench (**Plate 5**).

- 6.3 Trench 2 exposed a stone-lined drain at some depth. Although not firmly dated, this feature possibly relates to the construction of a building depicted on the redevelopment site on a late-18<sup>th</sup>-century map or, alternatively, could be associated with cultivation activities.
- 6.4 A layer of stone paving slabs was observed in the upper layers of the trench and possibly comprised the vestiges of a garden path or perhaps a base. This being the case, it is probable that the garden soil layer (201) onto which it was constructed comprised the original land-surface which has subsequently been covered over by modern material (layer 200).

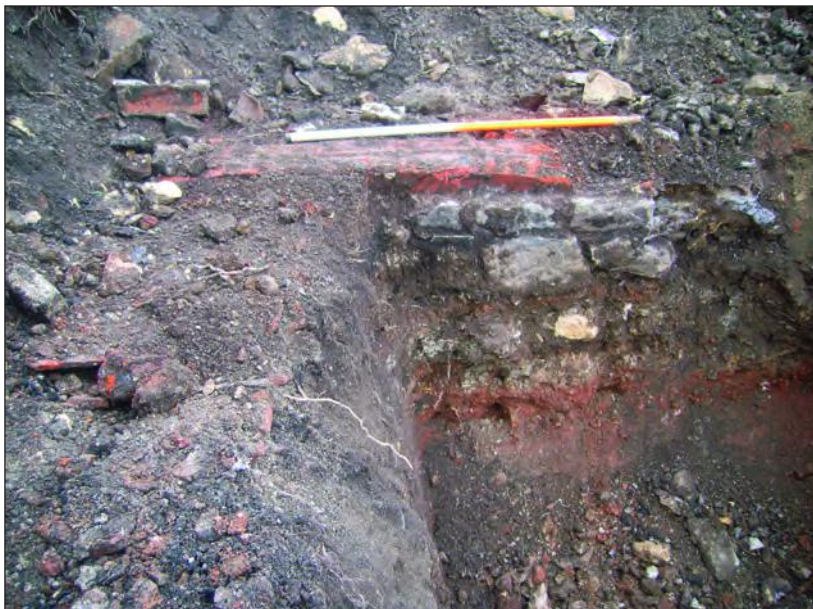
Plate 6 Trench 2, masonry wall in north-east section of trench, from the south-west

- 5.11 A masonry wall of roughly north-west/south-east orientation was observed at the north-east end of the trench which roughly corresponded with a known property-boundary. The wall appeared to be founded on deposit (203). The lower (foundation) courses of the wall were constructed with roughly shaped stone blocks bonded with and off-white mortar. A single course of bricks laid on to of the stonework was observed at ground level (**Plate 6**).
