**Archaeological Watching Brief  
IEP DEPOT,  
STOKE GIFFORD,  
SOUTH GLOUCESTERSHIRE.**

Report No. 3022/2014  
SGHER No. 20335  
OASIS: bristola1-170289

Archaeological Watching Brief  
at the  
**IEP DEPOT,**  
**(INTERCITY EXPRESS PROGRAMME)**  
**STOKE GIFFORD,**  
**SOUTH GLOUCESTERSHIRE.**

Prepared for **Hitachi Rail**

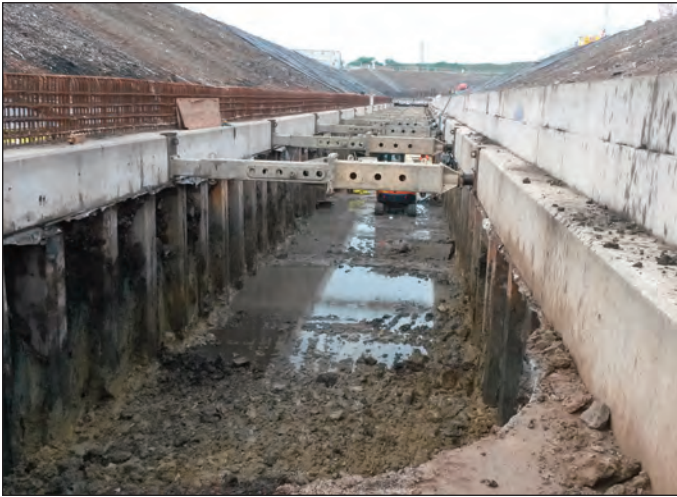
Plate 1 View along culvert, looking south-west

- 5.2 No archaeological features were observed during the groundwork. The site comprises landfill made up of predominantly building material, demolition rubble and industrial waste with mixed-in soil and clay, overlying natural clay and mudstone deposits (**Fig. 2**). Between 4-5m of this material was removed before piling occurred for the construction of the new culvert. The deposits recorded are from within these pilings during the excavation and construction of this culvert (**Plate 1**).

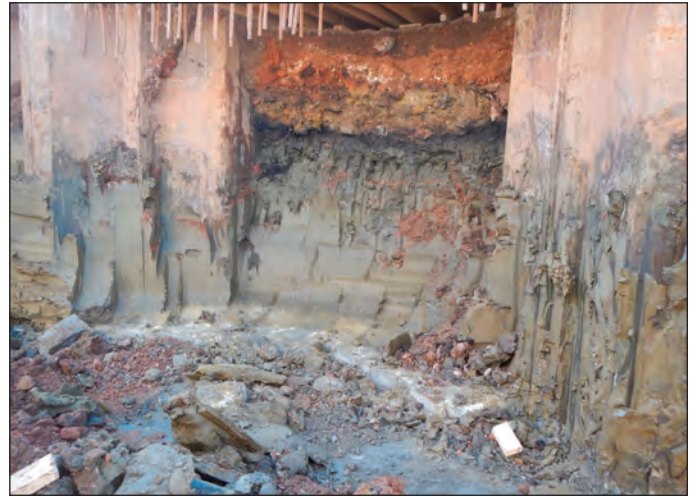
Plate 2 Representative section, looking south-west

- 5.3 The lowest deposit excavated on the site was mudstone (010) underlying clay deposits (007 & 009) containing a sandy clay lens (008) (**Plates 2 & 3**). Context 007 contained 2" and 3" extruded clay land drains in a possible herringbone pattern, the larger bore section of pipe running North - South with the smaller pipe angling North-East - South-West towards it. The junction was outside the excavation area. There was no visible evidence of pipe trenches or backfill. Above this context were a series of redeposited bands of material consisting of various mixes of building and demolition rubble, crushed brick, stone, concrete, and soil (002, 003 & 004); context 002 being truncated by the current development and overlaid with context 001 during the construction of the culvert. At the north-eastern end of the excavation these were gradually replaced by a thick deposit of railway ballast (011).

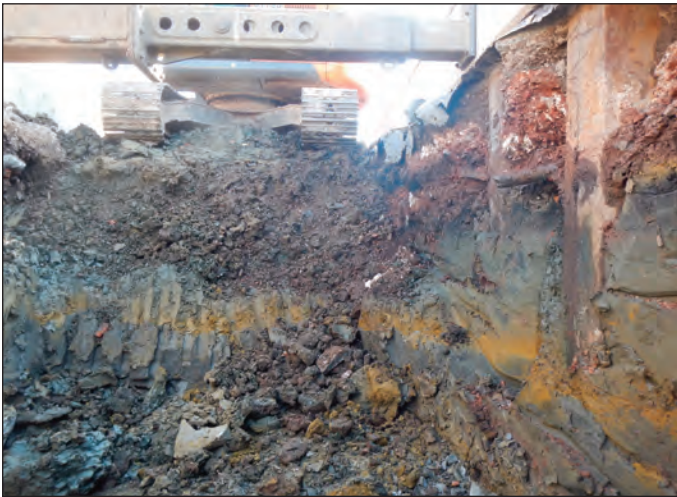
Plate 3 Sand lens in section, looking north-east

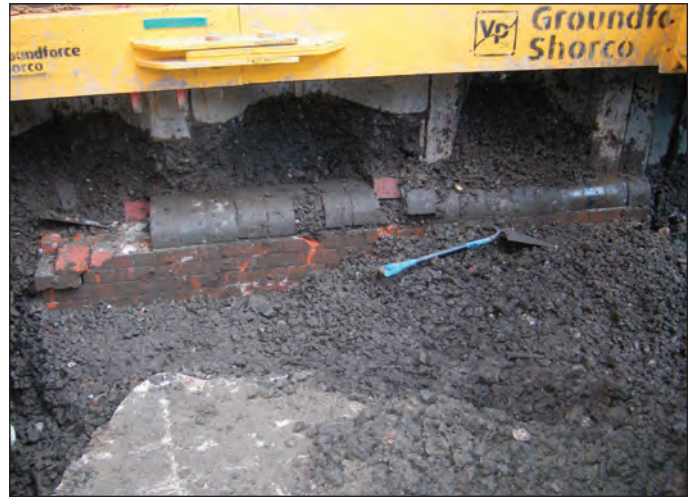
Plate 4 Top of original culvert, looking north-east

- 5.4 At the north-eastern end of the site the original brick culvert and later corrugated steel pipe (012) under the railway embankment were exposed beneath layers of railway ballast (011) (**Plates 4-6**).

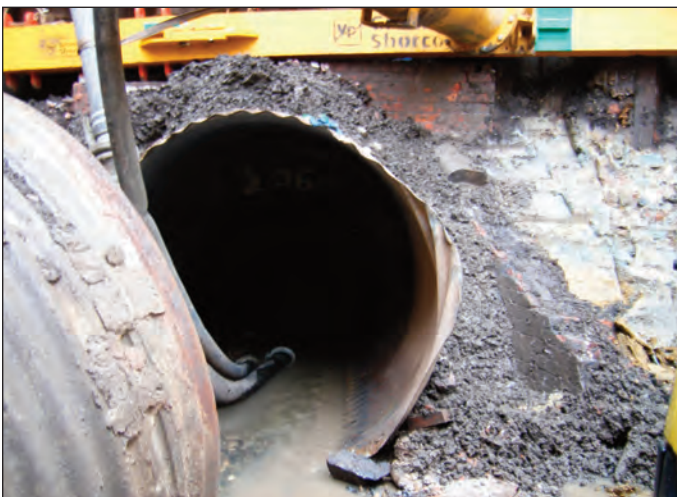
Plate 5 Corrugated steel pipe laid into brook and original culvert, looking north-east

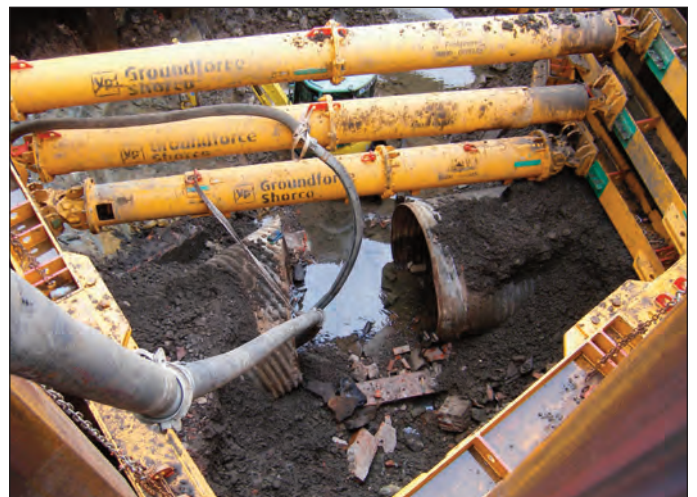
Plate 6 View down onto original culvert, looking south
