**Bristol and Region
Archaeological
Services**

**Archaeological Evaluation
ST CATHERINE'S PLACE,
BEDMINSTER,
BRISTOL.**

Report No. 3034/2014
BHER No. 25357
OASIS: bristola1-178155

Archaeological Evaluation
of
**ST CATHERINE'S PLACE,
BEDMINSTER,
BRISTOL.**

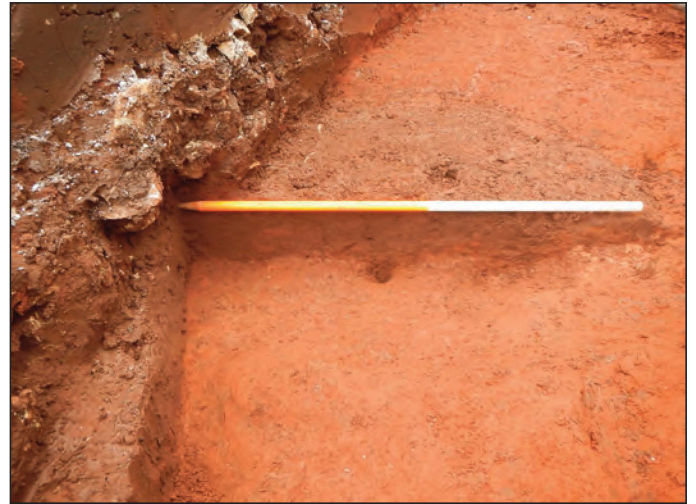
Plate 2 Trench 1, looking south-east, showing pit 114

- 5.3 The natural geology in trench 1 was a compact dark red sand (121), which was overlain by natural/made ground interface layer 124 and cut by undated pit 114 and posthole 112 (**Figs 4–5; Plates 2–3**). A single sherd of 11th–13th-century pottery was recovered from the fill (115) of pit 114.

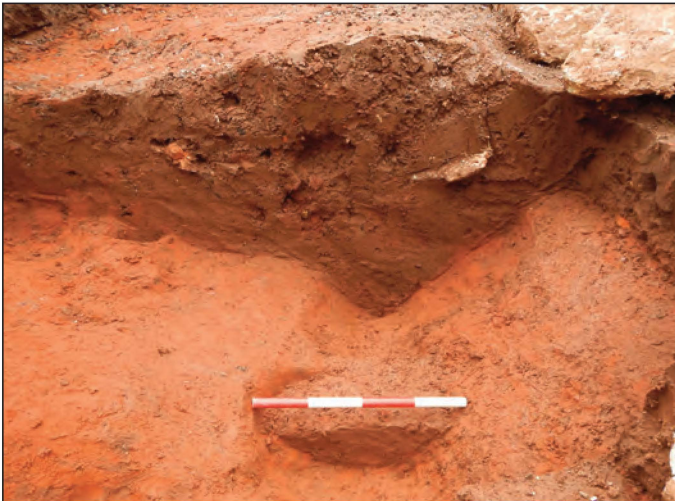
Plate 3 Trench 1, looking north-west, showing ditch 109 and posthole 112

- 5.4 Posthole 112 and pit 114 were both cut by post-medieval ditch 109 (**Figs 5–6; Plate 3**). This feature followed the NW – SE alignment of Mill Lane and is probably best interpreted as a roadside ditch. The ditch fills (110-1 & 120) contained late 17th–18th-century finds and a small but significant assemblage of residual medieval pottery.

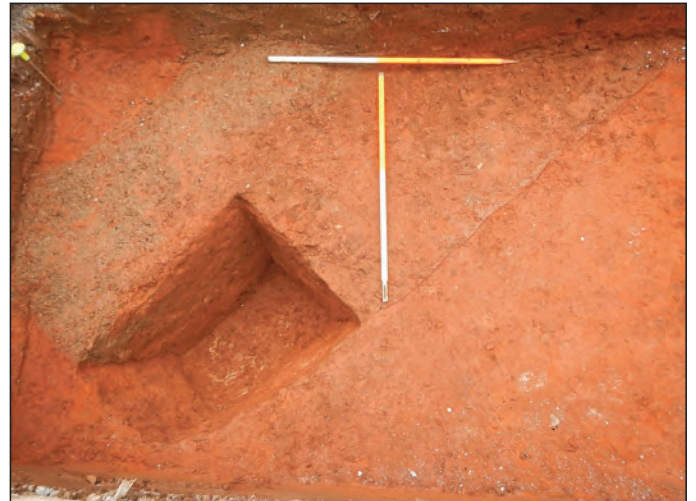
Plate 4 Trench 1, looking west, showing pit 116

- 5.5 Layer 124 was cut by a rectangular pit 116 (**Fig. 7; Plate 4**), which was backfilled with a mixture of re-deposited natural sand (117, 119, & 122-3) and a dump of grey sand and mortar (118) that contained a clay tobacco pipe dating from the period c 1690–1750.

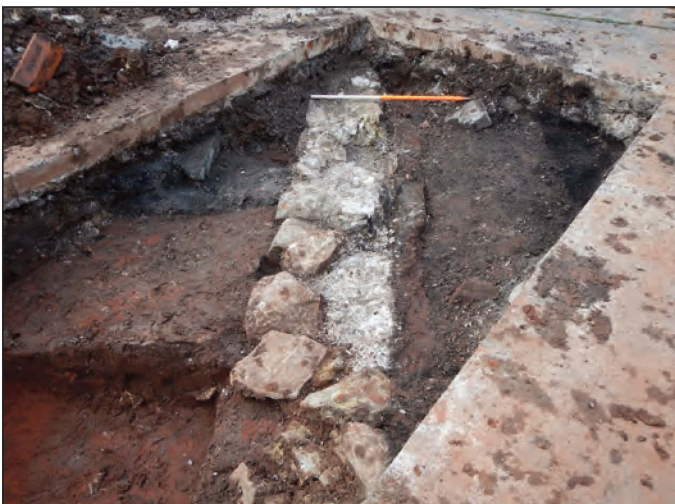
Plate 5 Trench 1, looking north-west, showing wall 101

- 5.7 Wall 101 (**Fig. 6; Plate 5**) followed the same alignment as ditch 109 and was constructed with limestone blocks bonded with a soft white lime mortar. This wall may have formed the north-east wall of a building depicted on Plumley & Ashmead's plan of 1828 and/or a boundary wall separating Gough's Court from Mill Lane, which is first depicted on Ashmead's plan of 1854.

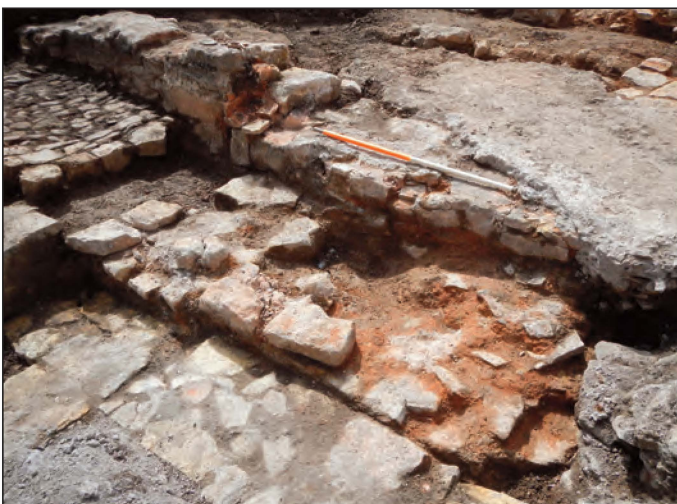
Plate 11 Trench 2, looking south, showing detail of walls 222, 257 & 278-9

- 5.15 Wall 278 (**Plates 8-11**) was probably contemporary with walls 213 and 222 (**Plates 7-8**), all of which were constructed with limestone rubble bonded with a pale pinkish or yellowish lime mortar. Wall 257 was constructed with limestone rubble and bonded with a reddish orange sandy mortar. Wall 257 (**Plates 8-12**) incorporated a steeply sloping stone-lined drain that flowed downhill towards the north. Wall 257 formed part of a retaining wall that probably defined the south-east side of a head race for the mill; its facing stones appear to have been removed during a later re-modelling of the head race. Wall 257 is probably broadly contemporary with walls 222 and 278. No dating evidence was recovered from any of these structures (213, 222, 257 & 278), and although the visible parts appear to be post-medieval, the possibility that they may incorporate the fabric of earlier structures cannot be discounted. Wall 286 may be contemporary with these structures. Wall 279 (**Plates 8-11**) appears to be an infilling of an opening between walls 222 and 257. This wall was constructed with limestone blocks bonded with an orangey pink lime mortar.

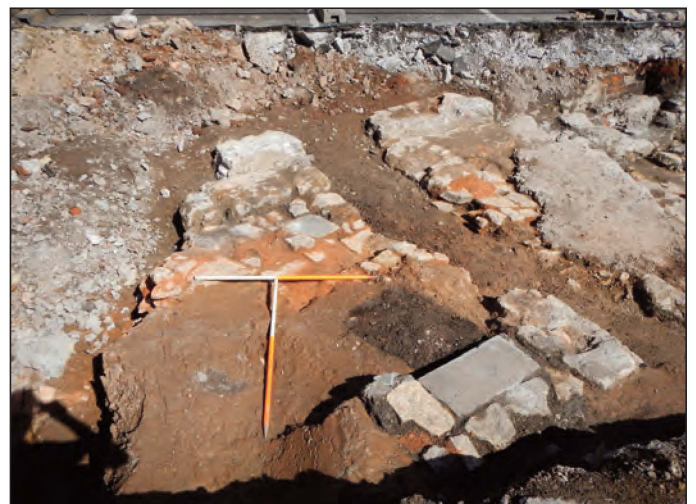
Plate 12 Trench 2, looking north, showing detail of structures 245-6, 257, 259 & 260

- 5.16 Wall 257 was abutted by retaining wall 259 (**Fig. 10; Plates 8-12**), which appears to represent a re-modelling of the head race. This structure was constructed with limestone blocks and very large yellow sandstone blocks, bonded with grey and cream coloured lime mortar. Structure 259 was abutted by wall 260.

- 5.17 Structure 246 (**Plate 12**) was constructed within cut 247 with a mixture of Pennant Sandstone and limestone blocks bonded with a grey lime mortar. The function of this feature, which appears to be a small surface, remains unknown. Structure 246 was cut by pit 248, which was filled with silty sand and gravel 249. The function of this pit remains unknown, but it appears to be associated with structure 246.

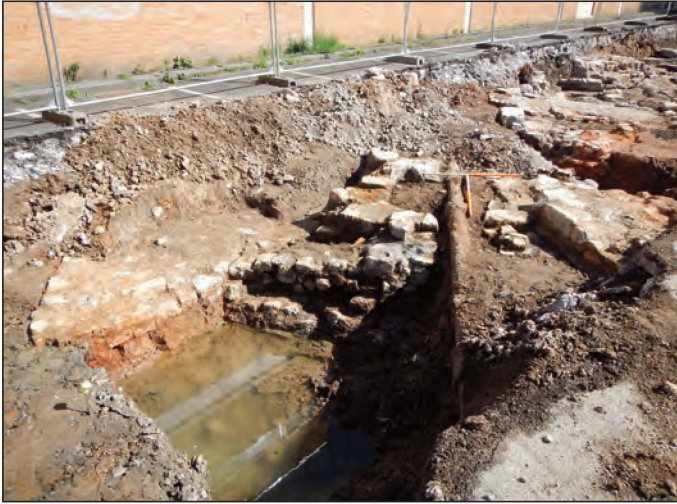
Plate 13 Trench 2, looking north, showing structures 266-71

- 5.19 Part of the millpond/mill leat was uncovered at the south-west end of trench 2; this feature was defined by retaining wall 266, cutwater 267 (**Fig. 9**) and dam 268 (**Plates 9 & 13**). The cutwater would have divided the flow of the water into two streams; one would have flowed to the north-west of trench 2, the other would have flowed over dam 268 and along head race 261 to a waterwheel located just beyond the north-west edge of the trench. Structures 266-8 were all constructed with substantial limestone blocks bonded with a yellowish grey lime mortar. Dam 268 abutted structures 266-7, but they are likely to be contemporary. A small infilled vertical notch in the south-east side of cutwater 267 (in-filled with 285) may have been used to locate a sluice gate. It is unclear if structure 270 was part of 268 or a later addition. Infill 273 is contemporary with dam 268. Structures 269 and 271 are later, and more crudely built, additions to the earlier parts of the dam. There were traces of a reddish sandy mortar in some of the lower parts of wall 266 (visible in section); this could indicate that structures 266-8 (or some parts of them) were contemporary with wall 257, but this is by no means certain.

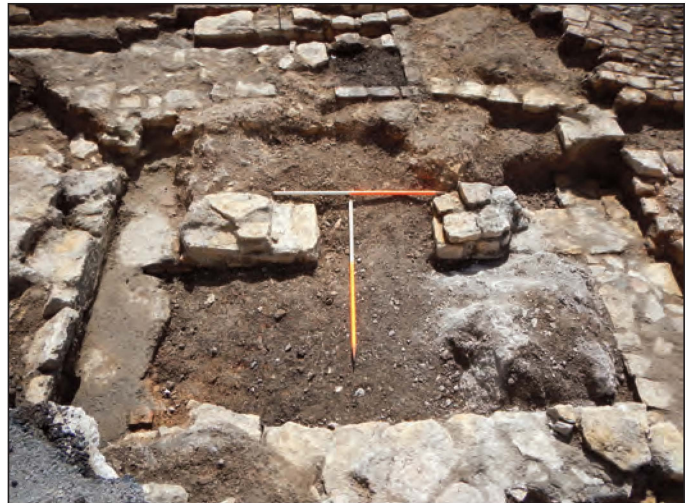
Plate 16 Trench 2, looking south-east, showing structures 233, 242, 229, 241, 264 & 276-7

- 5.24 Walls 233 and 264 (**Plates 7-9 & 15-16**) were both constructed with limestone rubble bonded with a pale grey lime mortar. These walls were abutted by and pre-date the construction of foundations 229, 241 and 276-7. Wall 264 was overlain by the bedding layer (220) for cobbled floor surface 221.

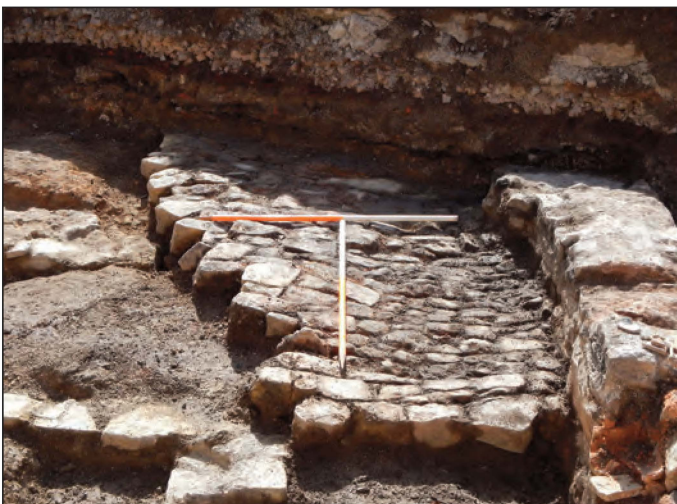
Plate 17 Trench 2, looking south-east, showing cobbled surface 221

- 5.25 Cobbled floor 221 (**Plates 7-10, 15 & 17**) abutted wall 237 and is probably contemporary with walls 210, 237, foundations 229, 241 and 276-7 and infill deposit 263. These contexts probably represent a single major reorganisation of the central part of the mill in the late 17th–early 19th century. Walls 210 (**Plate 18**) and 237 were both constructed with limestone rubble bonded with a grey lime mortar, and were overlain by layer 203.

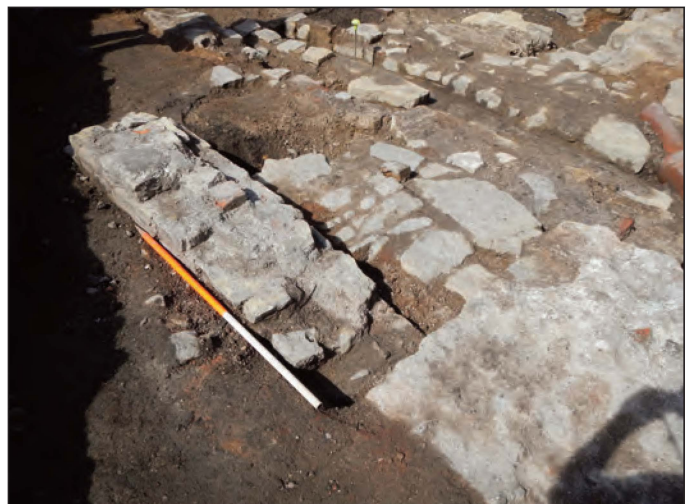
Plate 18 Trench 2, looking west, showing cobbled surface 209 & walls 210 & 255

- 5.30 Cobbled surface 209, which abutted stone-lined well 211 (**Plates 8 & 18**), was probably an exterior surface around the well. Surface 209 and well 211 were both cut by construction trench 231 for wall 210. Well 211 was constructed with limestone blocks and red handmade bricks bonded with a grey lime mortar. The well probably truncates wall 213, but the relationship was not confirmed. It was unclear if the well abutted or was part of structure 226, but the fact that it was backfilled with deposit 263 suggests that it went out of use when foundations 229, 241 and 276-7 were constructed.
