Archaeological Watching Brief
**LAND TO THE REAR OF
NO. 9 RABY PLACE,
BATHWICK, BATH.**

Archaeological Watching Brief
on land to the rear of

**NO. 9 RABY PLACE,
BATHWICK, BATH.**

Date Issued: 10th November 2014

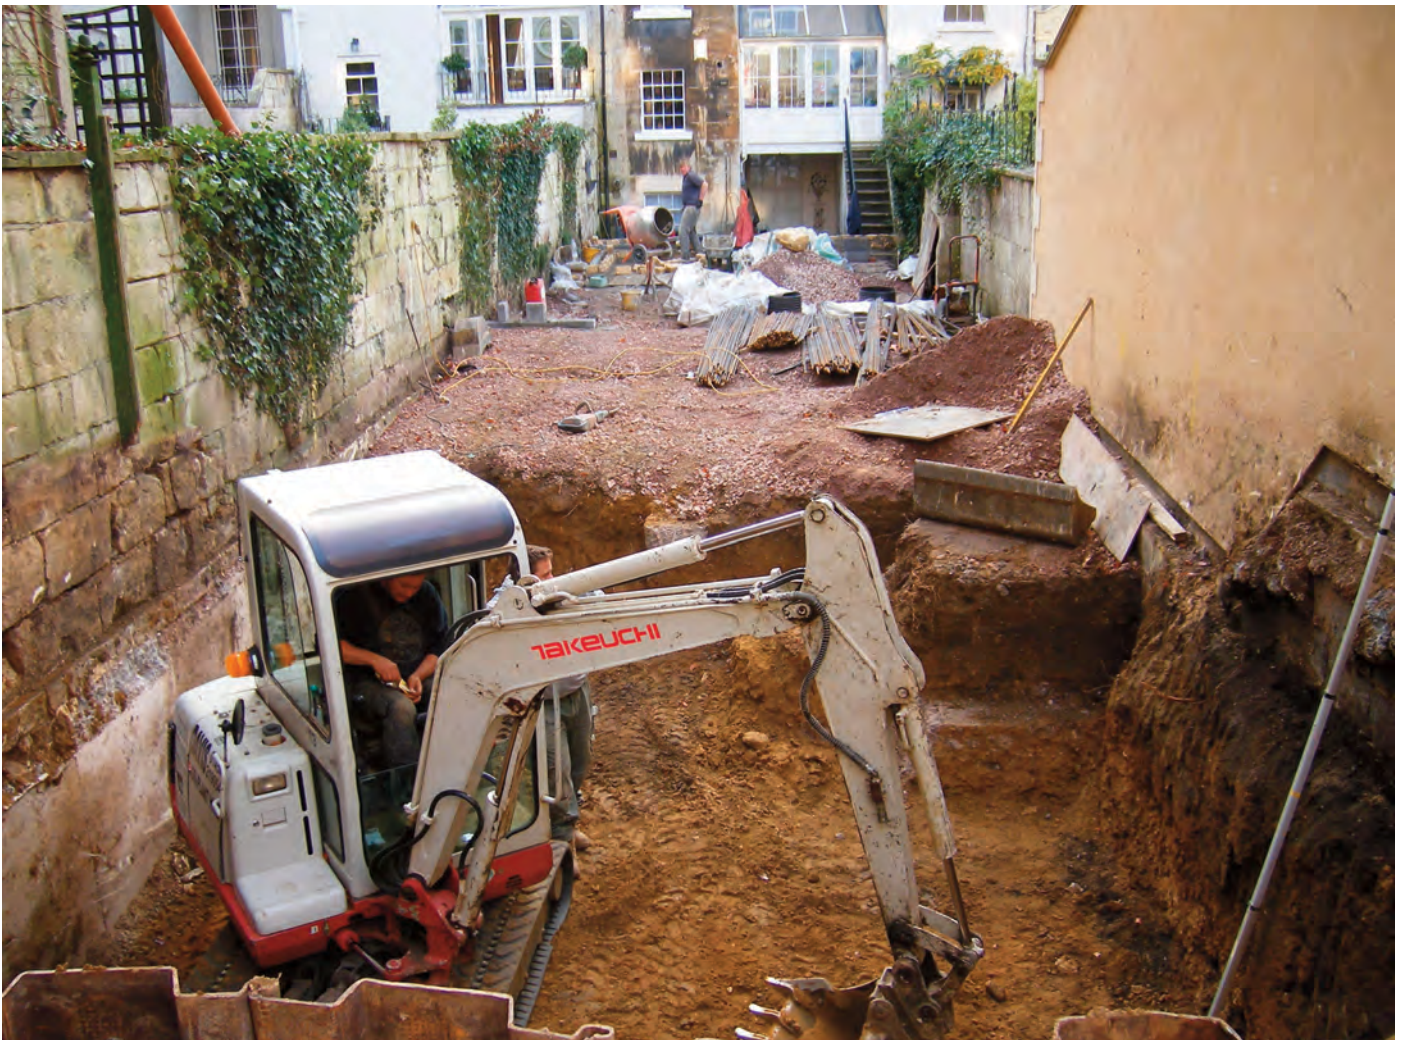
- 5.7 The excavation of the basement level revealed no archaeological features or variation in geology from the underpinning trench (**Cover & Plate 7**).

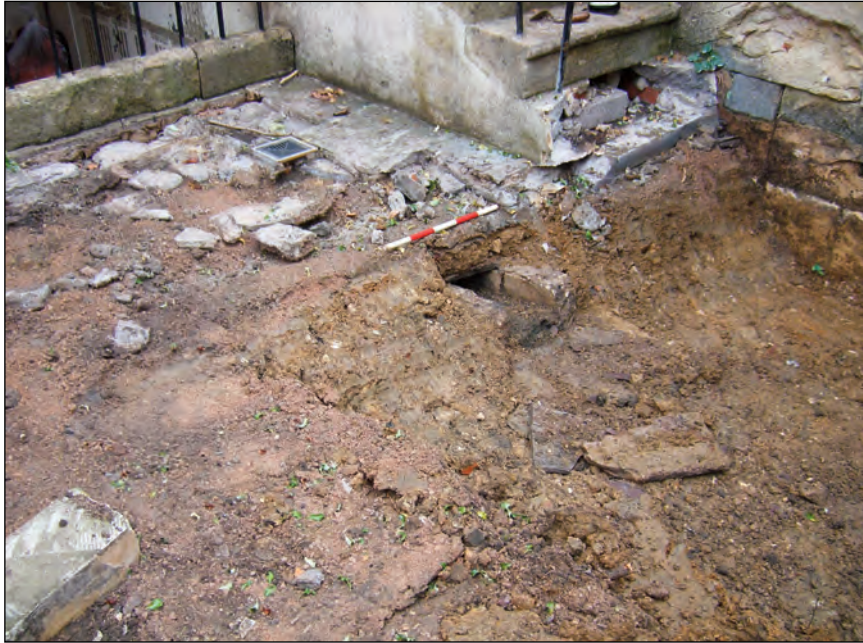
- 5.4 A truncated drain (104) (**Plate 1**) was exposed during the ground reduction at the house end of the garden with a possible further section (116) exposed during the connecting of the foul drains to the existing house system. This earlier system was truncated by plastic rainwater drains (119) for the house and patio limiting any interpretation to its original function, length and points of origin (**Plate 2**).

Plate 1
Truncated drain (104),
looking towards the stairs
up to the house (102),
looking west

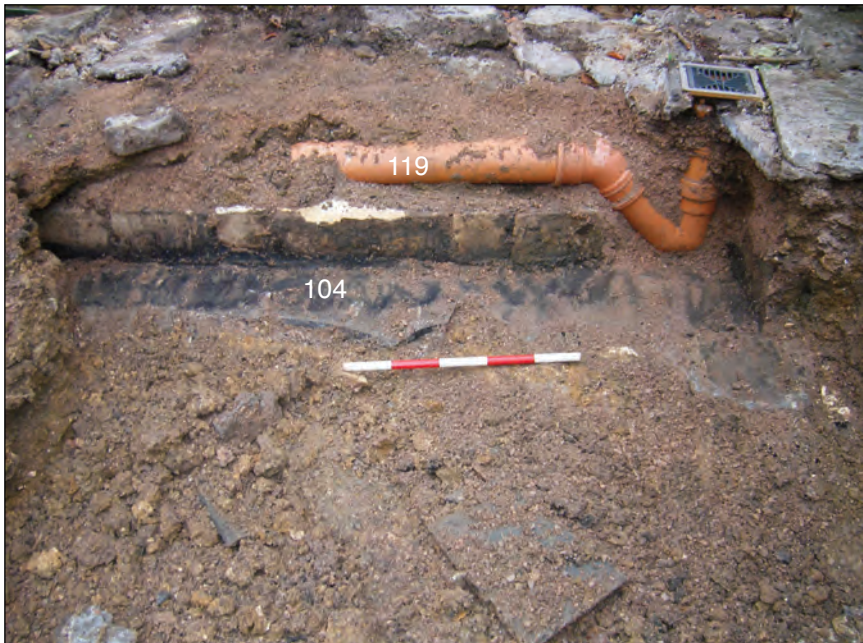
Plate 2
Truncated drain (104) and
modern rainwater drain
(119), looking south-west

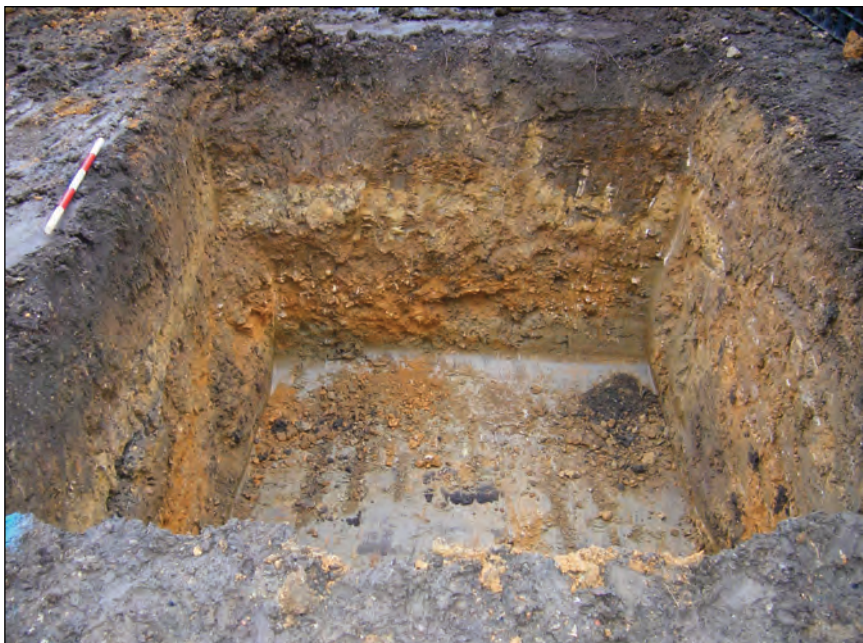
- 5.5 The excavation of an inspection chamber pit and soakaway exposed natural deposits of angular limestone gravels and sandy clays beneath disturbed and redeposited layers (**Plate 3**). Similar deposits were exposed during the underpinning of the wall (112) between 9 & 10 Raby Place at the mews end of the gardens (**Plate 4**).

Plate 3
Representative section in
soakaway pit, looking
north-east

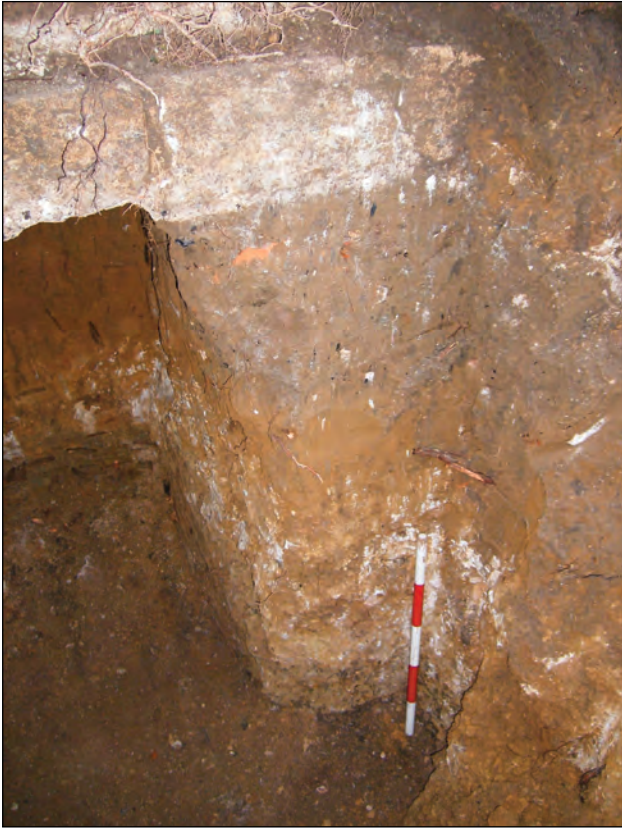
Plate 4 Representative section in underpinning trench, looking south

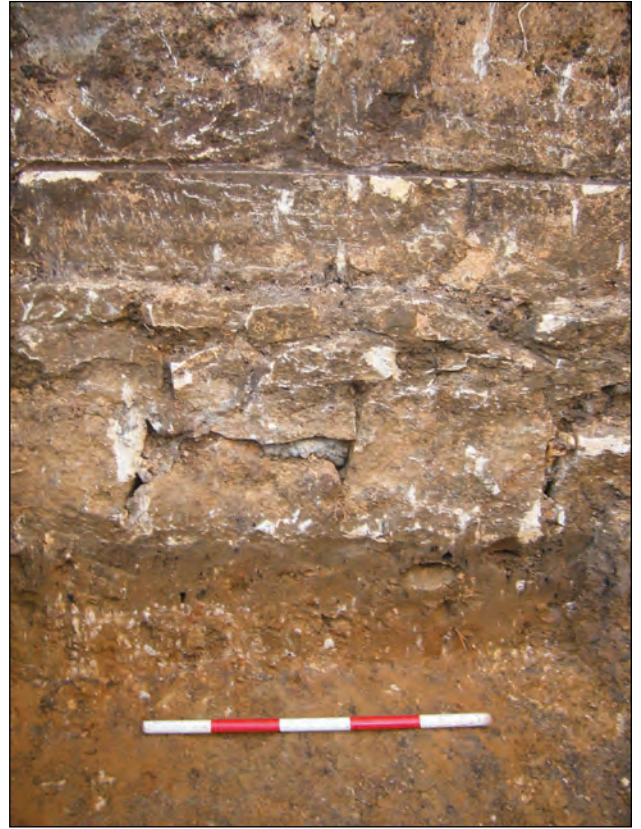
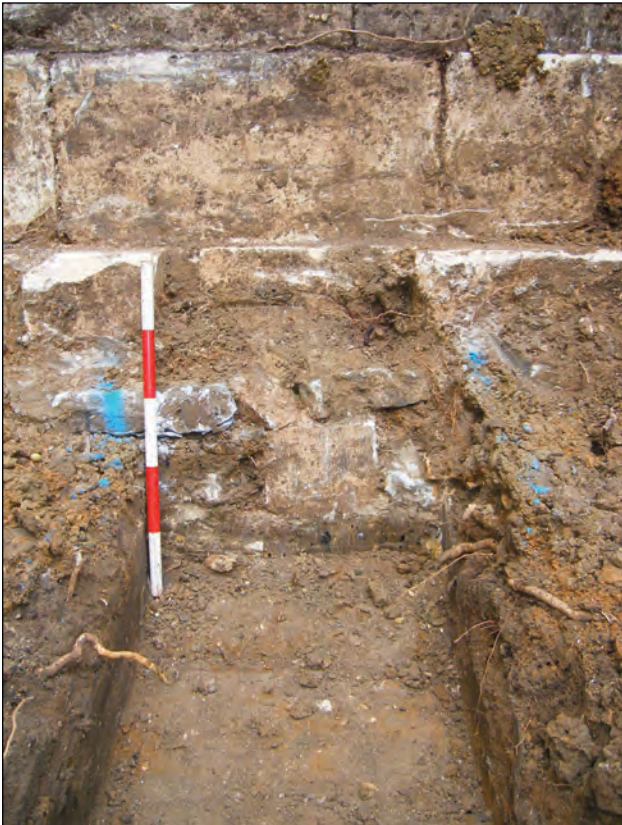
- 5.6 Groundwork alongside No. 8 Raby Mews exposed footings and work related to the shortening of the wall (112) separating the gardens of Nos. 8 & 9 Raby Place. Though the two garden walls (112/113) are of identical construction some variation in their foundations was visible in the trench sections, either as levelling or underpinning (**Plates 5 & 6**).

Plate 5 Representative section of south-eastern wall (113)

Plate 6 Representative section of north-western wall (112)

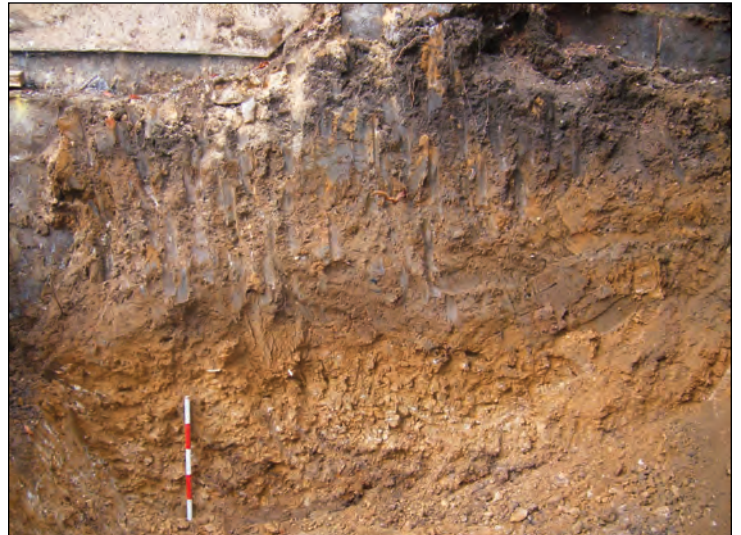
Plate 7 Representative section of basement area, looking north-west
