Archaeological Watching Brief
at
**NO. 15 MARKET STREET,
BRADFORD-ON-AVON, WILTSHIRE.**
for
Lambridge House Renovations Ltd.

Report No. 2079 / 2008

Archaeological Watching Brief
at
**NO. 15 MARKET STREET,
BRADFORD-ON-AVON, WILTSHIRE.**

Centred on
N.G.R. ST 8252 6110

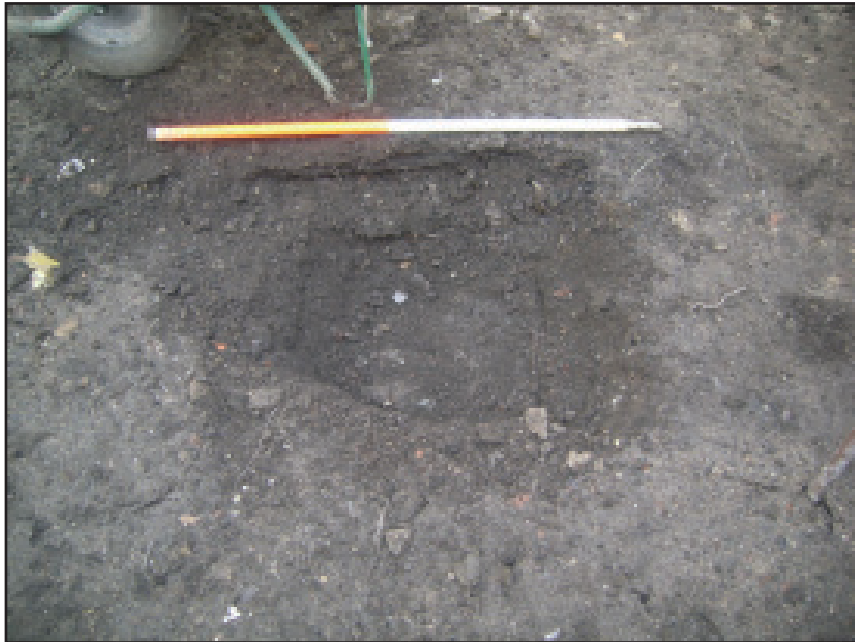
Plate 1
View of test pit 1, looking north

- 5.2 The test pits revealed no archaeology. They were dug to a depth of approximately 0.30m and 0.50m square (**Plate 1**). Due to the shallow nature of the southern toe, only 0.20m, it was decided that this was sufficient to indicate that no archaeology was likely to be disturbed during the excavation.

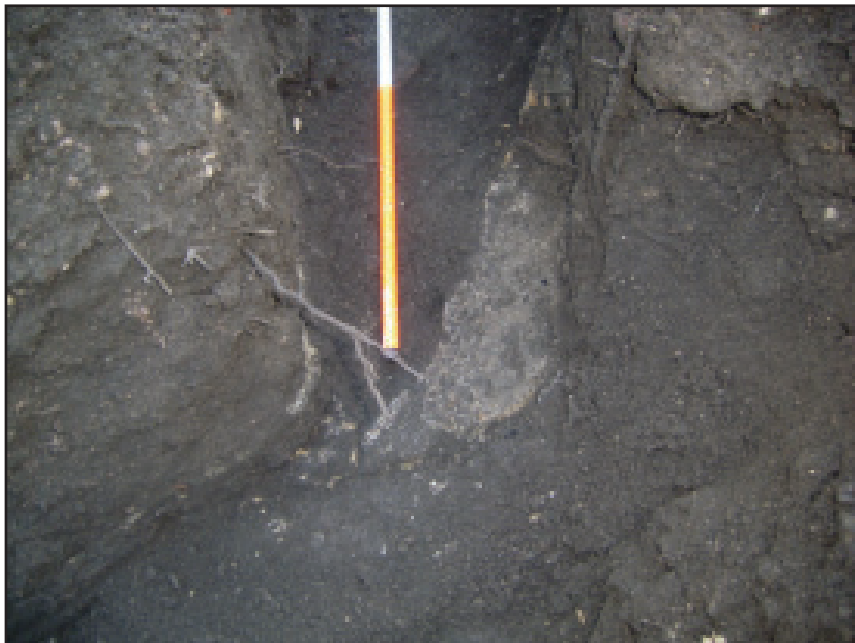
Plate 2
Section through wall (101), looking east

- 5.3 Sections of three limestone walls bonded with yellow sandy mortar were revealed during the excavation of the service trench and the northern toe of the foundations. Wall (101) was revealed at the west end of the services trench and ran east-west (**Plate 2**). Only the upper surface of the remains of wall 101 were visible and it is likely they formed part of the foundations for the short southernmost wall of the building shown on the historic maps (**Fig. 3**). No other remains of this building were observed. The top of wall 101 was at a depth of 0.60m bellow the surface level, it was 0.25m wide and only 0.90m of its length could be seen and the western end appeared to have been truncated.

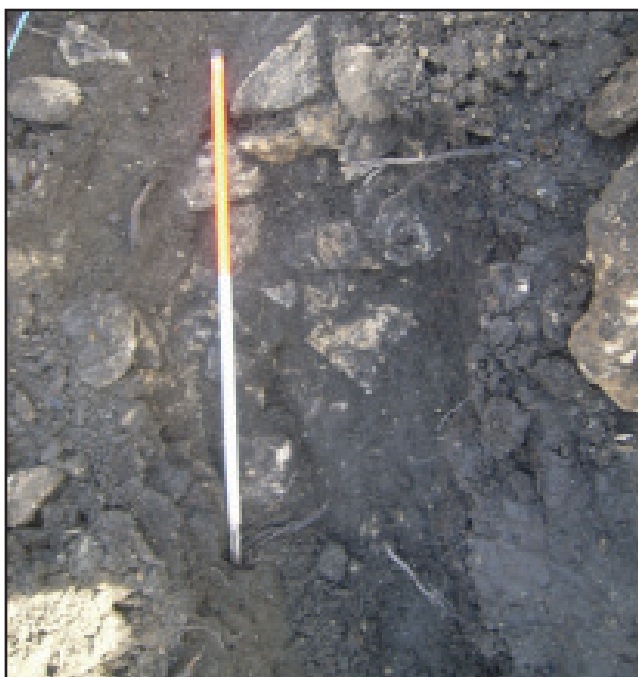
Plate 3
Wall (102), looking north

- 5.4 Wall 102 was observed running east-west at the junction of the east end of the service trench and the north toe of the foundations (**Plate 3**). The top of the wall was 0.25m below the ground surface, and it was excavated to 0.40m below the current ground surface. It was 0.68m wide and 1.1m of it’s length was exposed. It was roughly built of re-used limestone measuring up to 400mm by 380mm by 50mm.

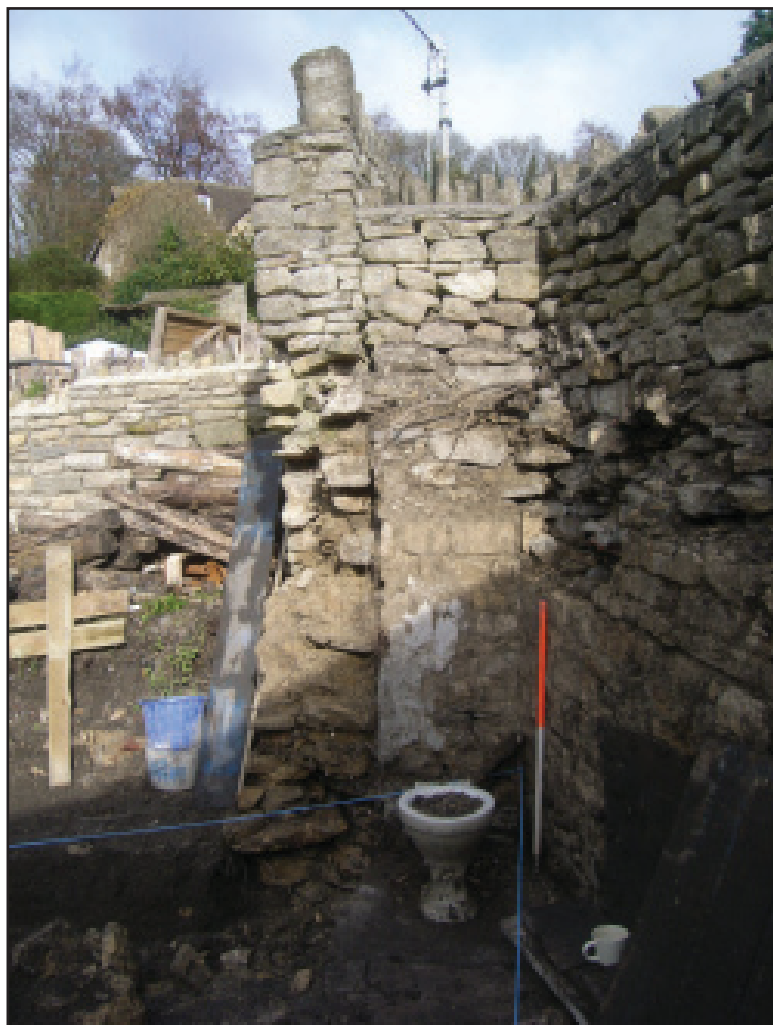
Plate 4
View showing the above-ground
portion of wall (103), looking north-east

- 5.5 Excavation for the north toe also revealed wall 103, part of which survived as part of the current garden wall (**Plates 4 & 5**). The wall was constructed of roughly hewn limestone blocks measuring up to 500mm by 400mm by 100mm, and stood a up to 3.58m above the ground surface. The upper 1.50m of the wall had been rebuilt, it was 0.60m wide at the base and was excavated to a depth of 0.28m. Wall 103 was probably the east wall of the building shown on the historic maps.
