Archaeological Watching Brief  
at  
**THE CHURCH OF ST. THOMAS THE MARTYR,  
THOMAS LANE, REDCLIFFE,  
BRISTOL.**  
for  
Corbel Conservation Ltd.

Report No. 2098/2009  
BHER No. 24710

Centred on  
N.G.R. ST 59115 72766

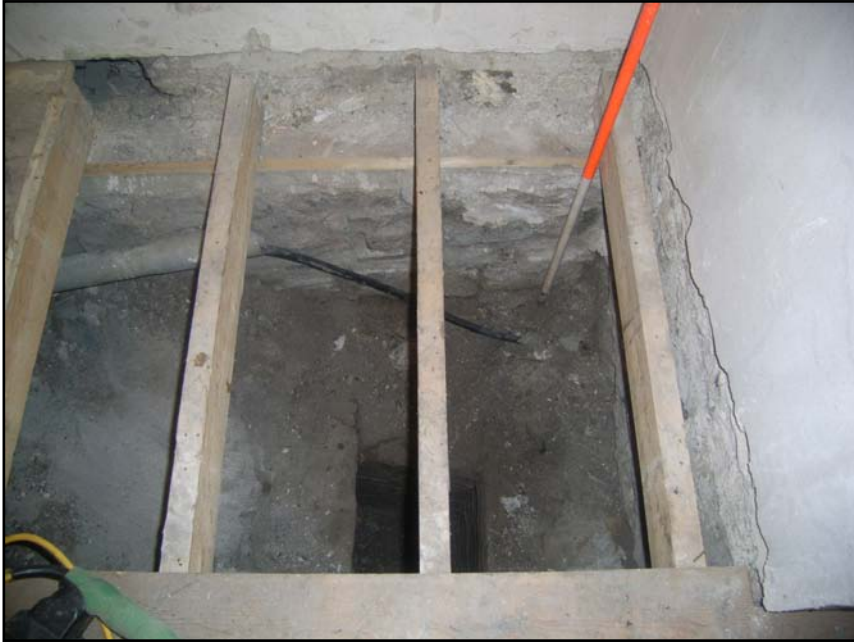
- 2.1 During the course of the watching brief two pits were excavated for services and one floor was lifted, all of which was done by hand.
- 2.2 The first pit (**Plate 1**) to be excavated was located in the northwest corner of the northwest vestry of the church. The pit was 1m square by 1.75m deep and revealed an empty brick built burial chamber with Pennant sandstone capping (**Plate 2**) and the footings for the walls of the current church. A width of approximately 0.40m of the north side of the burial chamber was removed for services to run through (**Plate 3**).

Plate 1  
North-east vestry service  
pit, looking north during  
excavation

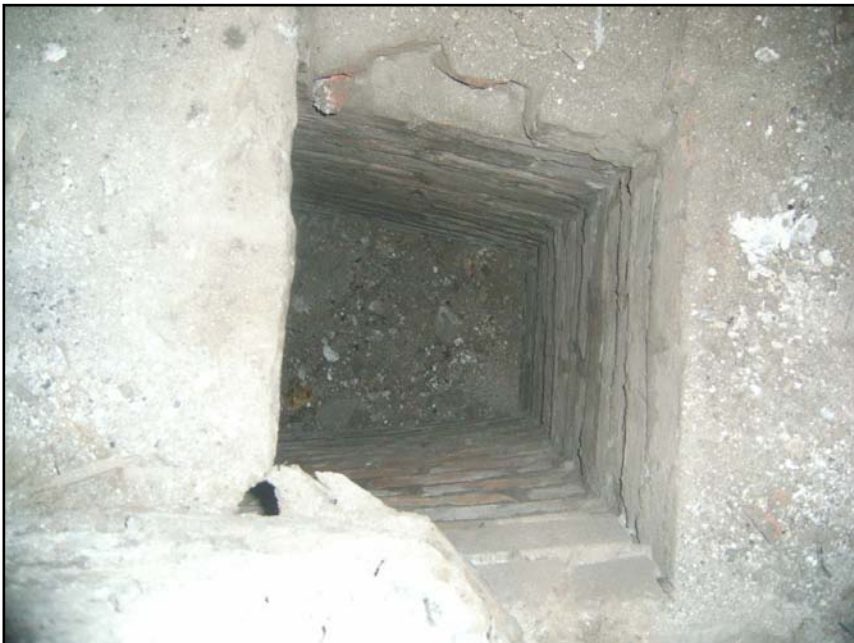
Plate 2  
Burial chamber, from  
above

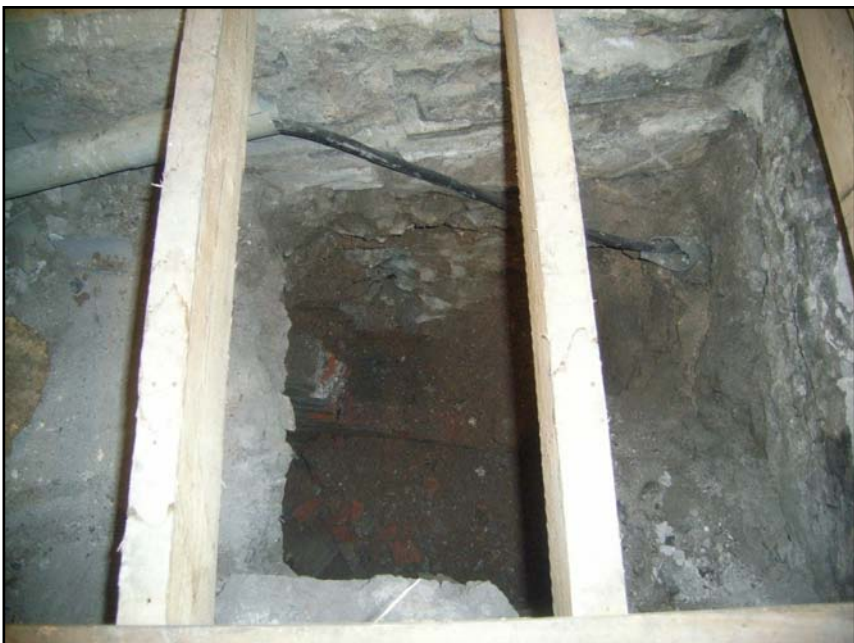
Plate 3  
Vestry service pit after  
excavation, looking north

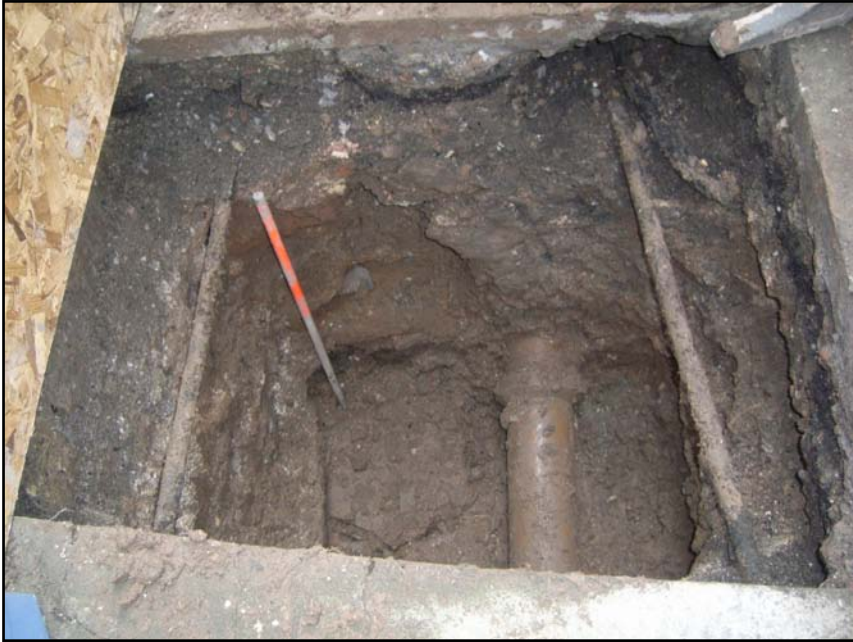
- 2.3 A second pit (**Plate 4**) was excavated through Long Walk, the path for the old graveyard, measuring 1.40m by 1m by 1.58m deep. This trench was heavily truncated by services but did reveal the footings of the north wall of the current church as well as a reddish brown silty clay deposit and a wall running east to west. The colour of the mortar in the wall does suggest an early date and it would be on the right alignment for the wall of the previous church. However this cannot be determined for definite as no artefacts were recovered and both the deposit and the wall were heavily truncated.

Plate 4  
Long Walk service pit,  
looking west

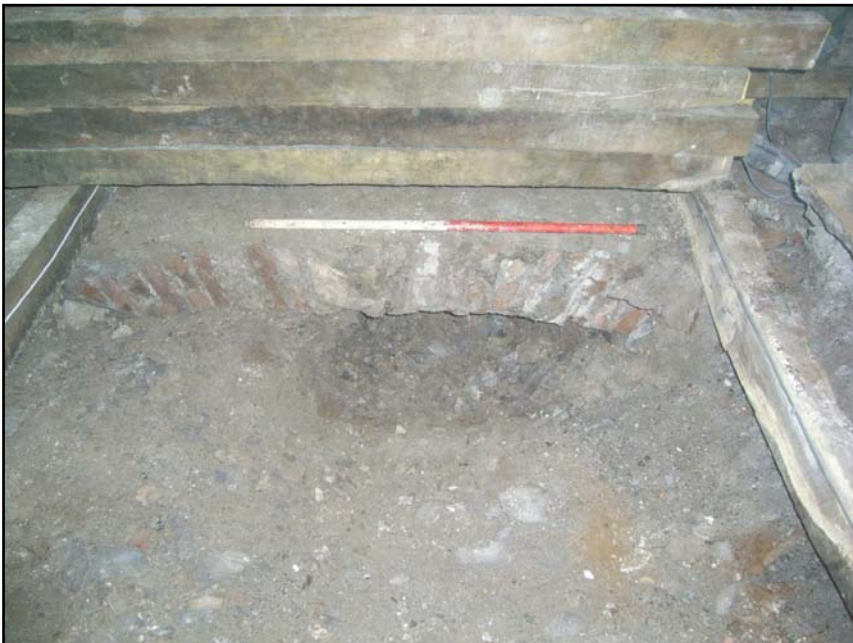
- 2.4 The removal of the timber floor in the south-west vestry revealed the edge of a brick built wall and arch (**Plate 5**). The nature of the arch and wall suggests that this may have been a filled-in crypt entrance.
- 2.5 Full details of all the contexts are contained in Appendix 2.

Plate 5  
Brick arch in south-west-  
ern vestry, looking west
