Archaeological Building Assessment  
at the rear of  
**NO. 4 HARLEY PLACE,  
CLIFTON, BRISTOL.**  
for  
Mr Edward Ware

Report No. 2115/2009  
BHER No. 24765

Archaeological Building Assessment  
at the rear of  
**NO. 4 HARLEY PLACE,  
CLIFTON, BRISTOL.**

Bristol and Region Archaeological Services were commissioned to undertake a building assessment at 4 Harley Place, Clifton, prior to the demolition of the garage at the rear of the property. The evaluation was commissioned at the request of the BCC Conservation Officer in order to assess the building materials that it may be possible to reuse. The garage of no. 4 Harley Place had five principle elements of construction; a wooden roof, flagstone floor, 19th-century brickwork, rubble side walls and modern rebuilding of the front (north) elevation. The majority of these materials are unlikely to be of reuse value. Based on the materials used the structure dates to the early 19th century.

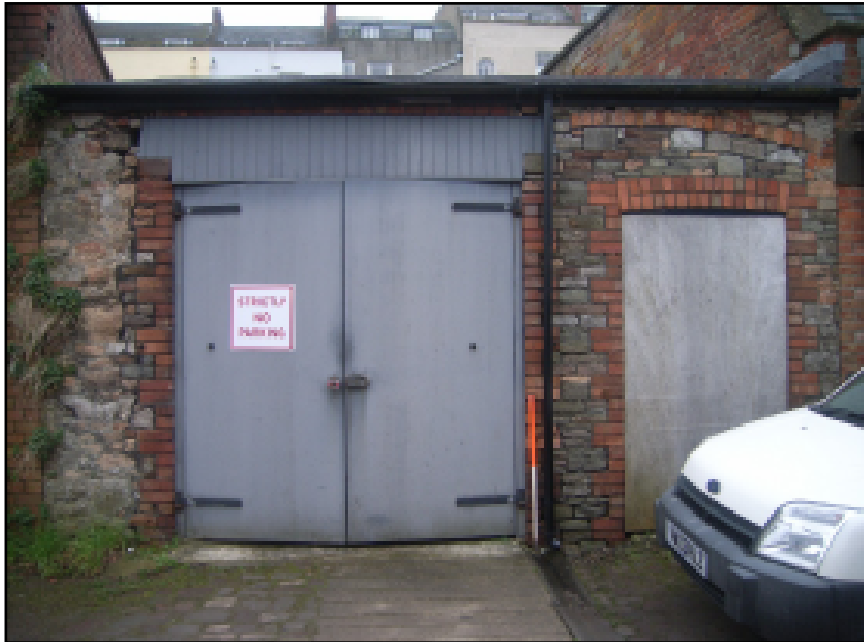
- 2.2 The north elevation of the garage faced on to the small lane and comprised a set of wooden double doors, a small section of wood panelling above these, and a boarded up doorway to the west of the double doors (**Plate 1**). These were modern openings and the majority of the brickwork and stonework of this elevation was modern. A remnant of an original brick arch was located on the west side of the elevation above the modern single doorway, the bricks quite degraded. A small area of original stonework also existed in the top west corner of the north elevation (**Plate 2**). On the east side of the elevation was a larger area of original stonework, formed from Pennant sandstone blocks. These blocks appear to be un-worked and un-coursed, the original walls being of rubble construction.

Plate 1  
View of the front  
elevation, from the north

- 3.2 The majority of the front elevation of the garage is a modern construction, the reuse of these materials appears to be of little benefit.
- 3.3 The two side walls (east and west elevations) are of rubble construction. Some of the larger pieces of Pennant sandstone could be re-used in the construction of the new building, although the value of doing so is debateable given that the majority of the material of the side walls are not visible beneath render within the existing building. It is possible that the stone beneath the render may be worked or of better quality, however no indication of this was observed on site.

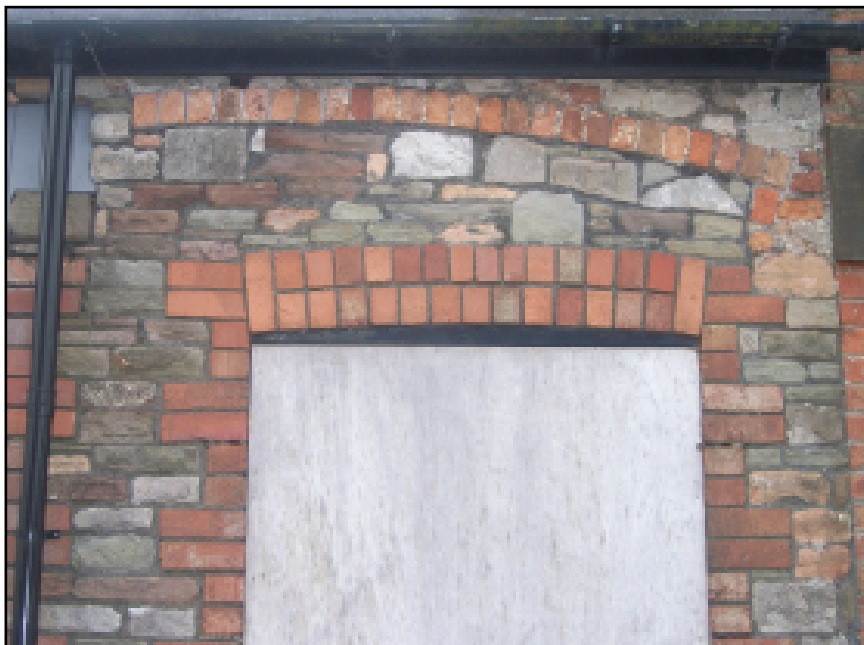
Plate 2  
View of the top west  
corner of the front  
elevation, from the north

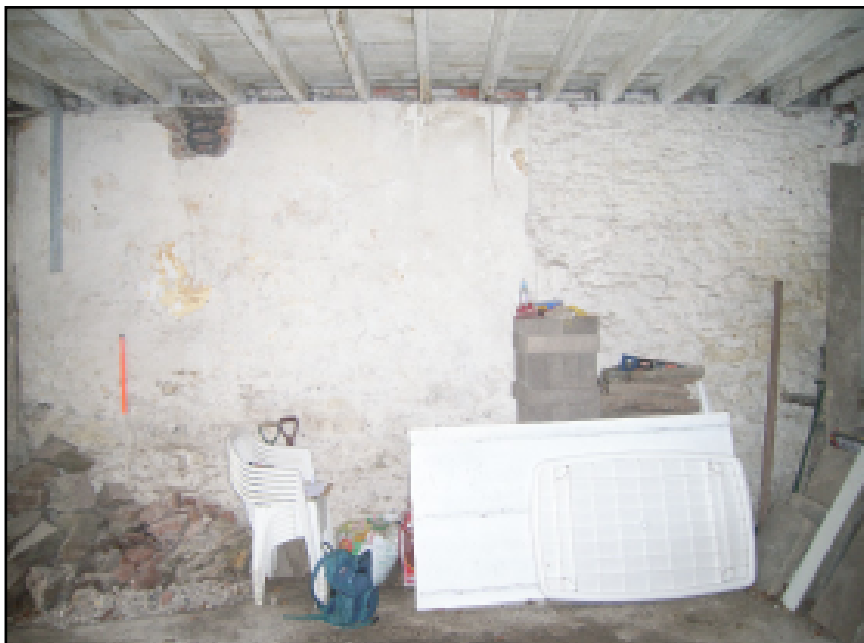
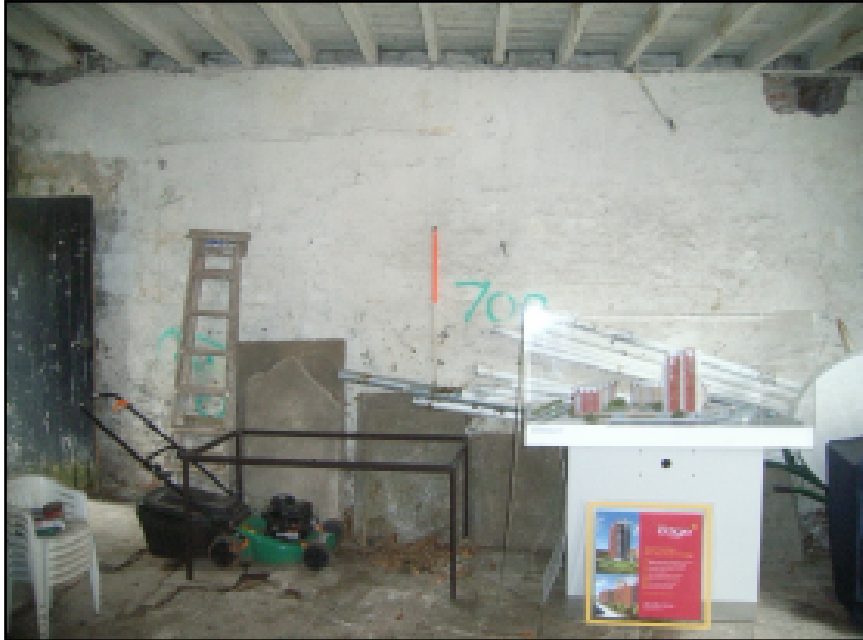
- 2.3 The examination of the east and west elevations was restricted to the internal faces, and was limited by the walls being partially rendered and whitewashed (**Plates 3 & 4**). However, the south end of the east elevation was not rendered, and a small area near the top of both elevations had been dismantled allowing the construction of the wall to be examined (**Plate 5**). Both walls appeared to be of rubble construction with blocks varying in size from 85 mm x 50 mm to 300 mm x 280 mm. All of the stone observed was not worked and very rough. A wooden wall plate ran along the top of both walls on which the roof joists rest.

Plate 3  
Internal view of the east  
elevation, from the west

Plate 4  
Internal view of the west  
elevation, from the east

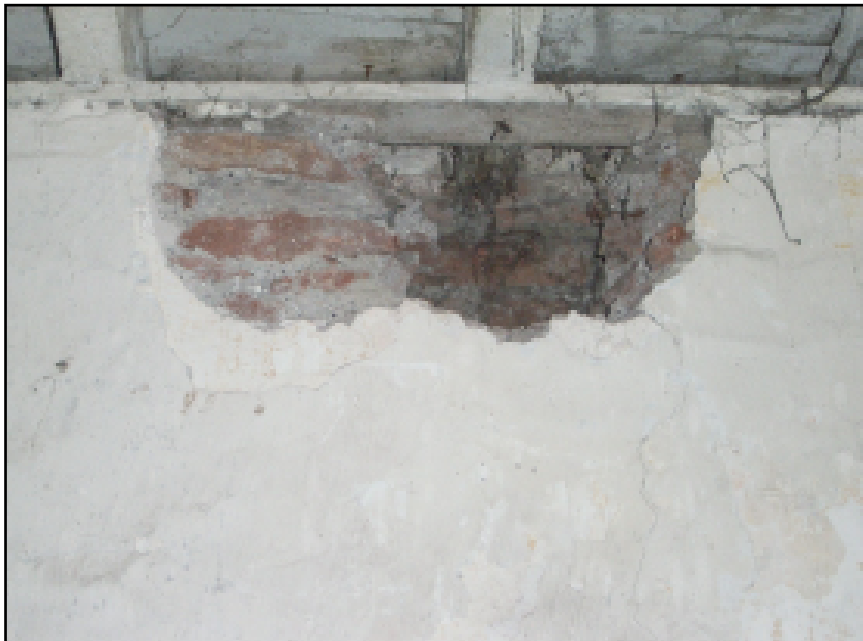
Plate 5  
Detail view of the con-  
struction of the west  
elevation, from the east

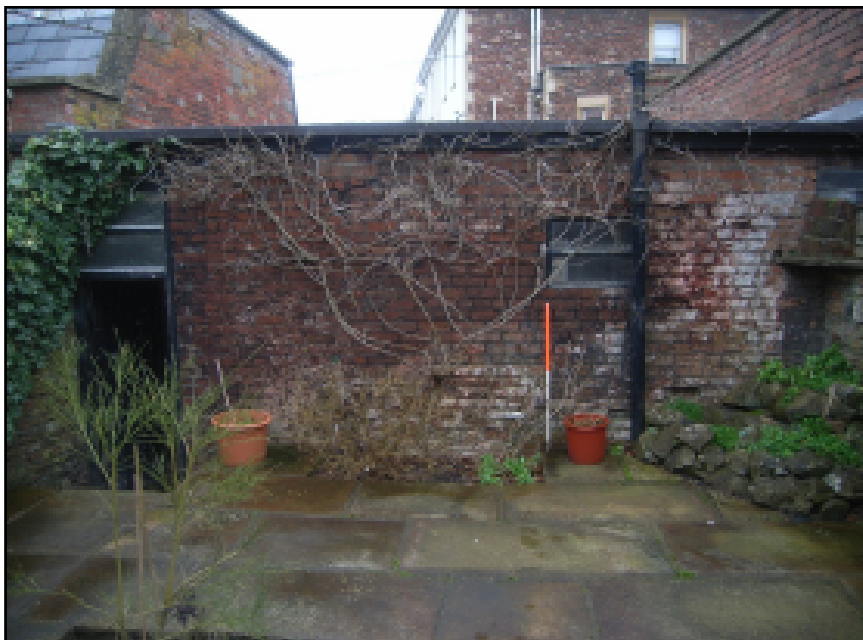
- 2.4 The south elevation was constructed from red brick, built in a variation of American common bond, with header courses separated by six or seven stretcher courses (**Plate 6**). A doorway with an overlight was located on the west side of the elevation, and a small window on the east side. Vertical breaks in the brickwork (**Plate 7**) indicated an earlier opening, which had gone out of use. The size of the bricks (68 x 110 x 225 mm) and their form suggests an early 19th century date for the elevation's construction. The mortar was grey, lime-based and contained a lot of charcoal, and appeared to be the same mortar used in the construction of the east and west walls, suggesting a similar date for the original construction of the building as a whole. The brickwork as a whole was not in good condition and in places was badly degraded (**Plate 8**).

Plate 6  
View of the rear  
elevation, from the south

- 3.4 The rear (south) elevation was constructed from red brick, and based on the mortar and size of the bricks dates from the early 19th century. The brickwork was not in good condition and in places is degrading quite badly suggesting that the bricks may not have been of very high quality when first used, very likely in what was clearly a utilitarian buildings out of view at the rear of the main property. Reuse of some of the bricks may be possible, although many will probably simply break apart.

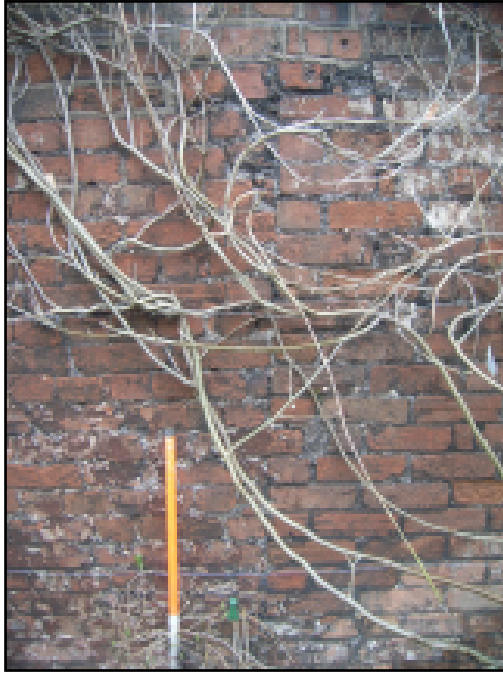
Plate 7  
View of the vertical break  
in the brickwork of the rear  
elevation, from the south

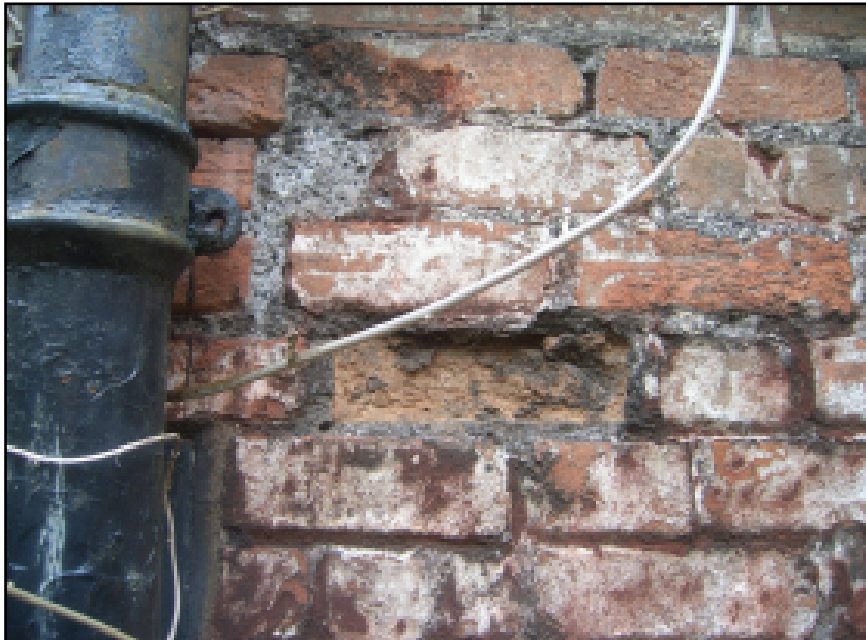
Plate 8  
View of degraded brick  
forming the rear  
elevation, from the south

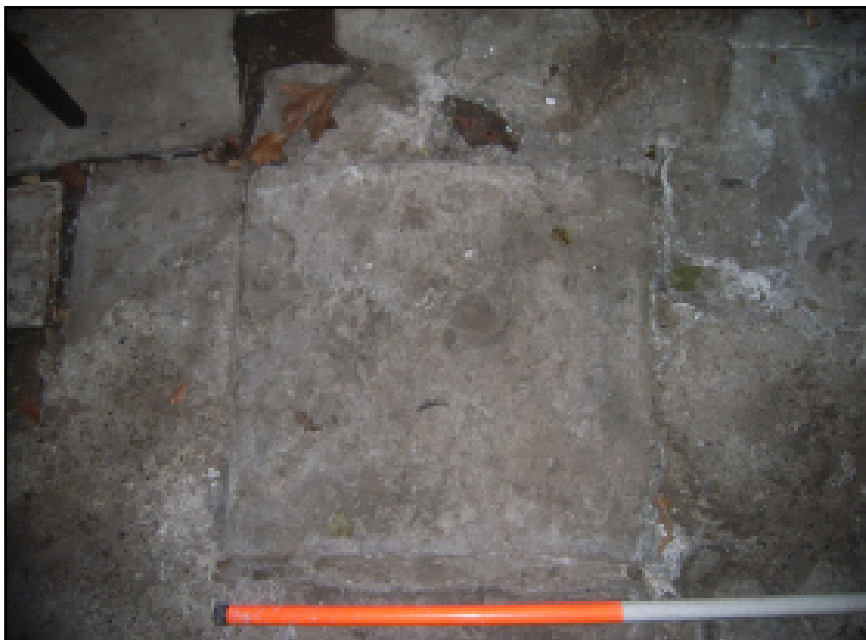
- 2.5 In places the original flagstone floor was visible (**Plate 9**). The flagstones measured approximately 580 mm x 550 mm.

Plate 9  
View of flagstone forming  
the floor of the garage,  
from the east

- 3.5 The timbers forming the roof did not appear to have any particular reuse value. The one element of the structure that may be worth preserving was the flagstone floor. Only a small section of this was observed but appeared to be good condition, however whether the rest of the floor surface is intact is not known.
