Archaeological Building Survey

of HARTCLIFFE METHODIST CHURCH, MOWCROFT ROAD, BRISTOL.

Report No. 2132A/2009 BHER No. 24781

Bristol and Region Archaeological Services

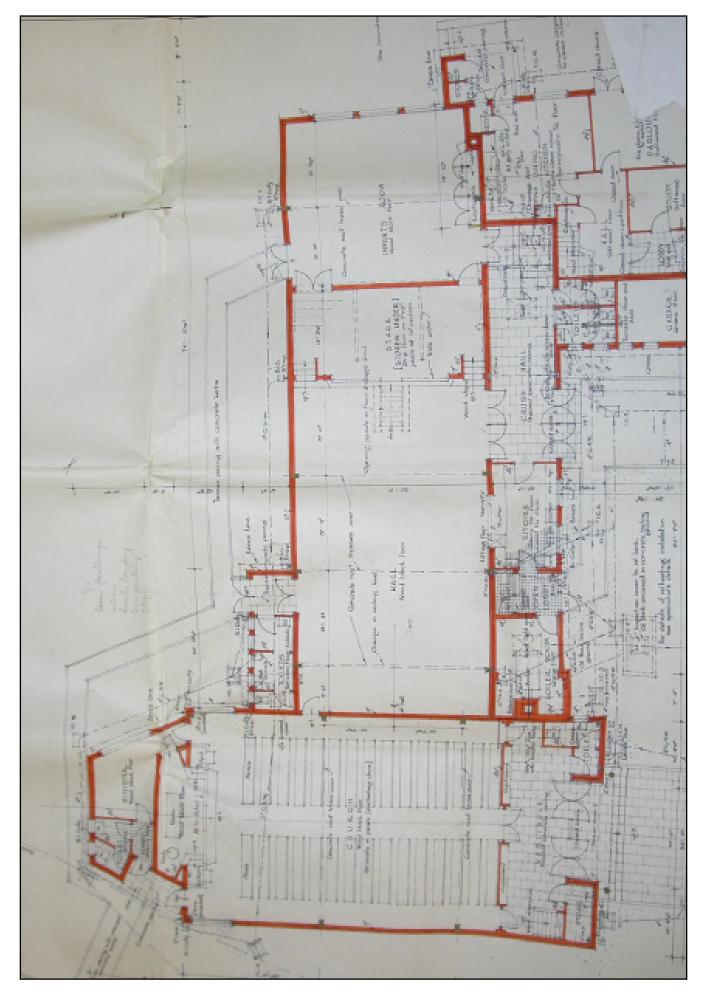
- 5.1 Hartcliffe Methodist Church (**Fig. 2; Cover & Plates 1-5**) was comprised of three interconnected rectangular buildings: the disused old church with accompanying square tower near its south-west corner, a rectangular hall with stage (the latter in use as multi-denominational charity shop in 2009), and the present day chapel (worship space), formerly the Infants' Room, a single floor rectangular space with a high ceiling.

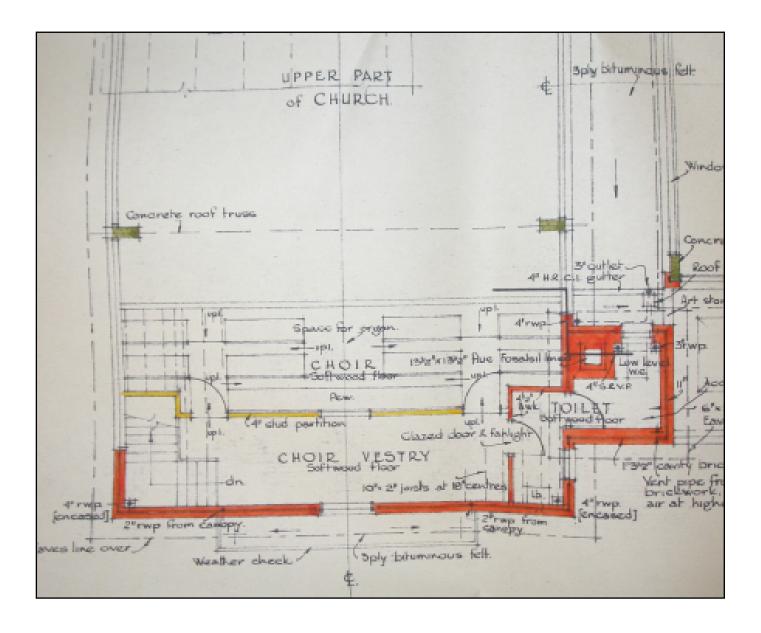
- 5.3 In the main worship space a number of rows of wooden pews were still in place (Plate 6): the 1957 design allowed for 15 rows of two pews each, seating 180 persons). Above the western entrance vestibule, or narthex, was a choir gallery with organ, and a choir vestry behind (Fig. 4; Plate 9). At the opposite end of the church was a raised platform at the eastern end with the pulpit in the south-east corner (Plates 10 & 11); the original design had also allowed for a lectern, font and communion table. A shallow apse extended just 5 feet (1.52m) beyond the main east wall of the church, lit on either side by a tall, narrow window (now boarded up), and with a large cross on the inside of the blank east wall (Plate 12). Natural lighting for the main worship space had been provided by tall windows at the east end of each side wall, and high-level windows in the remainder (Plates 7 & 8). Behind the east end of the worship space was the minister's room, now in some disorder with the ceiling panels having collapsed, exposing the joists above (Plate 13). The old church had a pitched roof that no longer retained its outer covering and probably as a consequence of this had fallen through in several places whilst the minister's room area had a flat roof. Both the old church and minister's room were constructed from red brick clad with cementbased render. The windows and entrances had either been boarded up or protected behind metal grilles.
