Archaeological Building Survey

**THE FORMER INTIER WORKS,
GOLDEN VALLEY MILLS, MILL LANE,
BITTON, SOUTH GLOUCESTERSHIRE.**

Updated Report No. 2413/2010
SGSMR No. 18919

Archaeological Building Survey
of
**THE FORMER INTIER WORKS,
GOLDEN VALLEY MILLS, MILL LANE,
BITTON, SOUTH GLOUCESTERSHIRE.**

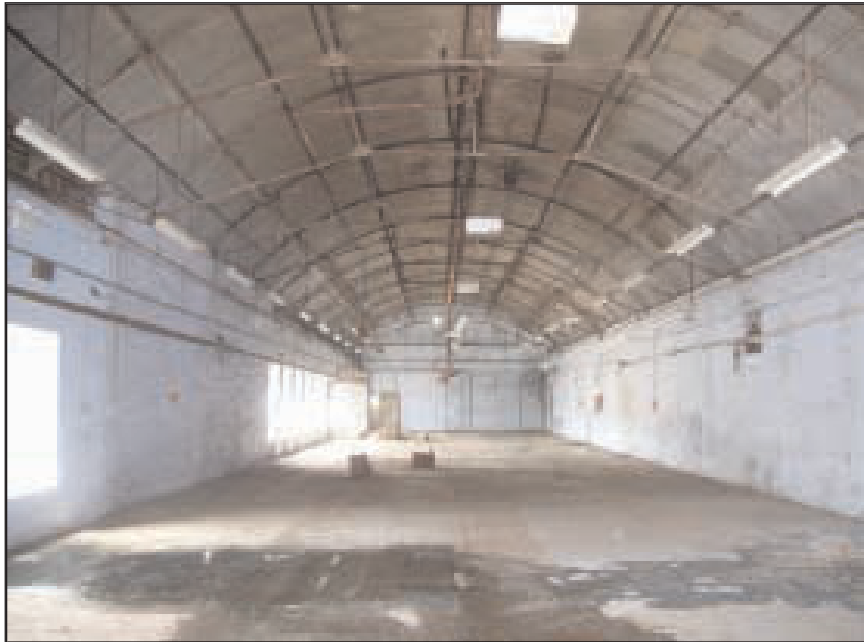
Plate 1
BR 516 2009/44
First floor of the phase 1
building, facing north-
west

- 5.2 The earliest building on the site was believed to be that which forms the south-western part of room 2, as labelled on the Barton Willmore plans, and comprised a ground and first floor. With rubble wall construction, a curved roof (**Plate 1**) and vaulted ground floor ceiling forming the floor of the upper storey (**Plate 2**), a number of blocked first floor windows were identified on the north-east side, indicating that this side of the building would once have been external (**Plate 3**). Part of the south-west wall had been rebuilt with concrete blocks (**Plate 4**), probably at the time of the demolition of the smaller neighbouring building of similar construction visible in aerial photos from 1935 (**Plate 18**) and 1966 (**Plate 19**), the curved topped south-east end elevation of which survived (**Plate 5**). An early photo (**Plate 20**), taken between 1912 and 1935, shows that many of the buildings on the site at this time were of the same construction. A form of curved truss supported the surviving roof.

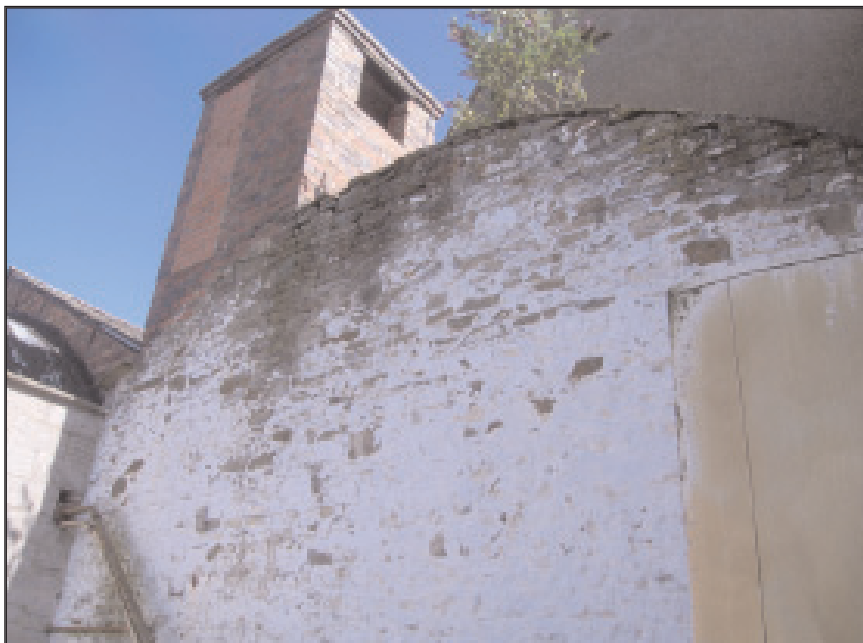
Plate 5
North-west facing formerly
internal elevation of
demolished building with
fire watcher's lookout post
behind, facing east

PIM fibre shop was a brick built fire watcher's lookout post (**Plate 5**), the access to which was not located. While not a unique structure the lookout post should be recorded prior to demolition, and the intention is to carry out this work once demolition to some of the surrounding structures has taken place, allowing the lookout post to be accessed safely.

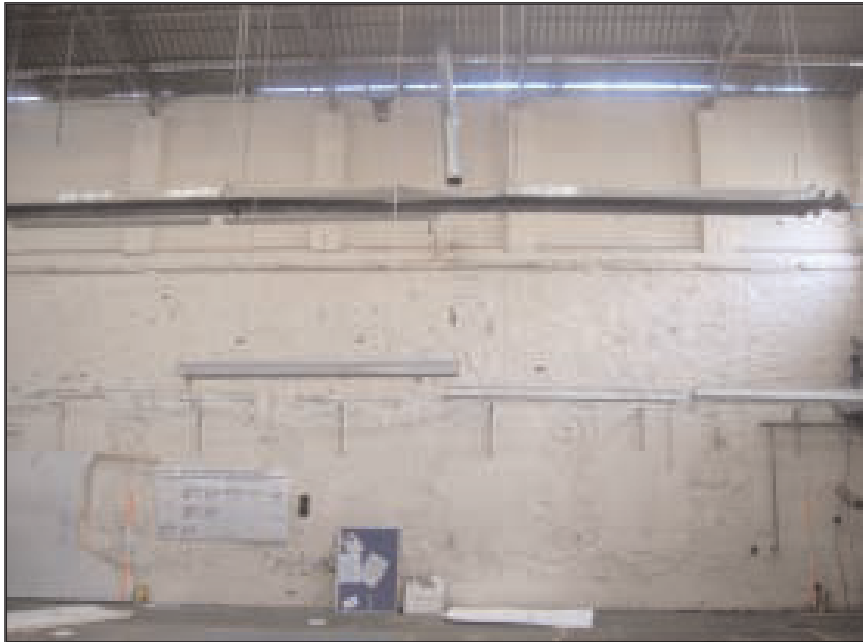
Plate 7
BRM 2009/44
South-west facing
internal elevation of
phase 3 building, facing
north-east

- 5.5 In addition the north-east elevation of the third phase building contained a remnant of flashing from a roof (**Plate 7**), at the top of the stone work of the original building and below the brickwork which subsequently raised the height of the building, probably associated with the roof on a neighbouring structure. What may have been a temporary structure or enclosure is shown on the 1912 Ordnance Survey Map, and comprised phase 4 of the site development.

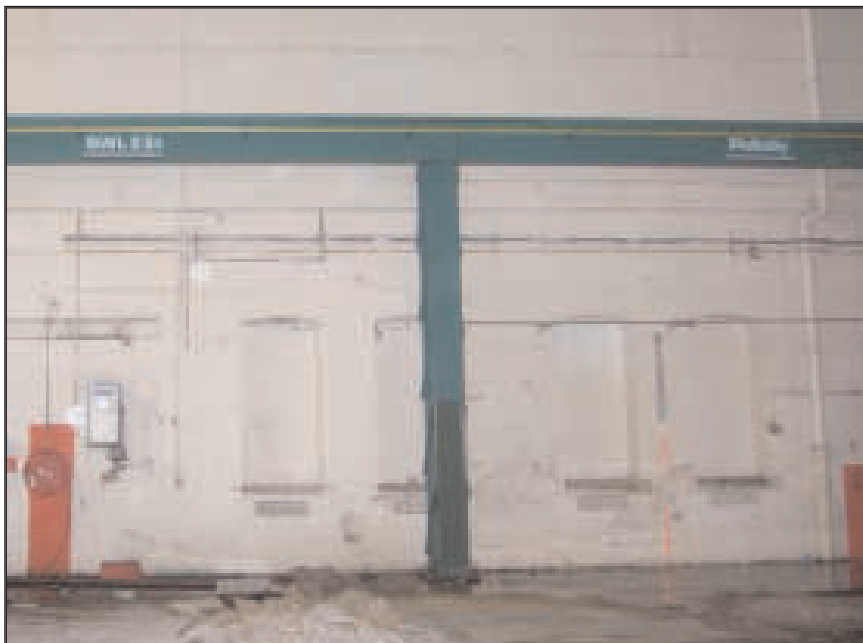
Plate 8
North-east facing
formerly external
elevation of phase 5
building, facing south-
west

- 5.6 The fifth phase was the construction of the PIM fibre shop, which now forms part of the south-west elevation of the larger amalgamated work space. The sills and vents beneath the blocked window openings (**Plate 8**) indicate that this would originally have been an external elevation. The first floor of the PIM fibre shop was supported by large cast iron columns (type 1), 229mm (9") in diameter and all stamped with 'BUSH & WILTON, IRON. FOUNDER, BITTON. OLD' (**Plate 14**). The Bush and Wilton iron works were located to the south-east of the mill off of Golden Valley Lane in an area which is now Baron Close. Surmounting the

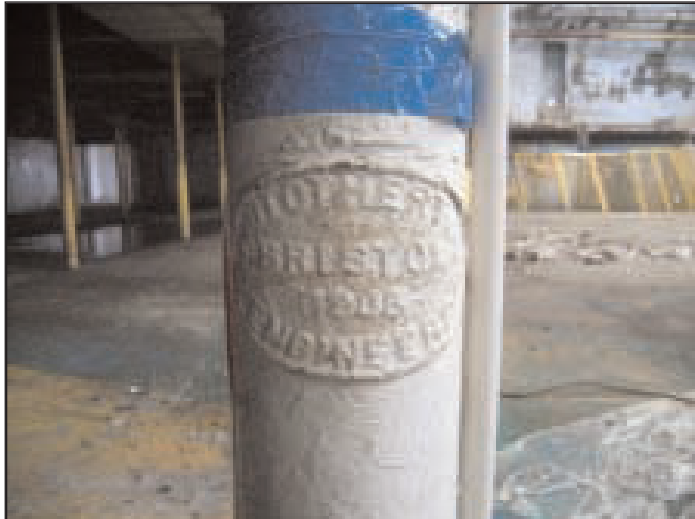
Plate 11
Column type 2 makers
stamp, facing north-west

- 5.3 A number of cast iron columns were used on the site, three of them to support the first floor of this building, types 2, 3 and 4. Type 2 columns were all located along the north-east edge of the building, measured 152mm (6") in diameter and were 2.82m in height. All were stamped near their base with 'G.K. STOTHERT & CO., BRISTOL, 1905, ENGINEERS' (**Plate 11**). Type 3 formed the middle row of columns (with the exception of the last two at the north-west end), was 140mm (5½") in diameter and 3.17m high, with no stamp (**Plate 12**). Type 4 were located on the south-west side and the north-west end of the middle row, were 152mm (6") in diameter and 3.17m high (**Plate 13**), again with no stamp. The opening at the south-east end of the building is supported by a large modern column, Type 5.

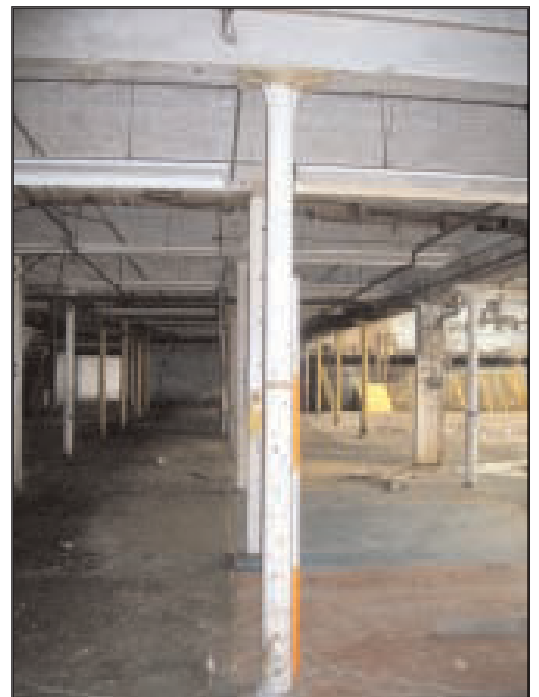
Plate 12
Column type 3, fac-
ing north-west

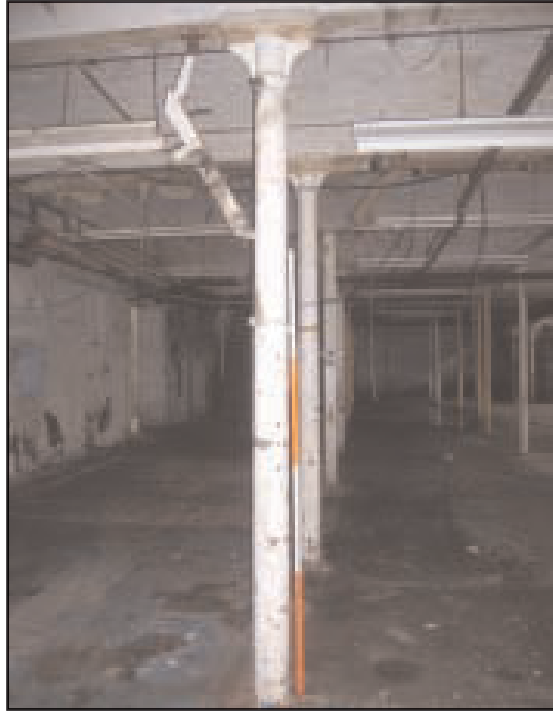
Plate 13 BRSMG 2009/44
Column type 4,
facing north-west

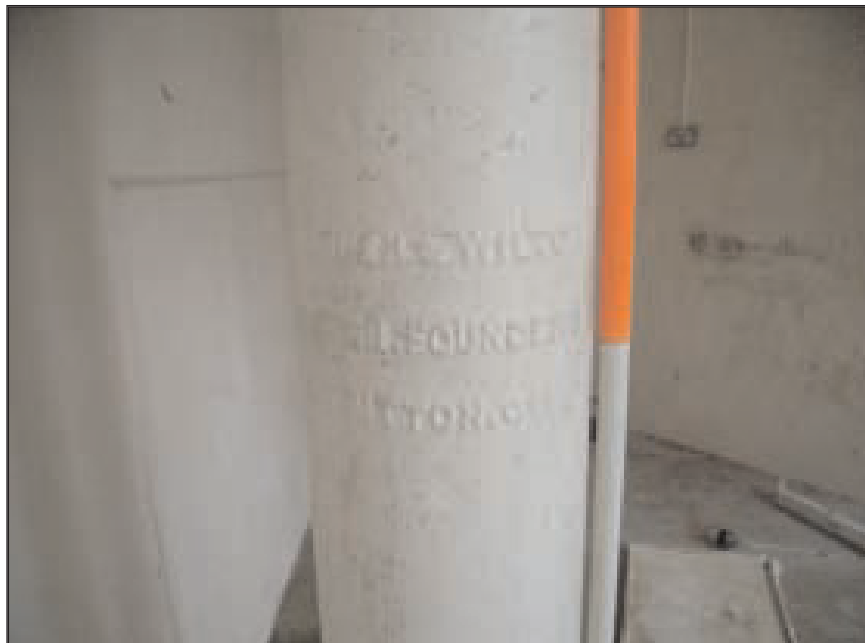
Plate 14
Column type 1 maker's
stamp, facing south-east

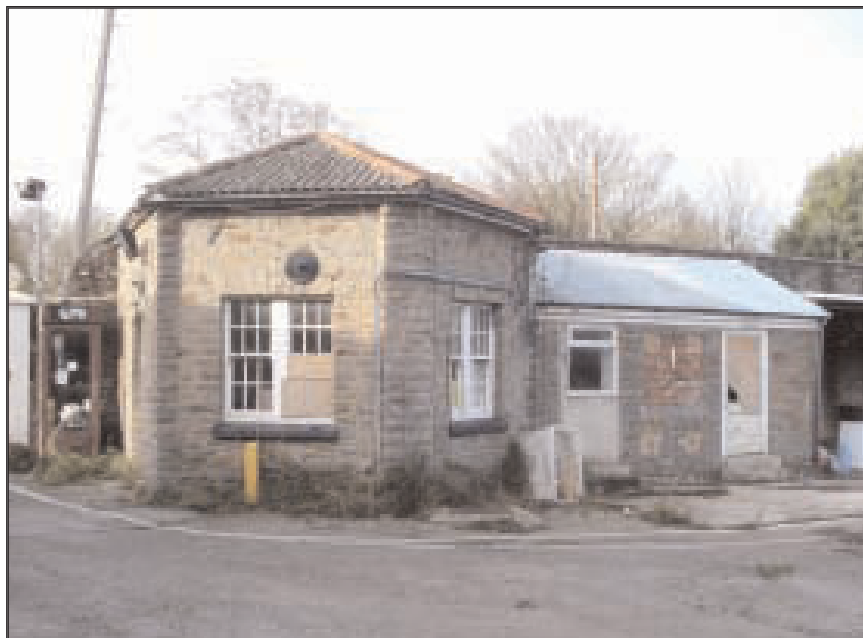
Plate 18
Gatehouse, facing north-
west

- 5.11 The gatehouse was pentagonal in shape (**Fig. 10 & Plate 18**) with a doorway in the south elevation, immediately within the gateway of the site (**Plate 19**). The south-east and north-east elevations each had a window within them comprised of two sash elements each of 12 panes (**Plate 20**), while the west elevation had a single narrow window with two panes. All of the windows and the doorway had Pennant sandstone voussoirs above them. The roof was formed from corrugated asbestos sheets with ridge tiles running from each of the corners to the apex at the centre. Circular pattress plates were visible on the south, west (**Plate 21**) and south-east elevations, as was a lightning conductor strip running down the east side of the south elevation. Externally the north elevation was largely obscured by a small rectangular addition to the gatehouse, which had a Pennant sandstone rubble construction for the east elevation (**Plate 22**) and a red brick construction for the north elevation. The south and east elevations of this addition were formed by the gatehouse and boundary wall respectively. The east elevation of the addition contained a doorway, a partially blocked doorway with a window inserted and a brick blocking of a window opening. The addition was roofed with modern corrugated metal sheets.

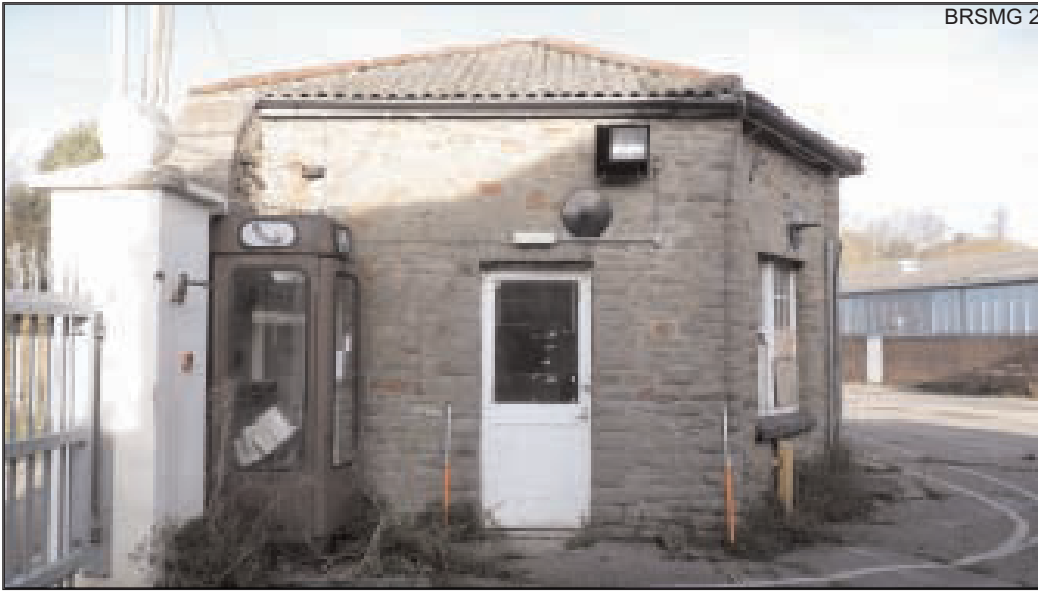
Plate 19 South facing external elevation of the gatehouse, facing north

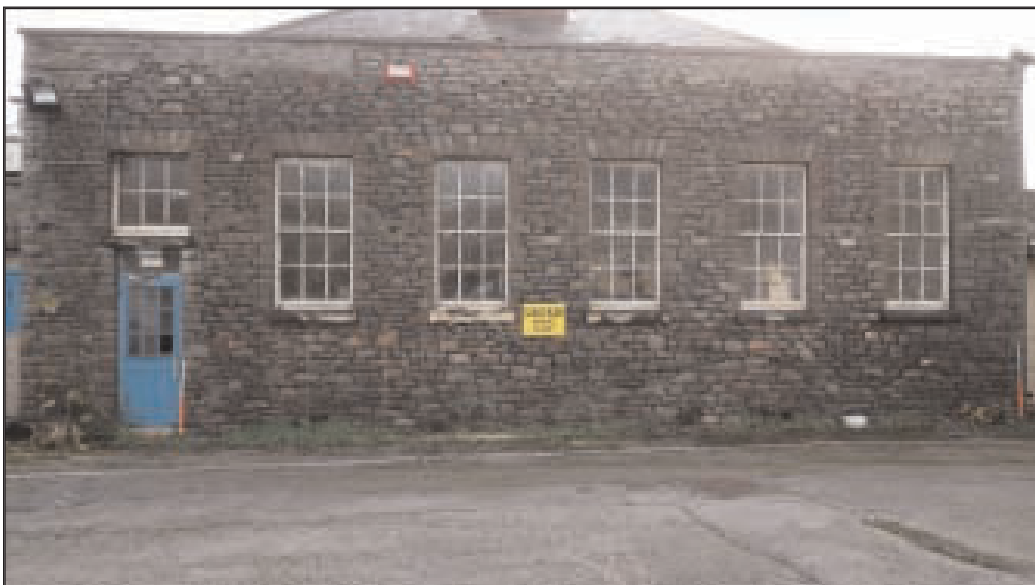
Plate 26 North facing external elevation of the canteen block, facing south

- 5.13 The canteen building (**Fig. 11**) was located to the south of the gatehouse on the opposite side of the main gateway into the site. The building was formed from three principle elements, the canteen itself in the centre, a small porch to the west and the kitchen block to the east. The south elevation had six windows located in the canteen section and the chimney of the kitchen was also located on this elevation (**Plate 24**). The porch dominated the west elevation with a single small window present (**Plate 25**), and the north elevation of the porch had a single doorway within it. Five large 12-pane sash windows were visible in the north elevation of the canteen with a 6-pane window set above the doorway at the east end (**Plate 26**). At each end

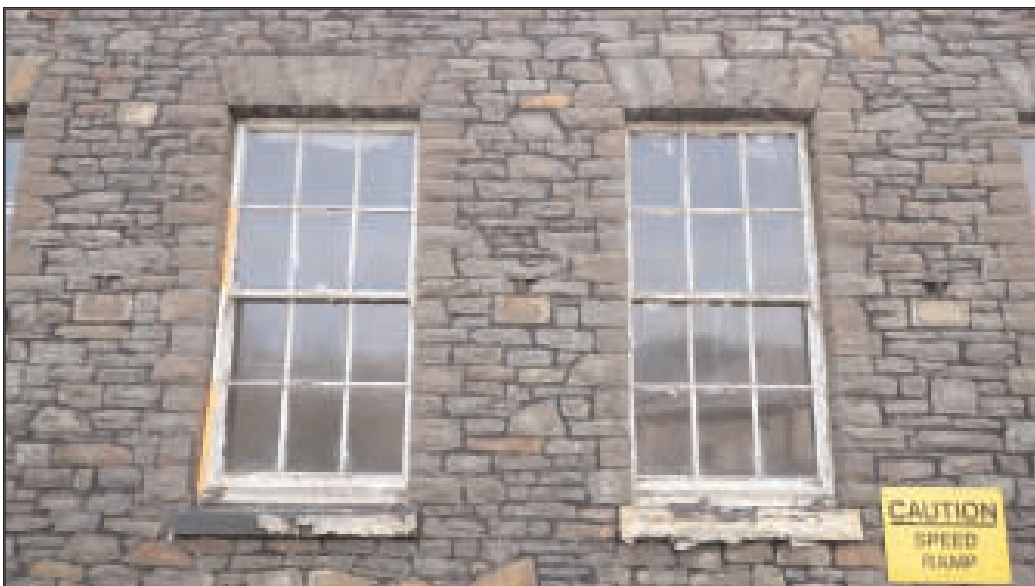
Plate 27 Windows and iron beams of north facing external elevation of the canteen block, facing south

and in-between each window was the end section of an iron beam set in the masonry at the same height as the middle of the large windows (**Plate 27**). These beams may have been used to support a canopy as possibly appears on the early 20th century painting of the Mill (**Cover**). The north elevation of the kitchen block comprised a doorway and three windows, two of them 4-pane sash windows (**Plate 28**). The east elevation of the kitchen had three small windows of identical dimensions. All of the windows and the doorway to the kitchen had Pennant sandstone voussoirs above them, with the exception of the smallest windows of the kitchen section that had Pennant sandstone lintels, and all the windows had Pennant sandstone cills. A pediment surrounded the hipped roofs of both the canteen and the kitchen sections, both of them roofed in slates with orange ridge tiles running up each hip to the central ridge. The kitchen roof included a timber skylight and the canteen roof a timber cupola surmounted by a weather-vane (**Plate 29**).

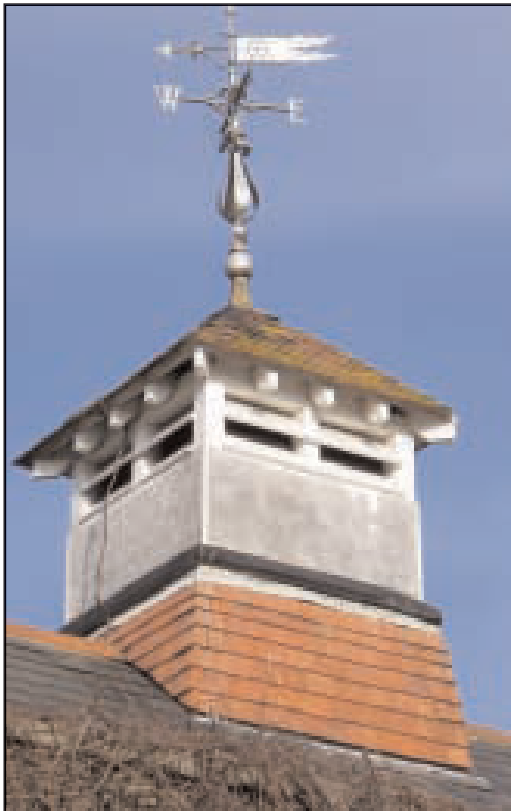
Plate 29 Cupola and weather-vane, facing north-east

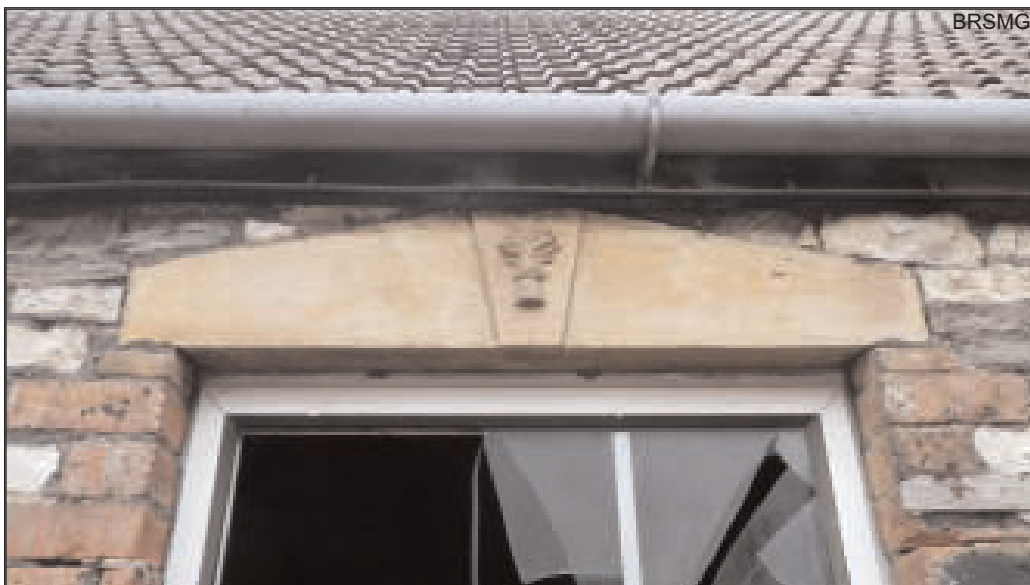
Plate 35 Cast iron lintel with wheatsheaf motif, facing north-west

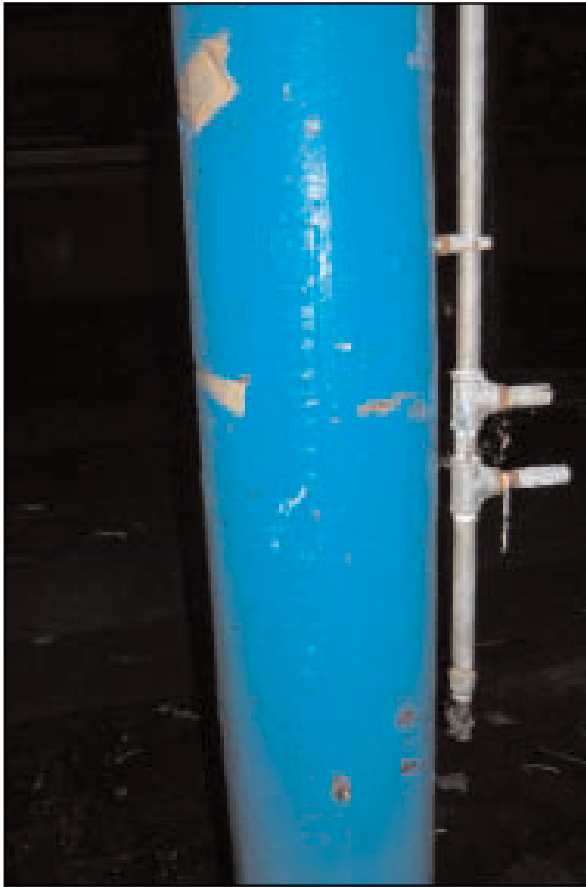
Plate 46 Maker's name on typical column

- 5.21 Within the former Foundry is a row of 8 no. cast-iron columns, set off centre, and marked as being the product of 'Torrance and Sons L^{td} Engineers Bitton Glo' (**Plate 46**). Further rows are to be found in the larger part of the factory, to the south of the brick wall. Here there are, all aligned east-west, reading from north to south, 10 no. cast-iron columns, then 5 no., another 5 no., and finally 6 no., the last now partly incorporated within a later blockwork wall. All are also marked as being the product of Torrance and Sons. According to an article about Torrance and Sons published in September, 1928, this larger area included the Machine Shop, Turning Shop, Heavy Lathes and Wheel Cutting Shop, the Pattern Shop and the Forging Section, also the Erecting Bay and Stores. While all the machinery and many of the fixtures and fittings have long since been removed, the basic roof structure, including beams and principal trusses, has survived. There are several major valley gutters, and each is equipped with a cast-iron guttering system that also carries the Torrance name (**Plates 47, 48**).

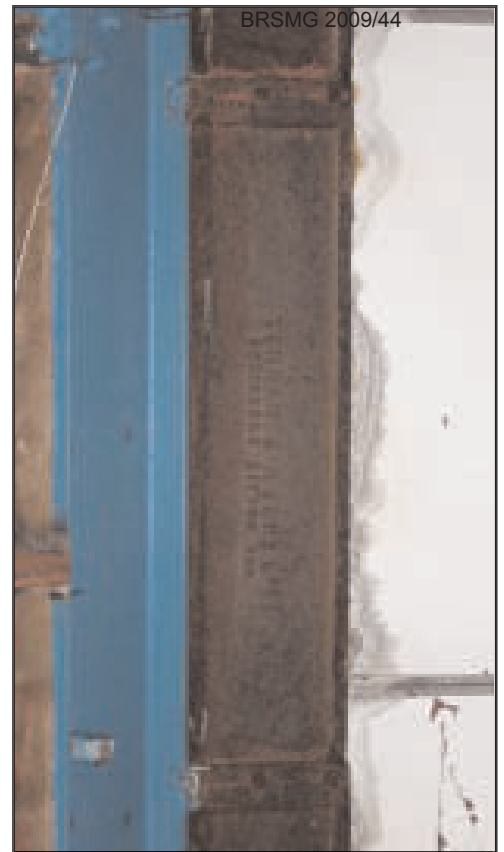
Plate 48 Torrance cast iron guttering - underside

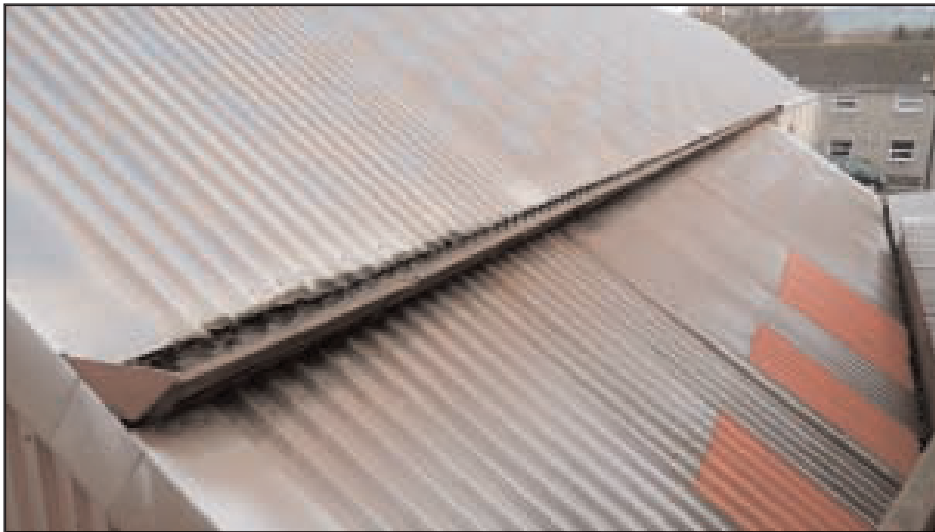
Plate 47 Torrance cast iron guttering system

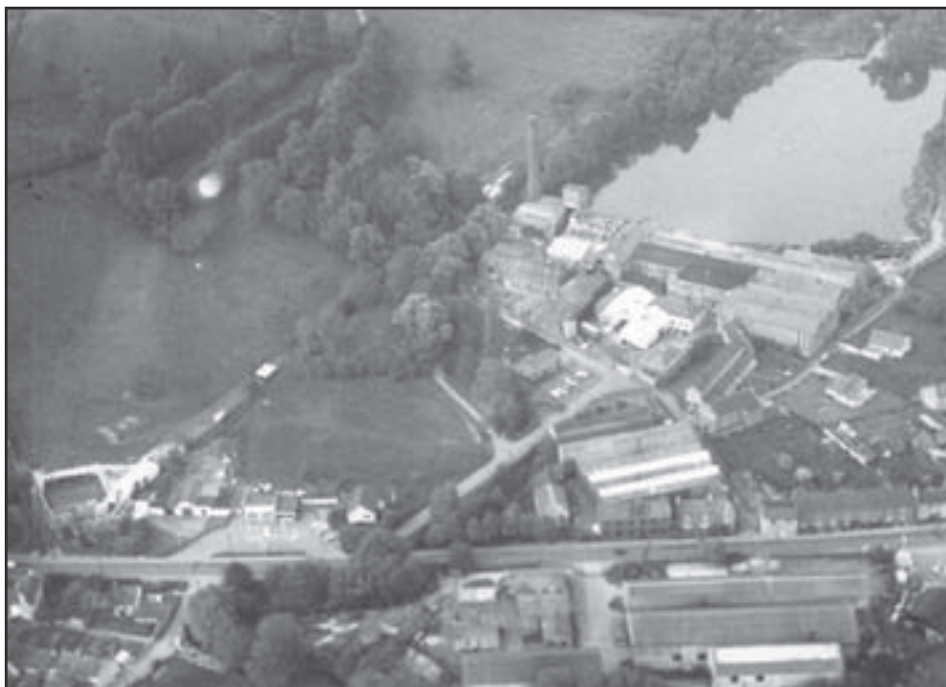
Plate 57 An oblique air-photograph of the study area in 1966, facing north

- 5.8 Phase seven was the raising of the height of the phase 3 building, with the side and end elevations being extended with the addition of brickwork sections added on top of the rubble walls (**Plate 7**). This occurred between 1935 and 1966, aerial photographs (**Plates 56 & 57**) of these years showing the change in height.
