Archaeological Building Survey
of
**THE FORMER RED COW PUBLIC HOUSE,
NO.113 WEST STREET, BEDMINSTER,
BRISTOL.**
for
Mr Gordon Page

Report No. 2155/2009
BHER No. 24791

Archaeological Building Survey
of
**THE FORMER RED COW PUBLIC HOUSE,
NO.113 WEST STREET, BEDMINSTER,
BRISTOL.**

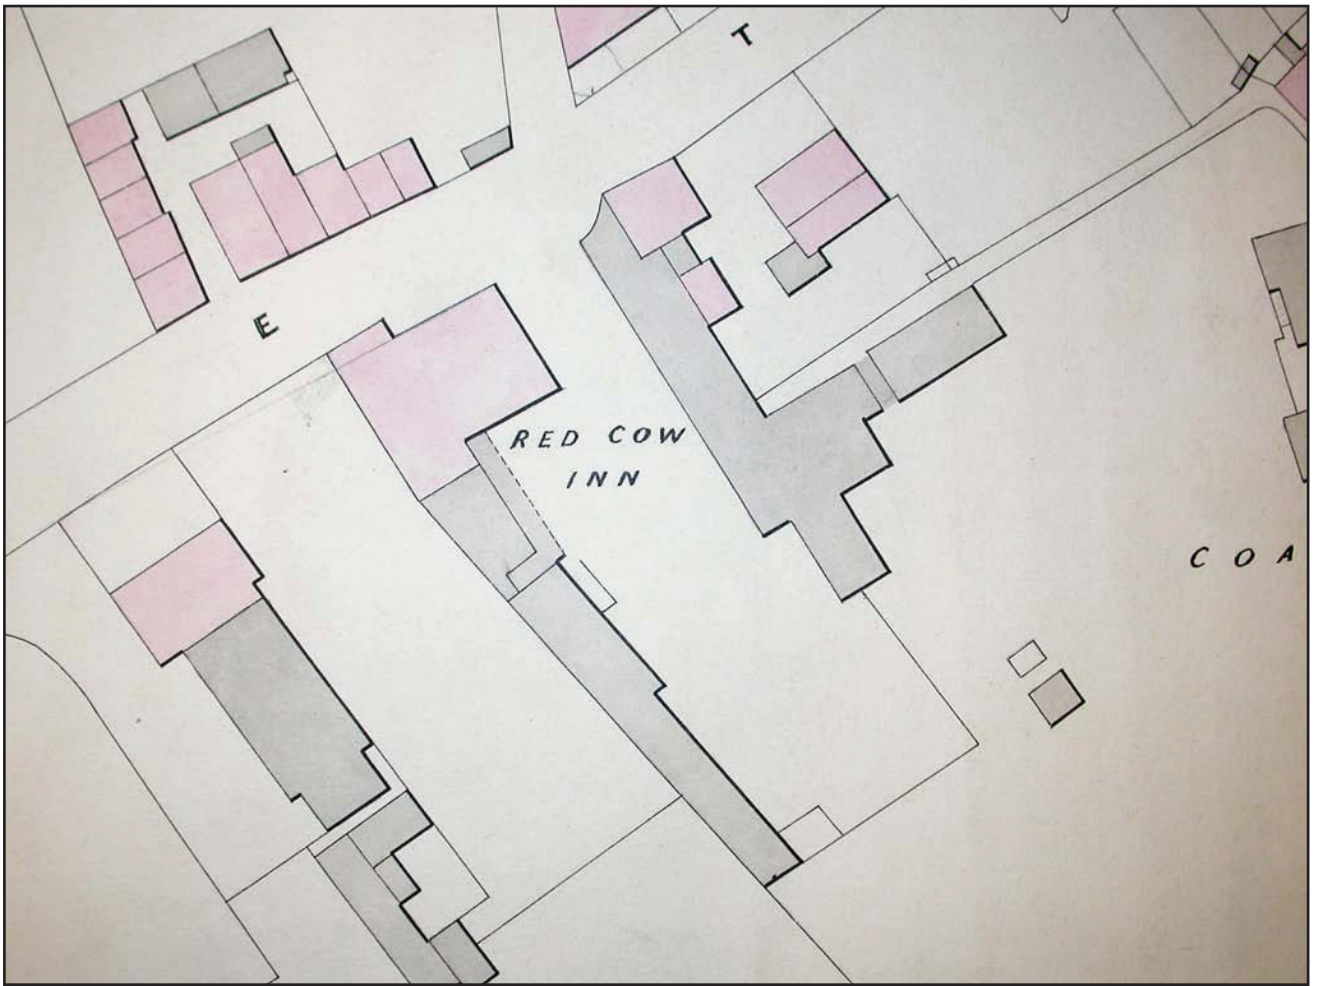
Fig.5 Ashmead survey of 1854

- 4.5 Ashmead’s 1854 1:600 survey of the city showed that the block later to contain the skittle alley was already standing (**Fig. 5**). The 1883-surveyed 1:500 OS plan showed the site very much as today, including the bay window to the street frontage and chimney breast on the north-east wall, although the main building seemed to continue south-eastwards a little further in what was latterly the skittle alley area (**Fig. 6**). By this time the brick-built stable and coach house had been erected. At this time the open area immediately north-east of the public house led to the gates of the Malago Vale Colliery, the major part of which was a short distance to the east. Little appeared to have changed before the turn of the 20th century, but by the time of the First World War the now disused colliery had given way to Argus Road, and the public house was shown as extending even further to the south-east by the OS 1:2500 plan (this was possibly an error). The area beside and behind the public house became known as Red Cow Yard and was utilised for events such as funfairs; one person was killed in Red Cow Yard during the Blitz.

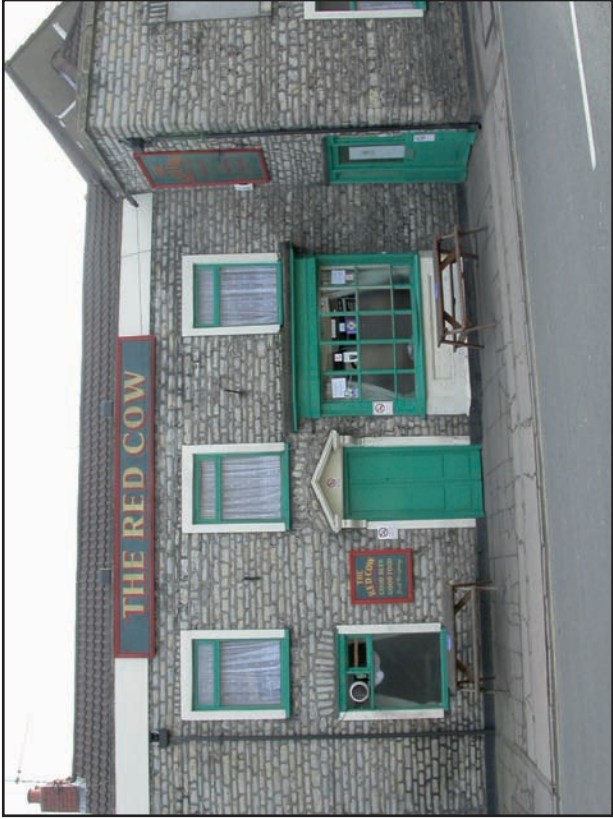
Plate 1 Street elevation in 2007

- 5.1 The Red Cow public house comprises a double depth two-storey building with a forward extension at its south-western end, and single-storey rear extension and outbuildings around two further sides of a yard (**Fig. 1; Cover & Plates 1-5**). Cellarage exists beneath the rear part of the main building and the nearer end of the skittle alley. A pair of parallel pitched roofs cover the larger part of the main building, the south-eastern roof being of wider span and hipped at its south-west end. A third pitched roof covers 75% of the south-western part of the building, but the remainder nearest the street (i.e. that part that projects forward of the main building line) is hipped and at a slightly lower level. The southern corner of the main building is single storey only, with a flat roof, but the high south-west wall suggests that this may once have had a second storey, a fact confirmed by the 1932 drawings (BRO Building Plan Book 118, fol. 18). Today all pitched roofs are covered with Double Roman tiles, some of modern manufacture.

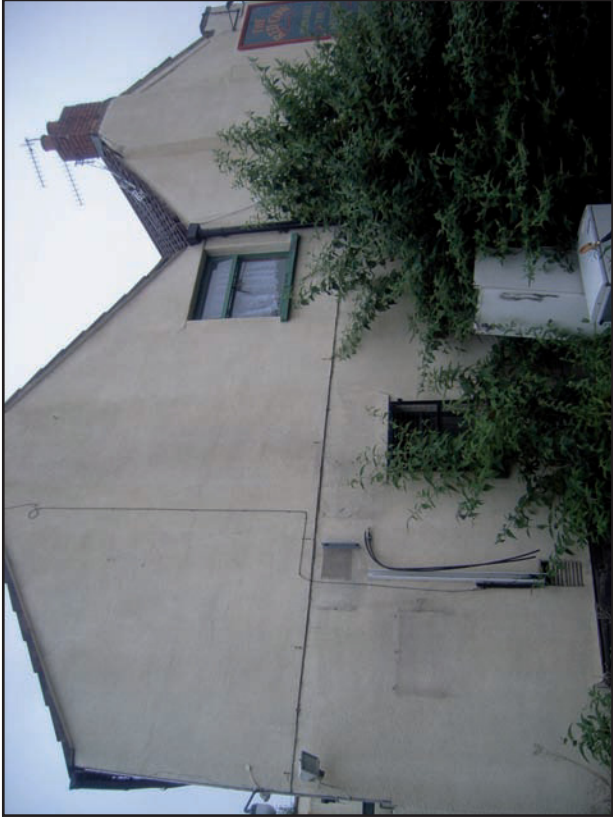
Plate 3 North-east elevation

- 5.3 An open space always seems to have existed at the north-east end of the building. Facing onto this space are two gable ends, that nearest the street slightly narrower and therefore with an increased roof pitch, and this gable only has a projecting chimney breast, with two pots (**Plate 3**). The other gable is a capped with a stack now shorn of its pots, but apparently containing two flues. All three windows in this elevation have modern frames. At low level against the south-east end of this elevation are a pair of wooden cellar doors, providing the sole external access to this facility; alongside hatch on its south-east side only is a short, very low length of Pennant rubble wall. Continuing the line of this elevation is the yard wall, pierced by a pair of large gates, beyond which is the end wall of an outbuilding with a single pitch roof. At the opposite end of the main elevation, a boundary wall abuts the north corner of the public house.

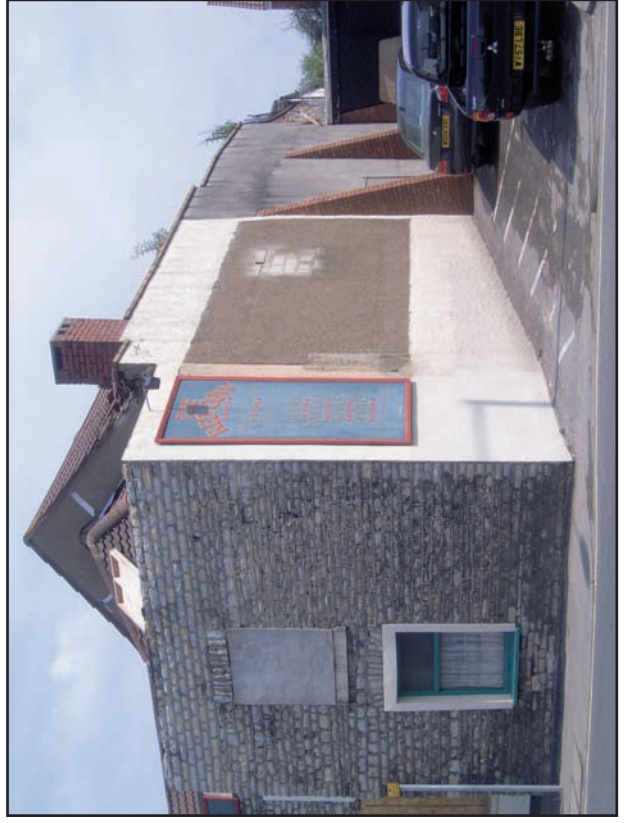
Plate 4 South-west elevation, seen from west

- 5.4 Despite having long been unobstructed, the south-west elevation of the building only appears to have had a single opening, a first-floor window, now with a blockwork infill (**Plate 4**). Nearer to the street, two parallel cracks in the render mark the location of a now- removed buttress, while above, a clean vertical line indicates a straight joint behind. The 1932 plan records second buttress, also since removed. There is a single chimney stack in relatively modern brickwork. The wall changes angle as it runs further back, and must have been considered unstable since it is supported by three modern steeply inclined brick buttresses, the westernmost of which replaces one recorded in 1932.

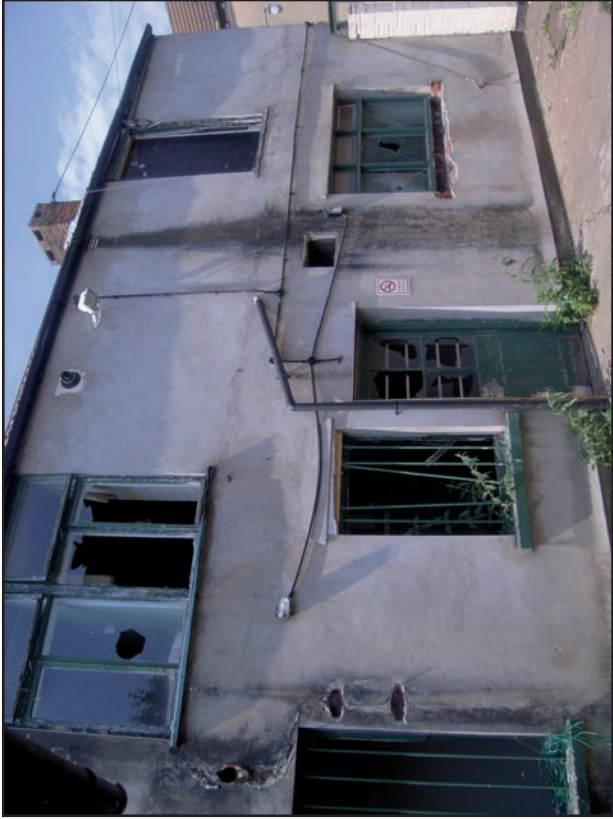
Plate 5 South-east elevation and yard

- 5.5 The south-eastern elevation of the main building mostly faces directly onto the yard and includes a doorway and a number of windows, most of the latter probably not original (**Plate 5**). To the left of the entrance, the two ground-floor windows are barred on the outside. In the angle with the south-western yard wall is a low box containing vents serving the cellar below (**Plate 6**). The south-west wall itself includes double doors leading to the skittle alley with a window to either side, and a larger window at the northern end of the wall, all windows again barred on the outside (**Plates 6 & 7**). Projecting beyond the wall face, the single pitch or catslide roof above the centre and south-east end of the skittle alley provides shelter at that end of the yard (in 1932 it was

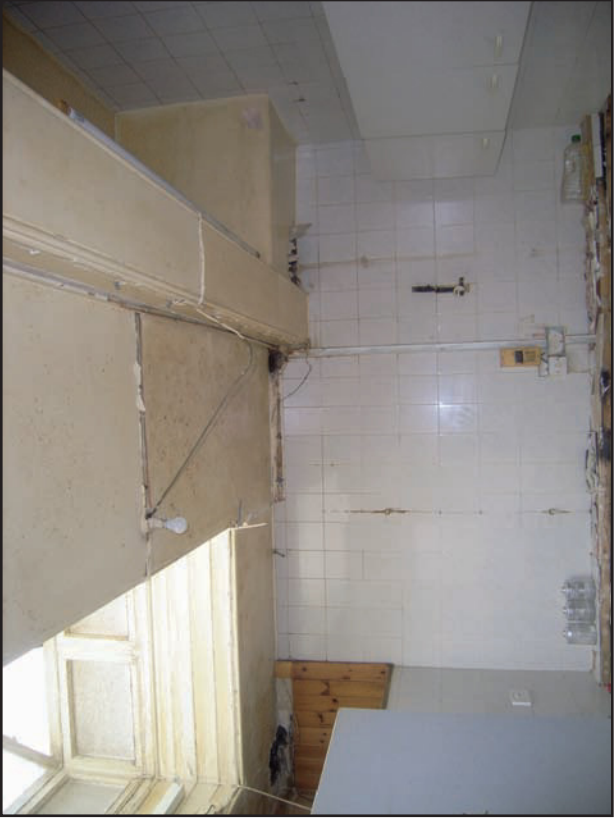
Plate 13 Kitchen, looking north-west – note higher ceiling to right

- 5.7 Much reorganisation has taken place in the ground floor area between the bars and skittle alley. The old store room south-east of the smoke room was reduced in size in 1932 when a ladies' lavatory was inserted alongside the main south-west wall: the remainder was later converted into a kitchen (**Plate 13**). Behind the old bar was a living room, with a small office squeezed between the two: a trapdoor in the floor provided internal access to the cellar, as it still does today (**Plate 14**). Stone winders lead into the western corner of a barrel-vaulted cellar that runs north-east as far as the outside flaps in Red Cow Yard (**Plate 15**). A short passage leads into another cellar room beneath what is now the north-west end of the skittle alley (**Plate 16**). Ventilation is provided through the passage wall from the box in the corner of the yard. Back at ground-floor level, a short passage leads past the bottom of the staircase and the small kitchen created out of the old living room, providing access to the skittle alley. The south-east wall of this passage together with that of the rear lobby comprises two segmental arches with flattened heads, infilled on their outer sides, features that originally may have been open to the yard (**Plate 17**).

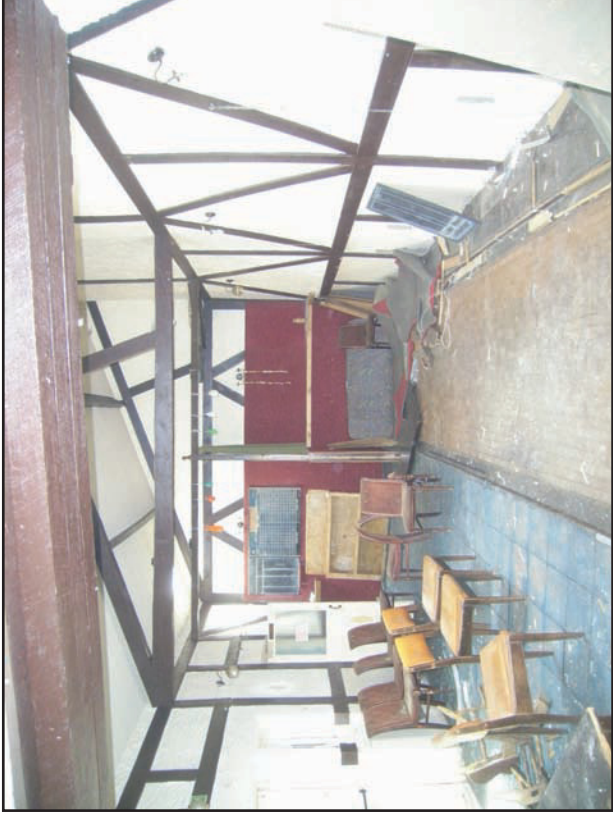
Plate 19 Skittle alley looking south-east towards pins end

- 5.8 Today a short skittle alley (reputedly the shortest in Bristol) occupies the southern corner of the site (**Plates 18 & 19**). The alley itself runs parallel to the south-west wall. Short, shouldered, stub walls to either side at about 3m into the room represent the remains of a once continuous wall that separated the old kitchen (to the north-west) from a scullery. The kitchen was equipped with a range in its north-west wall; a cupboard set within the opposite wall may have once been a window in an external wall. Against the south-west wall of the scullery was a staircase, underneath which, in the west corner of the room, was a copper, with a large sink in the north corner of the same room.

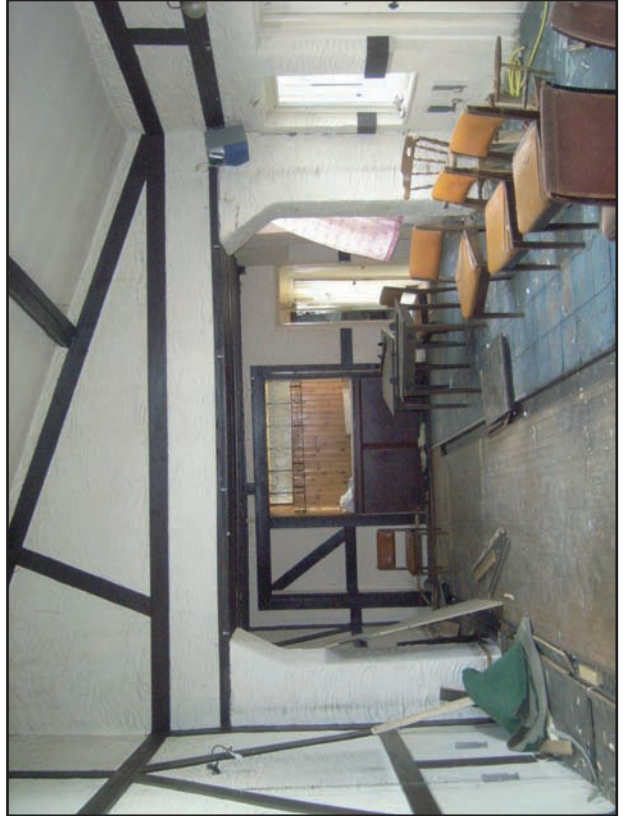
Plate 18 Skittle alley looking north-west from pins end

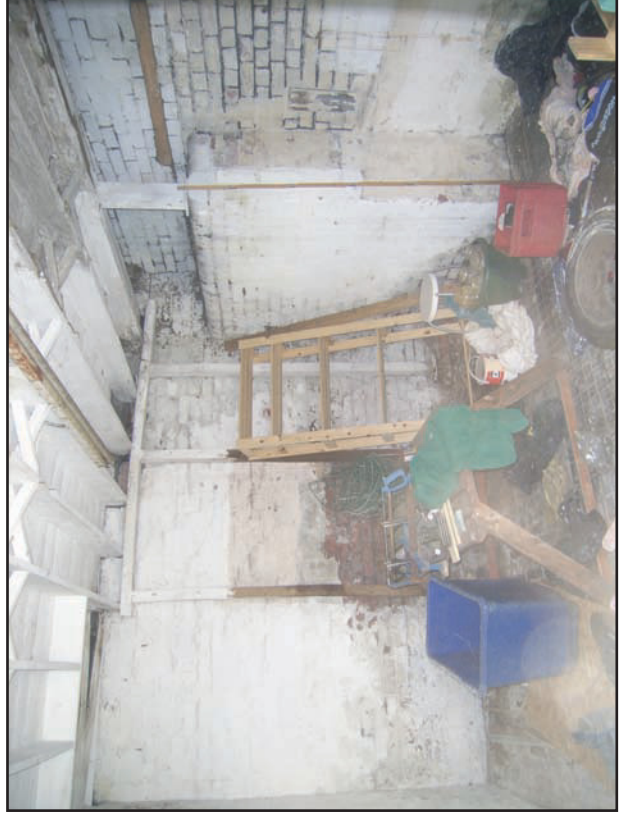
Plate 20 Interior of former coach house, looking south

- 5.9 The outbuilding with the double doors almost next to the skittle alley, now a store (**Plate 20**), has a brick floor and a small blocked-up window in its rear wall; there is a hatch to the roofspace above in the east corner of the room. Described as a stable in 1932, this may have been a coach house earlier. There is a small window towards the front end of the north-east wall (**Plate 21**). Close to the west corner is a thin iron or steel post supporting a joist or beam. Next door to the north-east is another store, also with a brick floor, accessed through a stable door. A small window opening in the north-east wall, now blocked in, matches that already mentioned opposite. This space is divided by a modern blockwork wall but was probably originally a stable, possibly partitioned into two stalls; several heavy-duty wooden pegs in the front wall may have been used for hanging horse harness or saddlery (**Plate 22**).

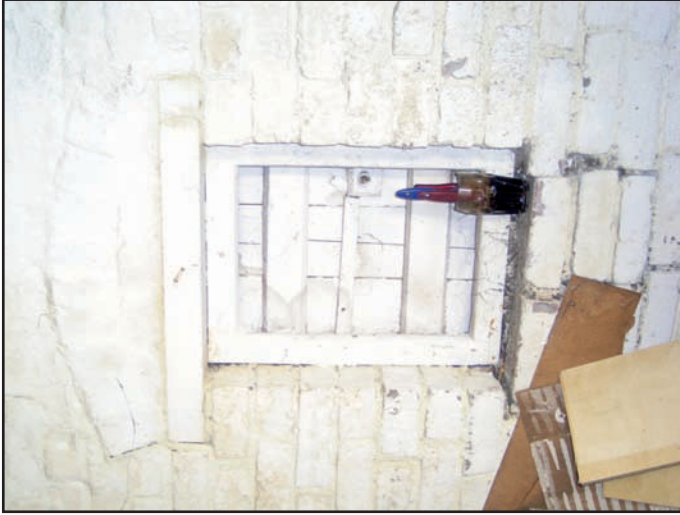
Plate 23

First floor long passage, looking north-east, with breast on right

than the late 19th century, and this is almost certainly not the site of the original stairs. The landing (**Plate 23**) extends south-westwards as far as a short flight leading to the raised south-west end of the building, entered through a doorway that was inserted after the 1932 plan was drawn. The remains of what was probably a chimney breast survive against the south-east side of this passage. Beside the top of the main staircase, the landing runs south-east for a short distance before rising one step, after which it turns south-westwards.

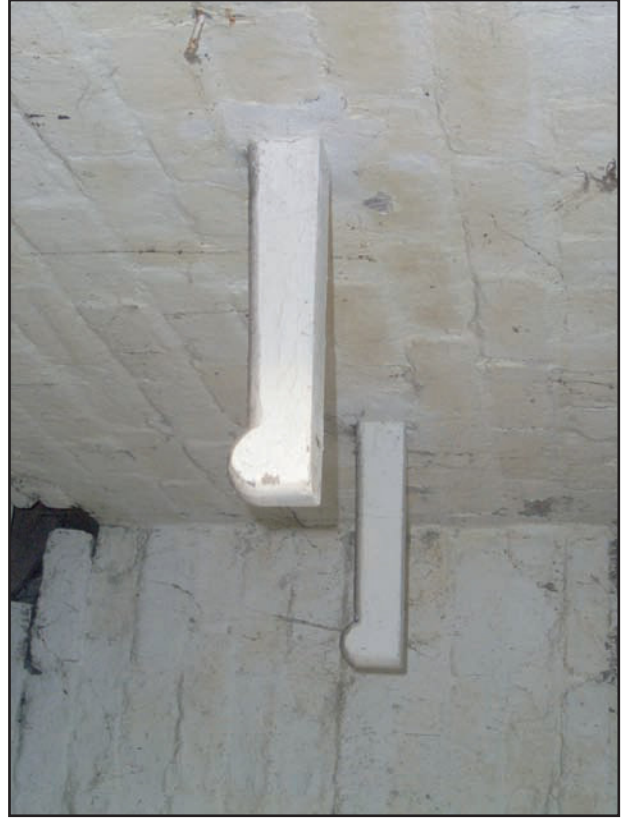
Plate 22 Wooden pegs in stable wall

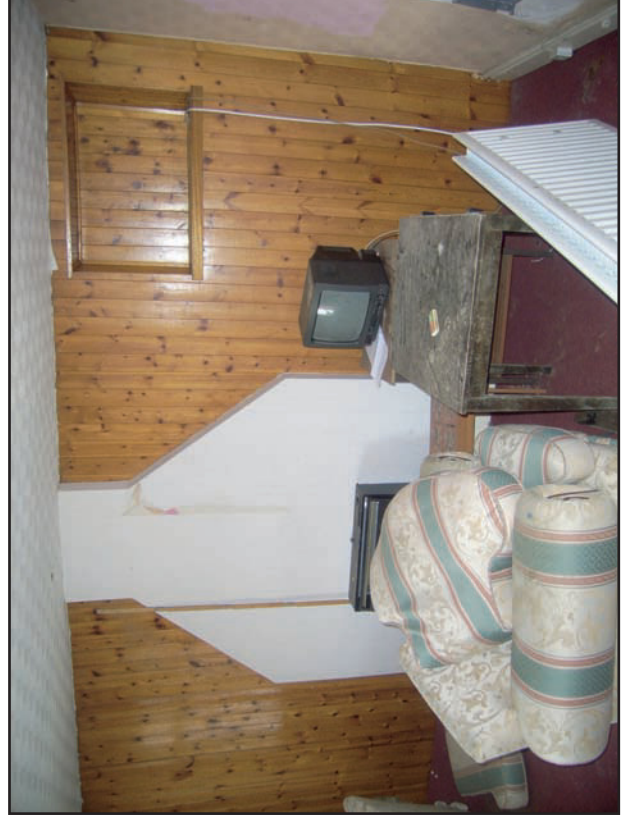
Plate 24 North bedroom: north-east wall showing breast and cupboard

- 5.11 Generally on this upper storey it appears that the rooms have been rearranged and no longer represent the original layout, although the eastern bedroom may be an exception. Thin partitions divide the two front bedrooms from the landing. Whereas the northern room (**Plate 24**) has a shallow chimney breast but no visible fireplace, with a small cupboard in the wall to its right (possibly a former window), the central bedroom is devoid of interest apart from a shallow beam running out of the front wall. Cupboards have been built into two angles of the eastern bedroom (**Plate 25**); the fireplace has been blocked up. In one corner of the windowless room the bottom of a hip rafter is visible where the ceiling is built into the bottom of the roofspace, which latter feature continues into one side of the adjoining bathroom. Removal of wall plaster in the external wall of the kitchen has exposed a small area of the original Lias limestone rubble walling. Through a hatch in the bathroom ceiling may be seen the hip end of the rear roof, showing a structure that is pegged together and includes butt purlins (**Plates 26 & 27**).

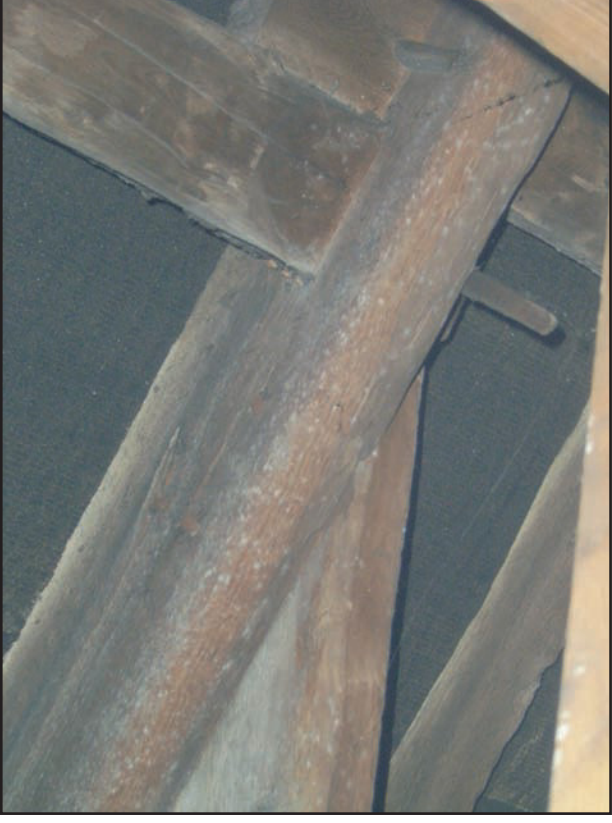
Plate 27 Detail of rear roof, as seen from bathroom hatch

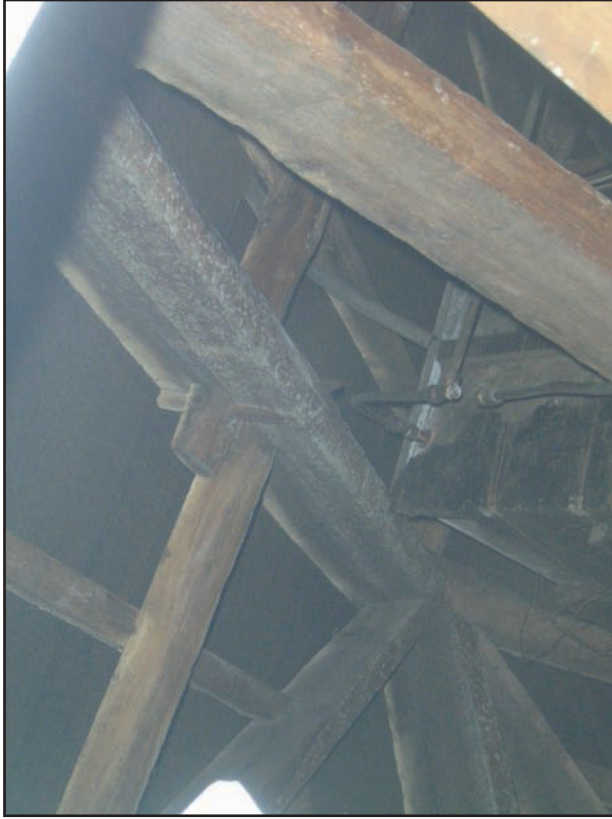
Plate 26 Hip end of rear roof, as seen from bathroom hatch

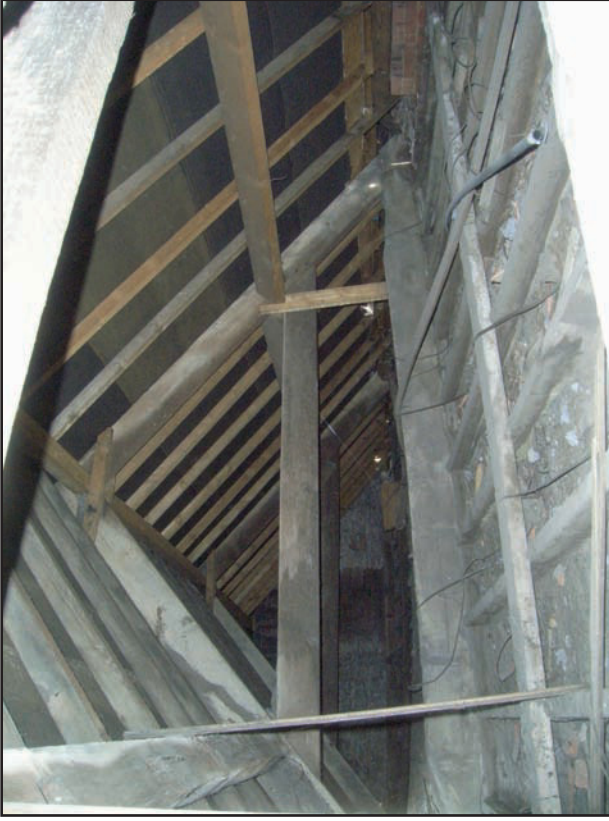
Plate 30 Roof above front part of building, looking east from hatch in former club room

- 5.12 At the time of the 1932 drawing the south-western end of this floor comprised a single room, the Club Room, separately accessed from the ground floor smoke room only. A new rear wall was built after the room was reduced in length in order to install a flat roof with lights above the store and new female lavatory behind the smoke room. At that time the room was lit by skylights plus a small window in the south-west wall but the front window already appears to have been blocked. Subsequently, the side window has been blocked in and the area partitioned into two bedrooms, although the chimney breast survives, albeit with the chimneypiece removed (**Plates 28 & 29**). This area is four steps above the main first floor landing, and consequently the ceiling is partly set within the lower roofspace: the bottom of a pair of principal rafters is visible, the south-western rafter consisting of a pair of machine-cut timbers bolted together. A hatch high in the north-east wall of the front bedroom provides access into the front roof of the double-pile part of the building: the roof is constructed with A-frame trusses that look to be of a good age, although the common rafters are machine-cut and relatively modern (**Plate 30**).
