Archaeological Watching Brief
at
**BRISTOL MATERNITY HOSPITAL,
ST. MICHAEL'S HILL, BRISTOL.**
for
Bristol Royal Infirmary (Estates Department)

Report No. 2128/2010
BHER No. 24793

Archaeological Watching Brief
at
**BRISTOL MATERNITY HOSPITAL,
ST. MICHAEL'S HILL, BRISTOL.**

Client: Bristol Royal Infirmary (Estates Department)

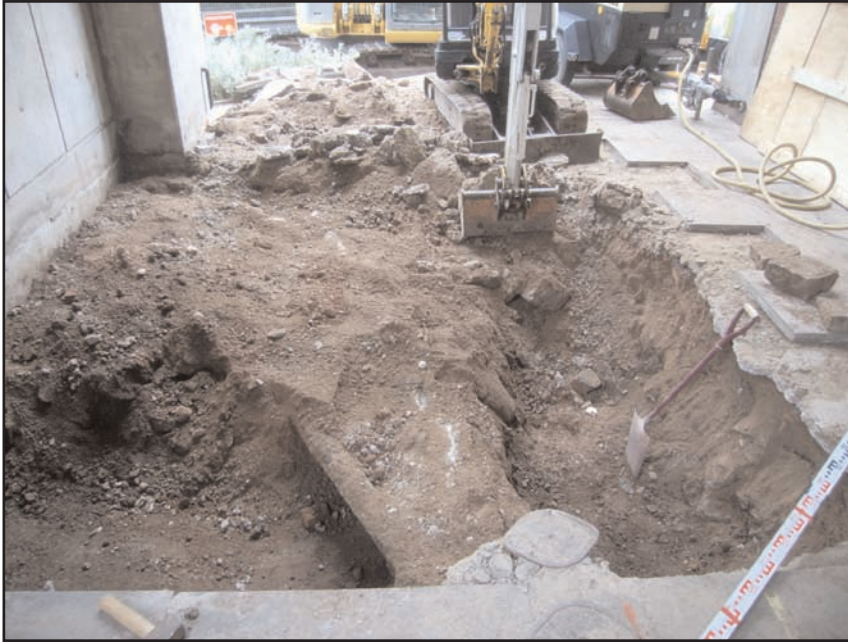
Was excavated to between 800mm and 850mm deep. A simple sequence of concrete slabs and bedding over mixed made-ground/demolition material was recorded. An iron service pipe protected with a covering of concrete crossed the trench. No features or deposits of archaeological significance were observed during these works.

Plate 1
General view of Service
Trench 100 after
excavation

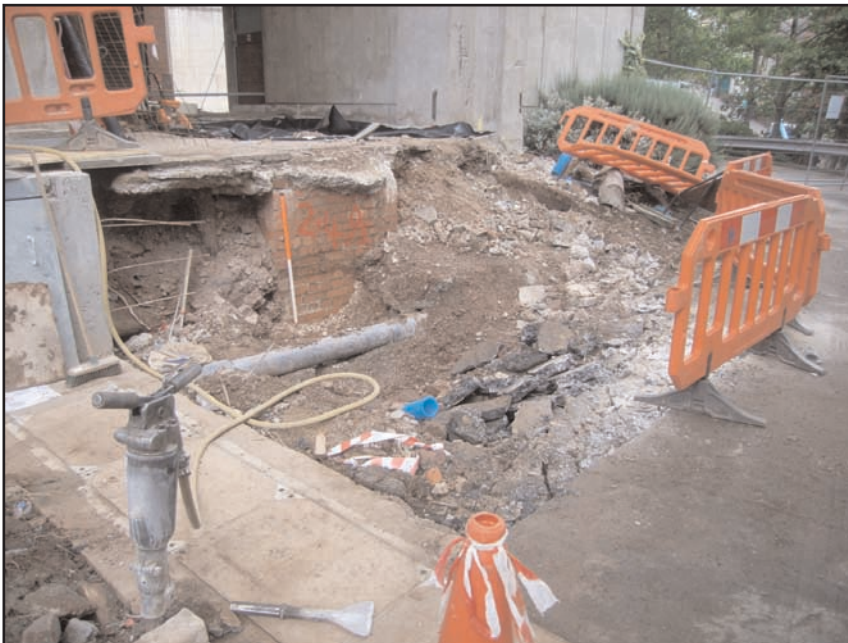
Part of a small landscaped area, between the hospital buildings and the service road, was reduced prior to the excavation of a new service trench (Service Trench 200, above). Also concrete retaining walls, surfaces and steps were removed as part of this work. The amount of material removed reached up to 1m in depth. Up to half of the material (decreasing in depth to the north) removed comprised topsoil/garden soil, the remaining material was mixed made-ground/demolition rubble.

Plate 2
Reduced level excavation
in area of Service Trench
200

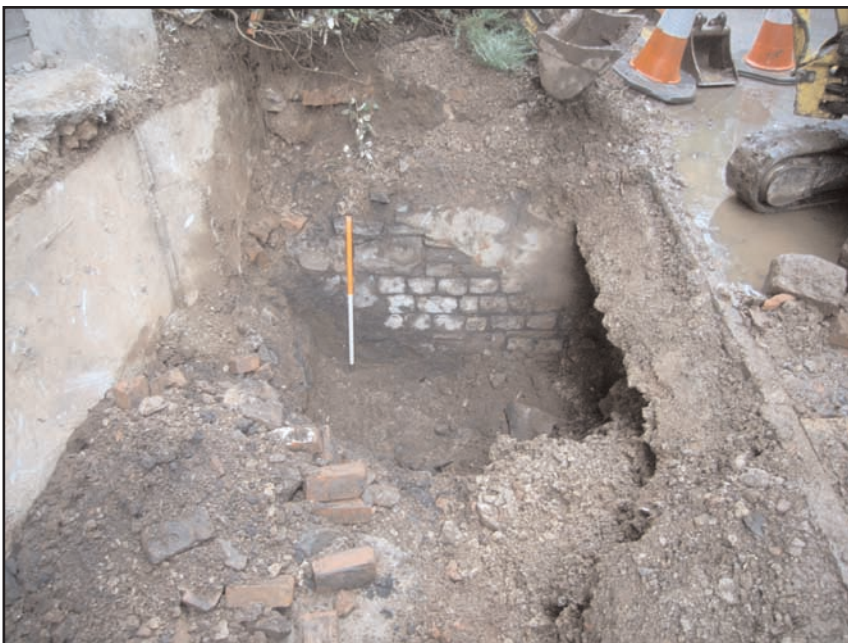
Except at the northern end, this trench was excavated after reduction of a bank above it (see below). The trench was excavated to a maximum depth of 1.2m. Those deposits recorded comprised a thin topsoil (north end only) sealing mixed made-ground/demolition rubble. At the north end of the trench a short length of post-medieval wall (Wall 201) was recorded.

Plate 3
Wall 201 and adjacent
made-ground deposits
exposed in Service
Trench 200

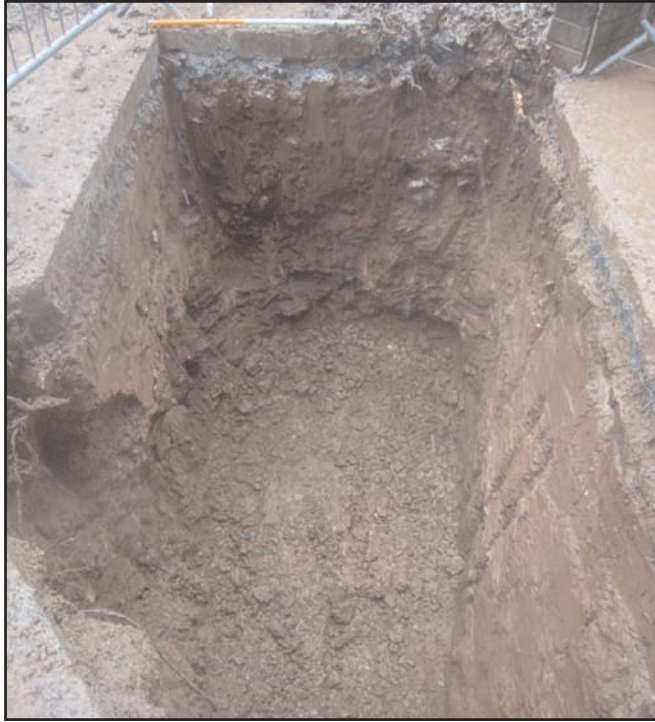
Actually comprised two pits excavated as one. The Box reached a maximum depth of 2.3m and revealed a simple stratigraphic sequence of concrete and bedding sealing archaeologically

sterile clay and mudstone deposits. No features or deposits of archaeological significance were recorded.

Plate 4
Pile-cap box D at the
completion of excavation

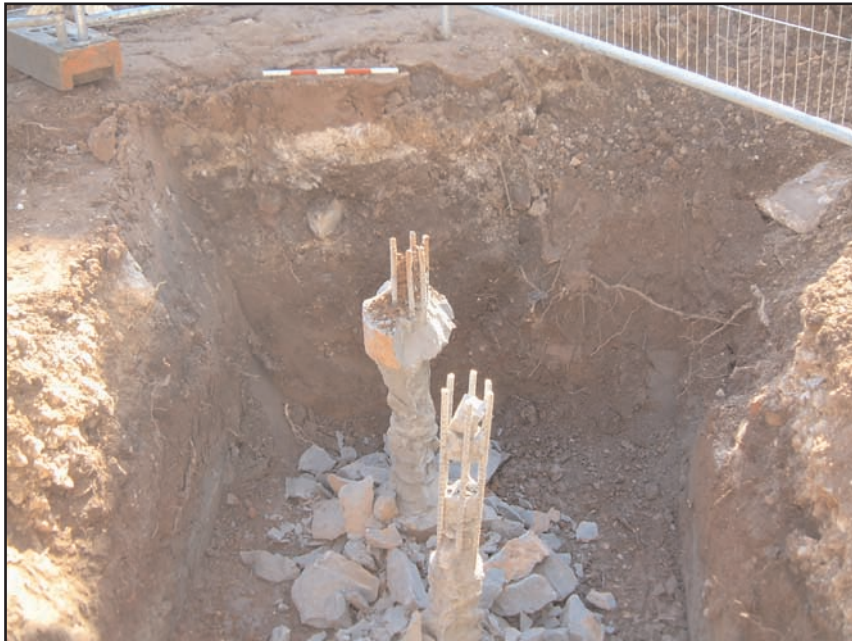
Excavated to a maximum depth of 1.4m. A simple stratigraphic sequence of excavation was observed, spoil from the box was dumped along the top of the section sealing gravel/scalpings a former topsoil horizon and subsequently deposits of red clay and tea-green marl clay. No features or deposits of archaeological significance were recorded.

Plate 5
Pile-cap box H at the
completion of excavation

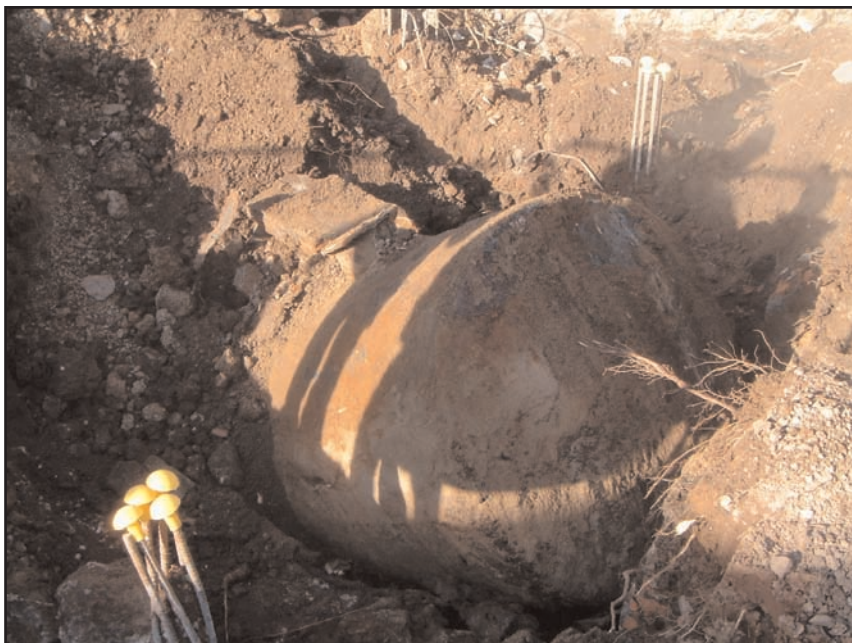
Excavated to a maximum of 1.4m deep. The box was excavated into a simple sequence of deposits comprising topsoil, redeposited clay, made-ground material and subsequently archaeologically sterile natural clay. In the west facing section of the box part of the brick retaining wall to house a diesel fuel tank was recorded. The diesel tank was 2m wide and 3m in length and sat in a rectangular structure of brick, bonded with cement. Sheets of corrugated Iron were also used to cover the tank. Later the diesel tank was removed and the upper part of the retaining structure demolished. The diesel tank and structure were only recorded in the edge of this pile-cap, whereas Pile-caps K and M were situated wholly within the hole created by its removal.

The area of this pile-cap was situated wholly within the area of the diesel storage tank, the removal of the tank meant no further excavation was required. Deposits and structures observed comprised the diesel tank, retaining walls and backfill and the cut and fill for the construction of the retaining structure.

Situated wholly within the area of the removed diesel storage tank. The results of the excavation were identical to those recorded for pile-cap K.

Plate 3
Removal of the diesel
tank in area of pile-cap
boxes I, K and M
