Archaeological Building Survey
of
ST. BRENDAN'S CHURCH,
ST ANDREWS ROAD, AVONMOUTH, BRISTOL.
for
Ferris Homes

Report No. 2187/2009
BHER No. 24811

Archaeological Building Survey
of
ST. BRENDAN'S CHURCH,
ST ANDREWS ROAD, AVONMOUTH, BRISTOL.

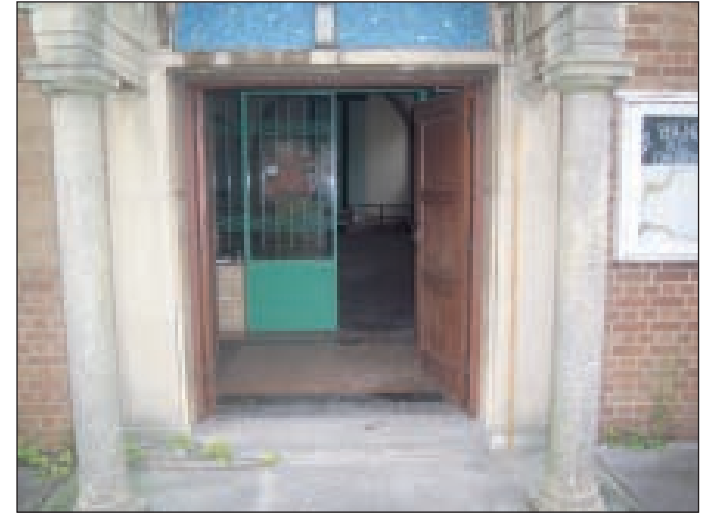
Plate 3 Main entrance and view through narthex

- 5.2 The main entrance is at the west end, through double doors beneath a canopied porch supported by two columns (**Plates 3 & 4**). Higher in the wall is a circular window. Short screen walls extend to either side of the front, each containing a small, empty niche in its front elevation (**Plate 5**). Inside the front doors is a tile-floored narthex with double iron doors in the centre of an ironwork screen that sits on low brick walls (**Plate 6**). Both doors and screen include zigzagging ironwork that may represent the crown of thorns, while each door has a centrepiece comprising three multiple arcs, representing the Holy Trinity (**Plates 3, 7 & 8**). Pairs of wooden doors lead off the narthex to north and south: beyond the doors are apse-ended spaces, that to the south being the baptistry (the font is missing, **Plate 9**) and that to the north housing the stairs up to the gallery. The staircase has a steel frame with wooden treads and open risers, approached by five straight steps but then comprising winders (**Plate 10**). A single window, splayed internally, lights the bottom of the stairs. At the opposite side of the building, but at higher level, is another circular window. The gallery above the narthex also spans above the base of the staircase to provide access to a hatch into the upper part of the tower, but at the opposite end, stops short of the upper part of the baptistry (**Plate 11**).

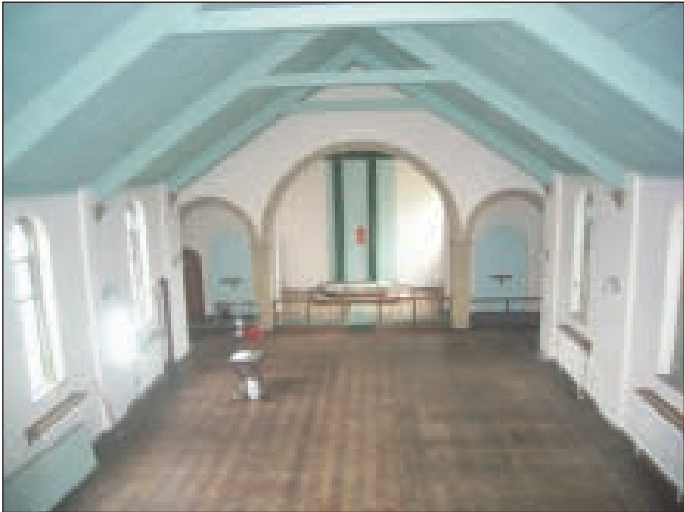
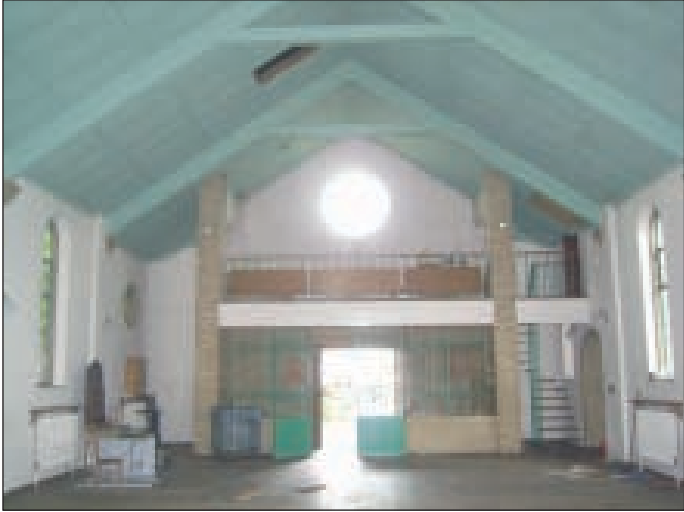
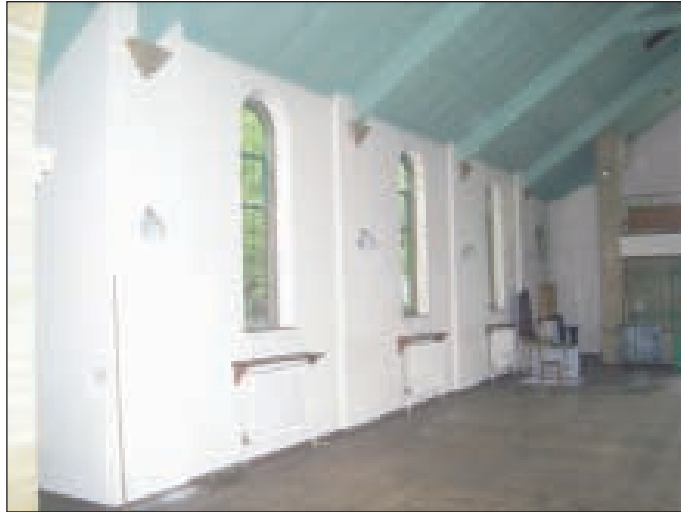
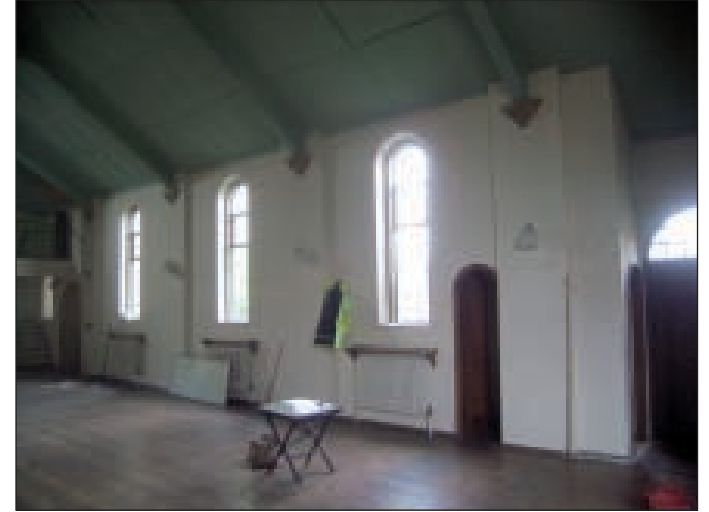
- 5.3 The nave measures approximately 14.5m by 9m and is lit by three round-headed windows in both north and south walls (**Plates 12-15**). Parquet flooring extends throughout both the nave and chancel. Walls are mostly plastered but the brickwork against the narthex is unrendered, as is the area beneath the tower and also the brick piers supporting the chancel arch. Each side wall is 4.40m in height from floor to roof: pairs of hooks at intervals indicate where the Stations of the Cross were formerly located. At the eastern end of the north wall is the side entrance, with the confessionals immediately to its west, the priest's booth lit by a small window (**Plates 16 & 17**). On the opposite side of the nave is a small south transept, lit by a circular window high in its south wall (**Plate 18**). The nave is open to the roof, exposing the A-frame trusses. All single doors in both nave and chancel are round-headed

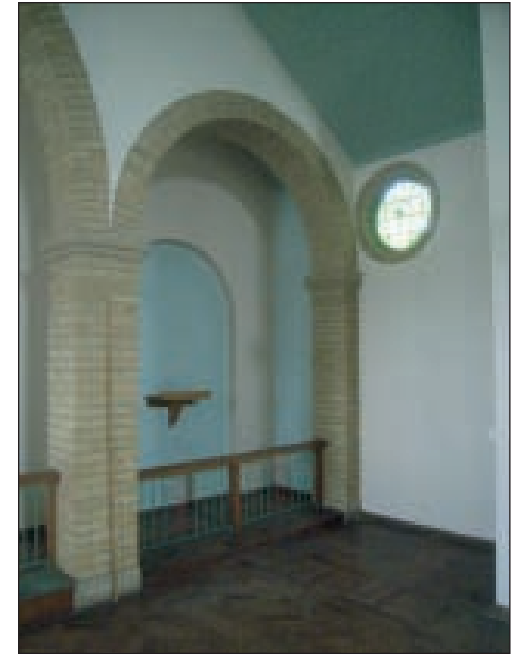
Plate 18 South transept and side chapel, from north-east

- 5.4 Terminating the eastern end of the nave are triple brick arches, the larger, middle one framing the view of the chancel (**Plate 19**). South of the chancel is a small, shallow side chapel with an arched recess in its rear wall (**Plate 18**), while a similar space at the northern end acts as a vestibule outside the vestry (**Plate 20**). The communion rail extends the width of the church at this point, occupying all three arches: the ironwork beneath the rail includes roundels, each containing a Christian symbol (**Plates 21-28**). A window with three round-headed lights takes up almost the full width of the south chancel wall (**Plate 29**); the opposite wall has a doorway into the vestry at one end and a date-stone at the other (**Plate 30**). Curiously, the stone is carved with the date MCMLIV, even though construction is said not to have begun until the following year (**Plate 31**). Although the altar has been removed, the stepped base against the blank east wall survives, as does the canopy suspended from the ceiling above (**Plates 32 & 33**).
