Archaeological Assessment & Recording
of a
**WATERWHEEL PIT AT TRENANT VALE, TRENANT,
EGLOSHAYLE PARISH, NORTH CORNWALL.**
for
Environment Agency

Report No. 2185/2009

Centred on
N.G.R. SW 99895 72580

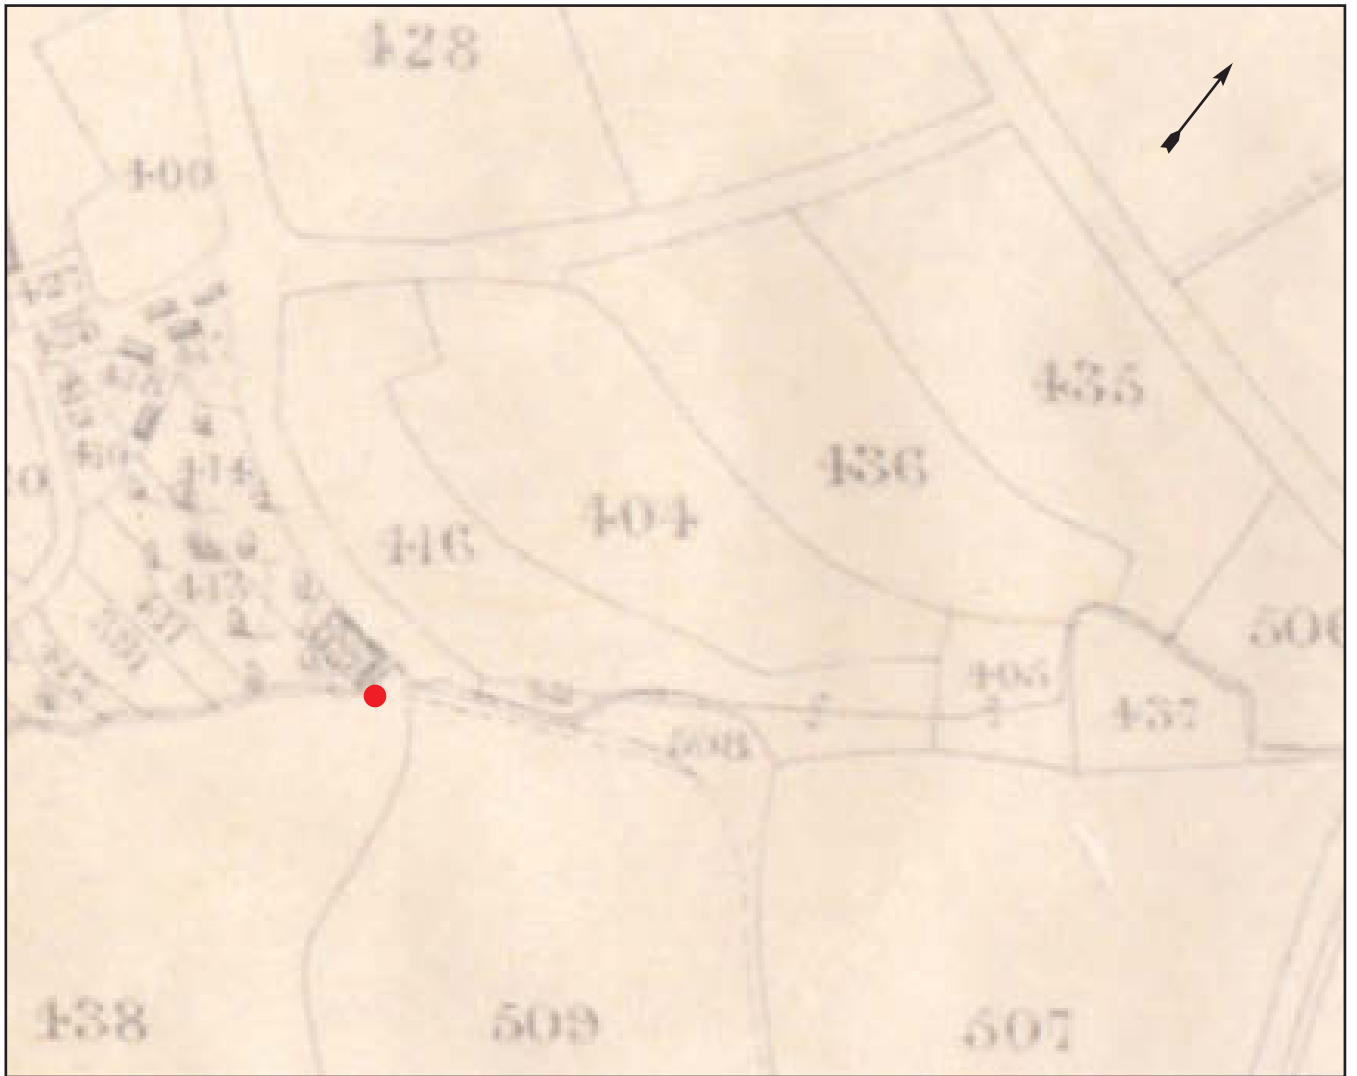
Fig.3 The Egloshayle tithe map, 1841

- 4.3 The Egloshayle tithe map, surveyed in 1841, and its accompanying apportionment, dated 1840, provide the first detailed information about the location of the waterwheel pit (**Fig.3**; CRO TM/52 and TA/52). The plot of land in which the waterwheel pit is located, no. 438 on the tithe map, was owned and occupied by William Pollard and was called ‘Lindaby Field’. No buildings are shown in the field. Hard against the west bank of the stream and immediately to the west of the waterwheel pit is a building numbered 415 on the map, owned and occupied by John Davey and described as a malthouse and yard. (This is presumably the malthouse referred to in the HER records as PRN 26217). The fields and properties shown on the tithe map in the vicinity of the waterwheel pit are listed below:

- 4.5 The tithe map shows a small pond to the north-east of the location of the waterwheel pit, on the southern edge of field no. 416 ‘Dry-house meadow’. This appears to have been formed by building a dam across the valley floor at the west end of the pond. It is probable that this pond was associated with the malthouse rather than a mill, as malthouses required a supply of water in order that the barley grain could be ‘steeped’ in rectangular tanks or cisterns, with the water in the tanks requiring frequent changing. Steeping the grain for a day or more caused it to swell and increase in bulk. Steeping tanks were usually located below the malthouse, the

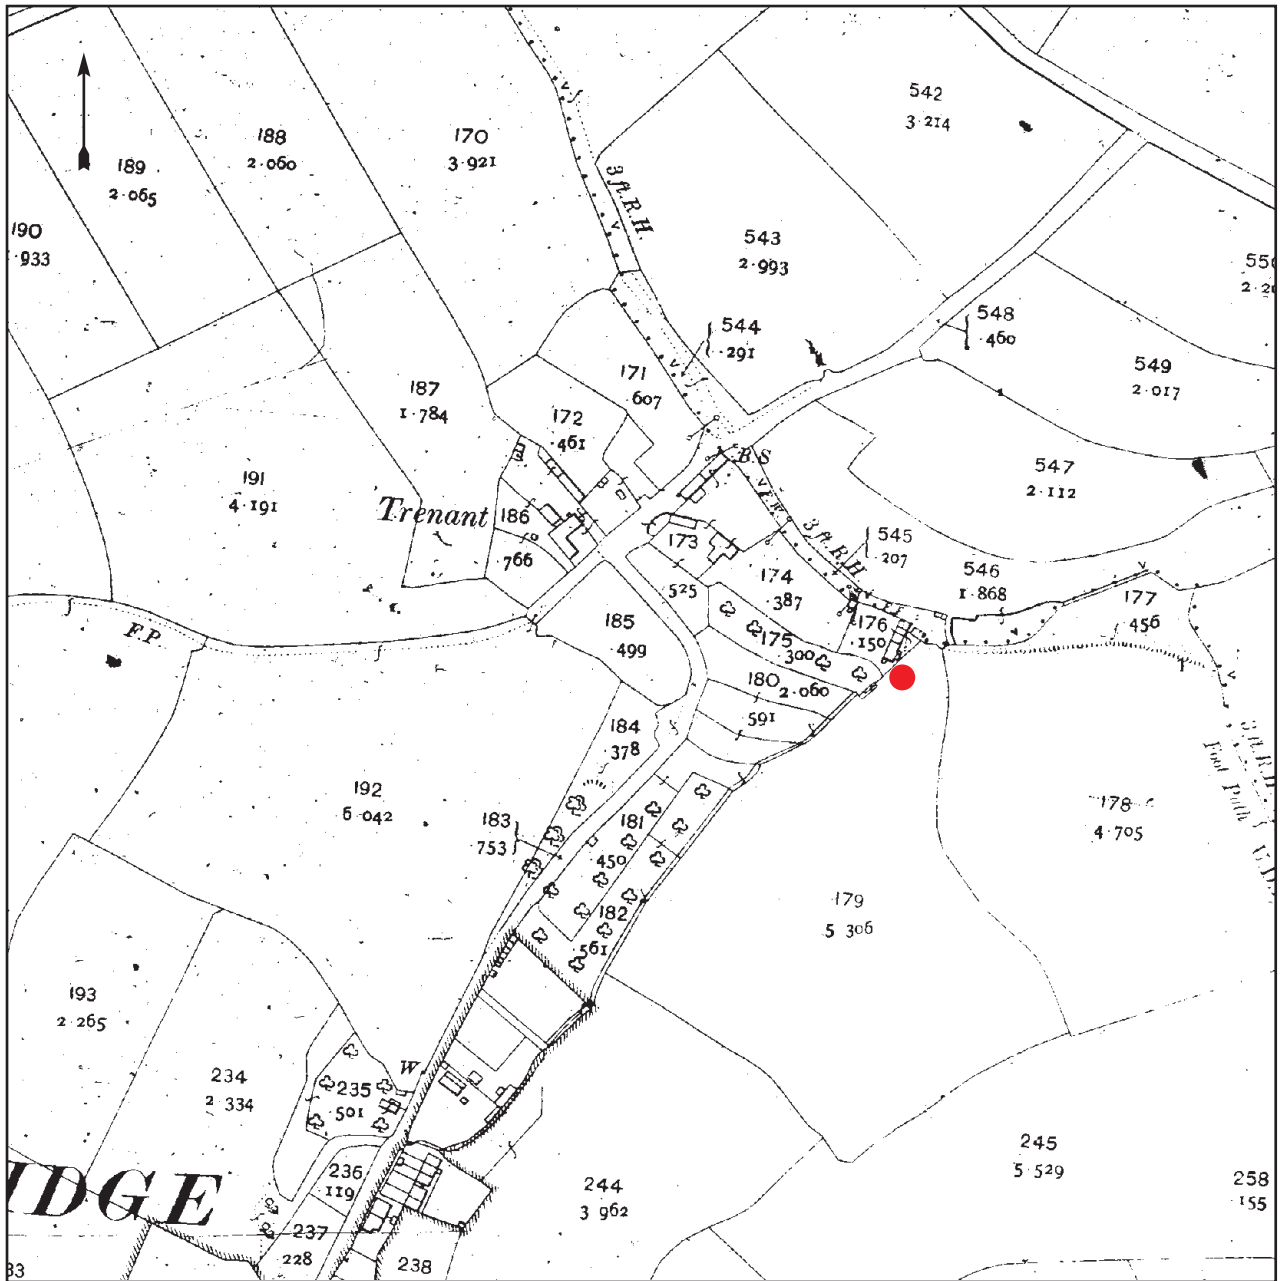
Fig.5 The Second Edition Ordnance Survey map, 1907 (scale 1:2500)

- 4.12 The Ordnance Survey Second Edition map, revised in 1906 and published in 1907 (**Fig.5**; scale 1:2500), again shows the probable mill-pond but the site of the waterwheel pit is devoid of buildings or structures. Similarly the map used for the Land Utilisation Survey of Britain dated 1946 (scale 1:63360) does not show a building in this location.

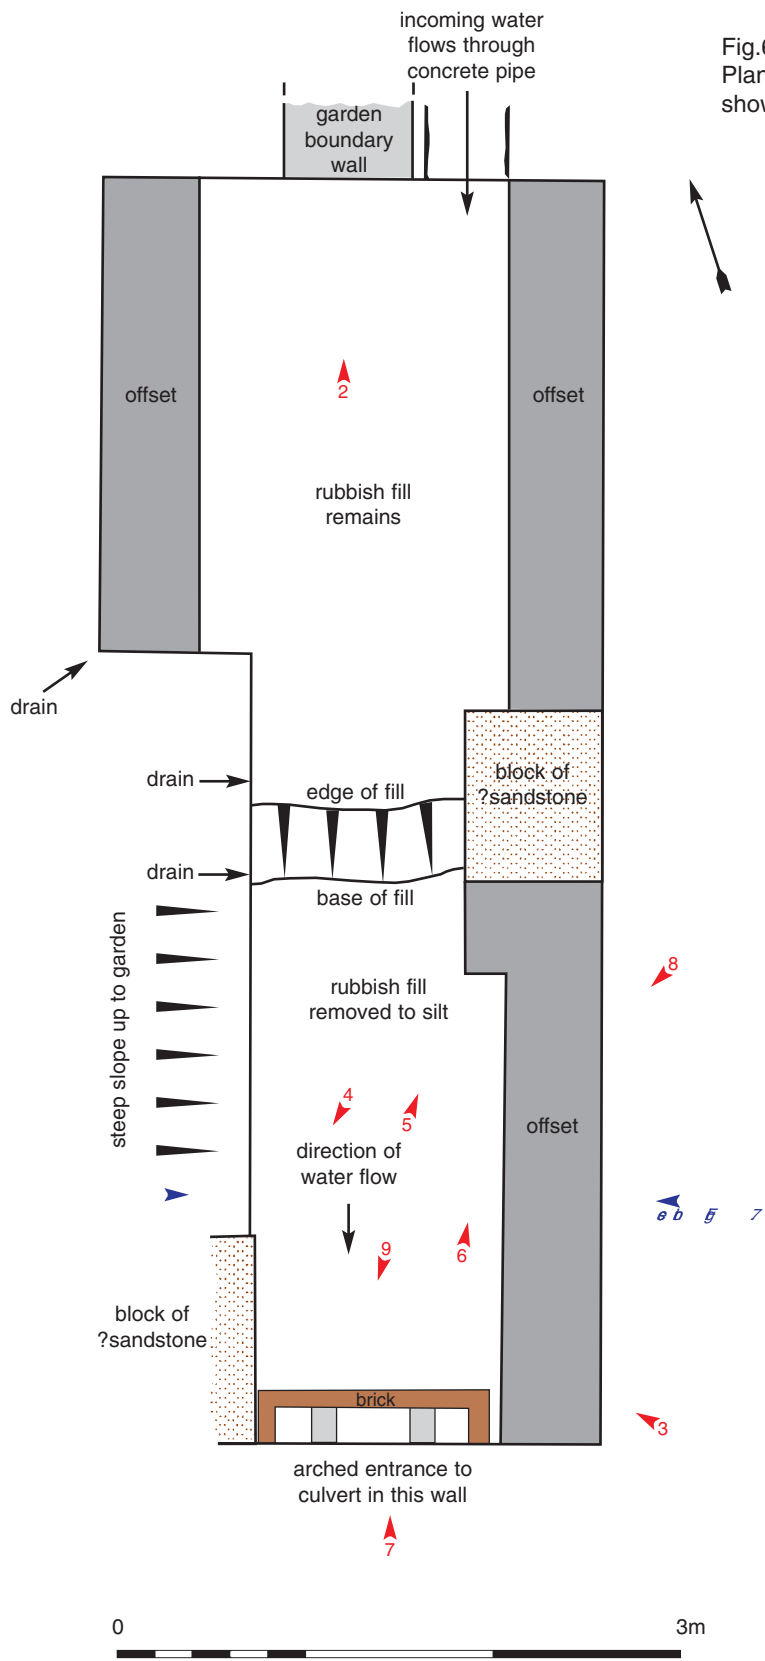
Fig.6
Plan of the waterwheel pit, scale 1:40,
showing the location and direction of Plates 2-9

- 5.4 The structure is 1.85m wide at its south-west end and 6.8m long (**Fig.6**). Its east wall is straight over its entire length (**Plate 5**) while, at a distance of 4.2m from its south-west end, the west wall is set back by 0.8m, so that the north-east end of the structure is 2.65m wide. Along the length of its east side and at a depth of 0.8m from the present top of the structure, is an offset 0.5m wide at its south-west and north-east ends, widening to 0.7m for a length of 1.4m at the centre of the east side (**Plates 5 & 6**). Here part of the offset is finished with a squared block of fine-grained stone, probably sandstone, 0.9m long and about 0.25m thick. At the northern end of the west side of the pit, where it widens, there is a similar offset also 0.5m wide along the remainder of that side.

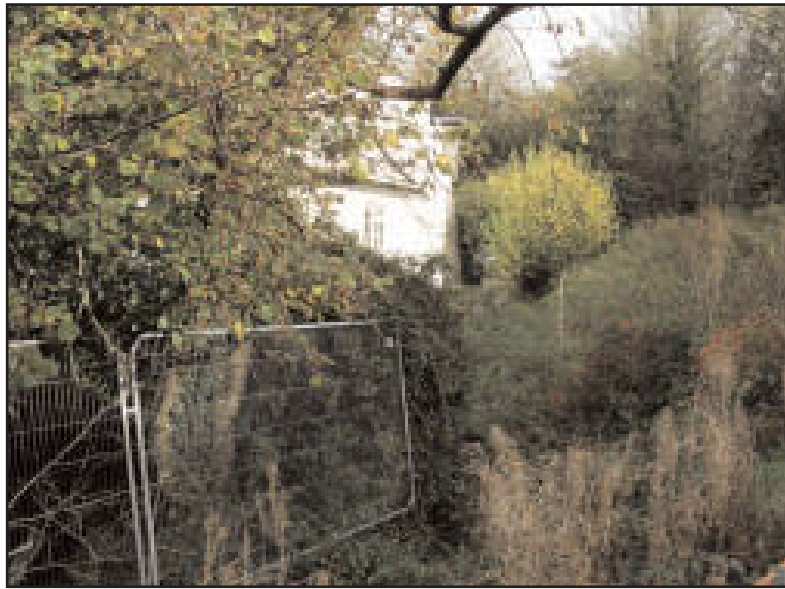
- 5.1 The waterwheel pit is located in an area of undergrowth, rough grass and trees (**Cover & Plate 1**). To the east the side of the valley rises quite steeply away from the pit while to the west the ground rises immediately from the edge of the pit by about 1.7 metres (m) to the level of the adjoining garden. There are three trees, each with a trunk diameter of about 0.6m, growing hard against the structure – two to the east and one to the west. The backfill of modern rubbish has been removed from the southern end of the pit while a substantial amount of fill comprising car tyres, rubble and other rubbish remains at the northern end. The pit is protected by wire mesh Heras fencing panels.

Plate 1 The waterwheel pit is behind the wire Heras fencing on the left, looking north-east

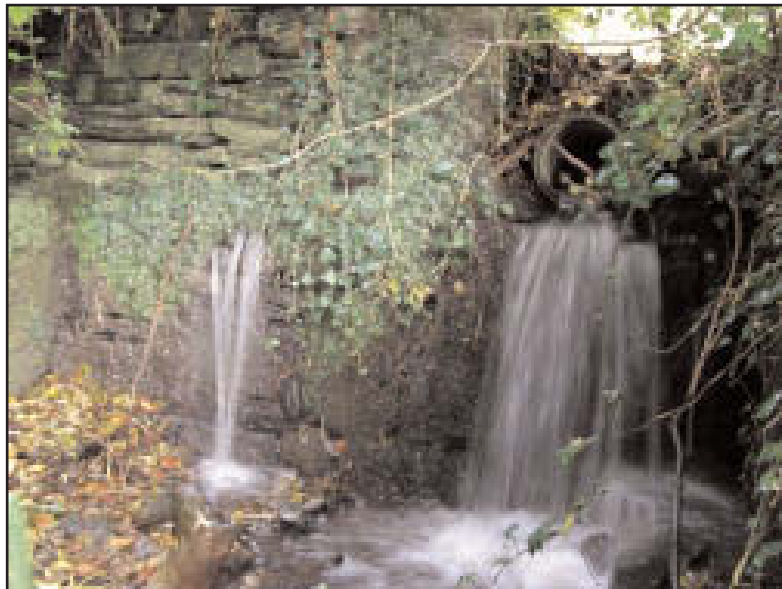
- 5.2 At present the stream flows into the pit through a short length of concrete pipe over the top of the wall at its north-east end (**Plate 2**) (and also through gaps between the masonry in that wall) and exits the pit through a stone-built culvert at the base of its south-west wall. At the time of the survey, after a period of heavy rain and during heavy showers, there was a considerable flow of water through the structure. Consequently all recording had to be carried out from the top of the pit.

Plate 2 The north-east end of the waterwheel pit, showing water entering through a concrete pipe, top right, looking north-east

- 6.5 This work will involve the casting of a new open channel through the pit's north-east wall which, as well as improving the flow of water, will prevent the wall from being further damaged by water flowing over and through it from around the existing concrete inlet pipe. The remaining flood prevention work will take place within the pit, leaving the structure of the pit intact. The pit is to be fenced but the writer has been informed that the fence posts will be placed well back from the structure to avoid damage.

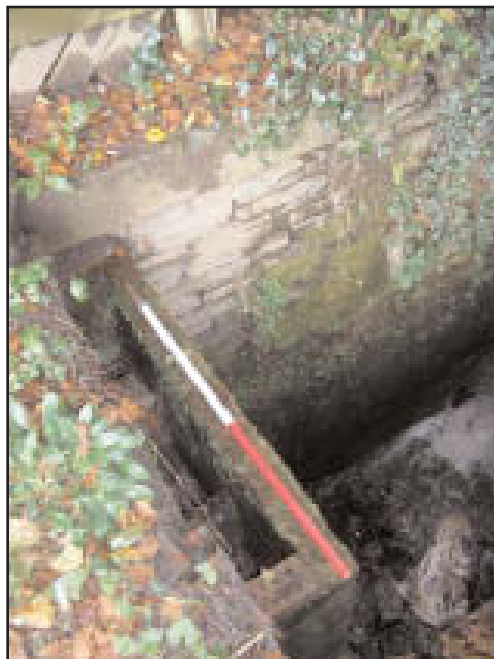
- 5.3 The structure is built of coursed slate (**Plate 3**) unless otherwise stated and this takes the form of a retaining wall or, in places, an offset wall, on its four sides, although the thickness of this retaining wall could not be determined. Where the modern fill has been removed from the pit it can be seen that at a depth of 1.7m on its west side the retaining wall has been built on top of the natural bedrock which is then exposed to the top of the silt at the base of the pit (**Plate 4**).

- 5.6 At the south-west end of the west wall of the pit, and slightly overhanging it, is a large block of squared fine-grained stone, presumably sandstone, 1.10m long by 0.25m thick (**Plates 3 & 8**).

Plate 3 The south-west corner of the waterwheel pit showing coursed slate in the west wall, a squared sandstone block on the top of the wall and the brick and stone structure projecting from the end wall, looking west (scale 1m)

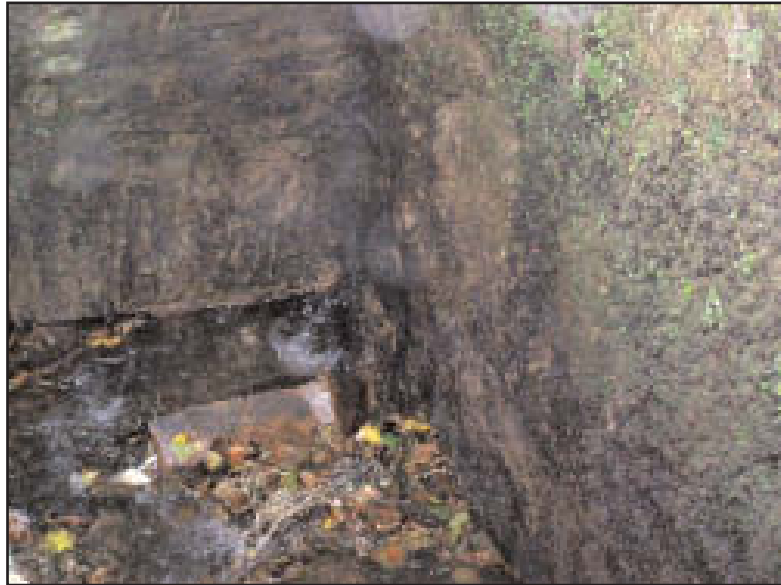
Plate 4 The south-west corner of the waterwheel pit showing the exposed natural bedrock forming the lower part of the west side of the pit, looking south-west

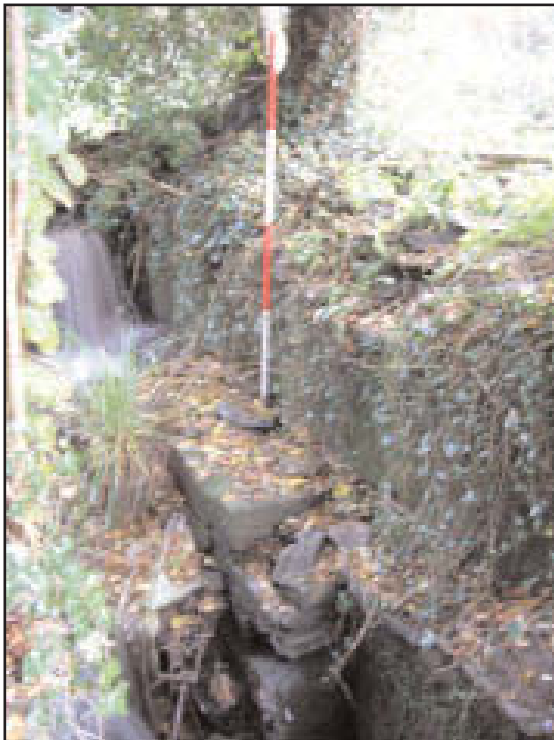
Plate 5 The east side of the waterwheel pit showing the east wall and offset, looking north-east (scale 2m)

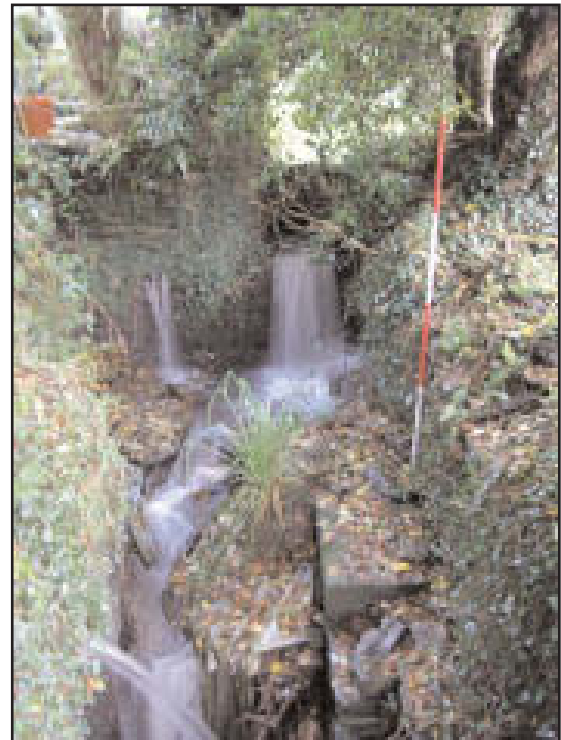
- 5.8 There is no evidence for a bearing or other attachment for the axle of the waterwheel. However, the large squared block of stone on the offset halfway down the east side of the pit

may have been the support for such a bearing. Photographs in Benney (1972, e.g. 51, 58-60) show these bearings were often raised above the level of the top of the waterwheel pit.

Plate 6 A view along the length of the waterwheel pit showing the offset on the east side with the squared block of sandstone (in front of the base of the ranging pole) on top of the offset, looking north-east (scale 2m)

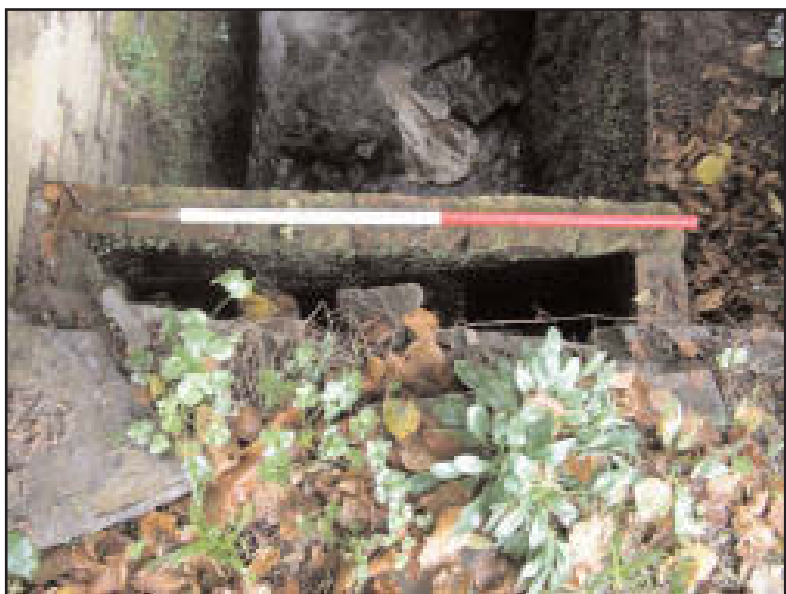
- 5.5 At the south-west end of the pit, and almost level with its top, is a projecting structure 1.23m wide built of five courses of brick 0.1m wide resting on three courses of squared stone (**Plates 3 & 7**). This structure projects 0.3m from the end of the pit and between it and the end of the pit is a gap 0.2m wide divided into three sections by further stones. This brick and stone structure only extends 0.9m down from the top of the pit and it is not clear how it is supported, but probably in a cantilever fashion by stones projecting from the end wall of the pit (**Plate 8**). The purpose of this structure is not known but it appears to form some sort of weir over which water could pass and be directed down the end wall of the pit. It may be a later addition.

Plate 7 The brick and stone structure at the south-west end of the waterwheel pit, looking north-east (scale 1m)

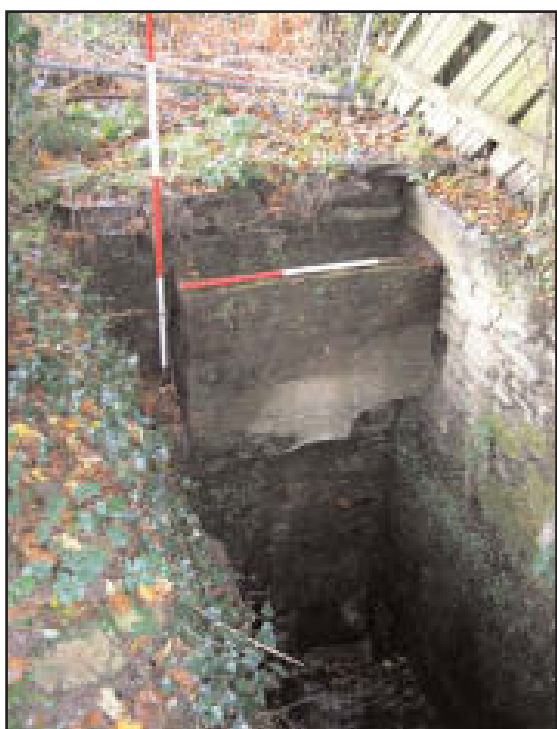
Plate 8 The brick and stone structure, looking south-west (scales 2m and 1m).

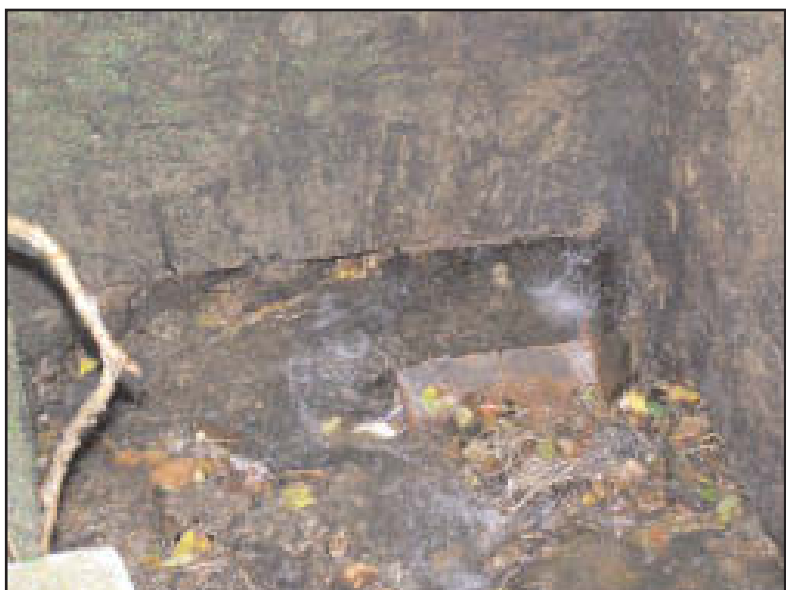
- 5.7 At its south-west end the pit is at least 3.4m deep (**Fig.7**). However, this measurement is to the top of what appears to be a deposit of silt rather than the actual base of the pit. Water flows out of the pit through a stone-built arch in its south-west end directly into a culvert – the tail race of the mill – which presumably emerges further down the valley, although this was not pursued (**Plate 9**).

Plate 9 The stone-arched entrance to the culvert in the south-west end wall of the waterwheel pit, looking south-west

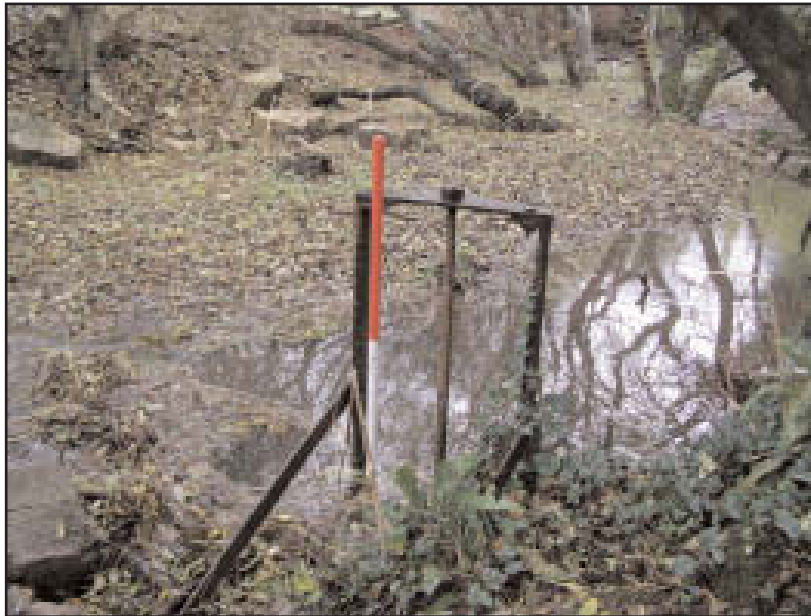
- 5.11 Although not included in the Brief the opportunity was taken to photograph the remains of the iron sluice gate on the mill-pond (**Plate 10**) to the north-east of the waterwheel pit and the silted remains of the mill-pond itself (**Plate 11**). The waterwheel pit is sufficiently further, and lower, down the valley from the mill-pond that the water could have been fed to the mill via a raised wooden launder giving an overshot wheel arrangement as opposed to a breastshot wheel as would appear to be the case from the way the water currently enters the pit.

Plate 10 The sluice gate on the west end of the millpond, looking north-east
(scale 1m)

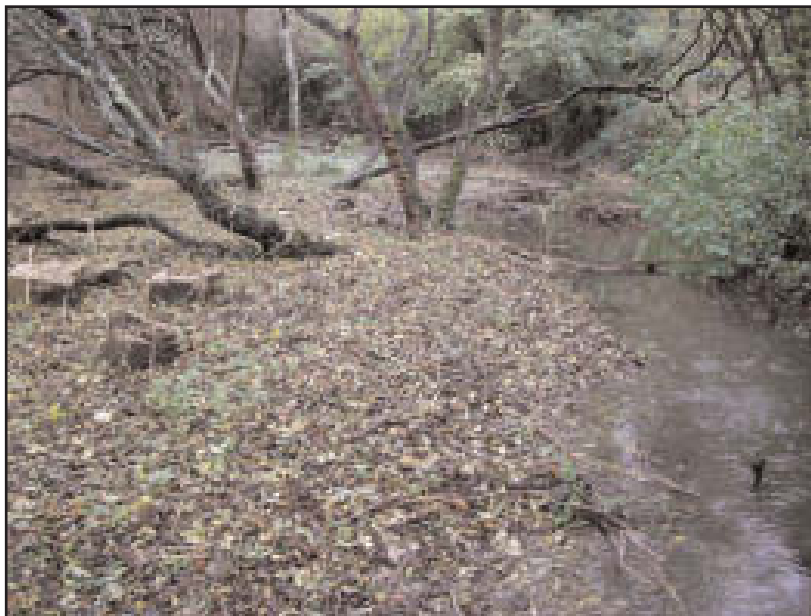
Plate 11 The silted up remains of the millpond, looking east
