Archaeological Watching Brief
at
THE FORMER WAGGON & HORSES PUBLIC HOUSE,
STAPLETON ROAD, BRISTOL.
for
Elim Housing Association

Report No. 2378/2010
BHER No. 24831

Archaeological Watching Brief
at
**THE FORMER WAGGON & HORSES PUBLIC HOUSE,
STAPLETON ROAD, BRISTOL**

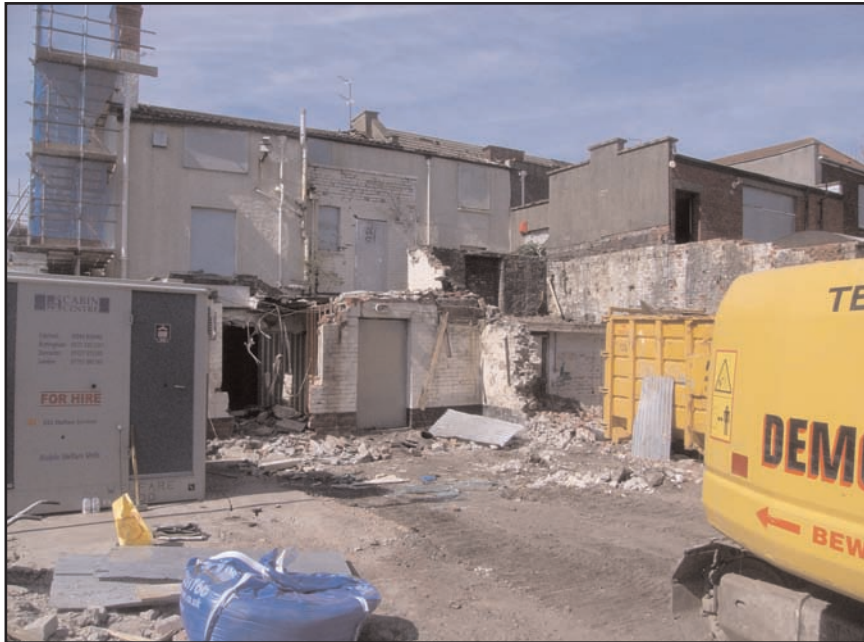
Plate 1
General view of the rear
of the Waggon & Horses
Public House during
demolition, looking north

- 5.2 Initially, the demolition of the former Waggon and Horses Public House was monitored, principally to examine the structure of the cellars and determine the existence of other possible subterranean structures, including further cellars.

- 5.3 During these works two cellars were located, the interior of the larger one of these was recorded in detail during the *Archaeological Building Survey of The Former Waggon & Horses Public House*, BaRAS 2009. Demolition of the second, smaller, cellar was not monitored.

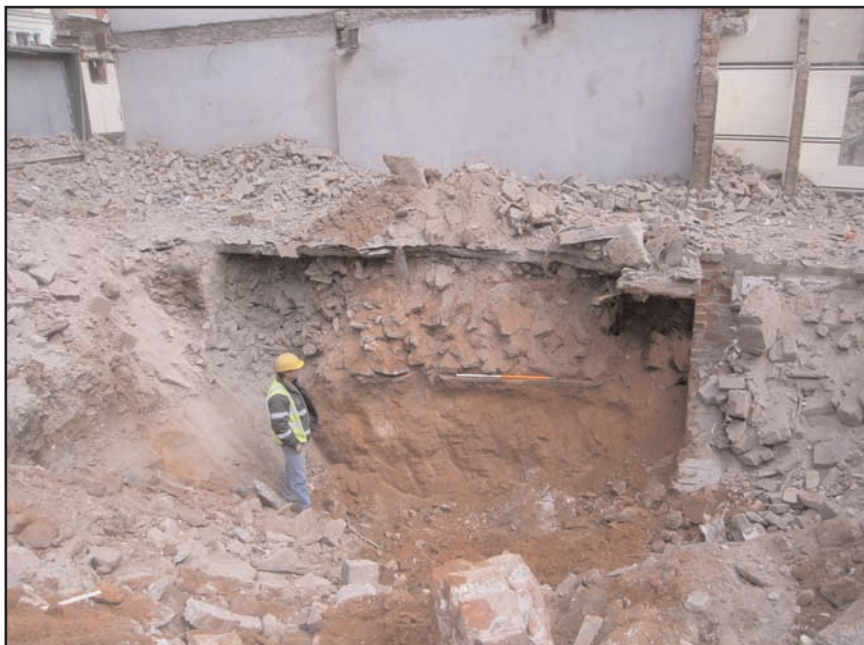
Plate 2
Detail of the main cellar
during demolition, also
shows the original floor
level outside the cellar
area and the cellar back-
wall continuing to the
north-east, 1m scale

- 5.4 Further details of the main cellar were noted during the work, principally that the northwest wall was of different construction and represented an earlier phase of construction to the main brick built portion. This was further borne out by the fact that the wall (north-west wall) extended to the north-east beyond the later north-east wall (Wall 128) of the cellar as far as the adjoining property boundary.

- 5.5 Behind Wall 128 an earlier floor of Pennant slabs was recorded at a level that suggested its association with the blocked up openings in the property boundary wall (openings 115 and 116 below) as recorded in the building survey (BaRAS *ibid*). A fragment of brick wall (Wall 127) represented a possible intermediate phase of construction between the Pennant floor and new cellar, this had been built over the Pennant floor but was sealed behind the cellar wall and would have been parallel with the cellar's north-west side wall.

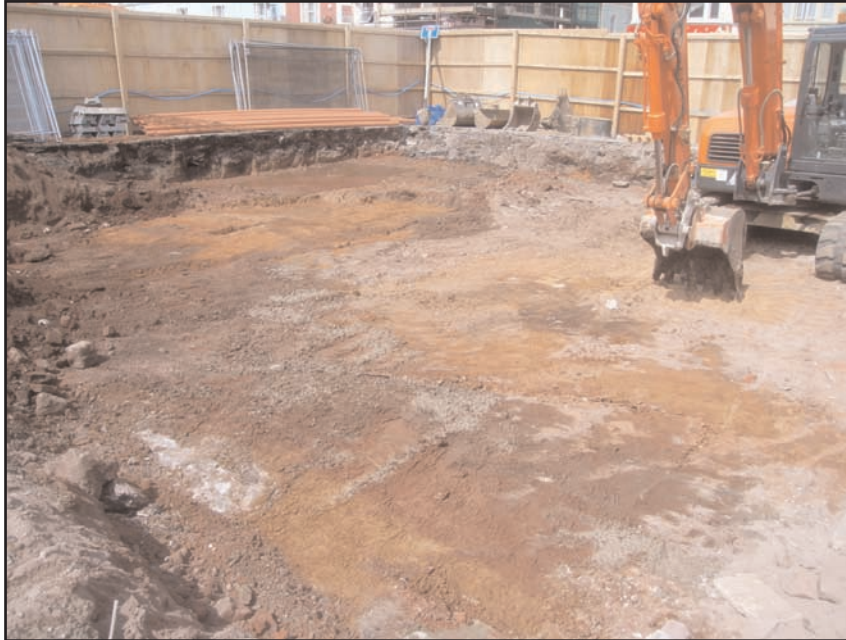
Plate 4
Reduced level
excavation of the western
side of site, prior to
foundation excavation,
looking west

- 5.7 The groundworks for the new residential properties comprised the excavation of standard strip foundations. Additionally, on the western side of the site the ground level was reduced across the area prior to the trench excavation.
- 5.8 The trenches were excavated to a maximum depth of 2m, those excavated in the area of reduced level excavation in the west of the site reached *c* 1.9m depth; 1m of this was excavated from the base of the reduced level.
- 5.9 A number of structures were recorded during the excavation of the foundation trenches. Additionally, the demolition exposed limited evidence of phases of alterations to the fabric of the building, in the north-east boundary wall.

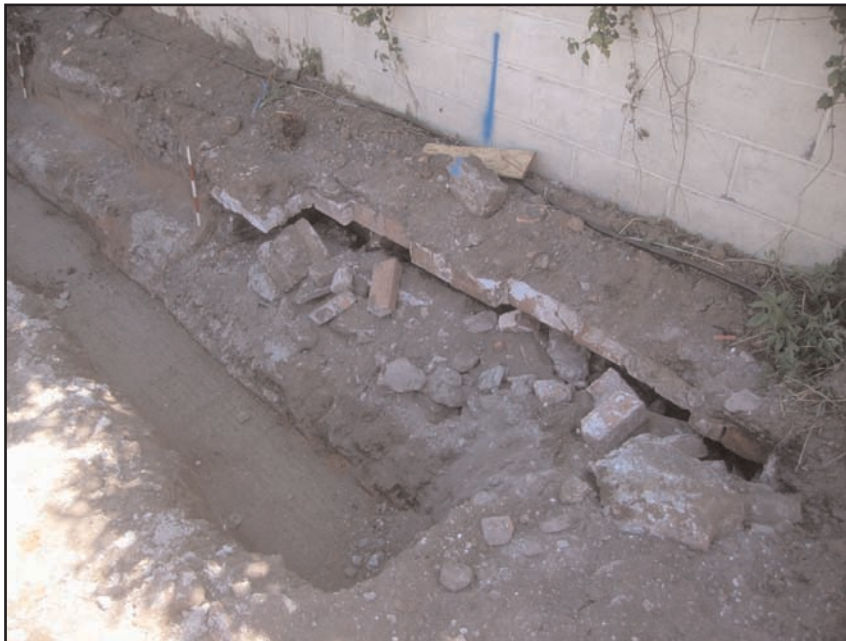
Plate 5
Septic tank, structure 117
truncated by foundation
trench 101, looking east,
0.5m scale

- 5.13 Trench (101) was excavated through a rectangular structure in the south-west corner of the site. The structure had drystone walls of random sized but generally thin sandstone rubble and a barrel-vaulted roof of bricks, bonded with white lime mortar. The walls were quite narrow, at approximately 250mm wide, the structure itself was about 3.3m long and 1.9m high. No floor to the structure was visible but the base was largely obscured by fallen rubble.

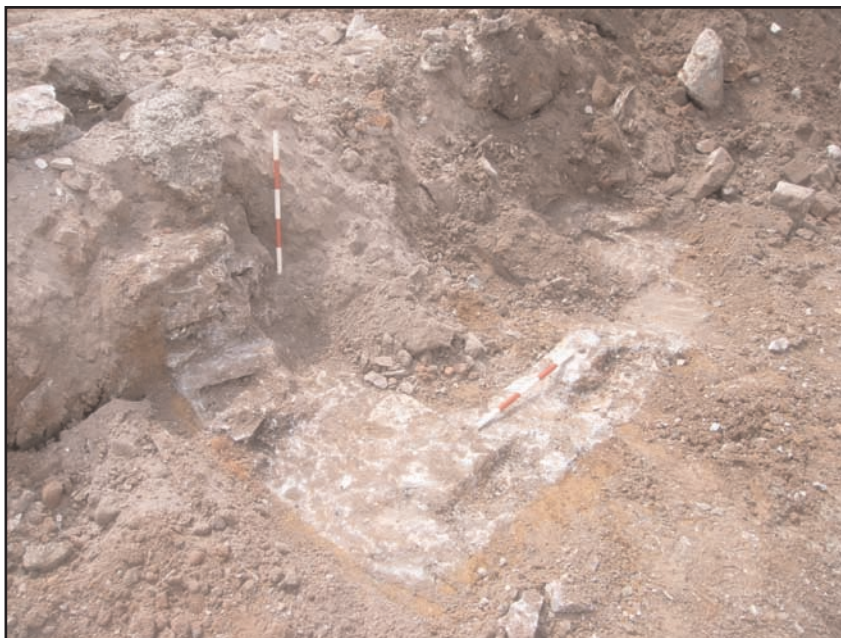
Plate 6
The north-west end of
the barrel roll as
exposed, looking south,
0.5m scales

- 5.14 Parts of a linear, subterranean structure were located, orientated from north-west to south-east across the site over a distance of 19.5m. The structure comprised two parallel walls and a barrel vaulted roof – none of the floor of the feature was observed during the works.

- 5.15 The walls varied in thickness from between 300 and 530mm and had rendered inner faces. Both comprised unworked, uncoursed sandstone rubble bonded with pale grey lime mortar with occasional lime and charcoal flecking. The space between the two walls averaged 1m wide but expanded to 1.2m wide at the north-west end. The base of the structure sloped downwards from the south-east to the north-west and was said to increase in depth from about 400mm to approximately 1.5m. At least one drain had been inserted into the northern side wall of the structure to allow drainage of ground water.

- 5.16 The structure is suggested to have been utilised to roll barrels of beer from the brewery at the rear of the premises to the public house at the front, possibly directly into the beer cellar, though no entrance or exit to or from the tunnel was identified.

- 6.3 It should be noted that although Structure 118 was interpreted as a barrel roll, or a tunnel for moving barrels from the brewery to the pub, no precedent could be found by the author for a structure of this type. Further, no evidence of the method of access or egress to the structure could be identified and it was could not be seen to connect with either of the cellars identified beneath the pub. Other possible uses include storage, although the size and shape of the structure make this an unusual, if not unlikely, design. A drain had been inserted into the northern side wall of the which was, therefore, clearly not designed to retain water.
