Archaeological Building Recording  
at  
**MICAWBER'S PUBLIC HOUSE,  
NO. 24 ST. MICHAEL'S HILL, BRISTOL.**  
for  
Punch Group (Retail Properties)

Report No. 2253/2010  
BHER No. 24835

Archaeological Building Recording  
at  
**MICAWBER'S PUBLIC HOUSE,  
NO. 24 ST. MICHAEL'S HILL, BRISTOL.**

<i>Author:</i>	Andrew Townsend
<i>Approved by:</i>	Bruce Williams
<i>Signature:</i>

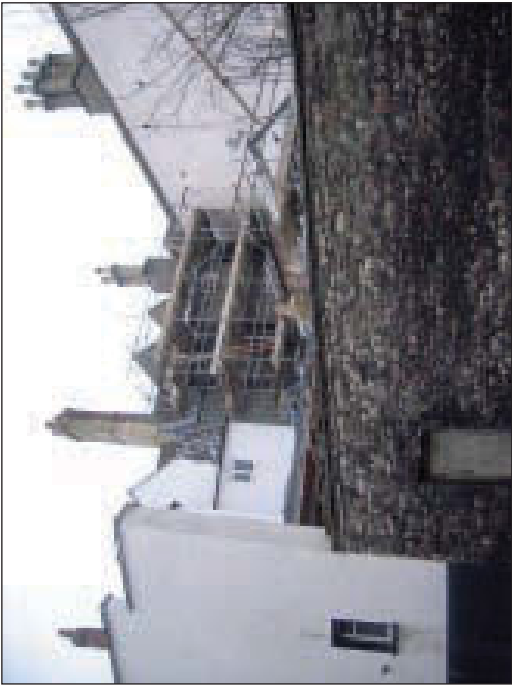
- 4.1 The building's main-roof structure (fronting St Michael's Hill) essentially comprised a collared roof incorporating an attic storey, with two dormer windows on each side, and a mono-pitched roof above a stairwell at the rear (north-east side) (**Fig. 2, Plate 1 & Cover Plate**).

Plate 1 General view of rear (north-east) elevation of the premises, from the east

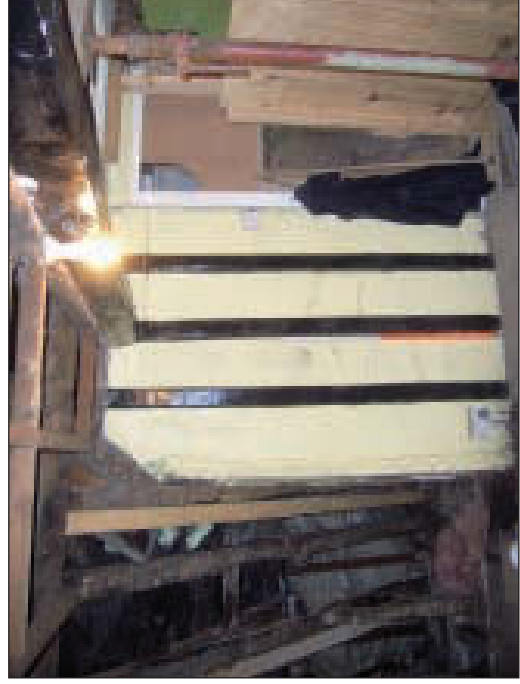
- 4.5 It appears that the attic storey was originally divided by a north-east/south-west stud partition, although this was not extant when the building-recording was undertaken. The stud partition separating the attic storey from the stairwell was extant (**Plate 6**).

- 4.8 The stud partition, of unknown date, separating the attic storey from the stairwell appeared to comprise vertical studwork probably infilled with plaster-and-lathe (**Plate 6**).

Plate 6 General view of partition separating attic storey from stairwell, from the south-west

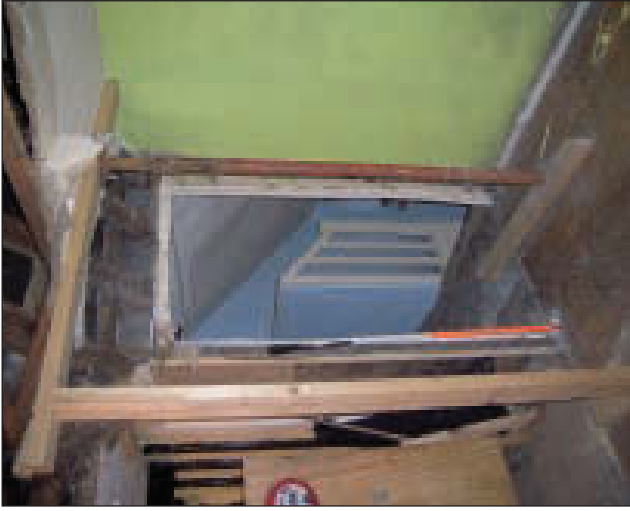
- 4.7 A short length of timber comprising a head over the doorway to the stairwell and valley between the north-west and south-east dormers on the north-east side of the building, was designated for replacement (**Plates 7 & 17**).

Plate 7 General view of door opening leading from attic storey to stairwell, from the south

- 4.2 The recording was undertaken in relation to two elements:
- (i) Attic roof-space (**Fig. 2[B]**);
  - (ii) Attic storey (**Fig. 2[C]**).
- 4.3 At the time the recording was undertaken, it was proposed only to remove a single length of extant timber, that forming the head of a doorway (**Plate 17**) leading to the stairwell at the rear of the building (**Plate 7**).

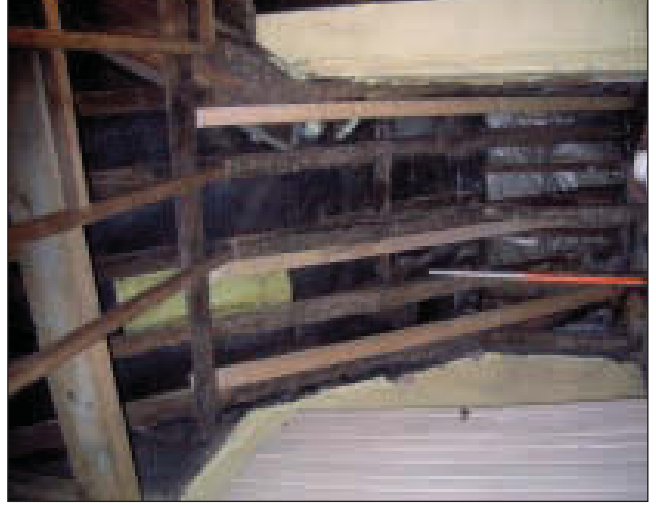
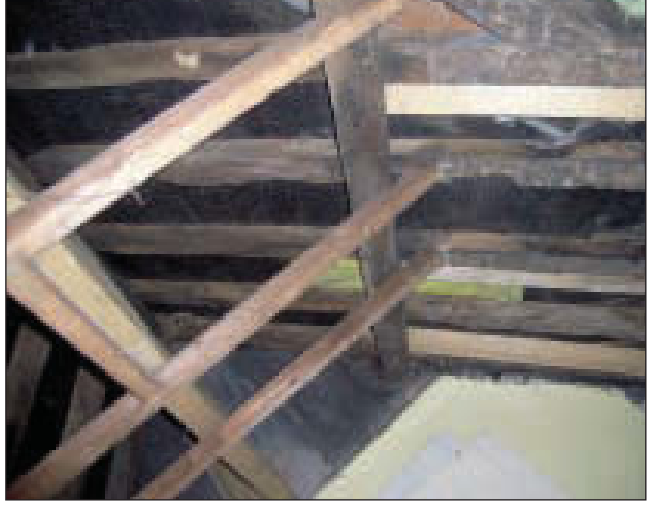
- 4.6 Three areas of exposed structural timbers were observed in the attic storey:
- (i) Structural timbers, incorporating new elements, associated with the north-west portion of the pitched roof on the north-east side of the building (**Plates 11-13**); the exposed rafters (n=5) appeared to have been sprocketed (**Plate 13**); a timber wall-plate was also visible at eaves level (**Plate 13**);

Plate 11 General view of lower (eaves) end of exposed structural timbers forming part of the main pitched-roof on the north-east side of the building, from the south-west

Plate 12 General view of upper (ridge) end of exposed structural timbers forming part of the main pitched-roof on the north-east side of the building, from the south-east

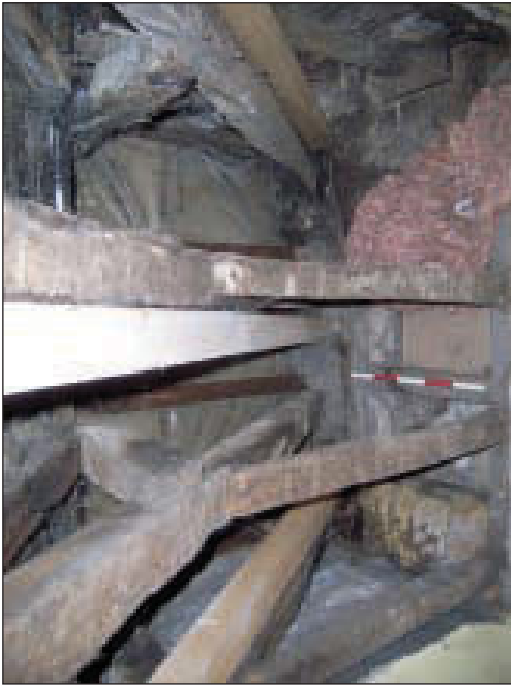
Plate 13 Detail view of lower (eaves) end of exposed structural timbers forming part of the main pitched-roof on the north-east side of the building, from the south-west

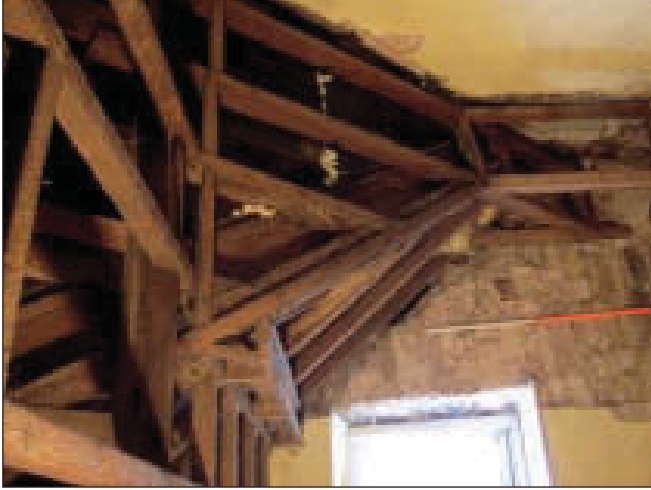
- (ii) Structural timbers associated with the valley of the north-west dormer and main pitched-roof of the south-west side of the building (**Plate 14**);

Plate 14 General view of exposed structural timbers to main pitched roof and north-west dormer on south-west side of building, from the north-east

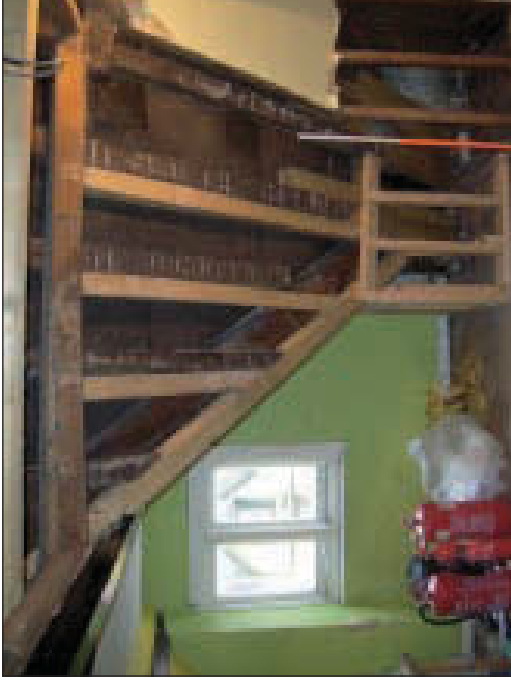
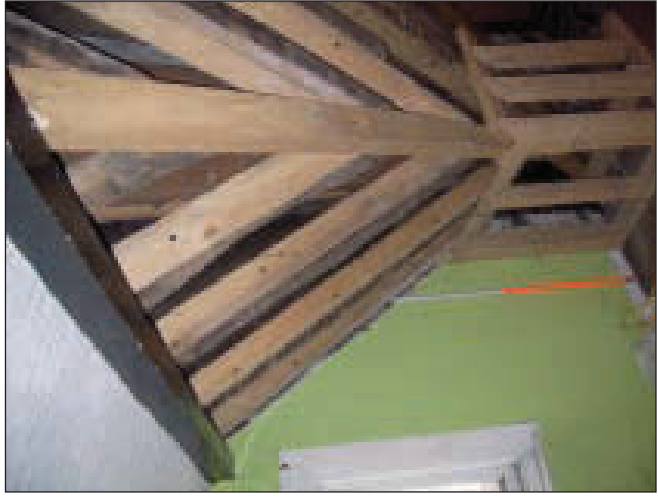
- (iii) Structural timbers, including new elements, associated with the south-east dormer and main pitched-roof on the south-west side of the building (**Plates 15 & 16**).

Plate 15 General view of exposed structural timbers to main pitched roof and south-east dormer on south-west side of building, from the north-east

Plate 16 Detail view of exposed structural timbers to main pitched roof and south-east dormer on south-west side of building, from the north-east

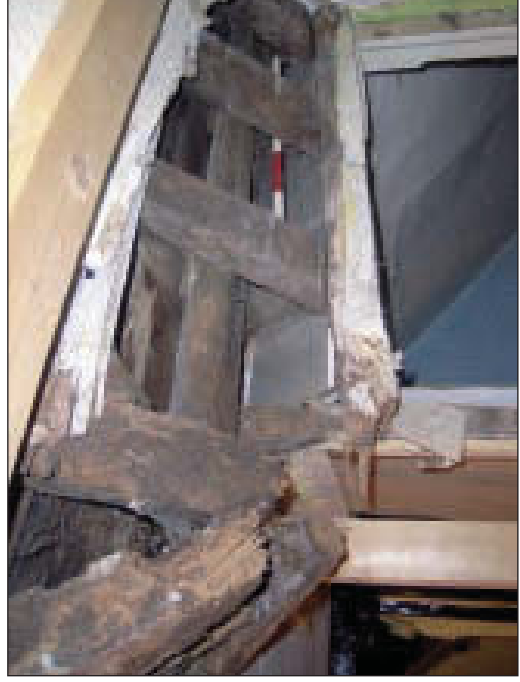
Plate 17 Detail view of timber element to be replaced above door opening leading from attic storey to stairwell, from the south-east

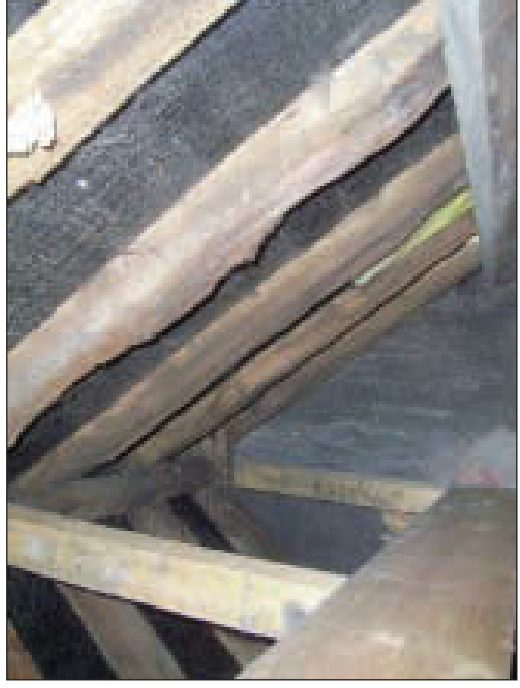
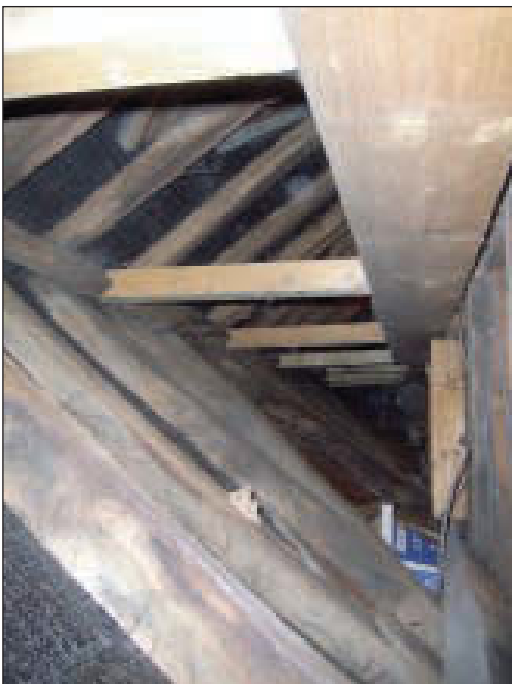
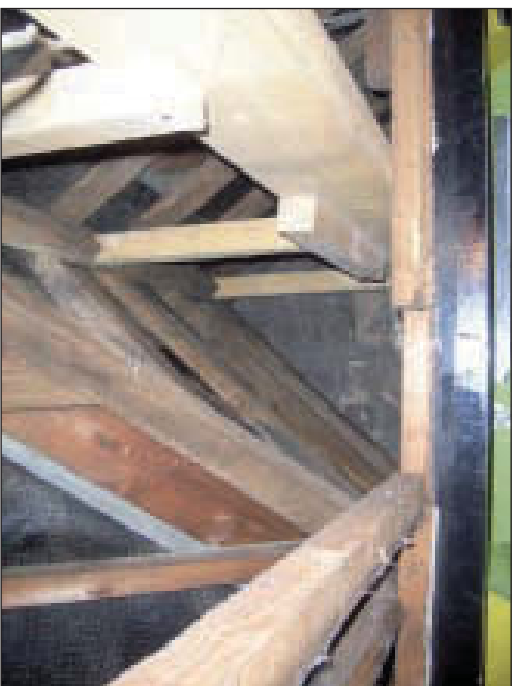
- 4.9 Four areas of structural timbers were observed in the attic roof-space:
- (i) Structural timbers, incorporating new elements, comprising the north-west/south-east pitched roof (**Plates 18, 23 & 24**);
  - (ii) Structural timbers comprising the north-west dormer on the north-east side of the building (**Plate 19**);
  - (iii) Structural timbers comprising the north-west dormer on the south-west side of the building (**Plate 20**);
  - (iv) Structural timbers comprising the south-east dormer on the north-east side of the building (**Plates 21 & 22**).
- 4.10 A vertical timber-strut on the north-east side of the building forming part of the north-west/south-east pitched roof incorporated what appeared to be carpenter's marks (**Plate 25**) (cf. Brunskill 1985, Fig. 47).

Plate 18 General view across attic space looking towards north-west gable of building, from the south-east

Plate 24 General view across attic space looking towards south-east gable of building, from the north-west

Plate 23 General view across attic space looking towards south-east gable of building, from the north-west

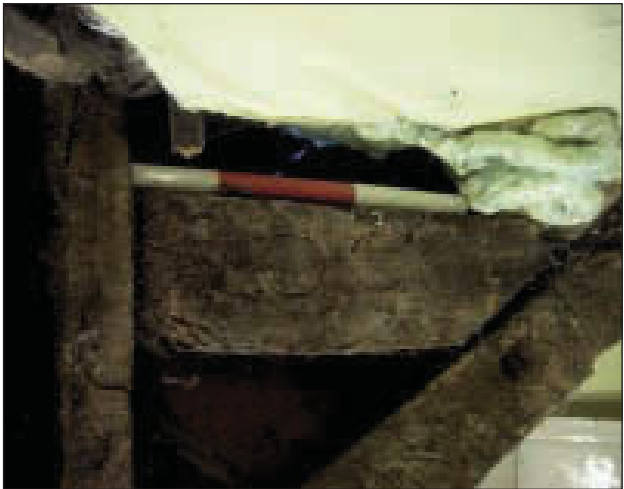
Plate 25 Detail view of structural timber incorporating carpenter's marks on north-east side of building, from the south-east

- 5.1 The extant main-roof at 24 St Michael's Hill, where this was exposed, incorporates structural timbers of various dates, many of which are of some age, and also new timbers resulting from recent remedial work. It was not, however, possible to establish if some of the older timbers comprised a part of the original late-17th-century roof structure of the building.
- 5.2 The areas of exposed timbers revealed that the roof structure had been considerably altered over time, incorporating structural timbers of various ages, a significant number of which probably date to the 19th and 20th centuries. It is possible that some of the older timbers comprise elements removed from other buildings and reused in the present roof-structure. Carpenter's marks were observed on one of the timbers, although this feature is thought likely to have comprised an off-cut from a larger roof timber.
