Archaeological Watching Brief
at
**THE TITHE BARN,
ST. MARY'S GROVE, NAILSEA,
NORTH SOMERSET.**
for
Nailsea Town Council

Report No. 2245/2010
NSHER No. 47504

Archaeological Watching Brief
at
**THE TITHE BARN,
ST. MARY'S GROVE, NAILSEA,
NORTH SOMERSET.**

Centred on
N.G.R. ST 4659 6990

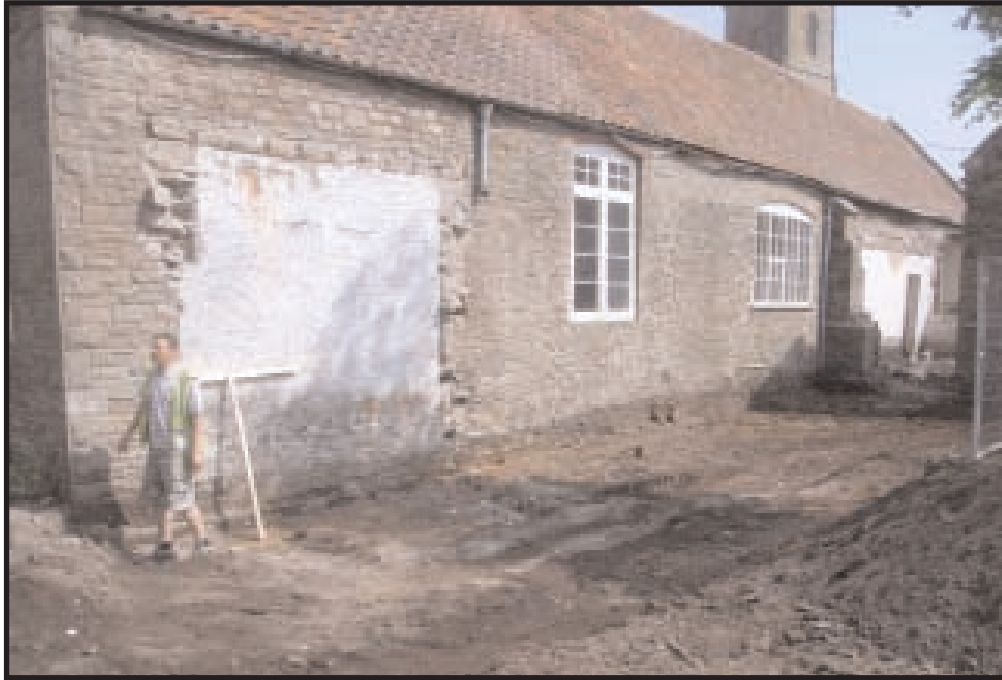
- Cover The footprint of the extension as stripped with the barn in background
- Plate 1 Structure 101 as initially exposed, looking east, 1m scale
- Plate 2 General view of the reduced level excavation with the footings of the demolished outbuilding and a modern ceramic service pipe in foreground, looking ENE

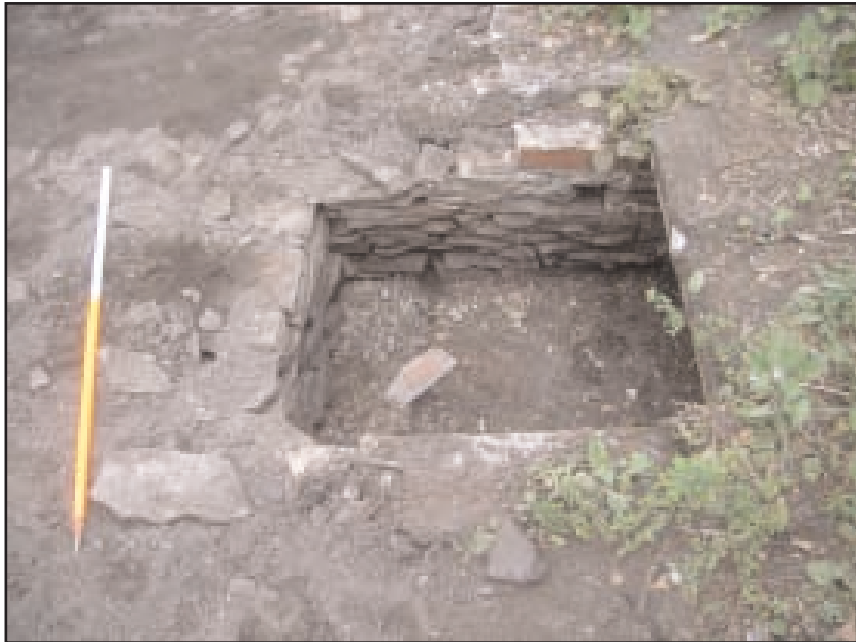
Plate 1
Structure 101 as initially
exposed, looking east,
1m scale

Part of a structure and a probable wall were located. The structure (101) was rectangular and of predominately drystone masonry topped off with a single course of bricks (with a mortar bond) and covered with Pennant slabs. A small concrete catchment pad with iron grill appeared to drain into the structure, which was apparently a sump for that drain.

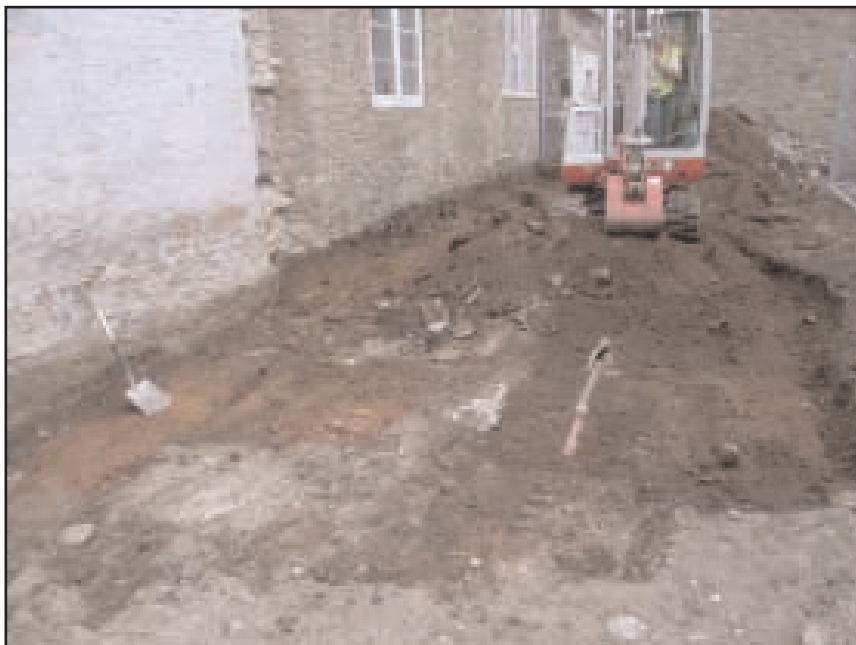
Plate 2
General view of the
reduced level excavation
with the footings of the
demolished outbuilding
and a modern ceramic
service pipe in fore-
ground, looking ENE

- 5.2 The footprint of the extension to the existing building was reduced in level from between 200mm and 500mm depth. A simple stratigraphy of topsoil, a patchy subsoil and finally weathered sandstone and sand was recorded over the majority of the footprint.

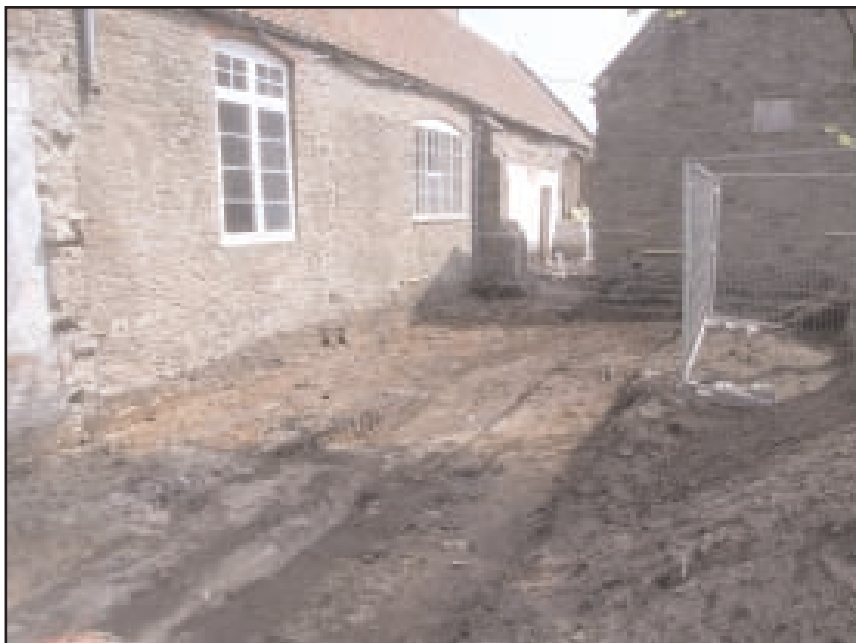
Plate 3
General view of the
reduced level excavation,
looking ENE

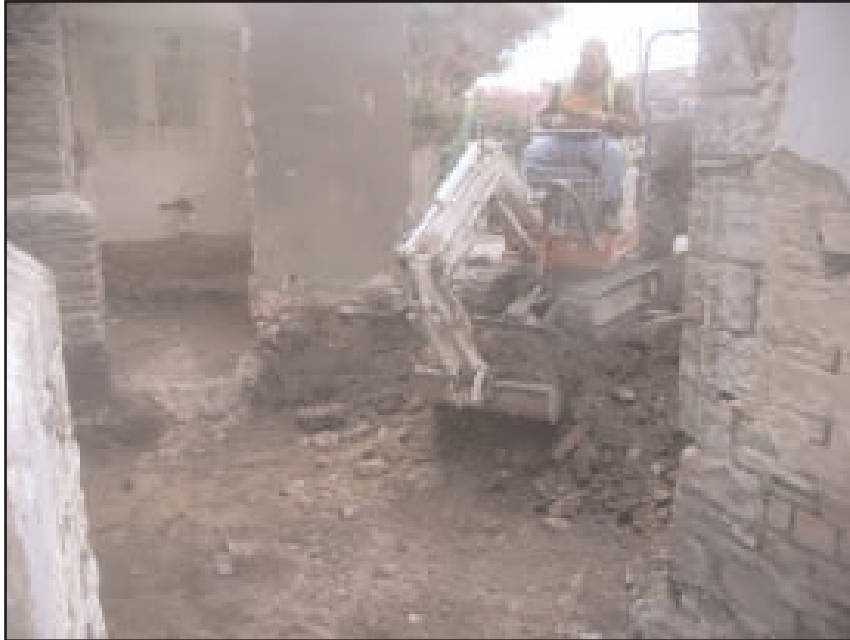
Plate 4
General view of the
reduced level excavation
between Rooms G1 and
G3, looking SSE

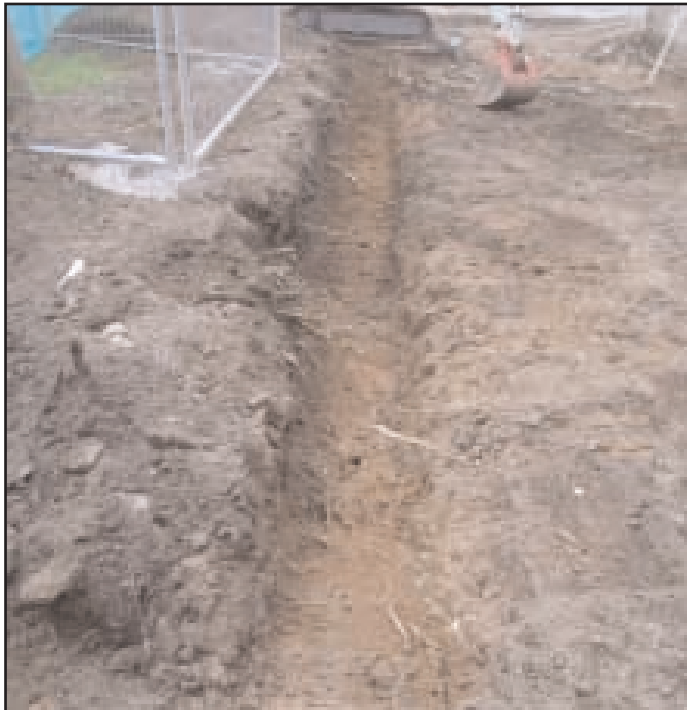
Plate 5
General view of foundation
trench excavation for the
extension, looking west

- 5.3 The footings for the extension comprised standard strip foundations approximately 500mm wide and up to 300mm deep. The wall observed was one of two that represented a probable structure of two parallel walls (102 & 103) that had been truncated at the east end by the Edwardian school building. The space between the two walls, which was approximately 2.2m wide, was filled with a soft, dark soil deposit, while the walls were cut into the surrounding weathered sandstone. The central space between the two walls was not further excavated and the purpose of the possible structure remains uncertain.

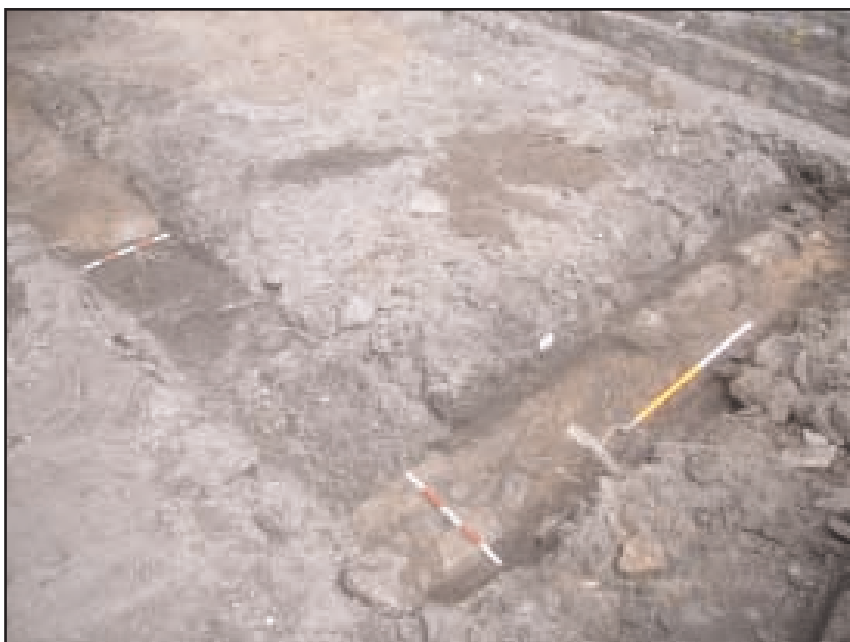
Plate 6
Walls 102 and 103 and
central fill (113) between
them, looking north-east,
scales 0.5m and 1m

- 6.3 During the groundworks outside the barn, two parallel walls were exposed in the footprint of the extension (walls 102 and 103). These are thought to represent part of a structure predating the later Edwardian school building and therefore the use of the site as a school, though they are not believed to be of medieval date. A drainage sump nearby appeared to be of later post-medieval or modern date, possibly to drain surface water from the adjacent playground.

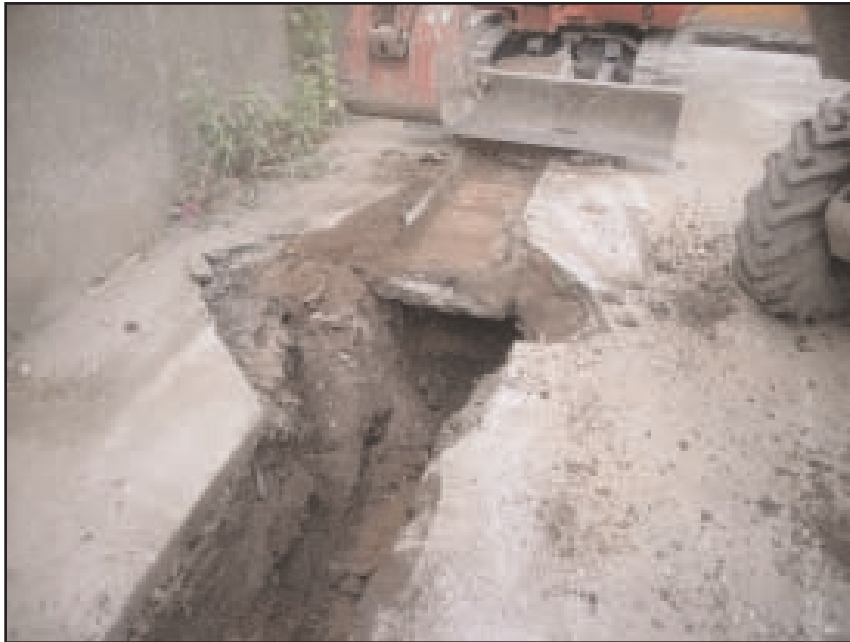
Plate 7
General view of service
trench excavation
adjacent to Rooms G16
– G18, looking north

- 5.4 A service trench running across the length of the extension was excavated to a maximum of 500mm below the reduced level surface. The trench was wholly excavated through subsoil (105) and natural sand/sandstone deposits (106). Further trenches excavated across the former playground, up to 800 mm deep produced similar results with tarmac sealing buried topsoil (104) and subsequently subsoil (105) that was not wholly excavated.

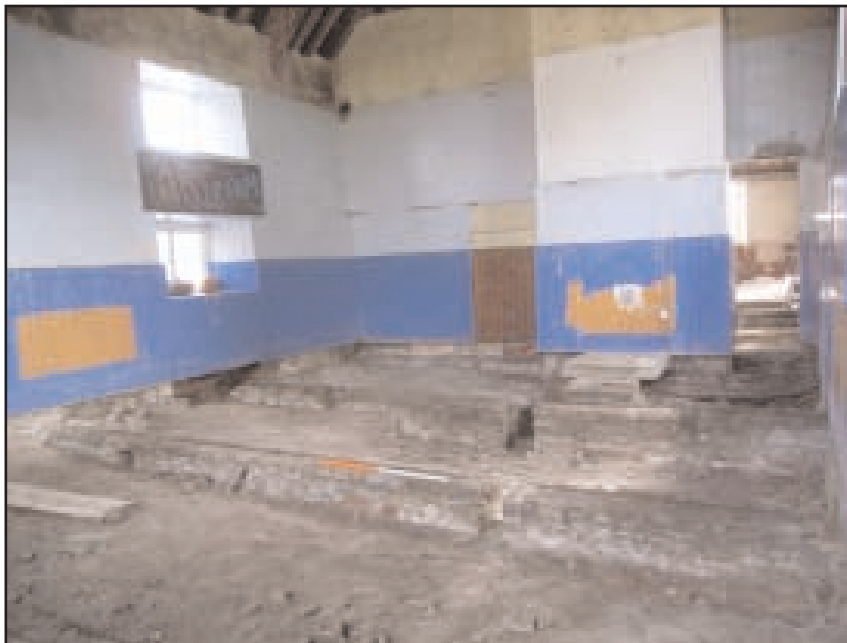
Plate 8
Beams for supporting
suspended wooden floor
as exposed in Room G2,
looking north-east,
1m scale

In Room G2, the suspended wooden floor was removed to reveal a system of beams for floor support. The beams could not be phased but all were of later post-medieval date, reflecting the use of the building as a school. A hole in the northwest corner of the room, below the suspended floor led to a drain outside the building of apparently modern date, which was not further recorded.

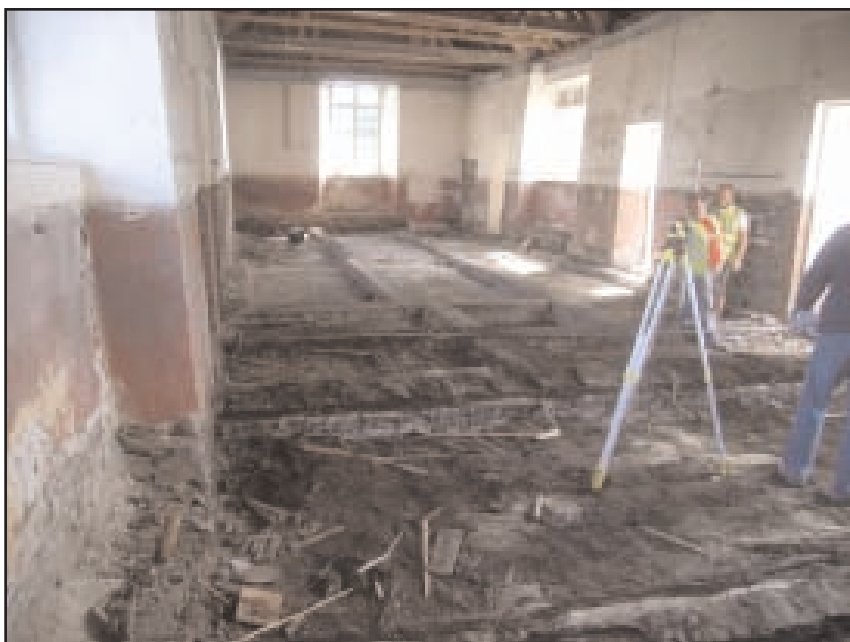
Plate 9
General view of the floor
beams in Room G1 after
removal of the suspended
wooden floor, looking west-
south-west

In Room G1, two separate phases of floor support beams were removed and these had been built over a sequence of materials that sealed an earlier floor of Pennant slabs. The pennant slabs remained only as a fragment of surface at the west end of the room that was probably the remains of a late medieval threshing floor.

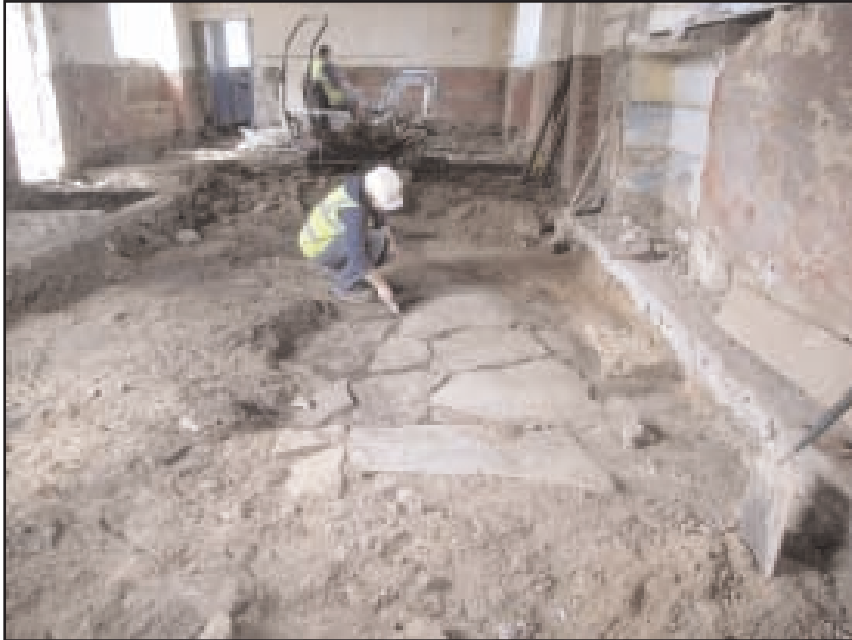
Plate 10
Working view of the
threshing floor in Room
G1, looking west

- 6.2 Elements of the barn (The original west end wall and a number of buttresses) of circa 1500 date are known to survive below ground level, therefore, the surface (114) is suggested to be contemporary with the earliest (circa 1500) phase of construction. The floor may have formed part of the threshing floor of the barn.

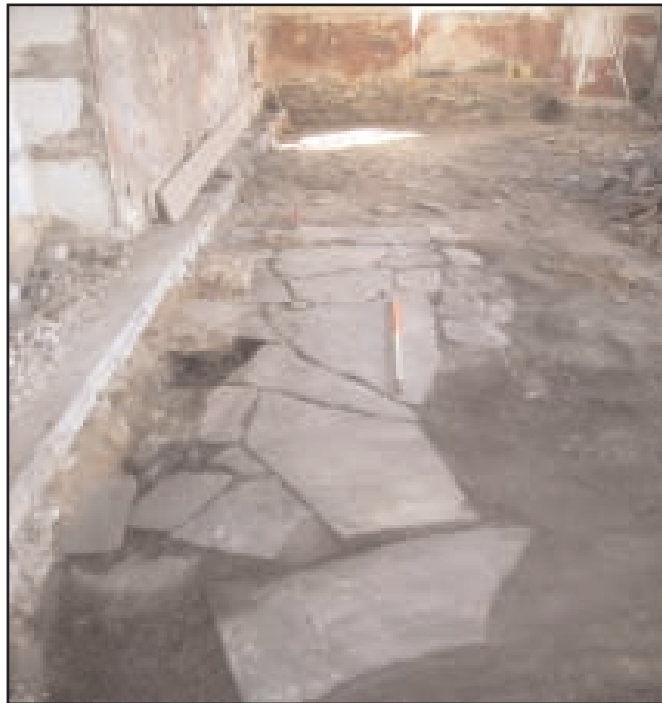
Plate 11
The threshing floor as
exposed, looking east,
1m scale

- 6.1 Archaeologically relevant alteration works within the barn comprised the removal of two phases of suspended floor that were believed to date to the later post-medieval use of the structure as a school. In Room G1, below the suspended floor beams and sealed by compacted soil and mortar deposits, parts of a surface of irregular Pennant sandstone slabs (114) was located.

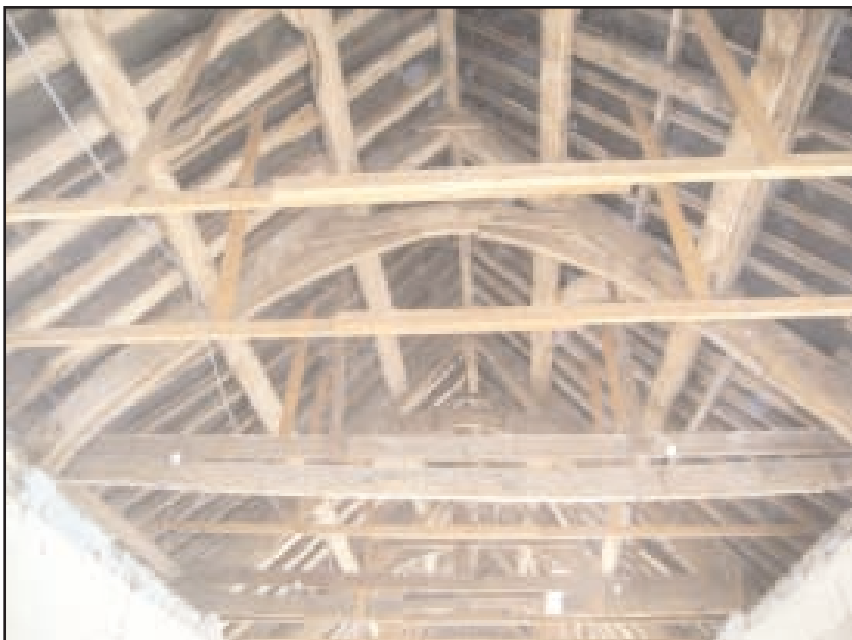
Plate 12
The timber frame supporting
the roof of Room G1,
looking east
